May 22, 2025

CITY OF COQUITLAM

**Ref: PRE-PROJECT HAZARDOUS BUILDING MATERIALS SURVEY FOR THE PLANNED RENOVATION OF
THE POIRIER ADMINISTRATION BUILDING AT 640/644 POIRIER STREET, COQUITLAM, BC**

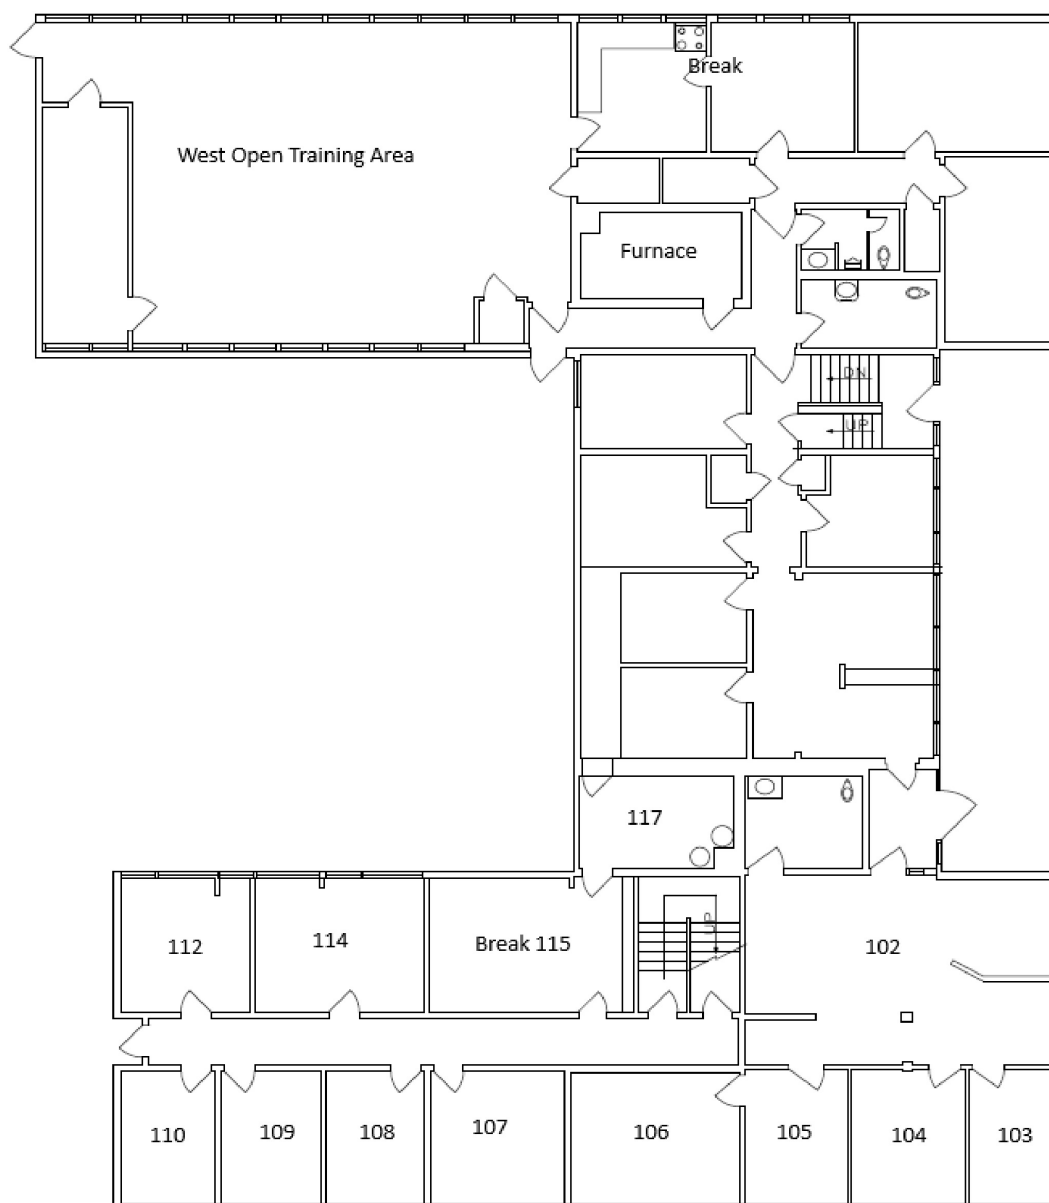
FIRST FLOOR
SCALE: $3/32" = 1'-0"$
SIZE: 11x17

POIRIER ADMINISTRATION BUILDING (SOUTH SECTION) - FIRST FLOOR

Break Room

- Potential asbestos containing sealants in wood-framed windows (see General Note #2 above).
- Non-asbestos paper backed sheet flooring.
- Non-asbestos plaster and non-asbestos filling compound on gypsum board.
- Non-asbestos cove base and adhesive.
- Non-asbestos coating on underside of metal sink.

Note: Until such time as the non-asbestos paper backed sheet flooring is removed and the sub-floor beneath uncovered, it must be assumed that asbestos containing floor tiles, asbestos containing flooring adhesive, and/or asbestos containing floor levelling compound may be present.

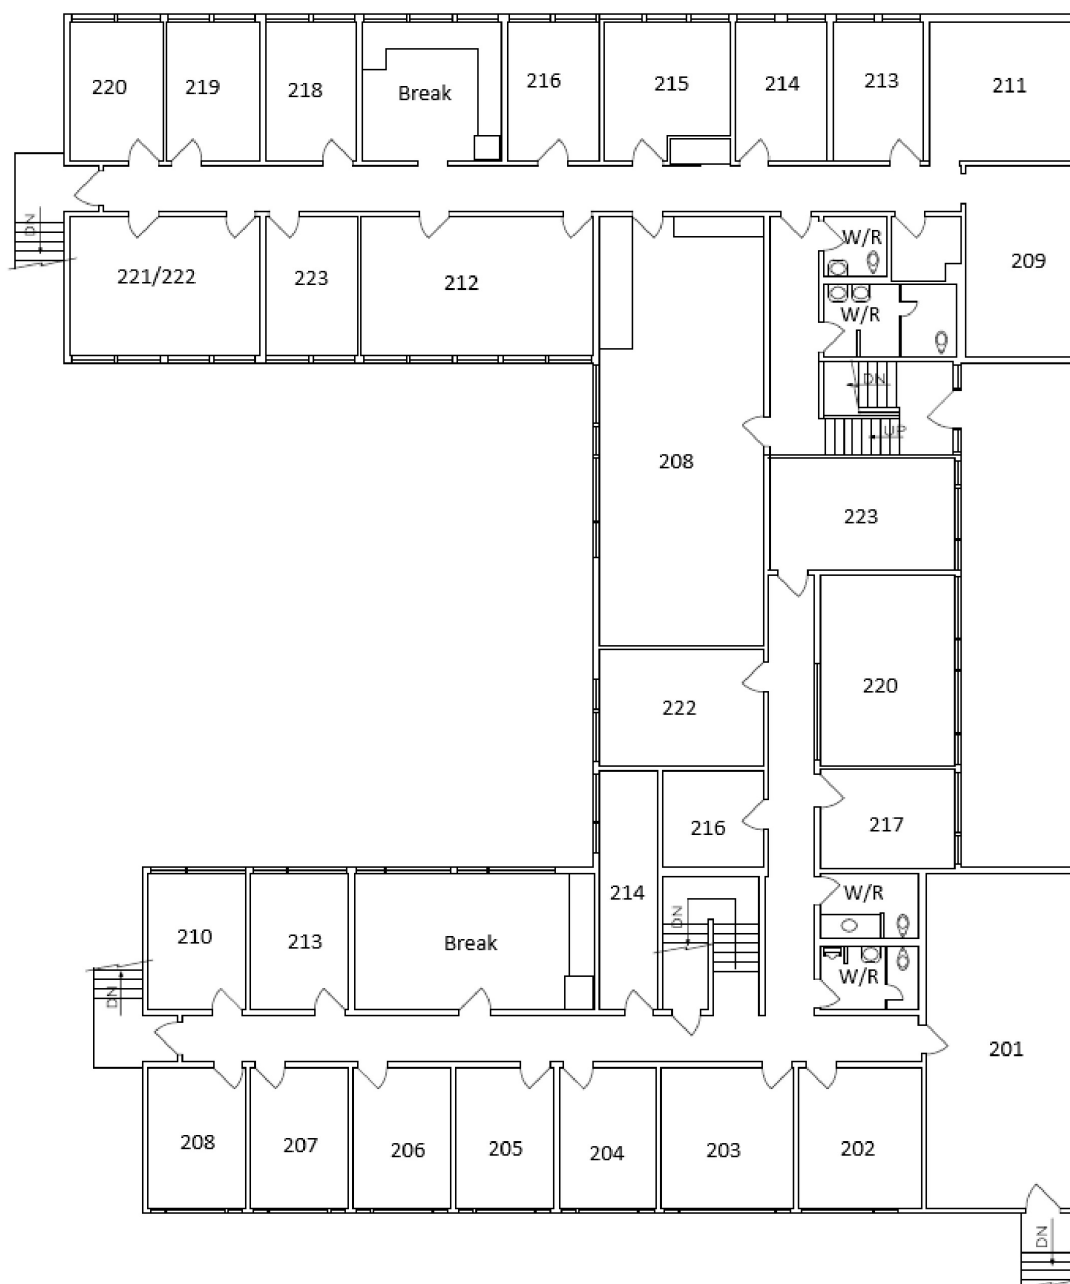
SECOND FLOOR
SCALE: $\frac{3}{32}'' = 1' - 0''$
SIZE: 11x17

POIRIER ADMINISTRATION BUILDING (SOUTH SECTION) - SECOND FLOOR

Break Room

- Asbestos containing 12" ceiling tile adhesive.
- Potential asbestos containing sealants in wood-framed windows (see General Note #2 above).
- Non-asbestos vinyl floor planking.
- Non-asbestos plaster.
- Non-asbestos cove base and adhesive.
- Non-asbestos coating on underside of metal sink.

Note: Until such time as the non-asbestos vinyl floor planking is removed and the sub-floor beneath uncovered, it must be assumed that asbestos containing floor tiles, asbestos containing flooring adhesive, and/or asbestos containing floor levelling compound may be present.

Men's Washroom, and Women's Washroom

- Non-asbestos vinyl floor planking.
- Non-asbestos plaster and non-asbestos filling compound on gypsum board.
- Non-asbestos cove base and adhesive.

POIRIER ADMINISTRATION BUILDING (NORTH SECTION) - SECOND FLOOR**Break Room**

- **Asbestos** containing floor levelling compound (concealed beneath a layer of non-asbestos paper backed sheet floorings and other building materials).
- **Asbestos** containing 12" ceiling tile adhesive.
- **Asbestos** containing coating on underside of metal sink.
- Potential **asbestos** containing sealants in wood-framed windows (see General Note #2 above).
- Non-asbestos plaster.
- Non-asbestos cove base and adhesive.

**Staff Washroom, and
Student Washroom**

- **Asbestos** containing floor tiles (concealed beneath a layer of non-asbestos floor tiles, non-asbestos flooring adhesive, and other building materials).
- Non-asbestos plaster.
- Non-asbestos cove base and adhesive.
