Site Observation Form

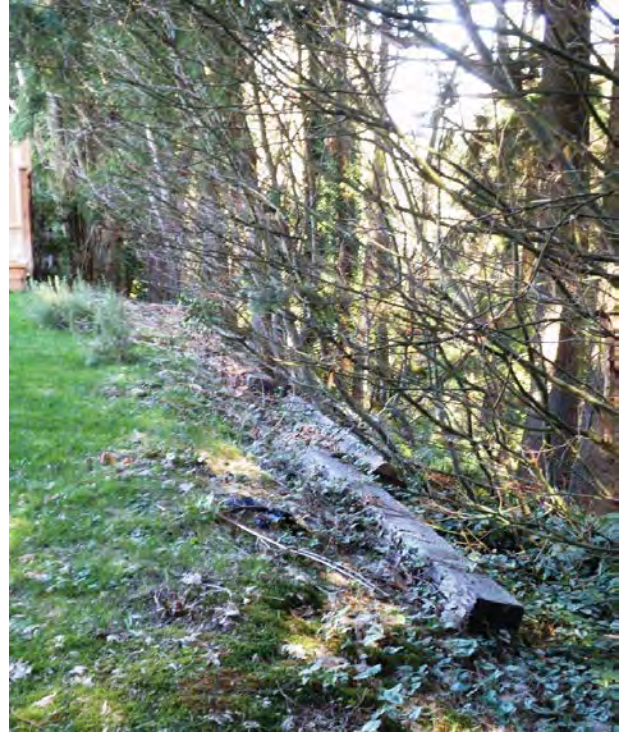
937 Canyon Court

Comments Slope failure below. Outer edge lawn subsided.

Headscarp of Failure Below Property Along Sundial Creek Tributary

Wood retaining wall should be replaced.

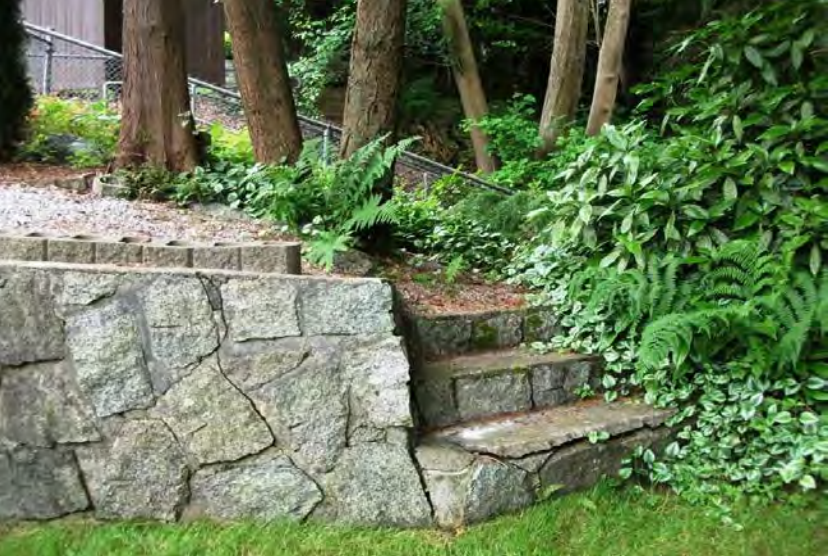
Crack in Block and Mortar Stairs From Settling

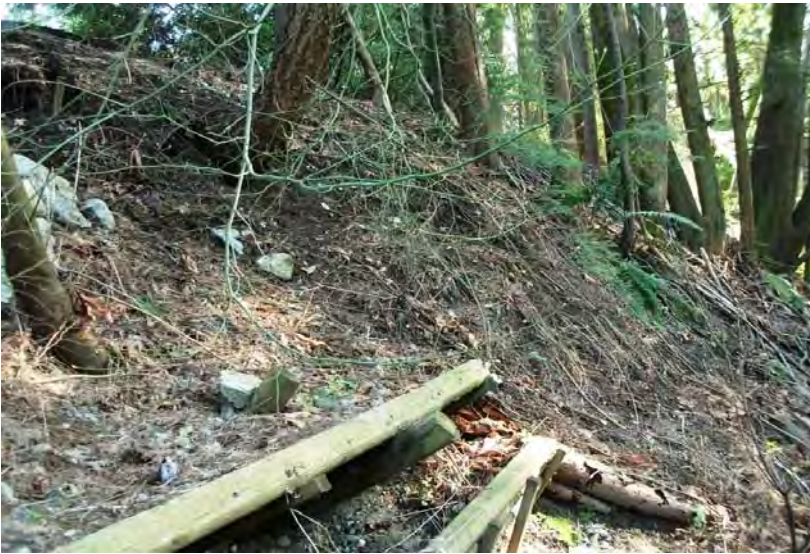
Possible Nose of Fill At Crest, Centre of Yard

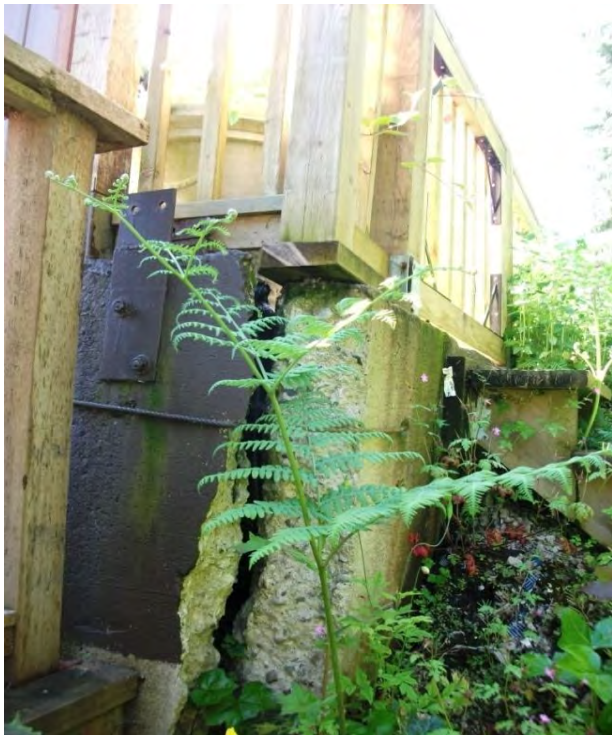
Crack in northwest corner of concrete retaining wall.

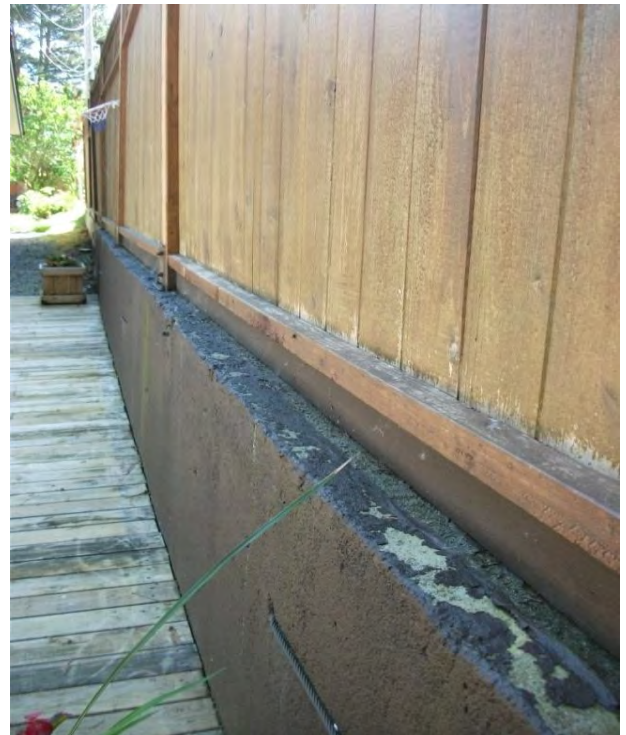
Concrete wall on north side of property, no cracks or alignment issues.

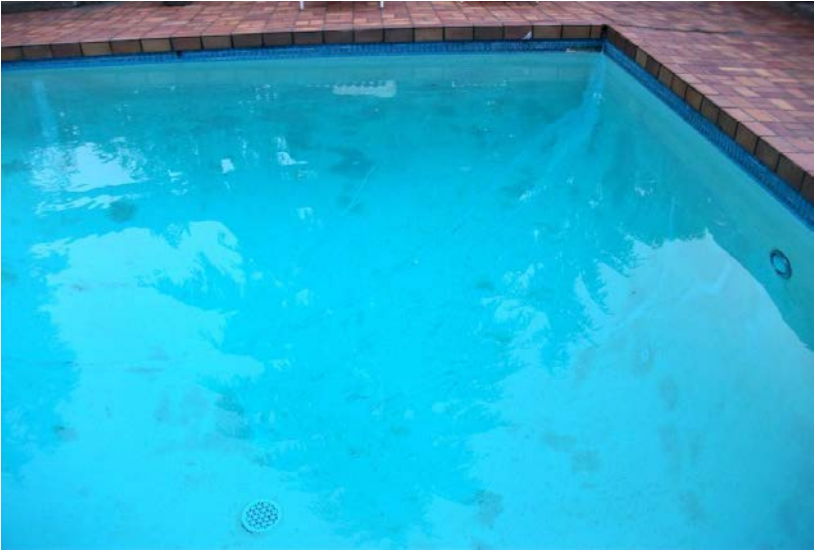
Pool With Repaired Cracks

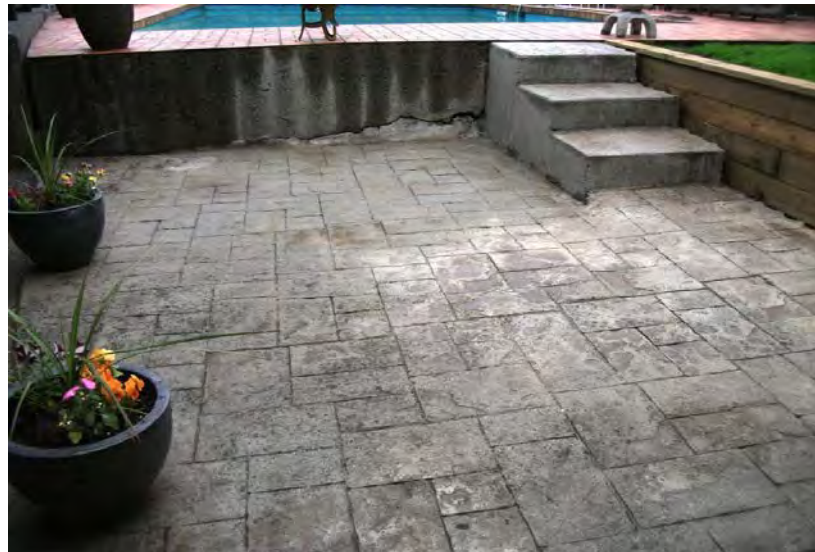
Patio Beside Pool With Subsidence Indicators

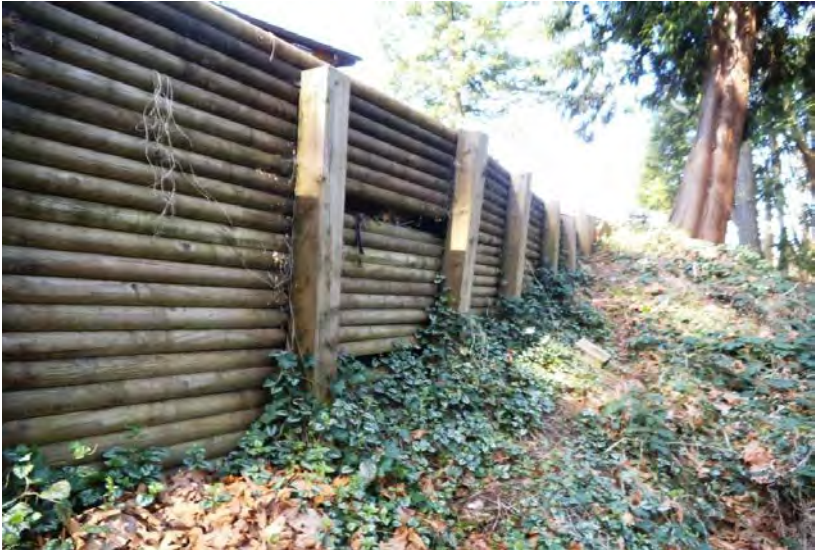
Central Wall Section With Broken Uprights and Ties

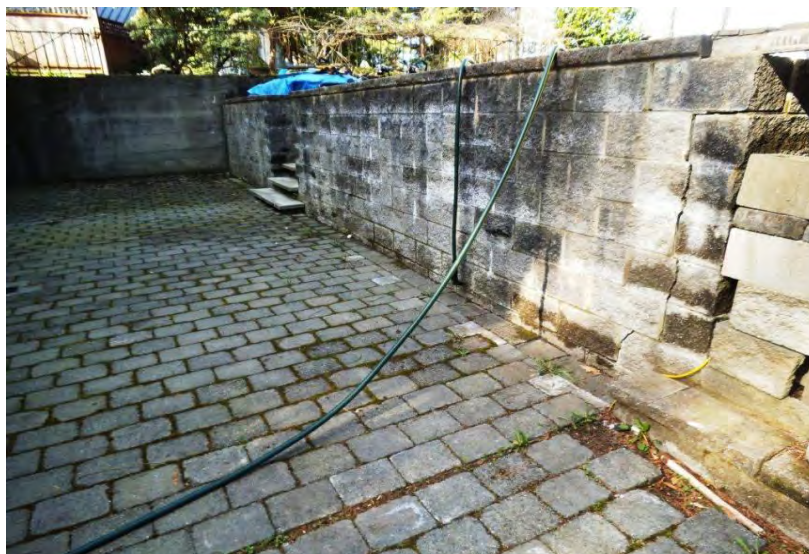
Patio Wall With Vertical Crack Near Crest

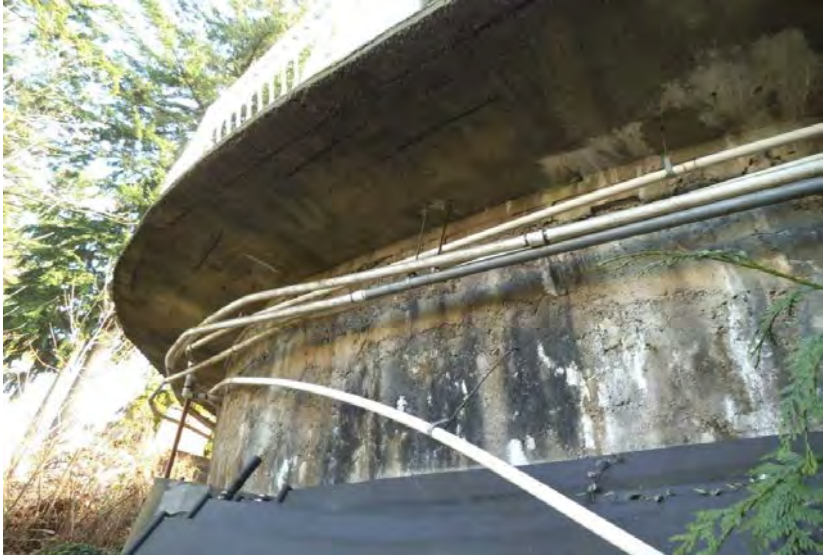
Pool Structure From Below With Rebar, Pipes, No Cracks or Seeps

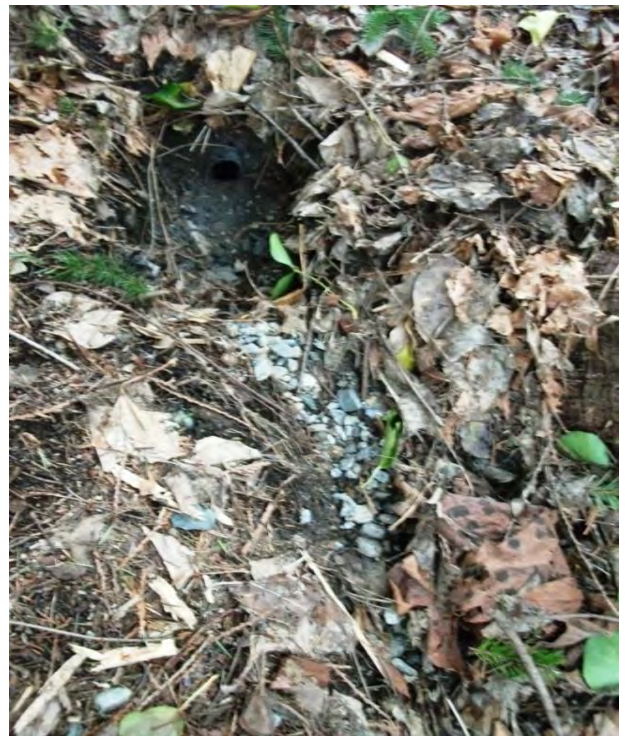
Roof? Pipe Outlet, Northeast Slope Below Crest

With Indication High Flow

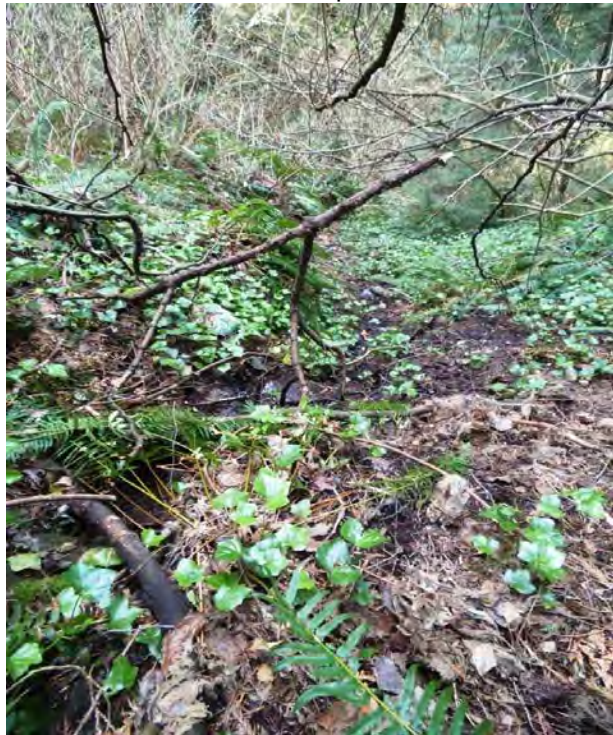
Wet Zone Below Pipe, East Side

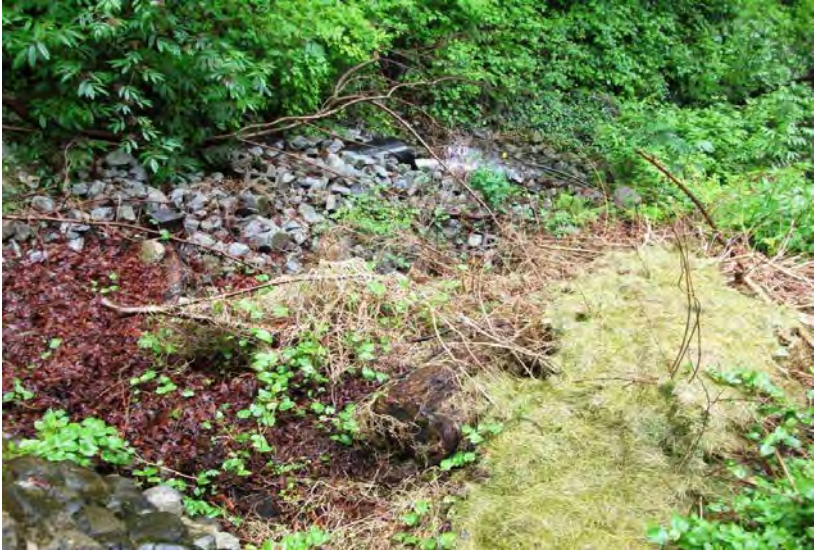
Gully below stormwater outlet, July 2011

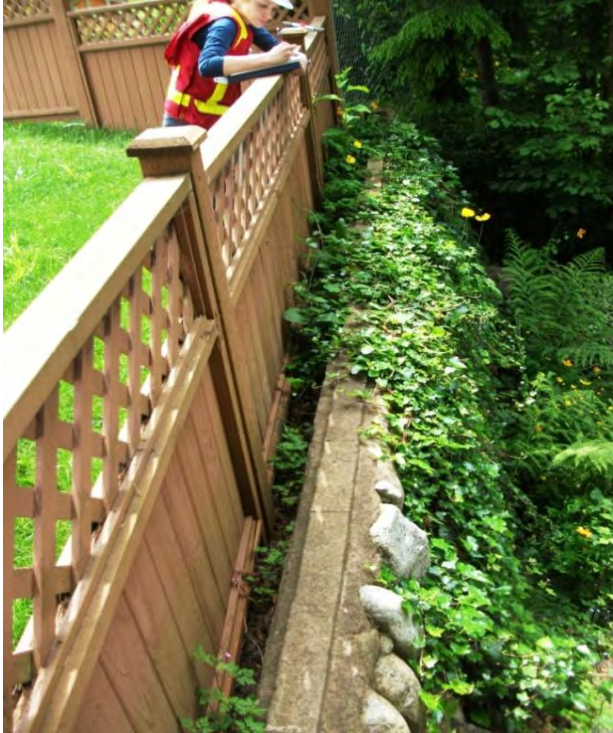
Concrete and boulder lower retaining wall with small cracks

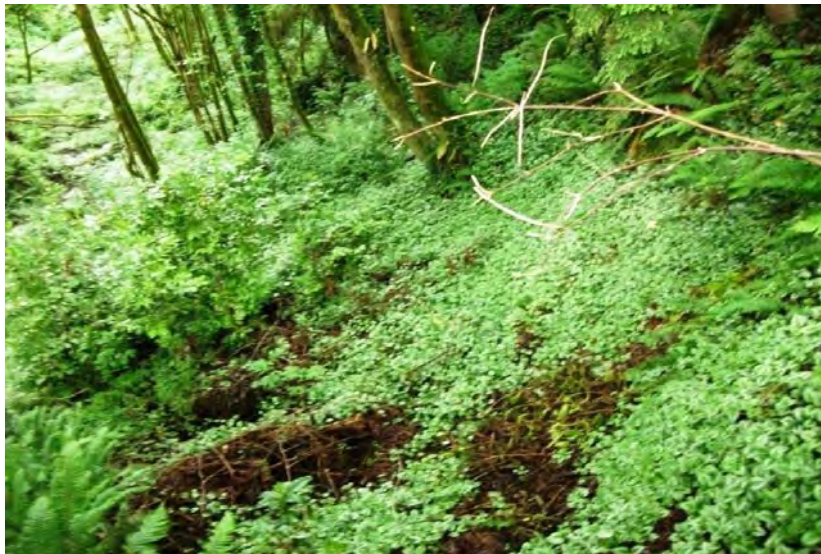
Revegetated Failure Scar Under Gabions

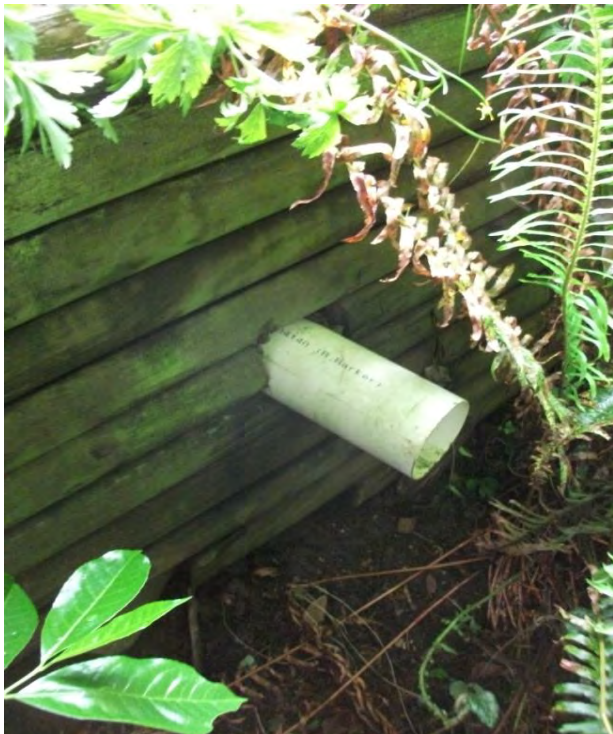
Drain Pipe Through Wooden Tie Retaining Wall

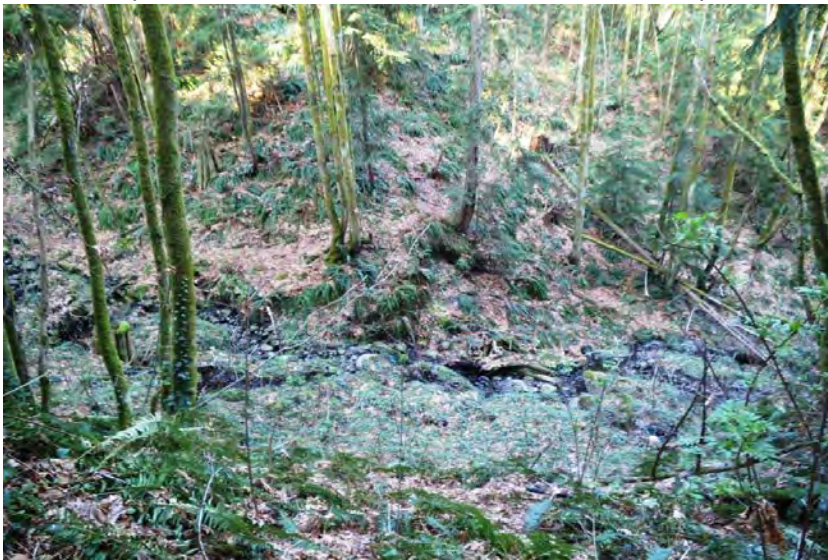
View of Deposit From Erosion Feature, Where Cobbles Displace Stream

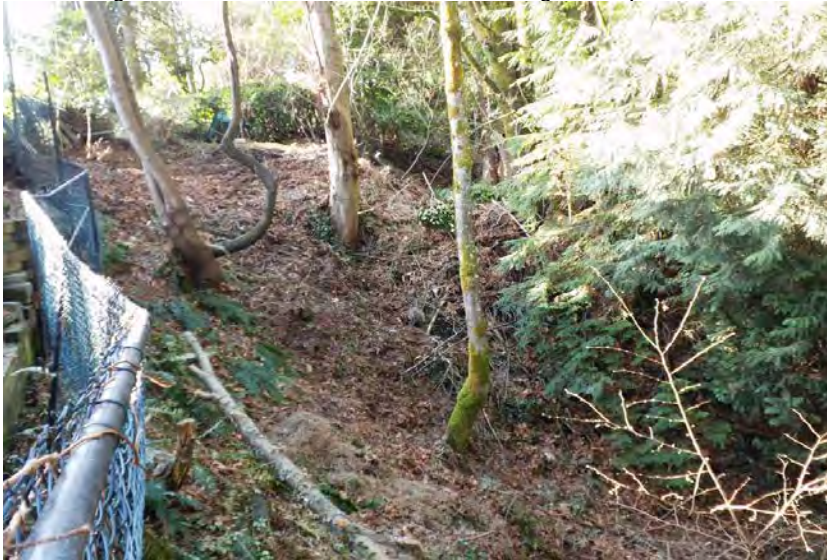
South Edge of Swale Below Crest With Damaged Maple Trees

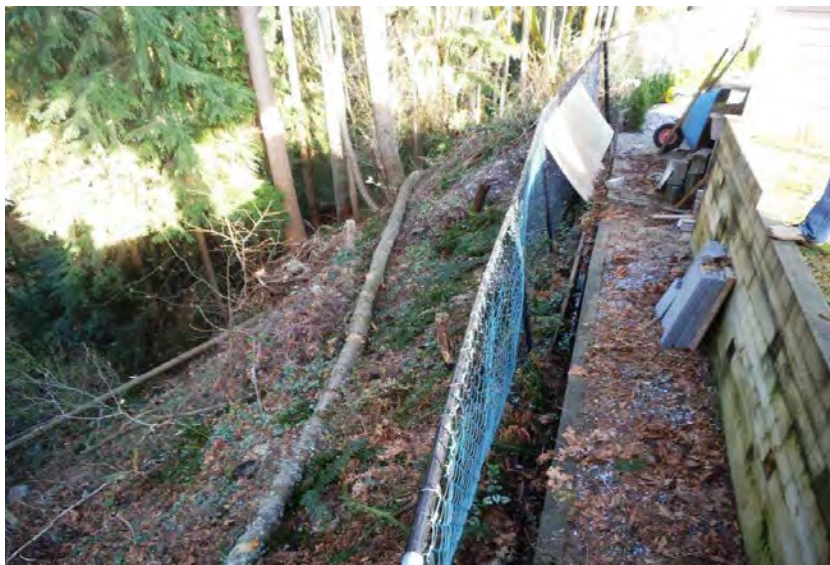
View Across Centre of Crest Area With New Soil Fill

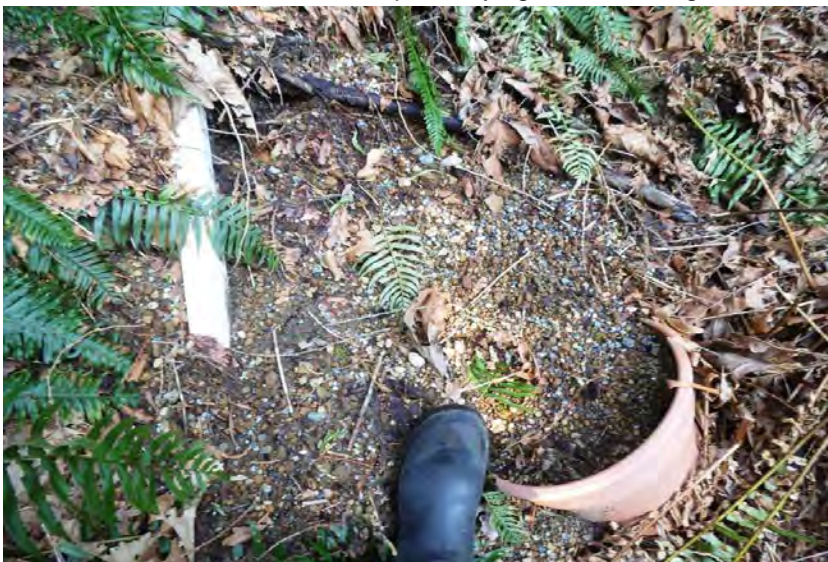
Evidence of Water Flow Downslope Carrying Gravel, Filling Plant Pot

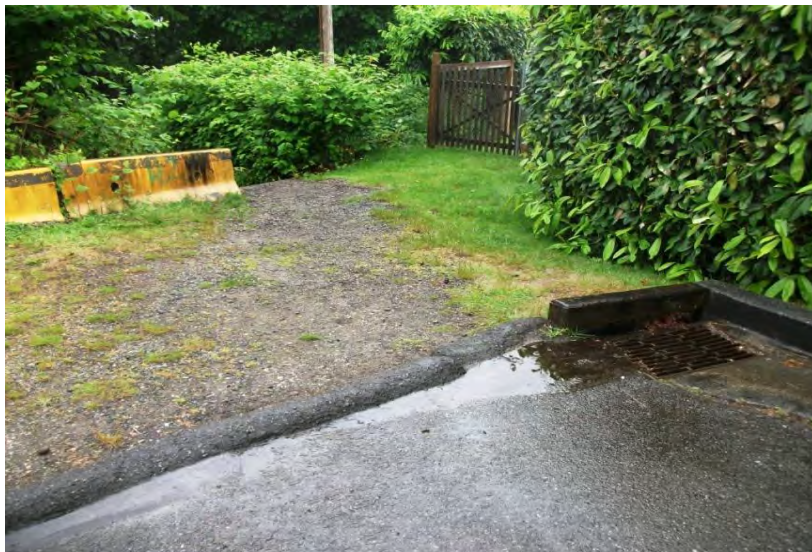
End of Blue Mountain with Potential Water Flow Past Grate to Slopes Below

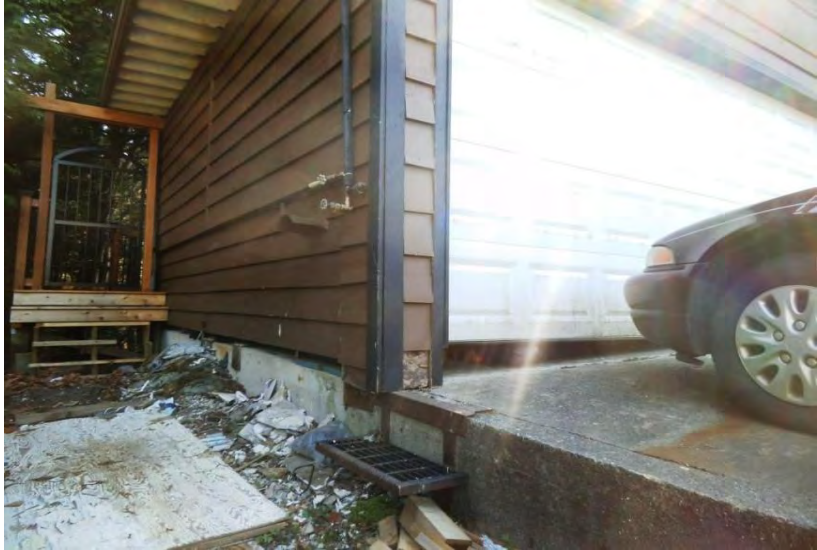
Gaps Below Garage Wall and Door, Suggest Some Subsidence or Jacking of Building Frame

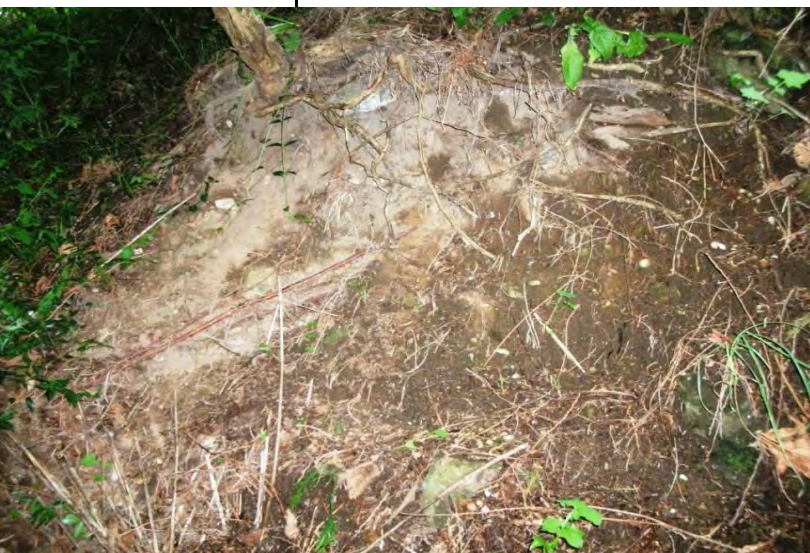
Shallow Soil Slough At Edge of Fill, Exposes Sands

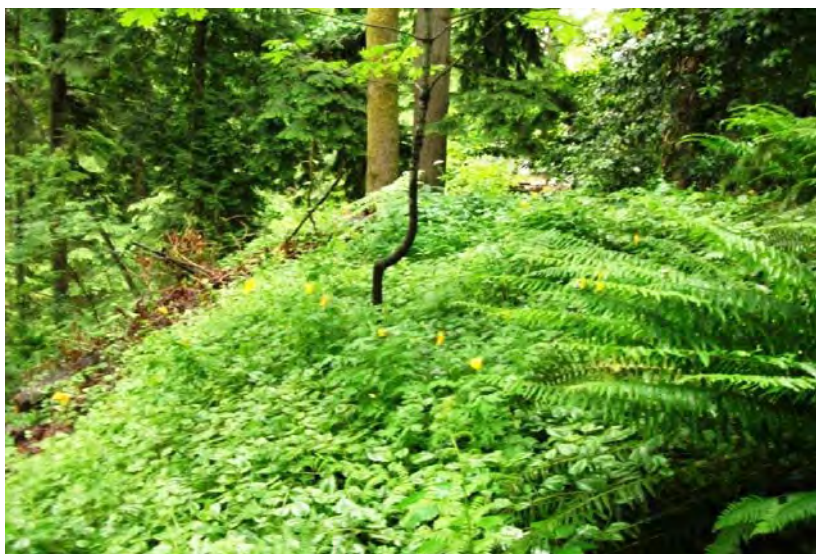
Lobe of fill about 4 m L, 8 m W and 1 m D at crest below centre of yard

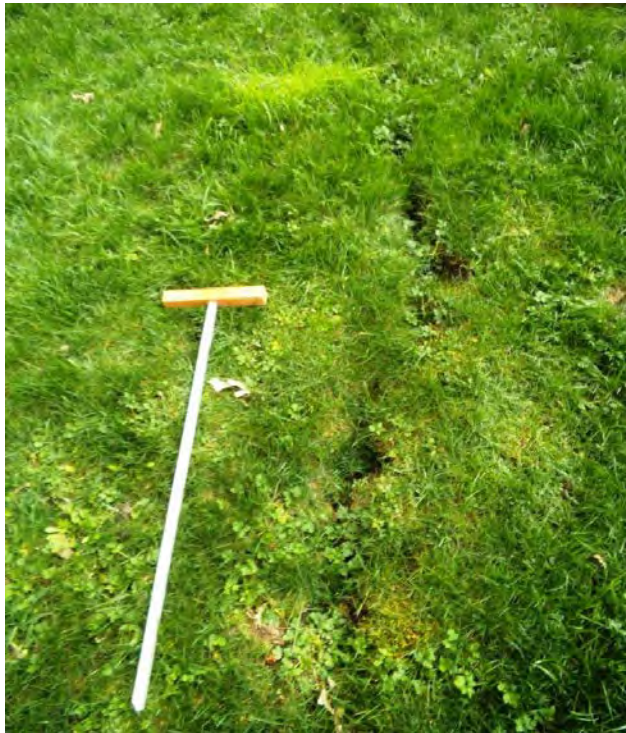
Tension crack or settlement feature, centre north half of back yard

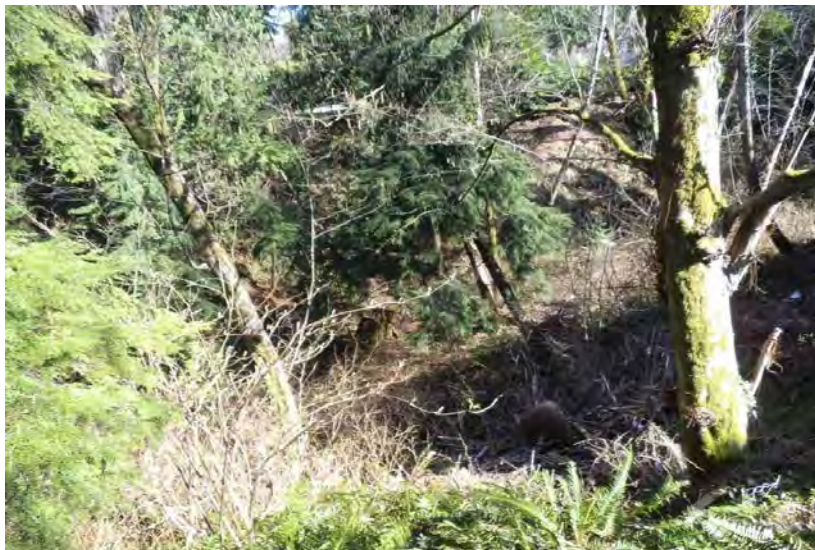
Fill below central part of crest and retaining wall

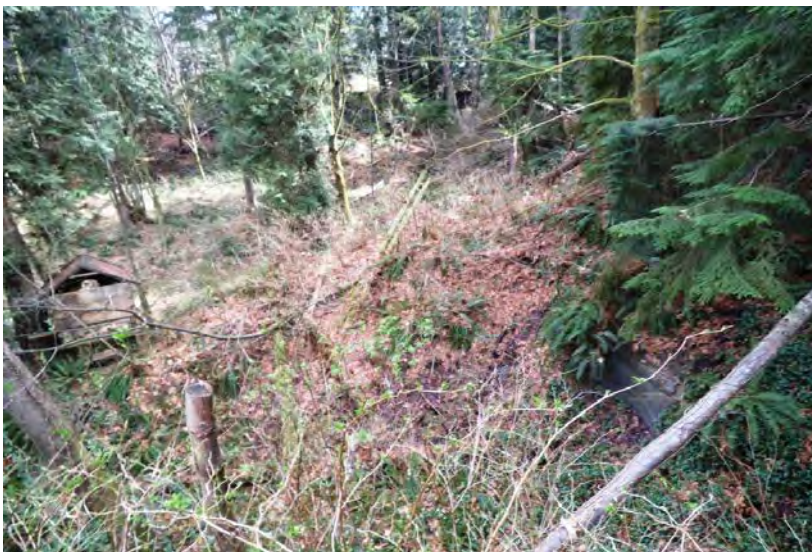
Ravine Park East of Lot. Vertical Soil Face Lower Right Corner

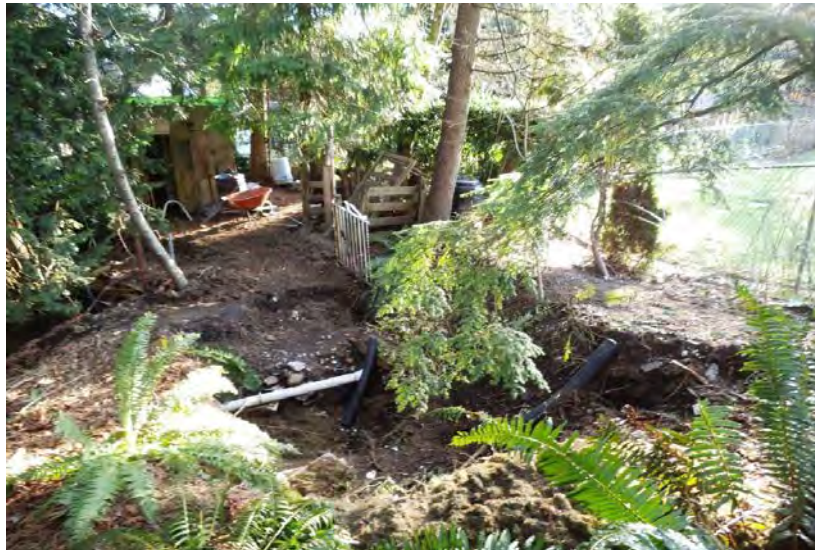
Head of Suter Brook, Excavation At Crest For Private Land Drainage Pipes
