GEOTECHNICAL INVESTIGATION AND STABILITY ASSESSMENT

Corona Crescent Area, Coquitlam, BC

Report Number: 1314470330-001-R-Rev1

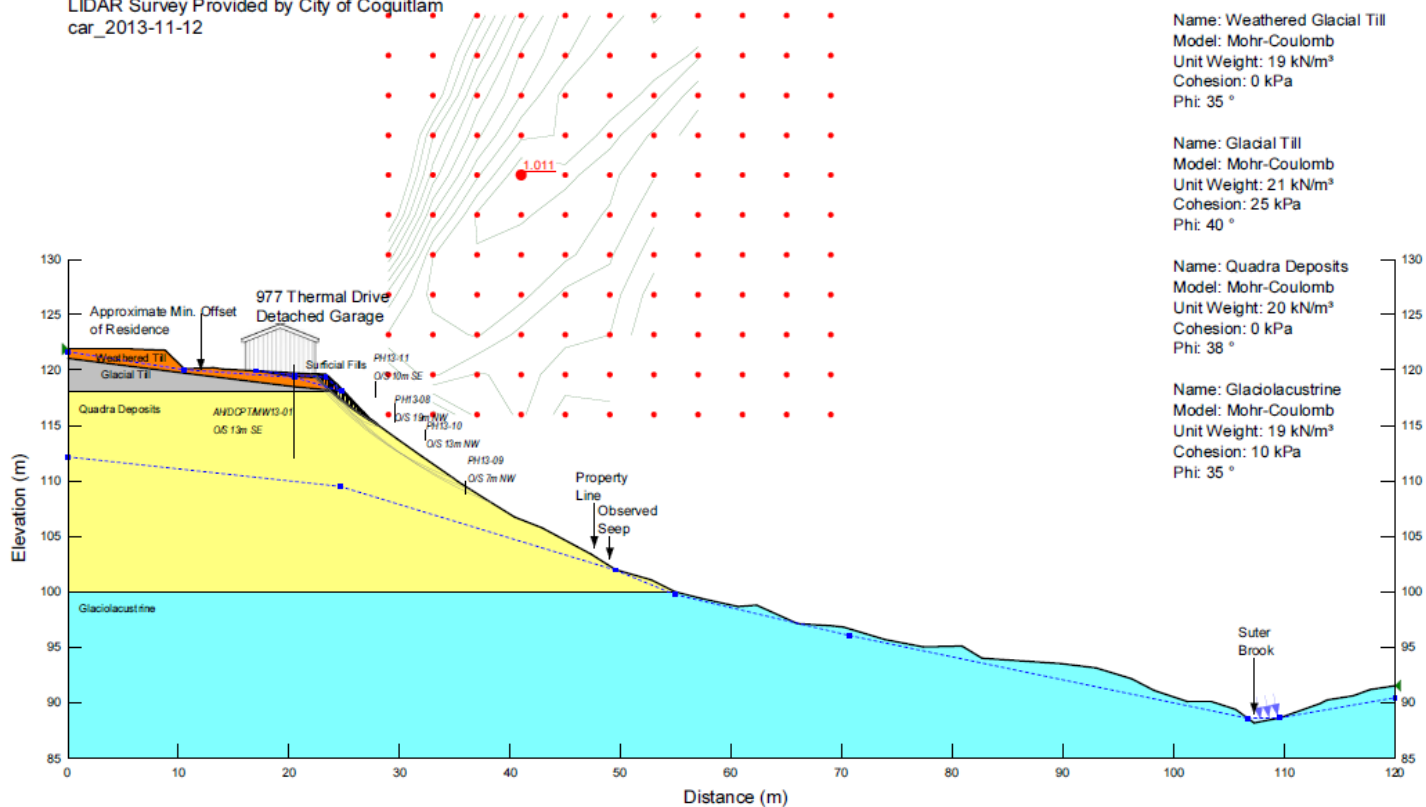
TITLE **STATIC SLOPE STABILITY ANALYSIS**
SECTION A-A' GARAGE (SHALLOW FAILURE)

The results of the analyses for the four sections (A-A', B-B', C-C', and D-D') indicate that the factor of safety against slope failures directly impacting residences are generally in excess of 1.3 as summarized in Table 7. However, factors of safety for decks, detached garages, and other portions of the properties closer to or downslope of the crest of the ravine slopes are generally lower than those potential slope failure planes extending to the residences. Notably, the garage and carport located at 977 Thermal Drive has FoS values of less than 1.1 (Figure 4B). Decks and patios extending at or close to the ravine crest at 976, 984, and 992 Corona Crescent are also anticipated to have FoS values significantly lower than those of the residences, particularly for those not founded on dense native materials. These factors of safety are consistent with observations on site, where leaning and "pistol-butted" trees were noted during the field reconnaissance suggesting creep-type movements within the surficial soils.

The analysis also indicated that there is potential for instability within existing surficial fills that have been placed along the crest of the slopes investigated. It should be noted that failure surfaces generally passing through the 992 Corona Crescent residence along section D-D' are anticipated to impact the residence at 2244 Park Crescent, where the toe of the slip surface daylight.

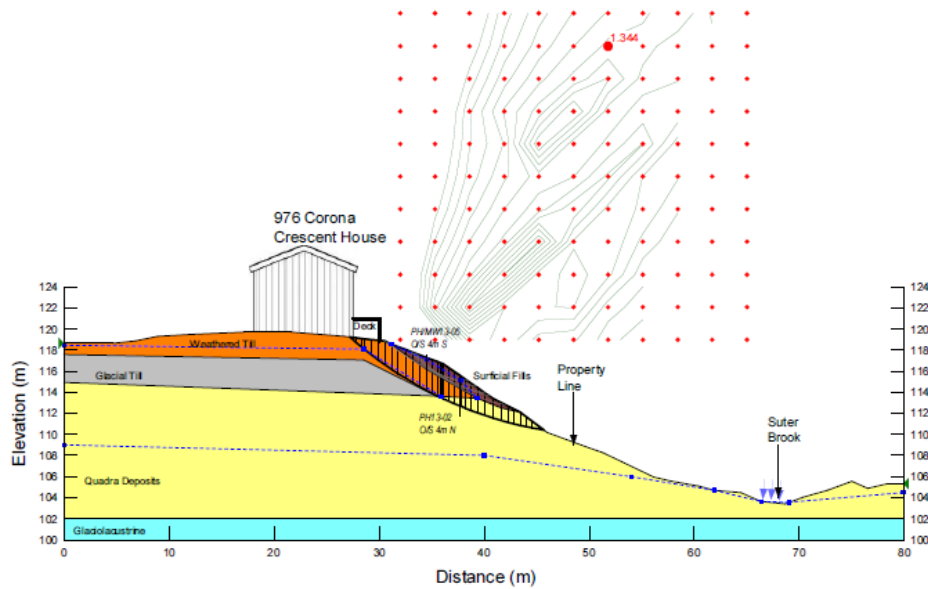
TITLE **SEISMIC SLOPE STABILITY ANALYSIS
 SECTION B-B'**

In addition to the above analysis considering static loading cases, the stability of the ravine slopes was analysed considering seismic loading conditions in accordance with APEGBC "Guidelines for Legislated Landslide Assessments for Proposed Residential Developments in BC". A design peak firm ground horizontal acceleration of 0.246g (24.6 percent of the acceleration of gravity), corresponding to a 10% in 50-year seismic event (1 in 475-year) was utilized in the analyses, consistent with DNV risk criteria for existing residential development. A factor of safety of 1.0 or more determined using pseudo-static analysis methods is generally considered acceptable for unsaturated slopes subject to earthquake loading.
