Preliminary - Arboricultural Inventory and Report

For:
The City of Coquitlam

Site Location:
560, 594, 596, 600, and 602 Sydney Avenue
Coquitlam, BC

Date: 2021.04.05

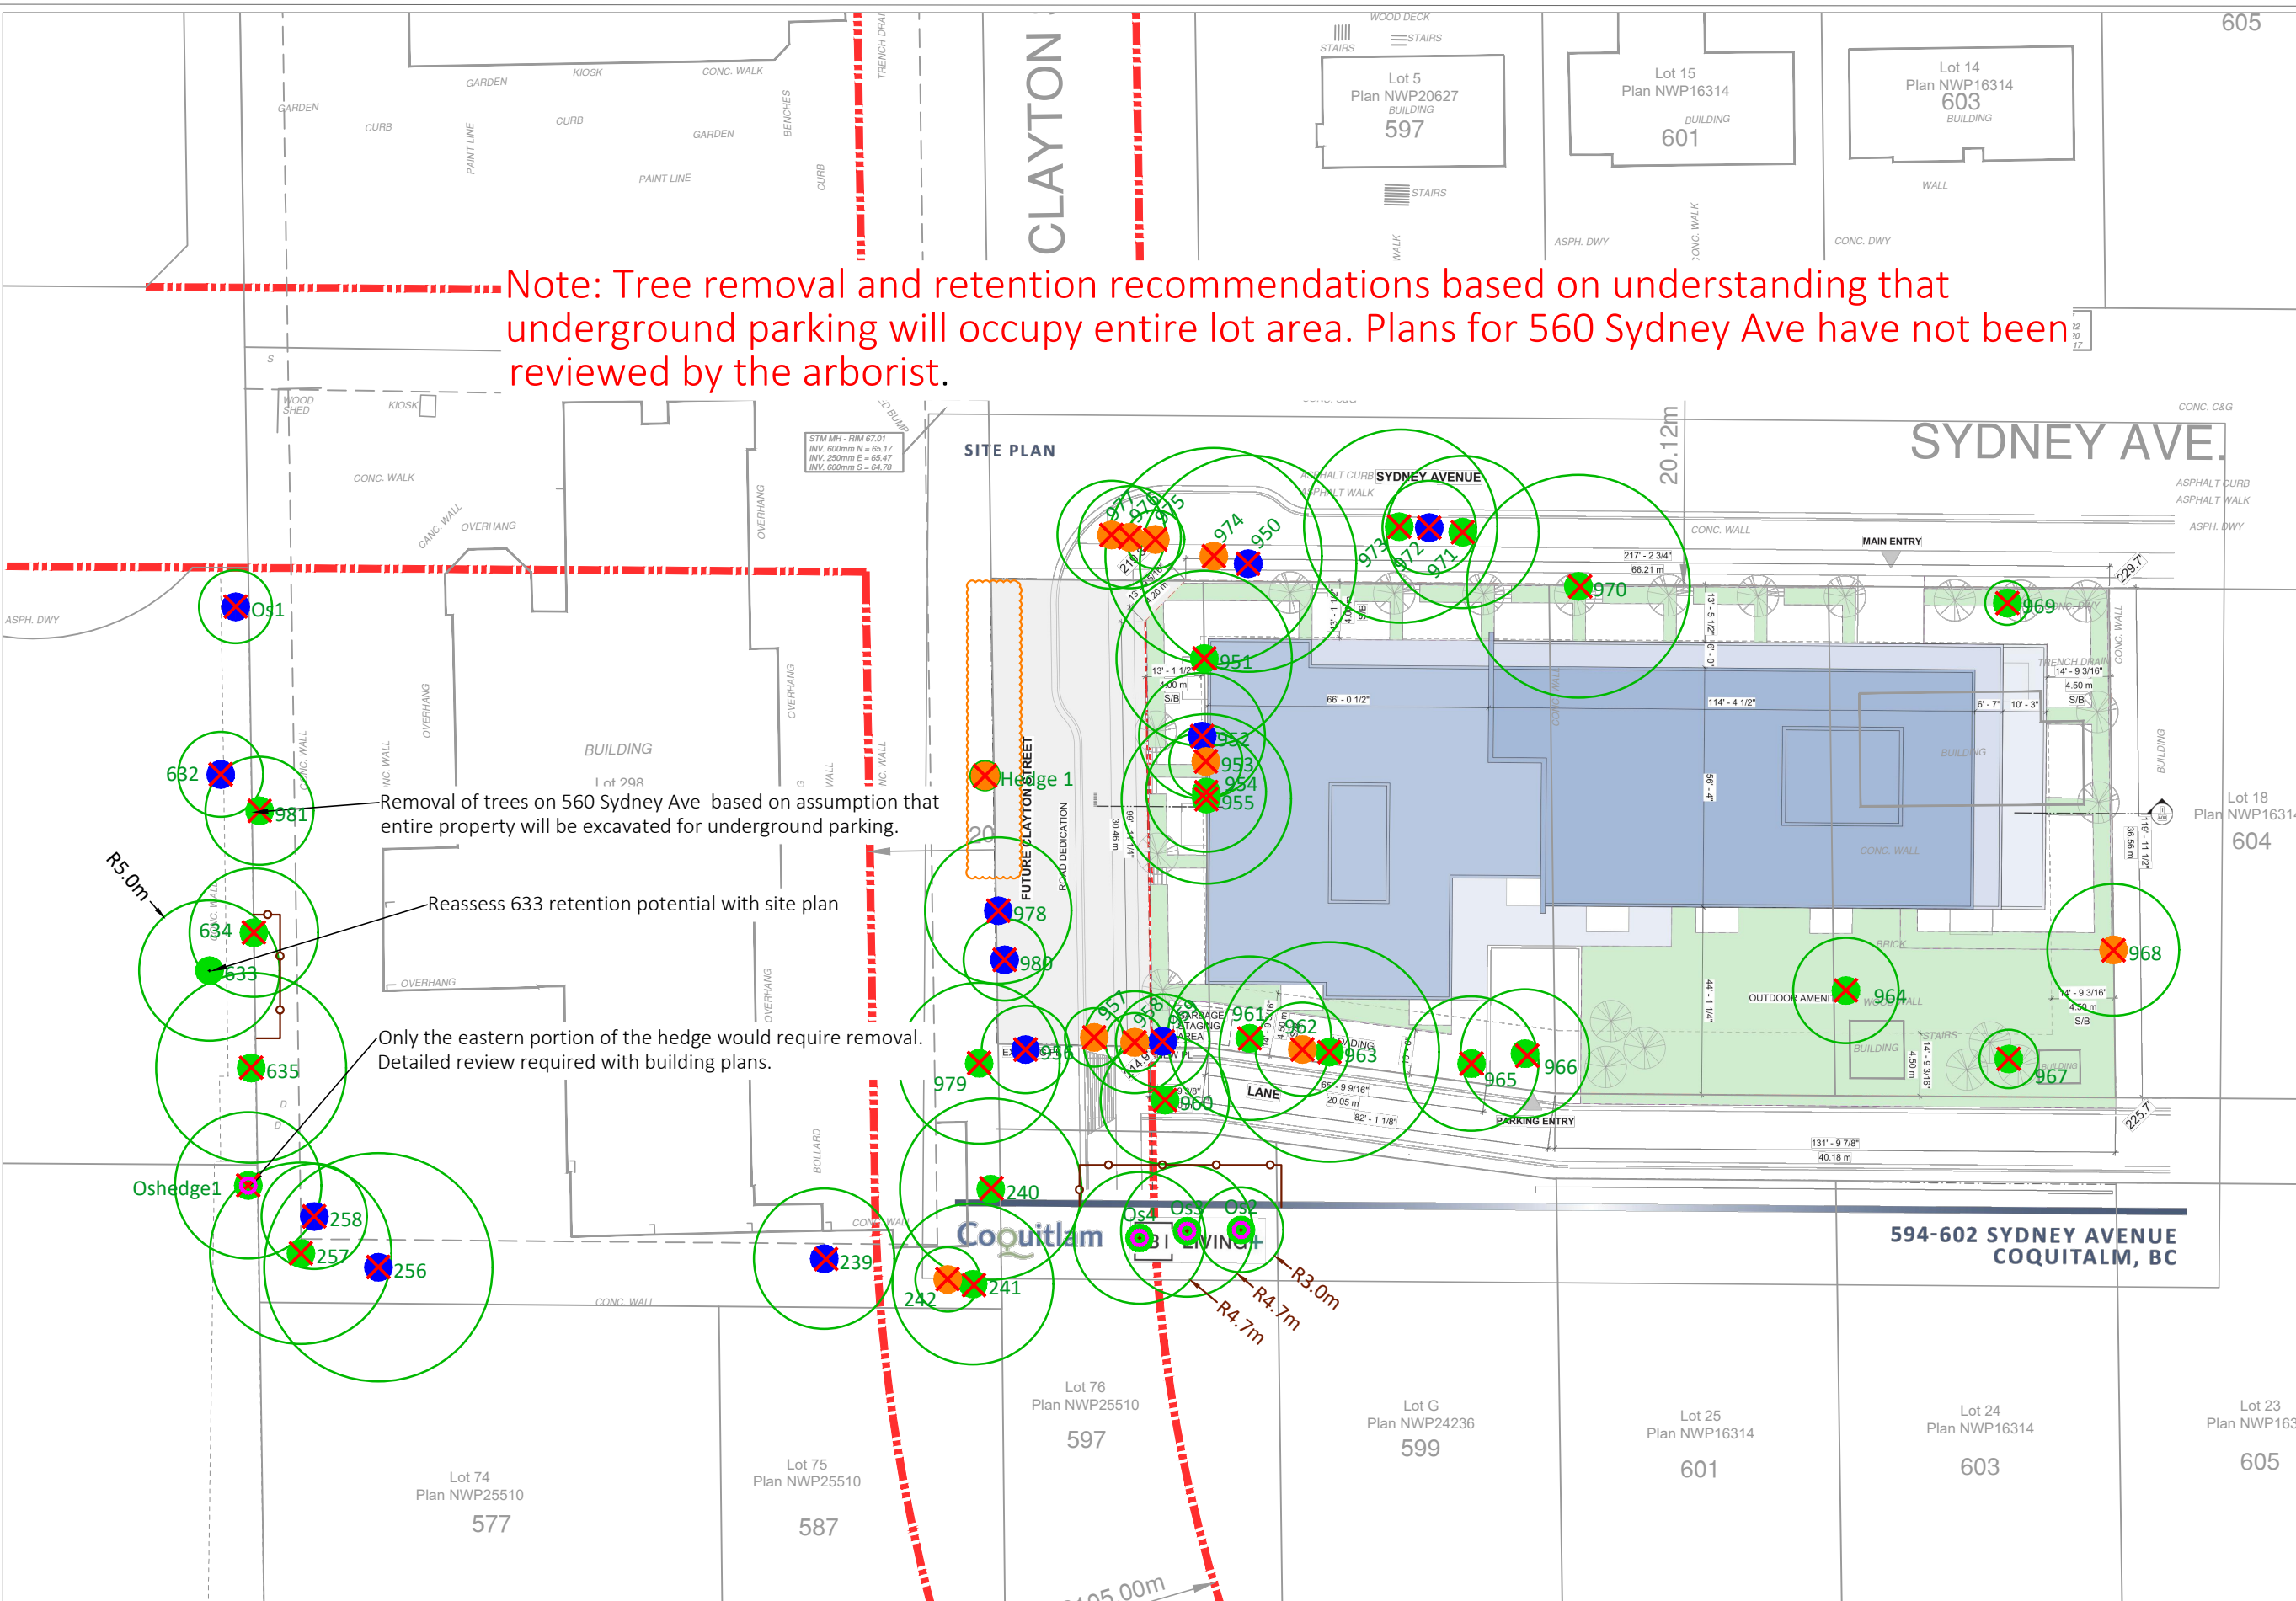
Removal of trees on 560 Sydney Ave based on assumption that entire property will be excavated for underground parking.

Only the eastern portion of the hedge would require removal. Detailed review required with building plans.

Reassess 633 retention potential with site plan

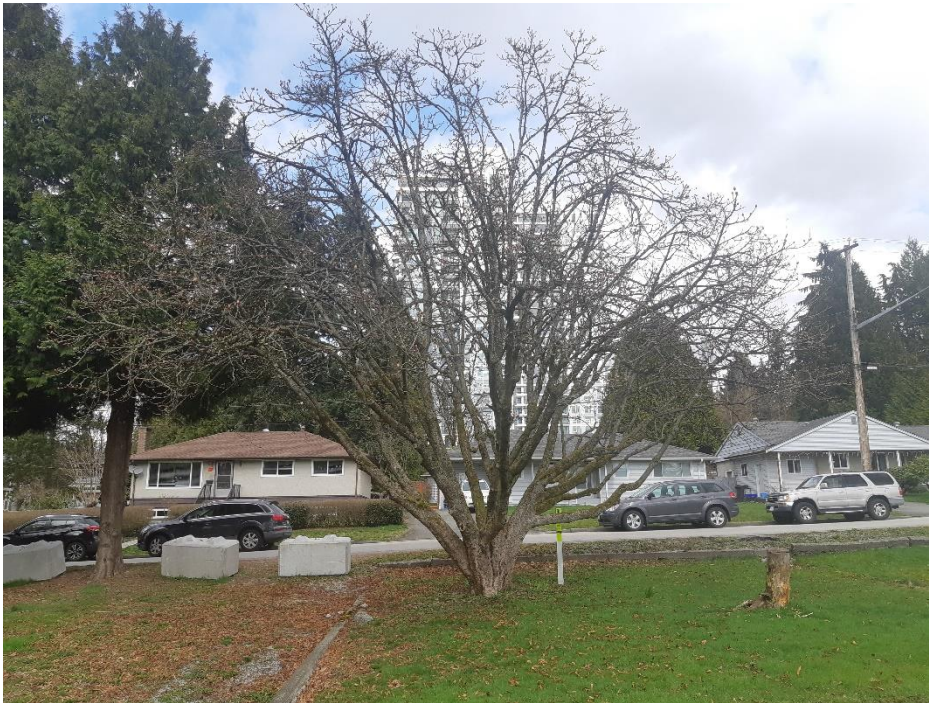
Photo 1. Tree 970, an open grown Horsechestnut on Sydney Avenue

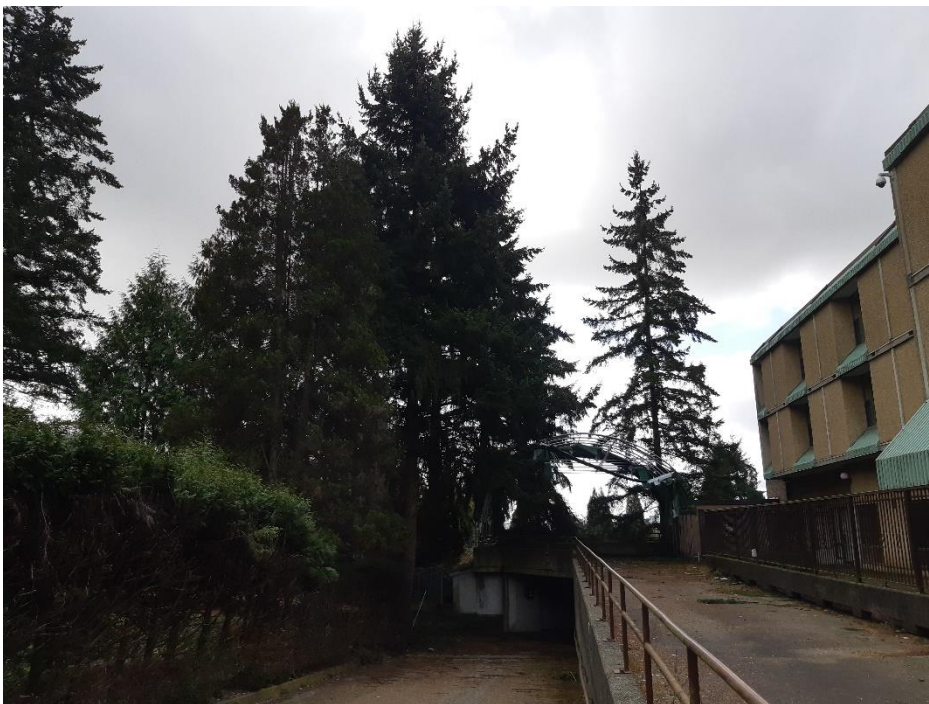
Photo 2. Average Douglas fir are good on the site. Open grown canopies with good vigor and form

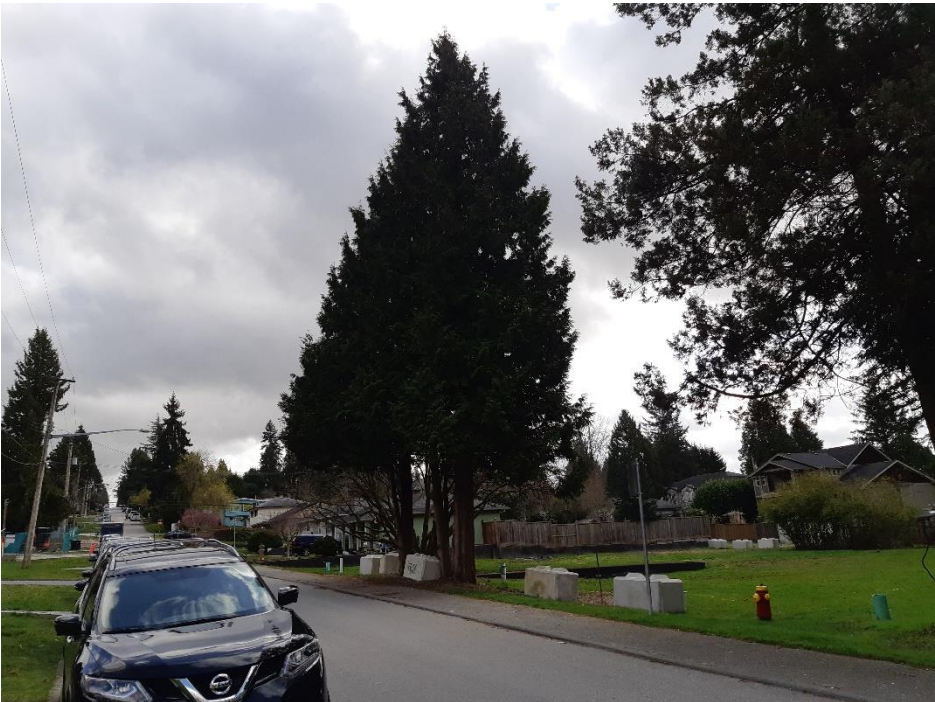
NA	972	City	Western Red Cedar	Thuja plicata	32	10	3	Good	Subordinate to 973, has asymmetrical crown. Only retain with 972.	Medium	Remove	In conflict with proposed road widening.	3.2
NA	973	City	Western Red Cedar	Thuja plicata	66	15	4	Good	Good taper and crown condition. Largest in group of three. Asphalt sidewalk over northern root zone has minor heaving.	High	Remove	In conflict with proposed road widening.	6.6

Photo 3. Cedars on Sydney Ave, 971, 972, 973

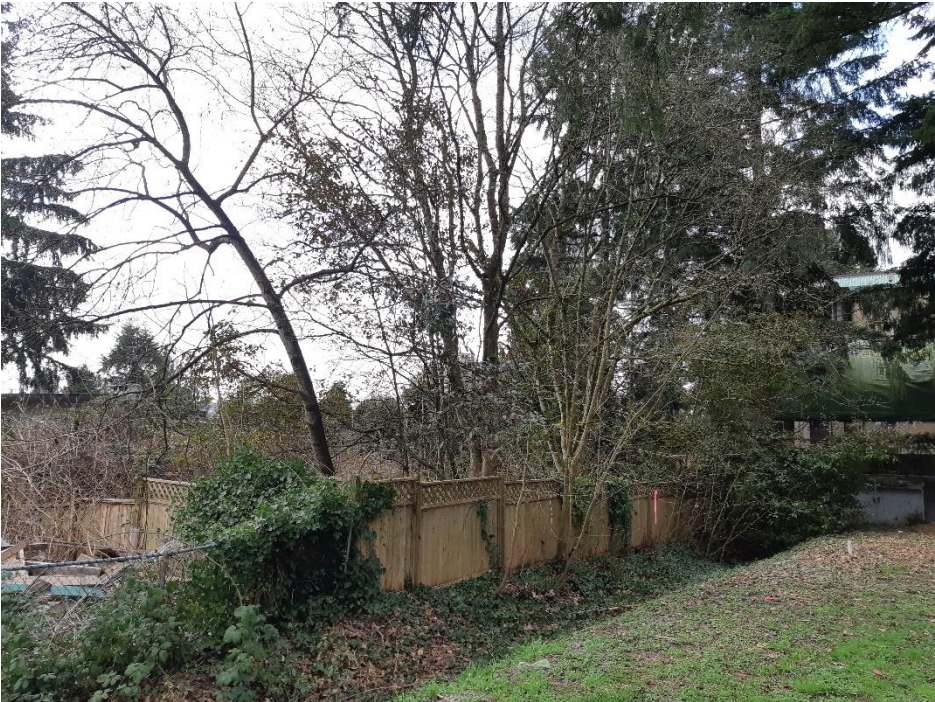
Photo 4. Offsite trees OS2, 3, 4, Are south of the proposed lane and separated from the site by an old ditch

- Offsite trees that have root zones overlapping with project area are generally good candidates for retention.
- Tree Os2, OS3, and Os4 can all be retained south of the new lane. Note that they will probably be removed by the project to the south.
- One tree, 633, could possibly be retained, depending on the extent of the proposed work.
- A notable cedar hedge (OS Hedge) located at 549 Dansey Avenue creates a visual break between the neighbouring apartment buildings and the proposed project.
 - The proposed development will require removal of the end tree or trees.
- Permission from neighbouring property owners will be required to remove offsite trees.

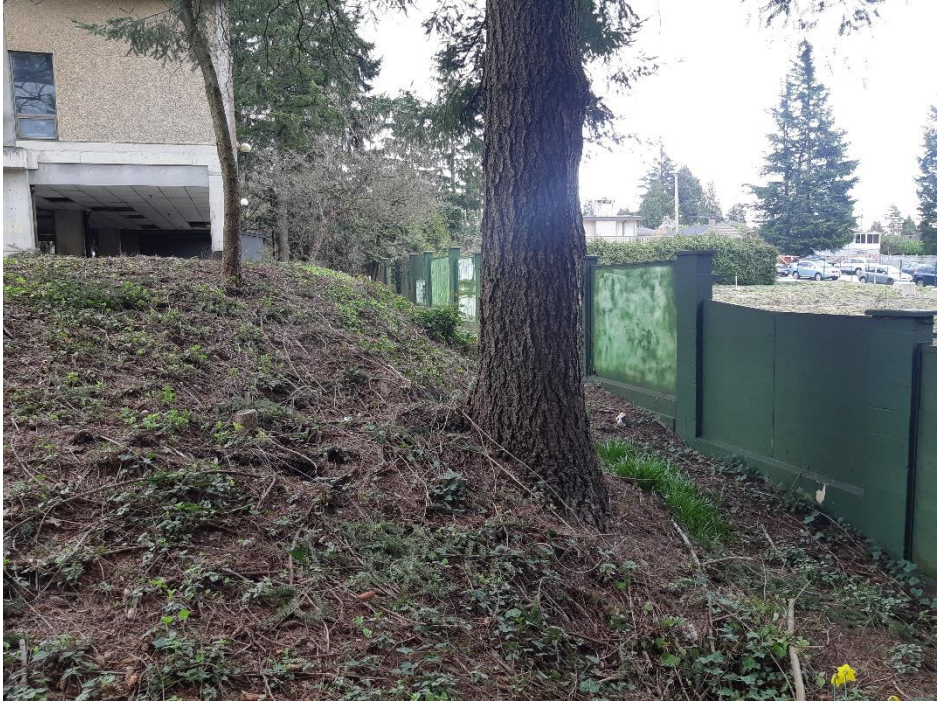
Photo 5. Tree 256 showing grades in southwestern corner of property, successful retention of trees in this area would require attention to grading.

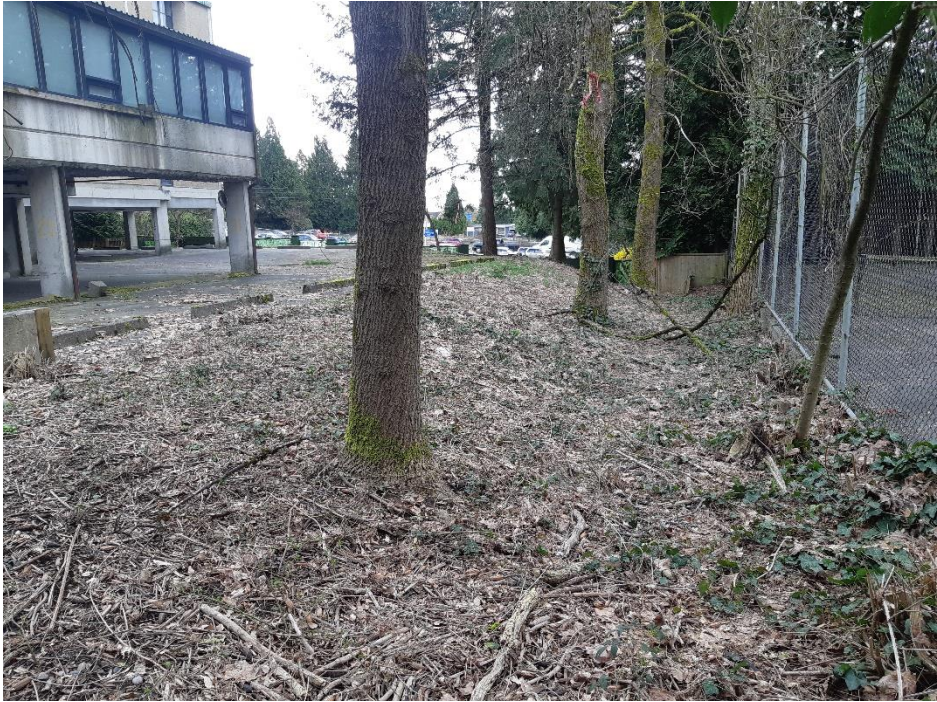
Photo 6. Trees 981, 634, 635, are growing in a row along the western property line

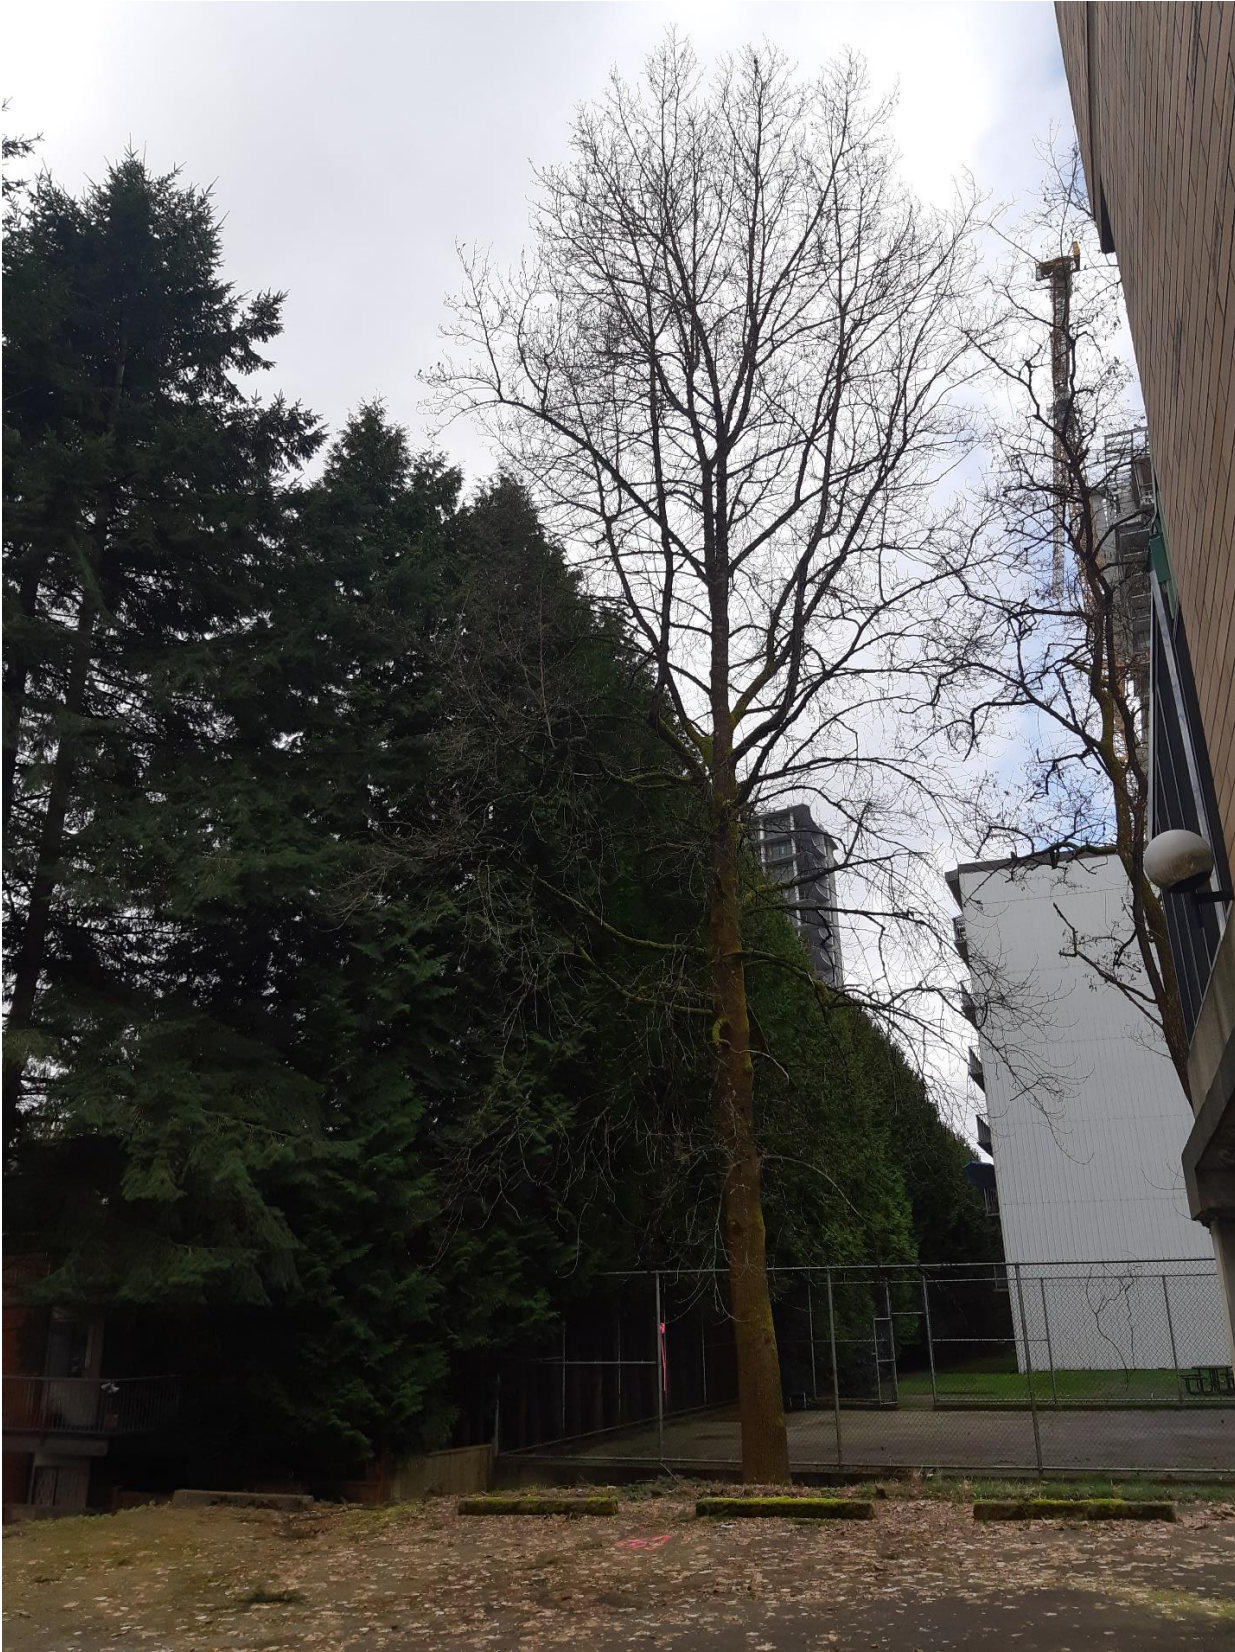
Photo 7. Tree 635 is a specimen Tulip tree

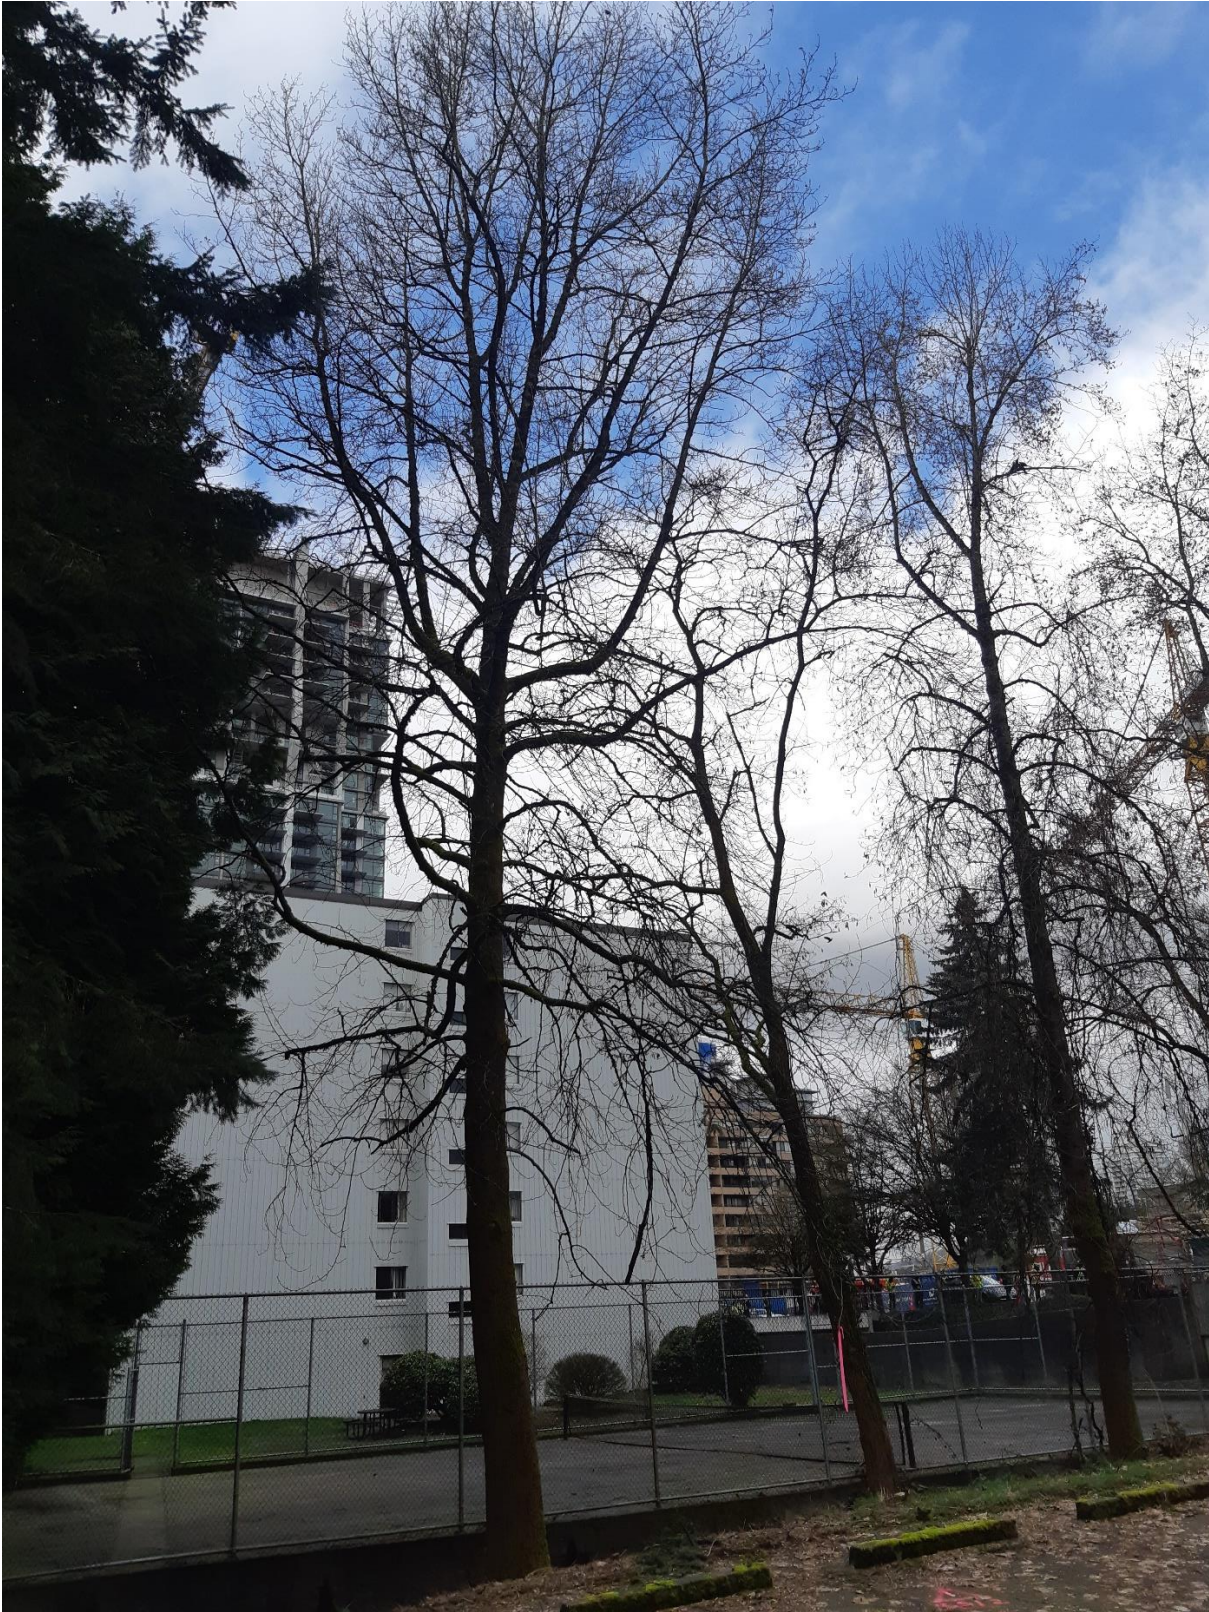
Photo 8. 635, 633, and 634, as viewed from onsite.
