Final Report

Nelson Creek Integrated Watershed Management Plan

Submitted to
City of Coquitlam

June 2012

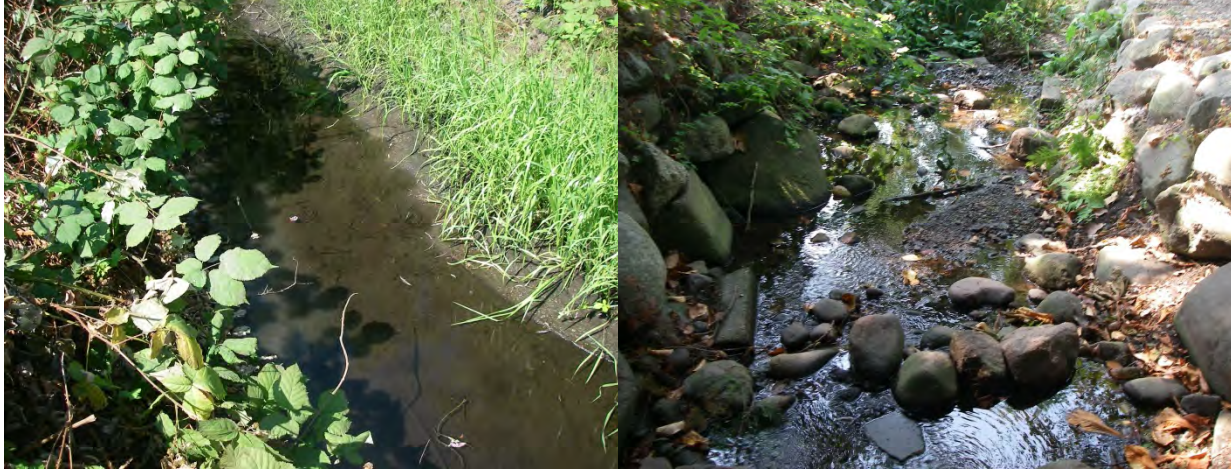
FIGURE 2-2
Mackin Park Enhancement Work

Nelson Tributary prior to realignment, with extensive invasive plant growth on the banks, summer 2010

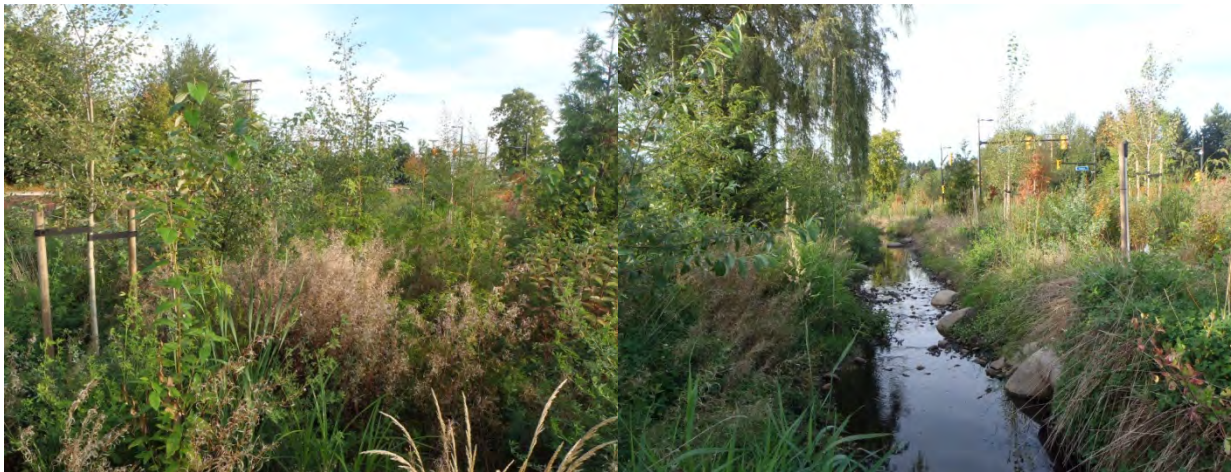
Nelson Tributary during construction, summer and fall 2010

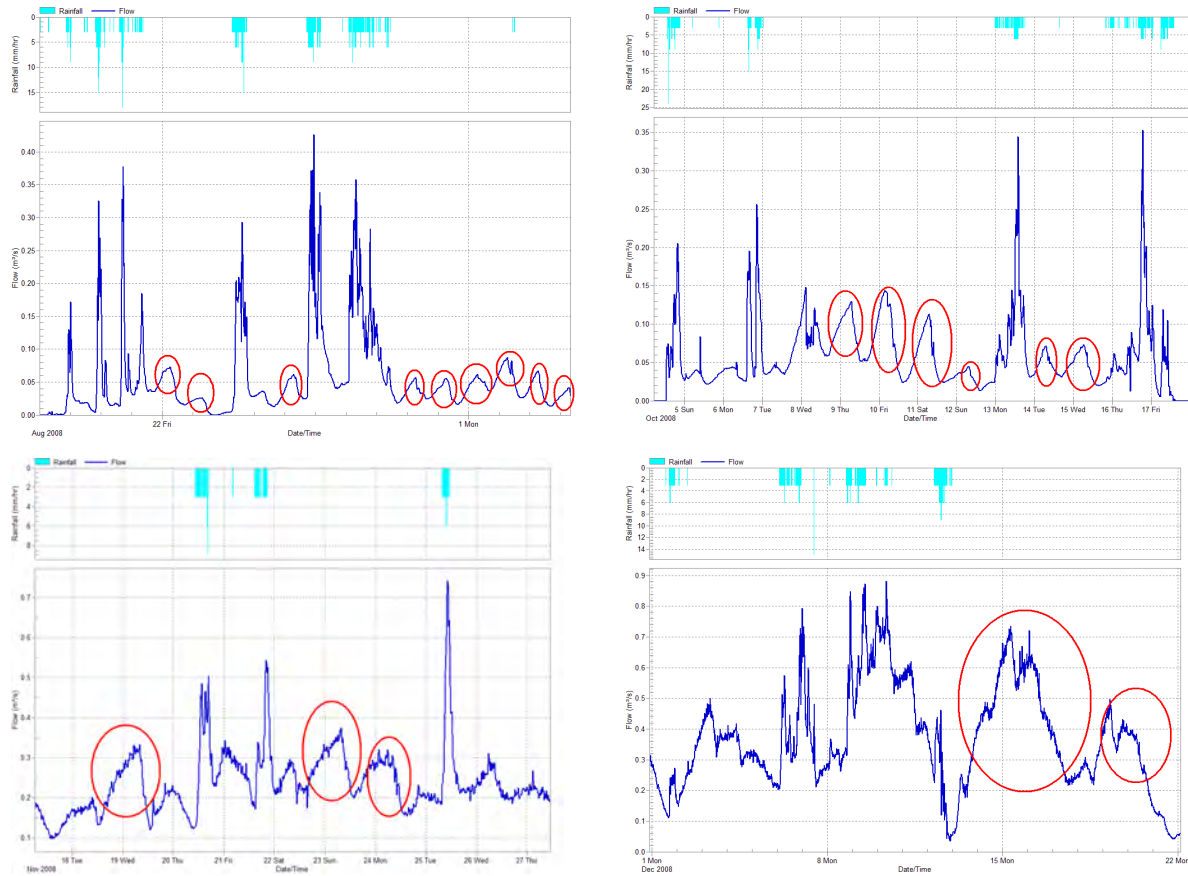
An interesting behaviour was observed in the flow monitoring data characterized by the presence of flow 'pulses'. Such pulses were observed during inter-event (i.e., between storm events) periods, in both summer and winter data. Because the operational condition of the equipment was repeatedly checked in the field (see Appendix I), and because the pulses were consistently observed throughout the monitoring period, monitoring errors were ruled out as a plausible explanation. Figure 4-3 shows the pulses circled in red for various periods. The pulses do not seem to be related to fast rainfall-runoff processes, but rather to late aquifer discharges. During the summer the peak pulse values were around 0.025 m³/s,

while during the winter the maximum peak pulse was 0.73 m³/s. These pulses acquire significance during the winter period because, if a precipitation event coincides with the occurrence of the pulse, the resulting stream peak flows from the rainfall-runoff process can be magnified. The implications of these pulses in the process of model calibration are discussed further in the text.

FIGURE 4-3
Hydrograph Close-ups Showing Groundwater Flow 'Pulses'

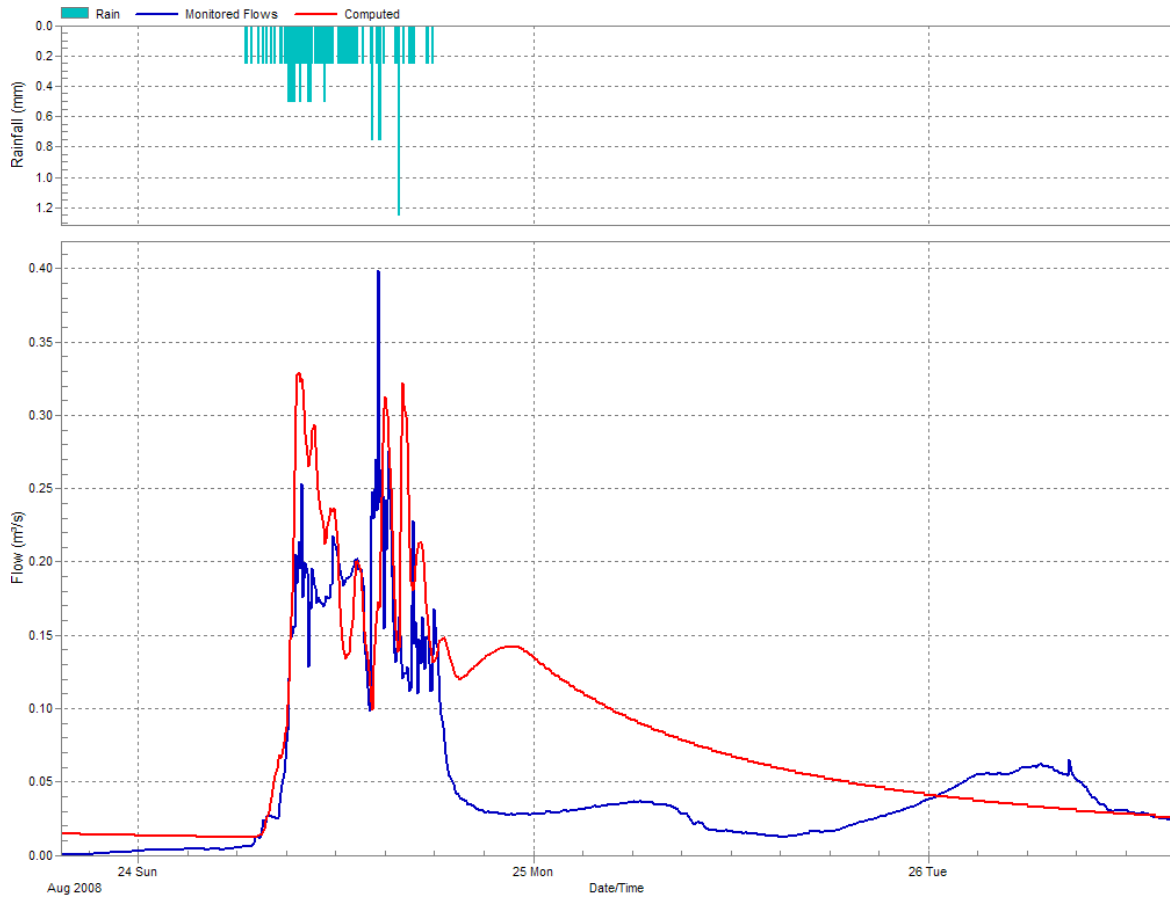
FIGURE 4-8
 Summer Calibration Event. August 24, 2008 to August 25, 2008

Observed Flow	Computed (XPSWMM)	Error
Maximum Flow(m ³ /s)	0.329	0.399	-18%
Mean Flow(m ³ /s)	0.077	0.047	62%
Total Flow(m ³)	18,710	11,530	62%

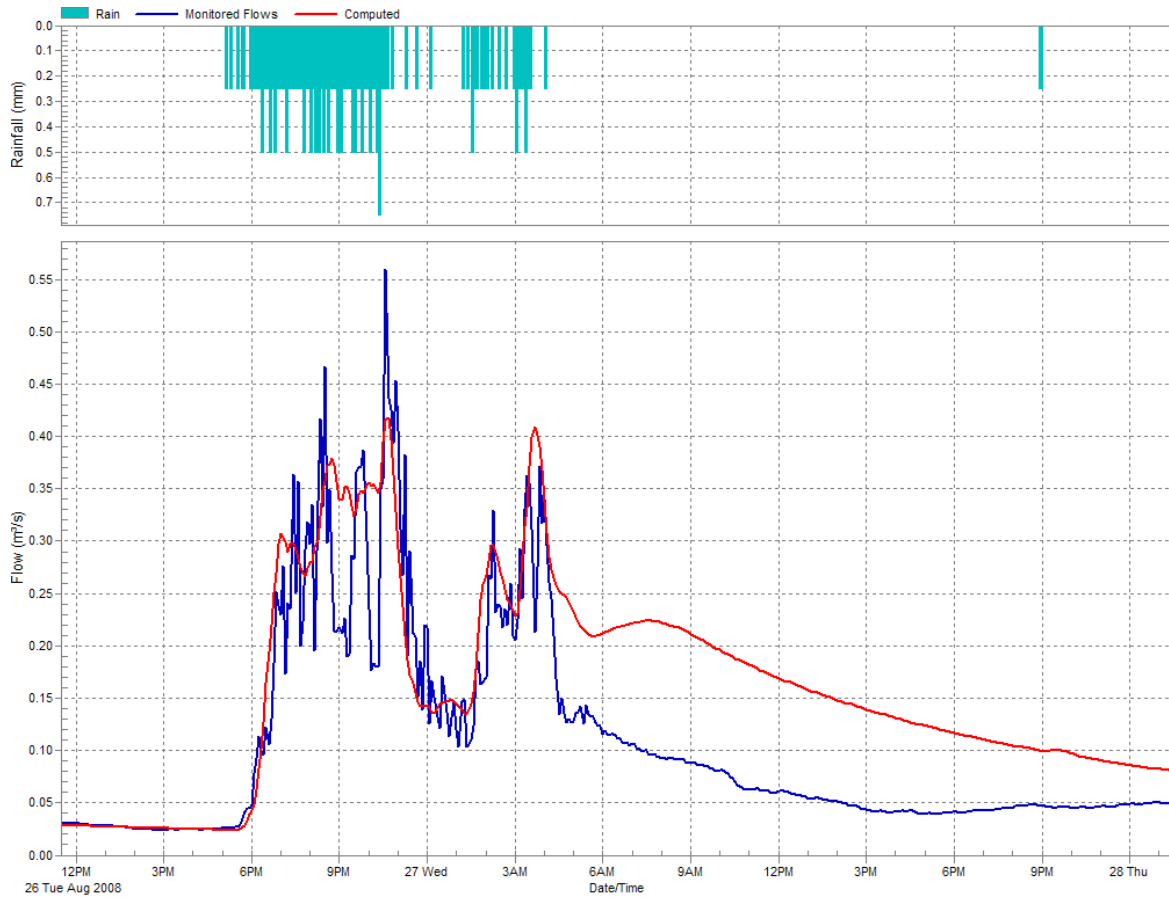
FIGURE 4-9
 Summer Calibration Event. August 26, 2008 to August 27, 2008

Observed Flow	Computed (XPSWMM)	Error
Maximum Flow(m³/s)	0.42	0.56	-25%
Mean Flow(m³/s)	0.15	0.11	50%
Total Flow(m³)	21,790	14,530	50%

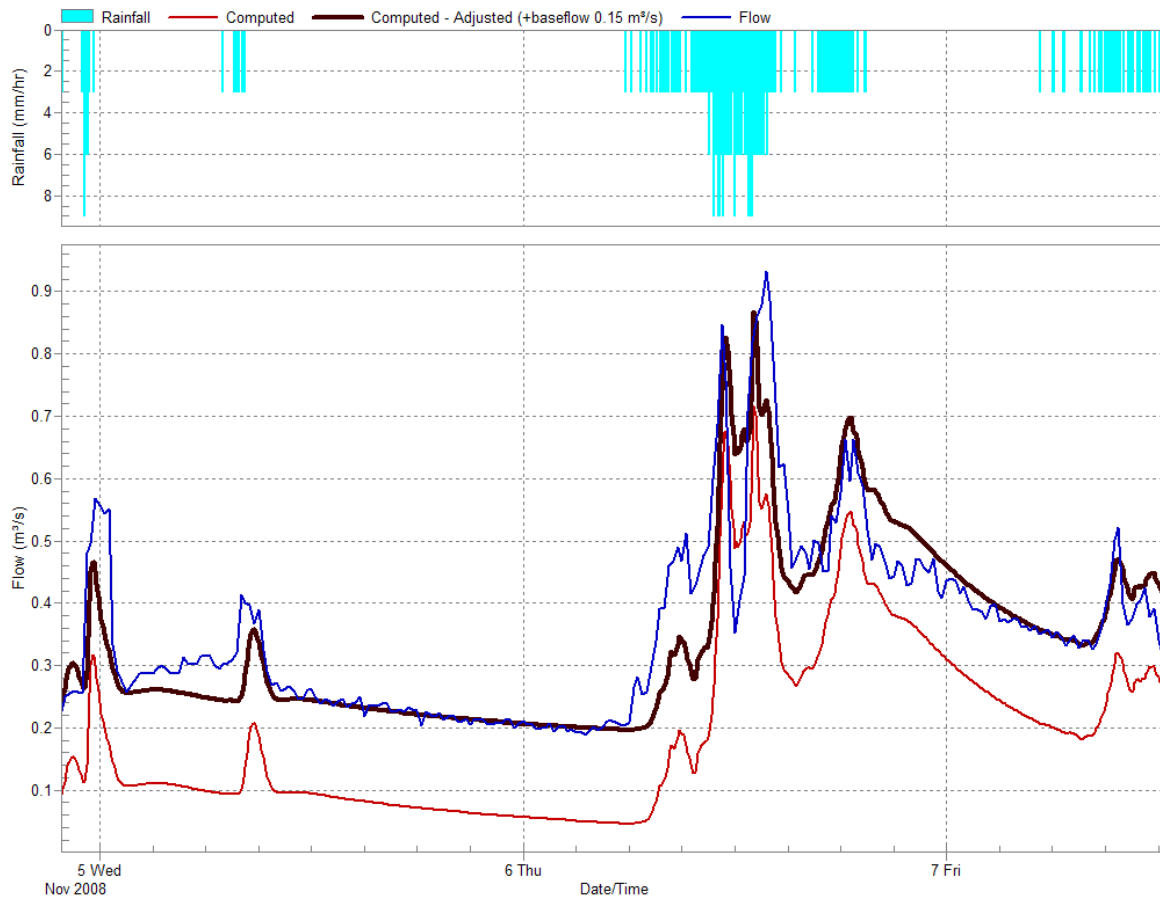
FIGURE 4-11
 Winter Calibration Event. November 6, 2008

Observed Flow	Computed (XPSWMM)	Error
Maximum Flow(m ³ /s)	0.932	0.717	-23%
Mean Flow(m ³ /s)	0.357	0.194	-46%
Total Flow(m ³)	80,800	43,850	-46%

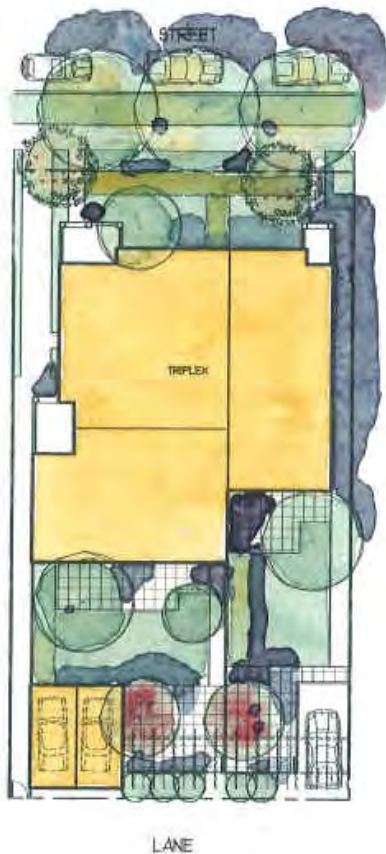
FIGURE 5-1
Small-Scale Housing Choice (Triplex)

The City's Planning and Developing Department is currently evaluating different alternatives of small-scale housing choices; however, the triplex was selected for modelling purposes. Figure 5-1 shows the site plan layout for the triplex, and Table 5-1 shows the percent of imperviousness for each land use type. The housing choices result in an approximately 15 to 20 percent increase in lot imperviousness.

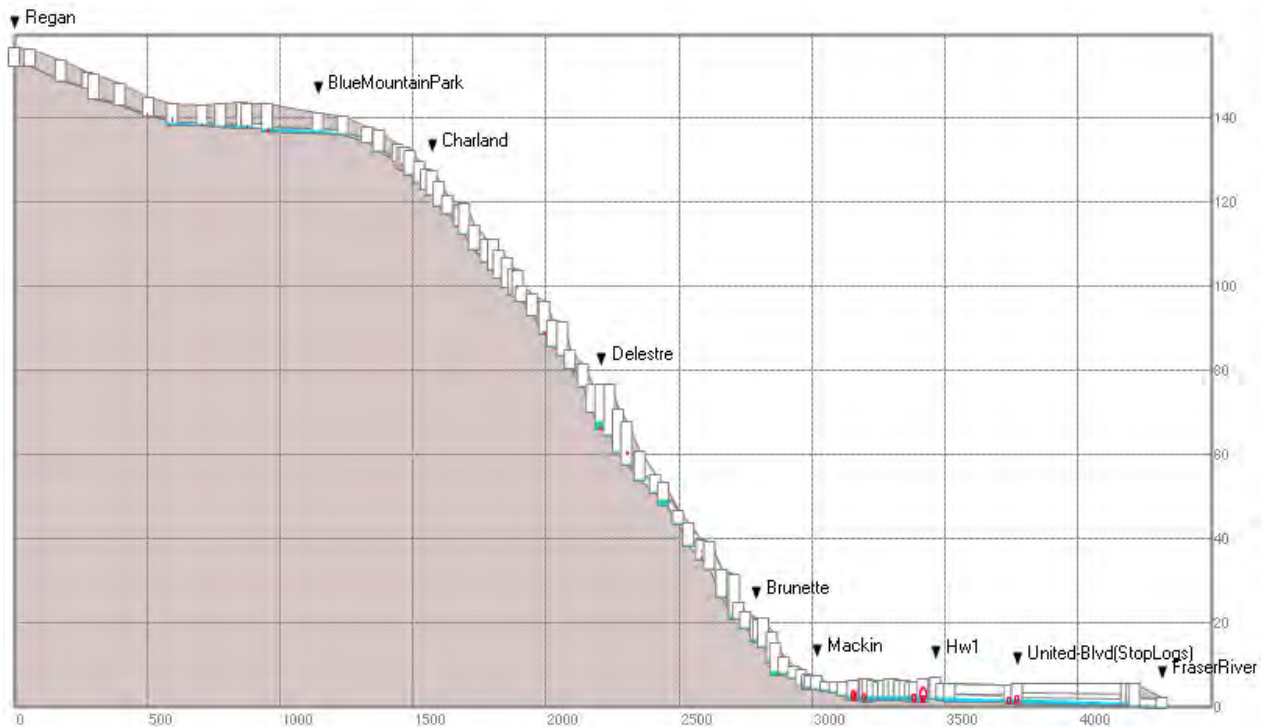
FIGURE 6-1
Nelson Creek Vertical Profile

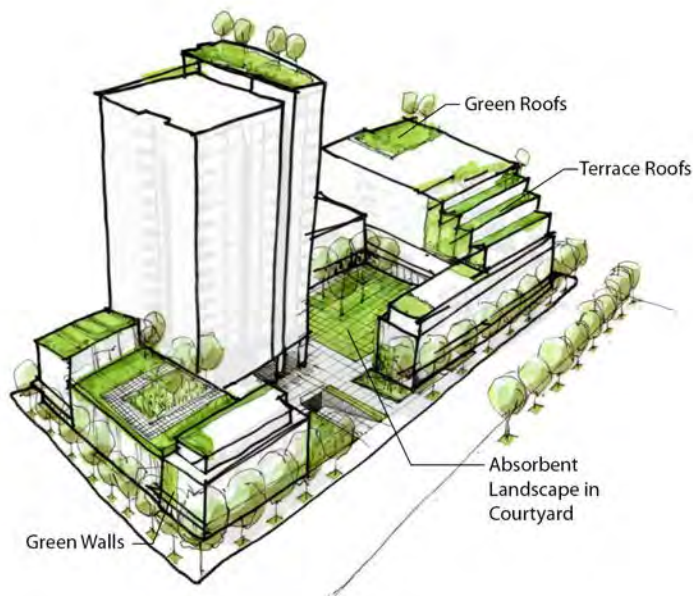
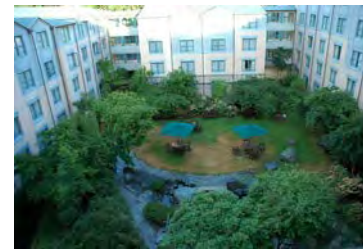
FIGURE 9-2
Onsite Rainwater Controls – Scenario 1

Absorbent Landscape in Courtyard
(Source: Peter Harrison)

For the Austin Heights Neighbourhood Plan, a Commercial Core Preliminary Preferred Concept has been prepared (HB Lanarc, 2009). For Maillardville, a New Development Concept was prepared and approved by Council (City of Coquitlam, 2010). The City confirmed that the Maillardville plan is intended to have a similar density to the Austin Heights plan. Since building heights and configuration were not available for the Maillardville plan, two different blocks of the Austin Heights plan were graphically modelled in three-dimensions (3D), as shown in Figures 9-2 and 9-3, respectively, in order to illustrate the following proposed onsite rainwater controls:

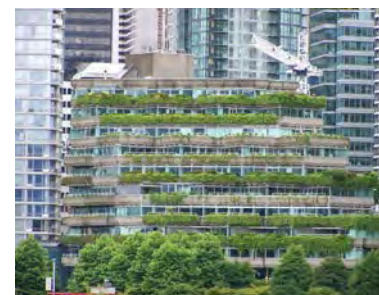
FIGURE 9-3
Onsite Rainwater Controls – Scenario 2

Terrace Roofs
(Source: NNECAPA)

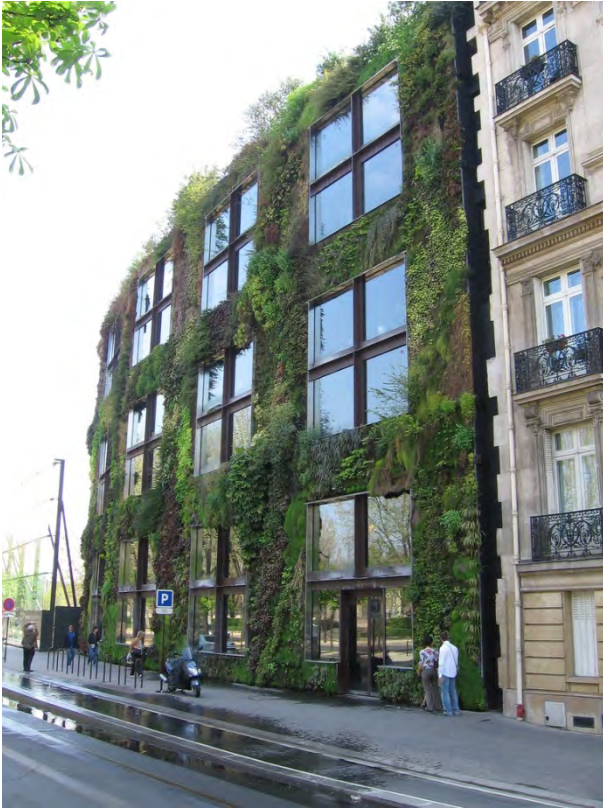
FIGURE 9-4
Onsite Rainwater Controls – Green Wall

Figure 9-4). Green walls are relatively expensive to build and maintain; however, they have high aesthetic value and can be used as a marketing tool.

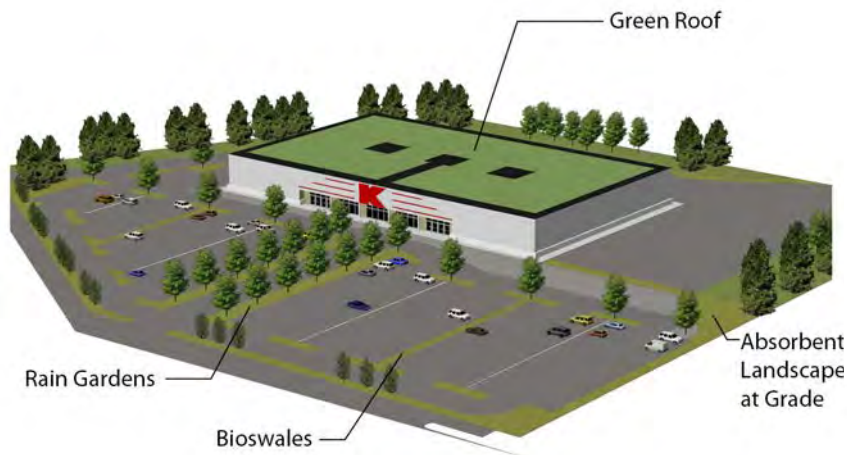
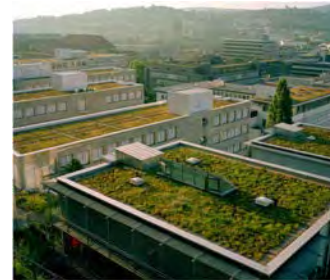
FIGURE 9-5
Large-format Retail Onsite Rainwater Controls

The City anticipates some new, large-format retail development in the Lougheed Highway/Schoolhouse Road area. This presents an opportunity to incorporate the rainwater management methods, as follows (see Figure 9-5):

- **Bioswales** – These are buried infiltration trenches with vegetation (grass, or low shrubs or herbaceous plants) on the surface. They are similar to rain gardens, but they also can convey water. In the example in Figure 9-5, bioswales are shown between every alternate double-loaded row of parking. Curbs will need openings into the bioswales,

Green Roof
(Source: Jeff McNeil)

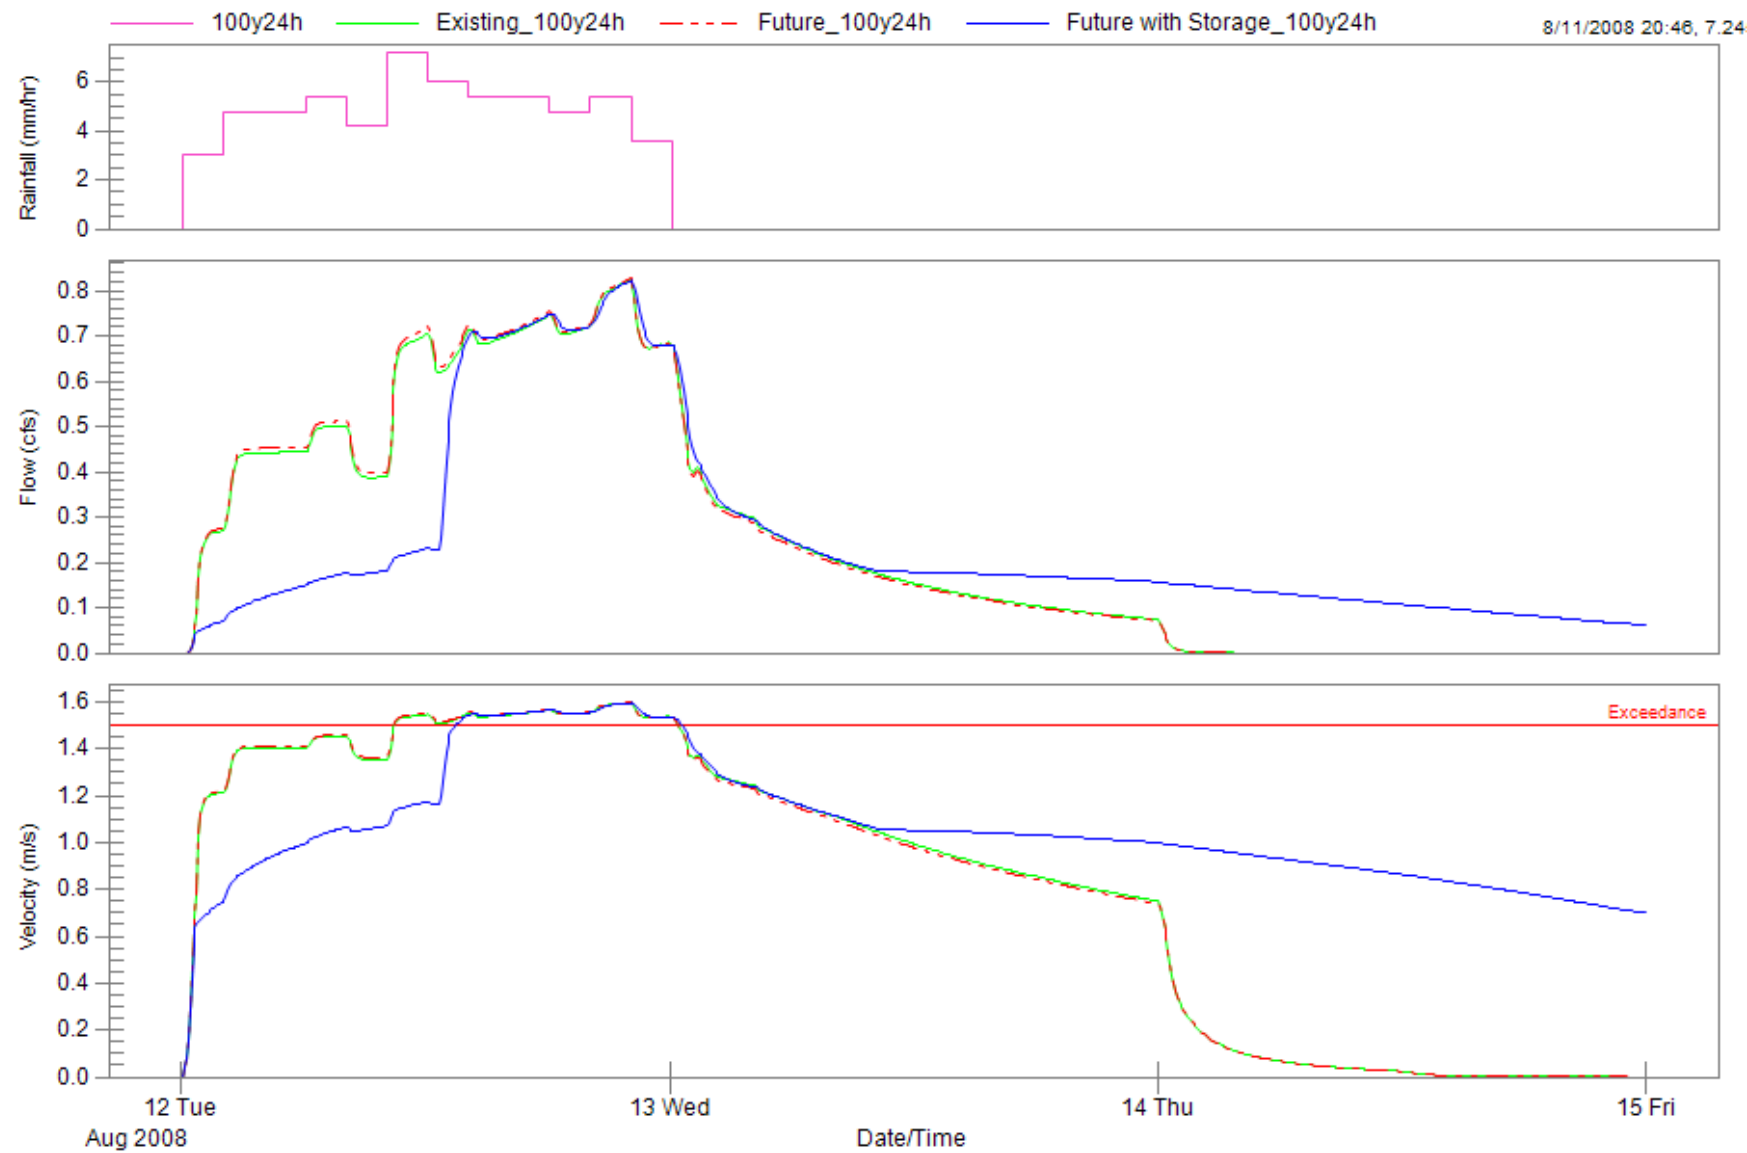
FIGURE 9-12
Peak Flow and Velocity (Link GID STL38) – 100-year 24-hour for Alternative 1

Description	Existing Conditions	Future Conditions	Future Conditions with Storage A
Total Rainfall (mm)	120	120	120
Maximum Flow (m ³ /s)	0.82	0.83	0.83
Maximum Velocity (m/s)	1.60	1.60	1.60

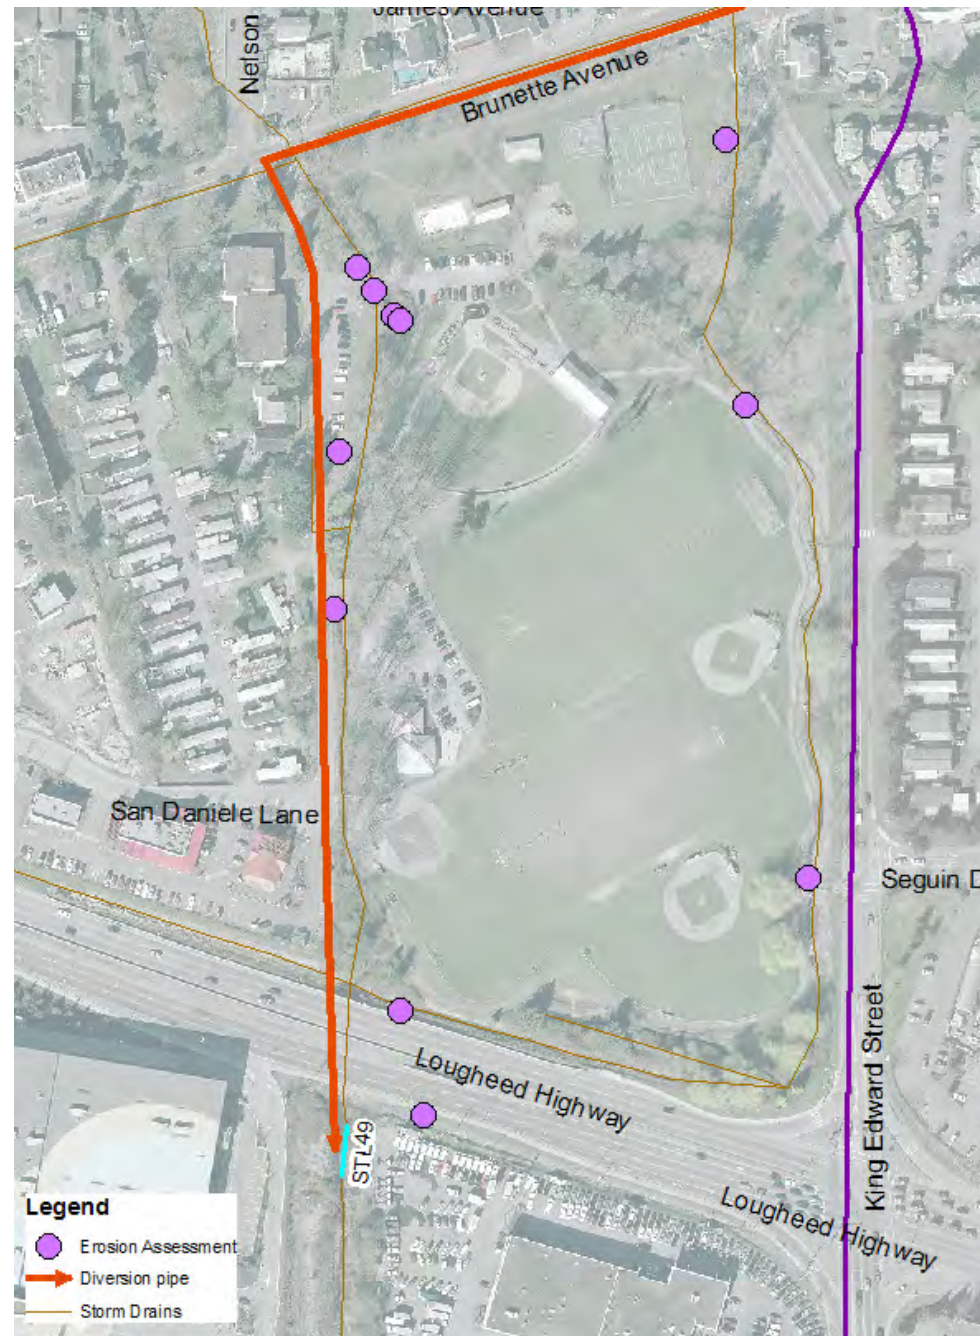
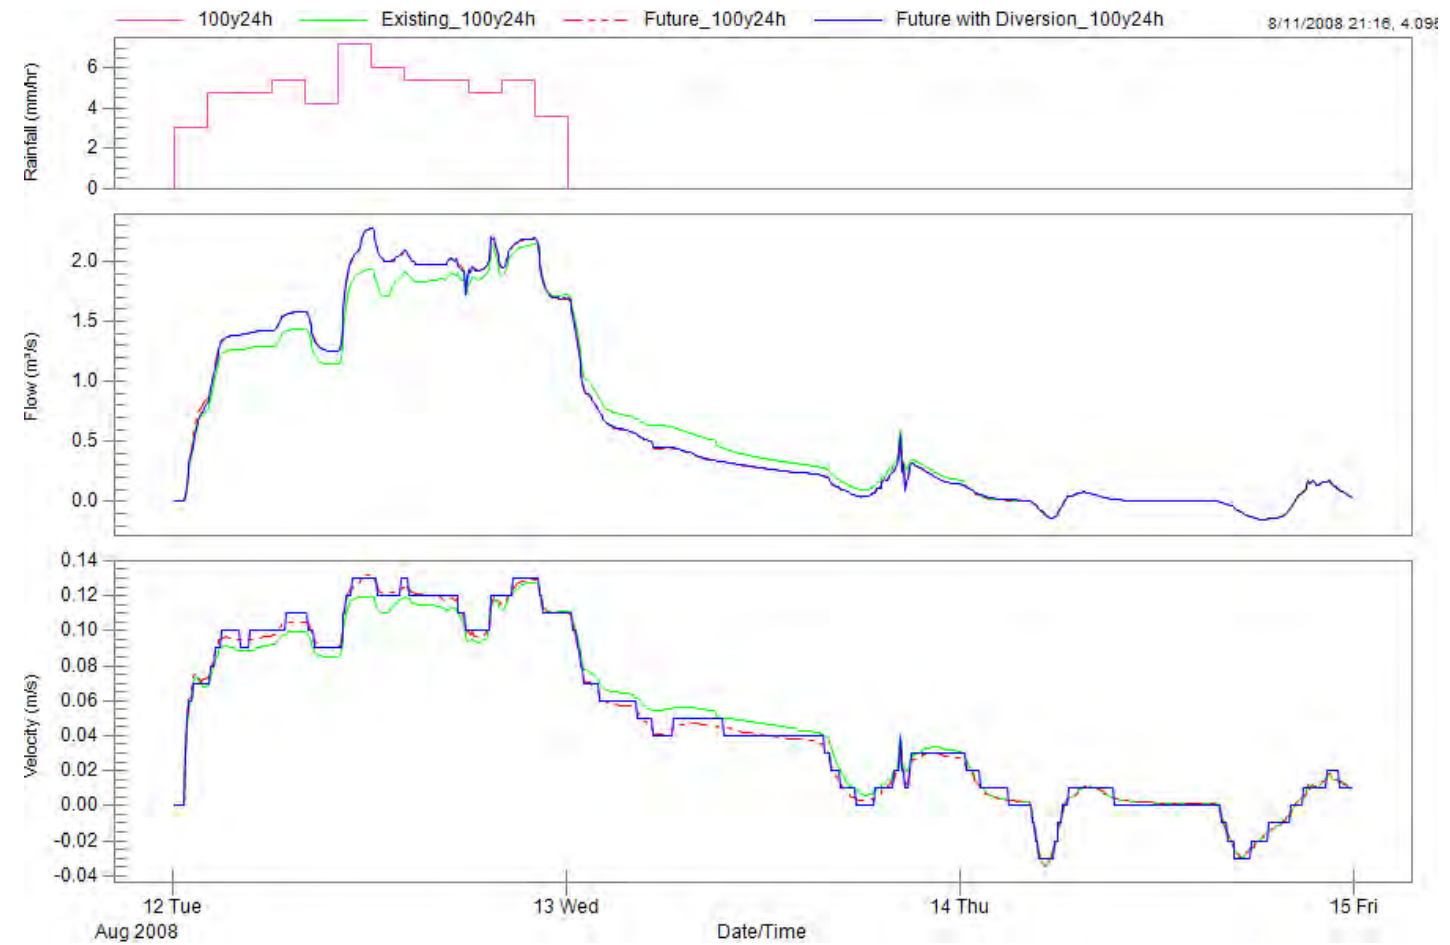
FIGURE 9-16
Peak Flow and Velocity (Link GID STL49) – 100-year, 24-hour Storm Event for Alternative 2, lower watershed

Description	Existing Conditions	Future Conditions	Future Conditions with Storage A
Total Rainfall (mm)	120	120	120
Maximum Flow (m ³ /s)	2.16	2.28	2.28
Maximum Velocity (m/s)	0.12	0.13	0.13
