HCA Heritage Inspection Permit 2021-0396

Re: Interim Summary Results and Recommendations Report for Recently Investigated and Tested Sections of Impact Zones Related to Various Upgrades to a Section of Cedar Drive in Coquitlam, and Summary of Proposed Development Scheduled to Commence in mid-2022; HCA Permit 2021-0396

Introduction and Background

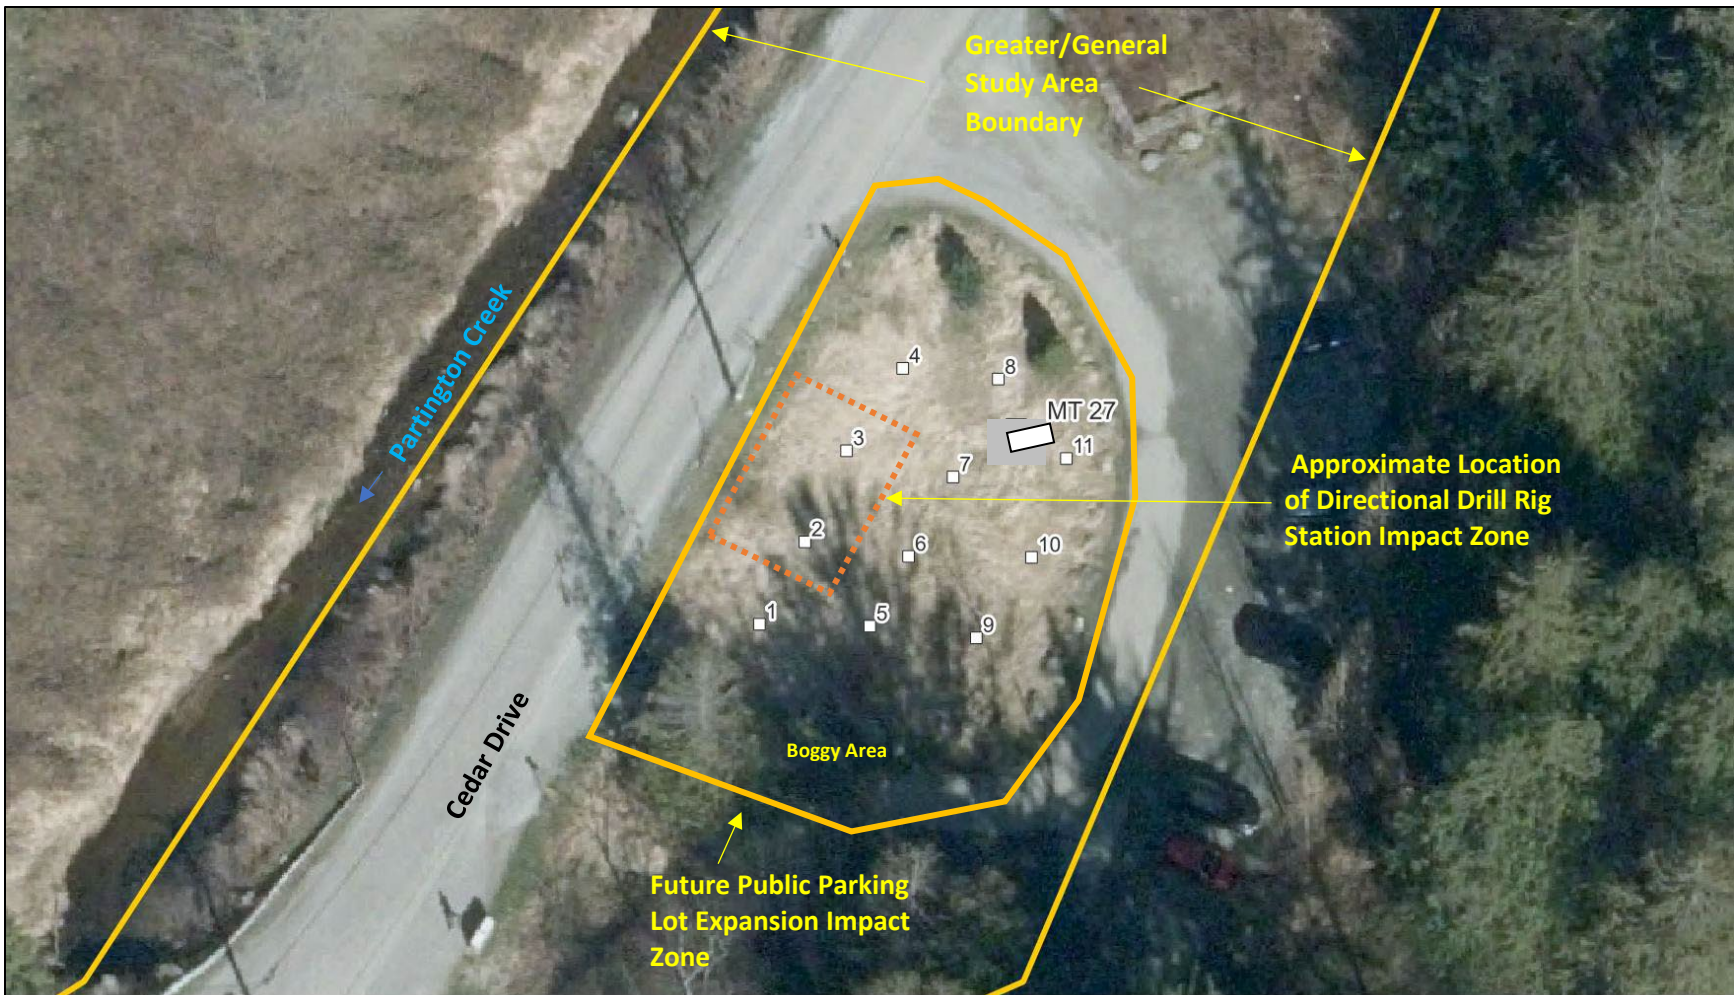
Figure 2. Aerial image map of proposed directional drill rig station impact zone and eventual public parking lot expansion inspected in February (shovel testing) and May (machine test) 2022.

Recommended Management:

Since no pre-contact period cultural deposits were encountered during the subsurface testing programs in this location, we recommend that land-altering activities related to the installation of the proposed directional drill rig station be allowed to proceed without any further formal archaeological fieldwork. Visual monitoring of land-altering activities is not recommended. However, the developer and contracting machine operators should be aware of, and participate in, a “chance find management protocol” procedure during land-altering activities in the event that something obvious is encountered (see Appendix V). If this area is eventually impacted by expansion of the public parking lot, we support this same recommendation management. It is our opinion that this specific location is associated with a relatively high water table level that likely also existed there in the distant past, rendering it rather undesirable for any pre-contact period occupation or significant use. The boggy environs may also explain why this location was not included in the existing parking lot plan. There are many more adjacent slightly sloping and much drier loci above the valley bottom to the west side of Partington Creek/Cedar Drive that would have been more attractive for short-term occupation or use. ***Construction activities for the directional drilling station are scheduled to commence in July, 2022.***

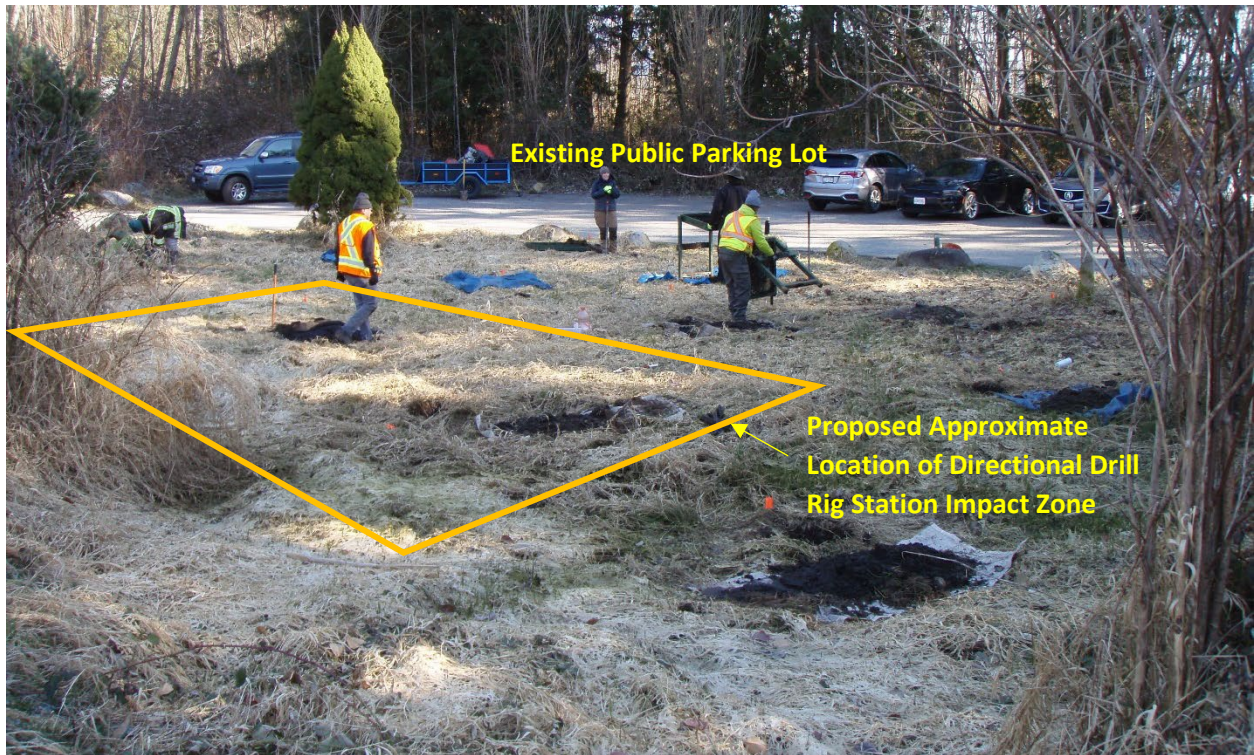
Figure 3. A February 22, 2022, view of shovel testing in progress in the grassy area at the existing parking lot at 4110 Cedar Drive at the SW end of the upgrade project ROW, looking northeast. This marshy area will be impacted by a directional drill rig station and eventual public parking lot expansion.

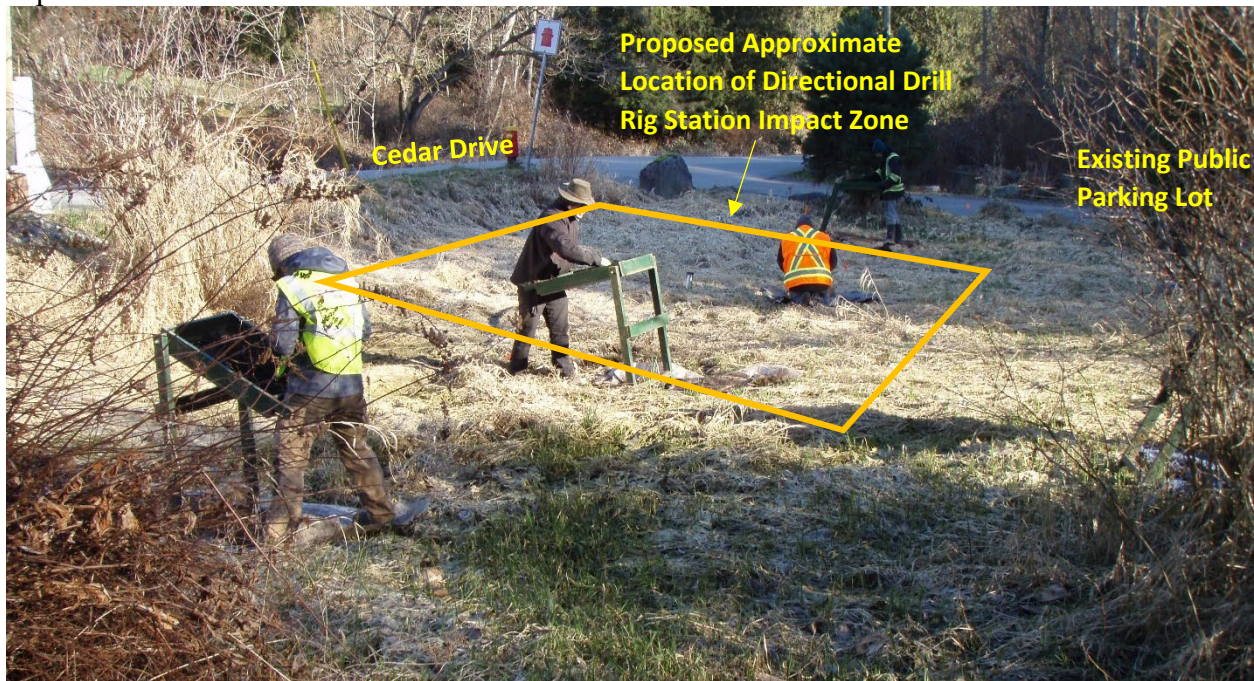
Figure 4. Another February 22, 2022, view of shovel testing in progress in the grassy area at the existing parking lot at 4110 Cedar Drive at the SW end of the upgrade project ROW, looking north. This boggy area will be impacted by a directional drill rig station, and eventual public parking lot expansion.

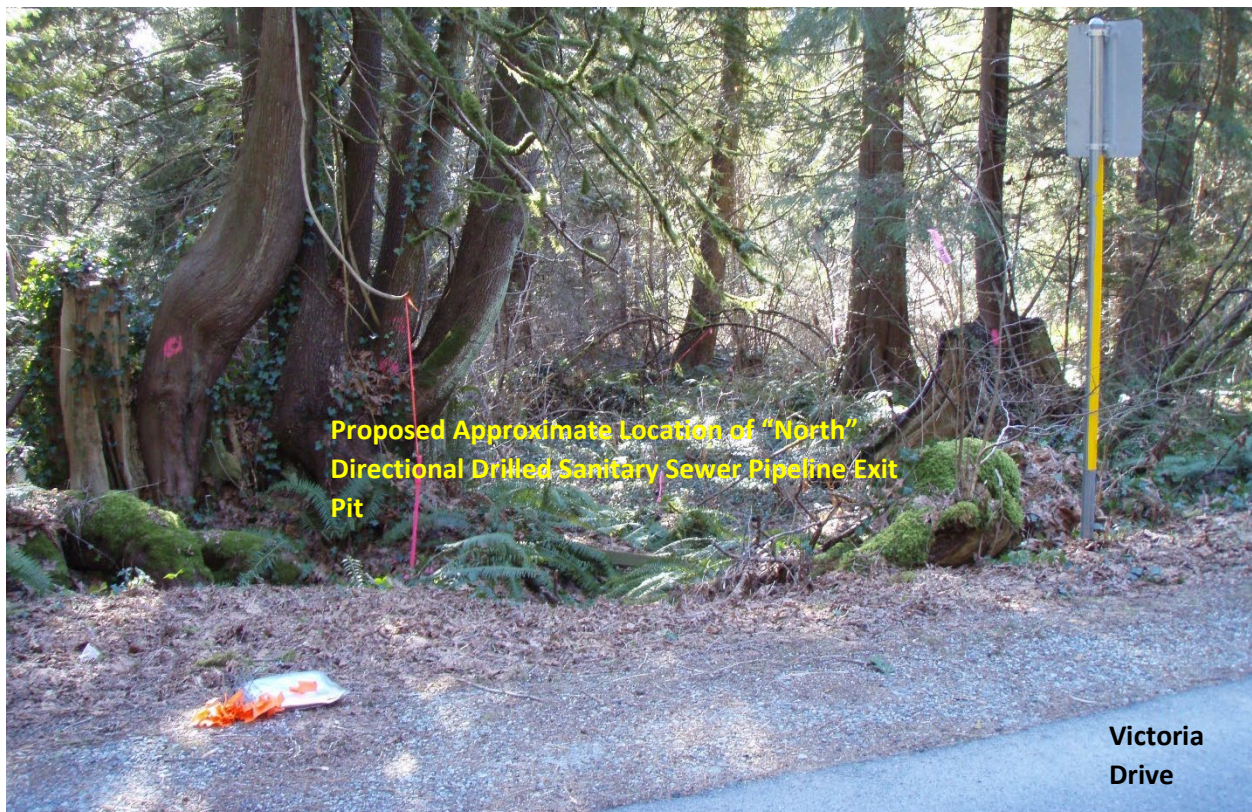
Figure 8. A February 22, 2022, view of Development Area 3 showing the currently proposed location for placing the “north” directional drilled pipeline exit pit (center photo) on the south side of Victoria Drive at the north end of the proposed sanitary sewer pipeline (Development Area 4), looking southwest. This location slopes moderately to the southeast.

Recommended Management:

For Development Area 3, we recommend that land-altering activities related to the installation of the exit pit for proposed directional drilled sanitary sewer pipeline be allowed to proceed without any further formal archaeological fieldwork. Subsequent archaeological visual monitoring of land-altering activities relating to this drill rig station is not recommended by Antiquus. However, please note that Kwikwetlem First Nation has requested that impacts to this location be visually monitored by one of their field technicians during land-altering activities, and minimal subsurface testing. This request could be easily accommodated and arranged, and the results can be included in the final report.

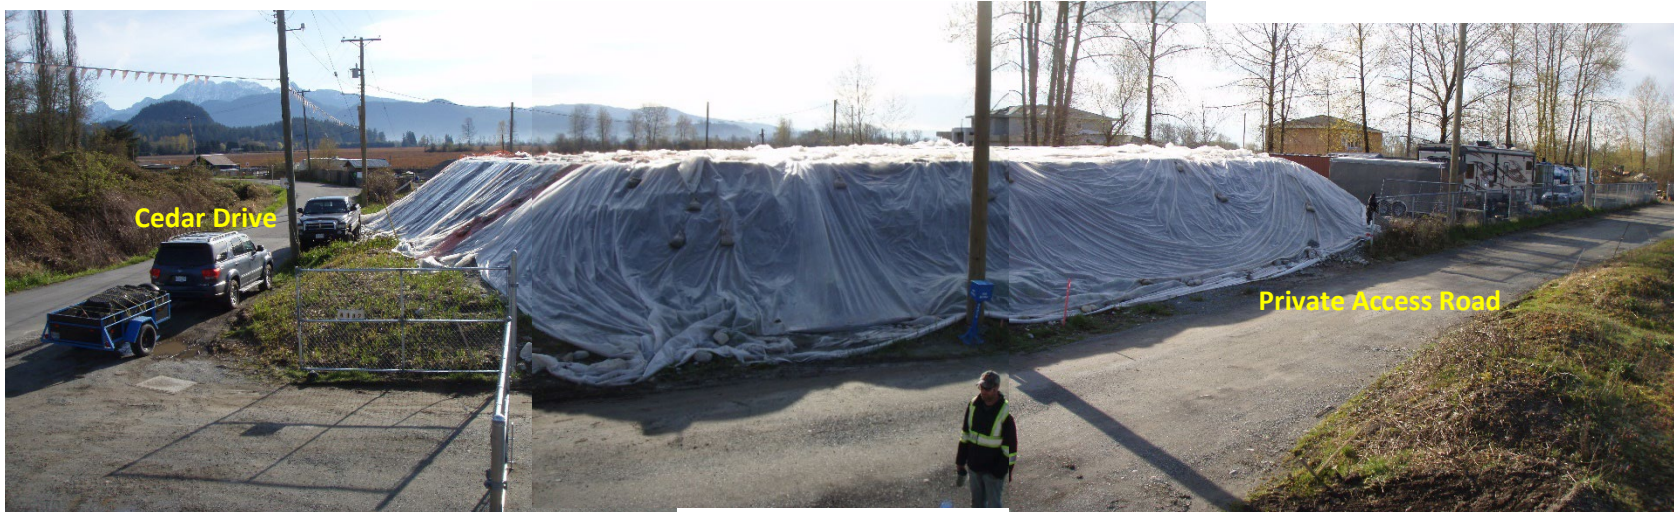
Figure 9. A panoramic view of the large pile of sand and gravel preload that currently occupies the location selected for the sanitary force main pump station (Development Area 5) at 4180 Cedar Drive, looking southeast. The sand and gravel preload will be removed in June, 2022 and transported to Development Area 7 (see below) where it will be placed on top of existing similar preload deposits within the new road ROW.

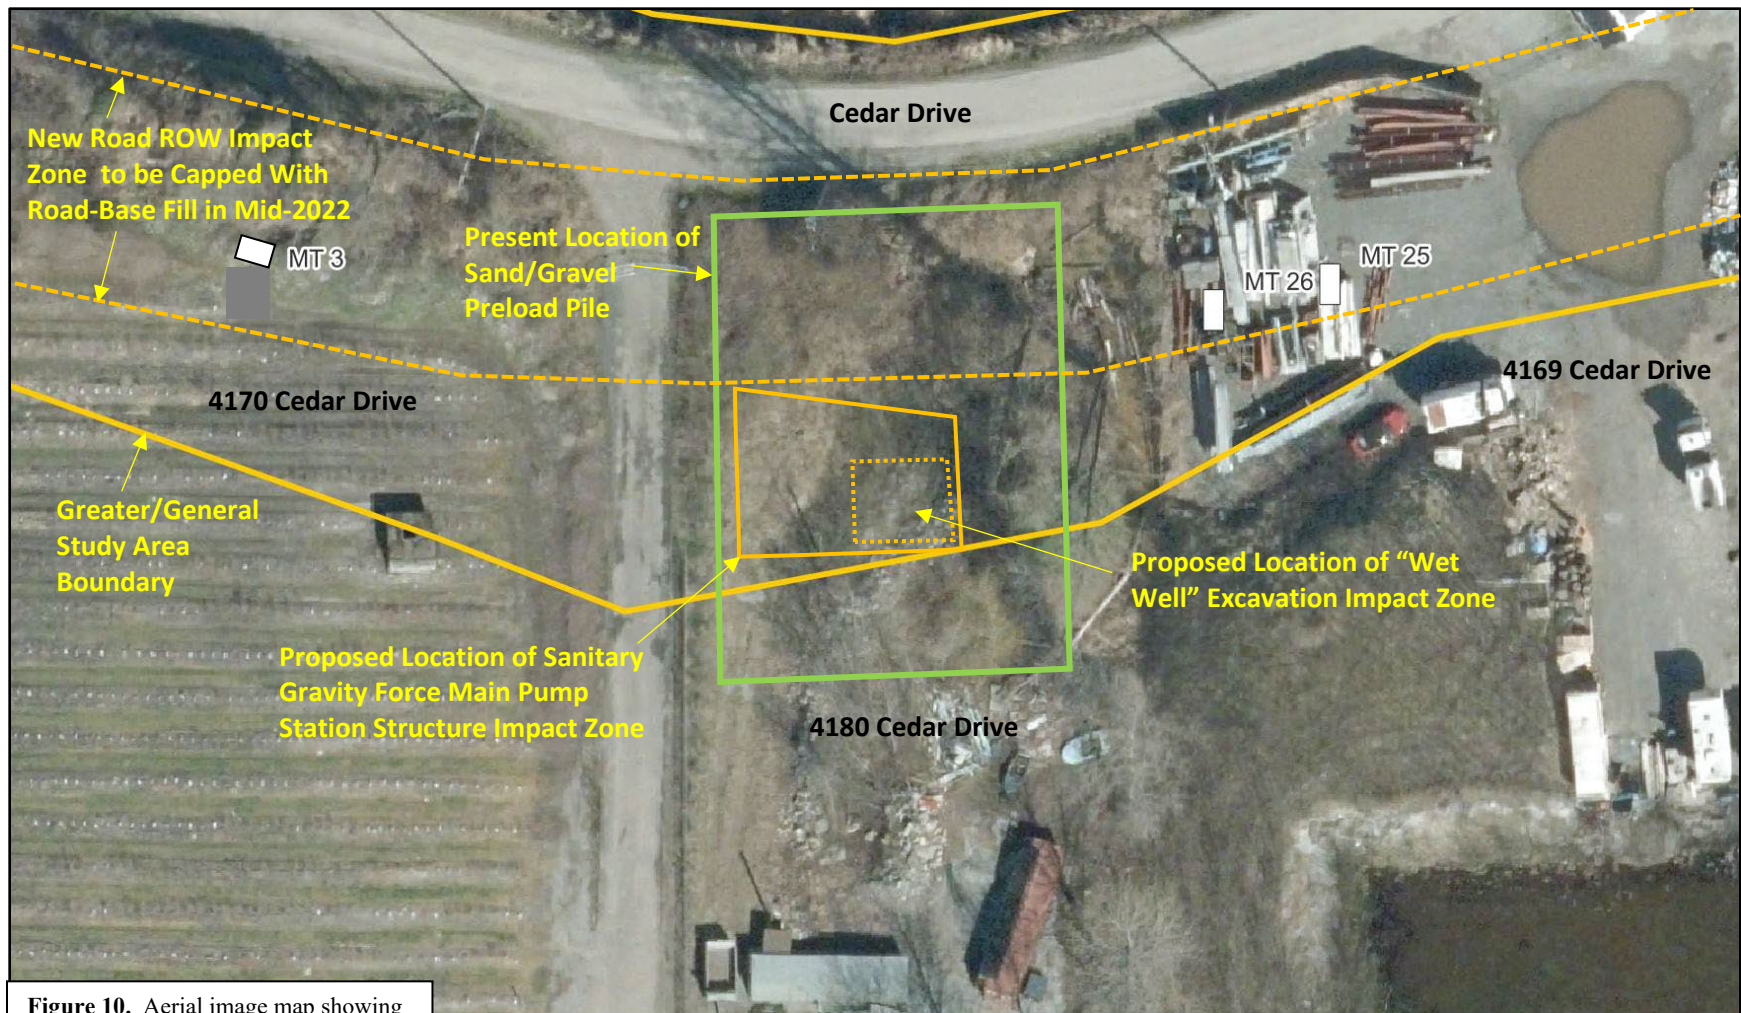
Figure 10. Aerial image map showing the location of the existing preload pile and proposed sanitary force main pump station (Development Area 5) to be constructed at the north aspect of 4180 Cedar Drive. The “wet-well” location is also indicated. See also Figures 9, 14 and 16.

Recommended Management:

For development activities proposed for Development Area 4 (Sanitary Force Main Pump Station) we recommend that:

- (3) *If no pre-contact period cultural deposits are encountered during the visual monitoring of the “wet-well” machine excavations or other related lesser machine excavation episodes, then we recommend that the construction of the remainder of the sanitary force main pump house should be allowed to proceed without any further formal archaeological fieldwork.*** However, the developer and contracting machine operators should be aware of, and participate in, a “chance find management protocol” procedure during land-altering activities in the event that something obvious is encountered during construction (see Appendix V). ***Construction activities for the proposed pump station are scheduled to commence in mid-2022.***

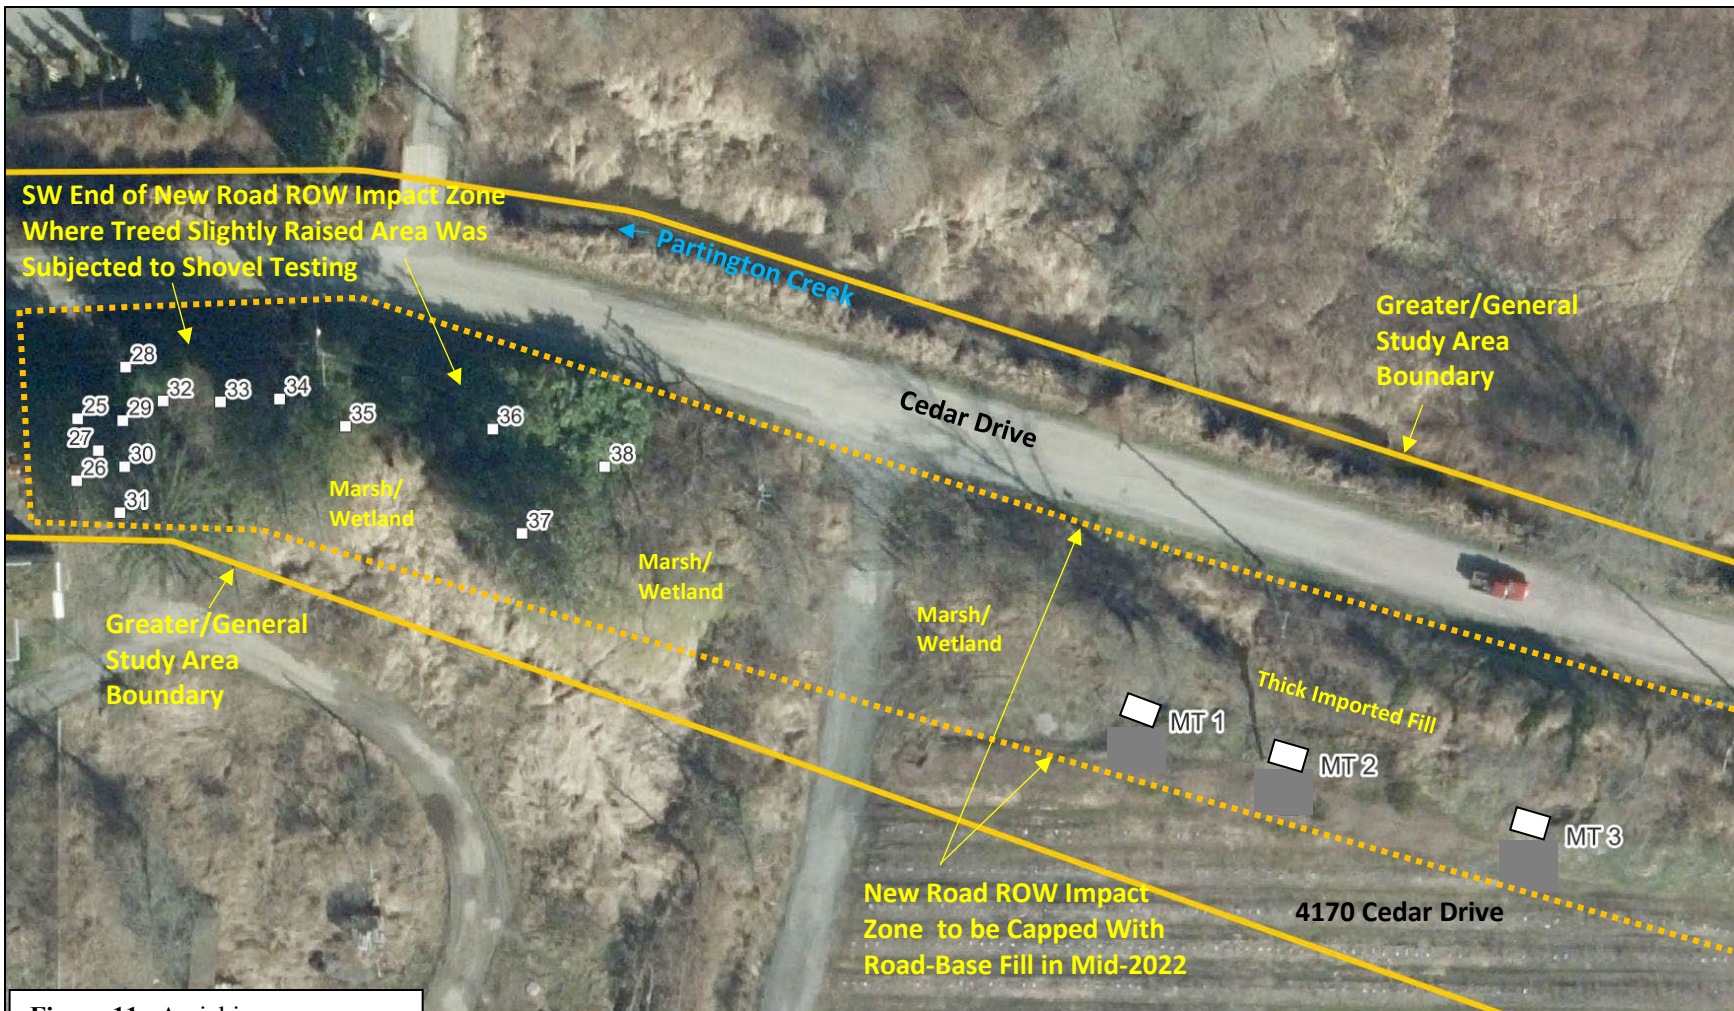
Figure 11. Aerial image map showing shovel test and machine test locations and new road ROW impact zone in Development Area 6 at the southwest end of the new road ROW at 4170 Cedar Drive. See also Figures 12 to 14.

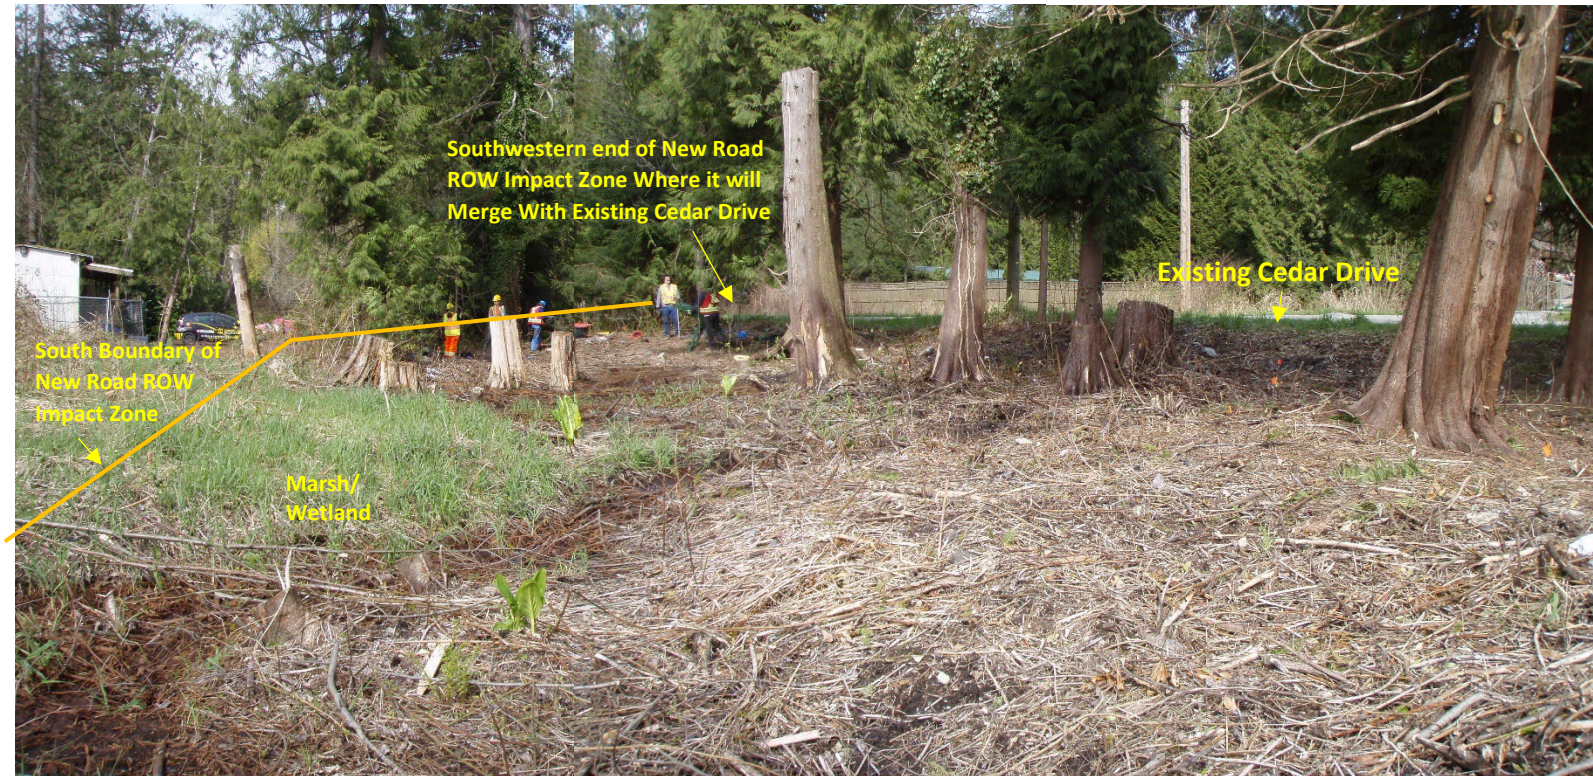
Figure 12. A general view of shovel testing underway in a recently de-vegetated raised treed area at the very western end of the proposed new road ROW impact zone in Development Area 6 where site potential was considered to be medium. Shovel tests 25 to 38 were placed in this area, which will be capped with road-base fill in mid-2022. The new road ROW will end and merge with existing Cedar Drive in the upper center of the photo. Note marsh/wetland in lower left of photo. See also Figures 11 and 13.

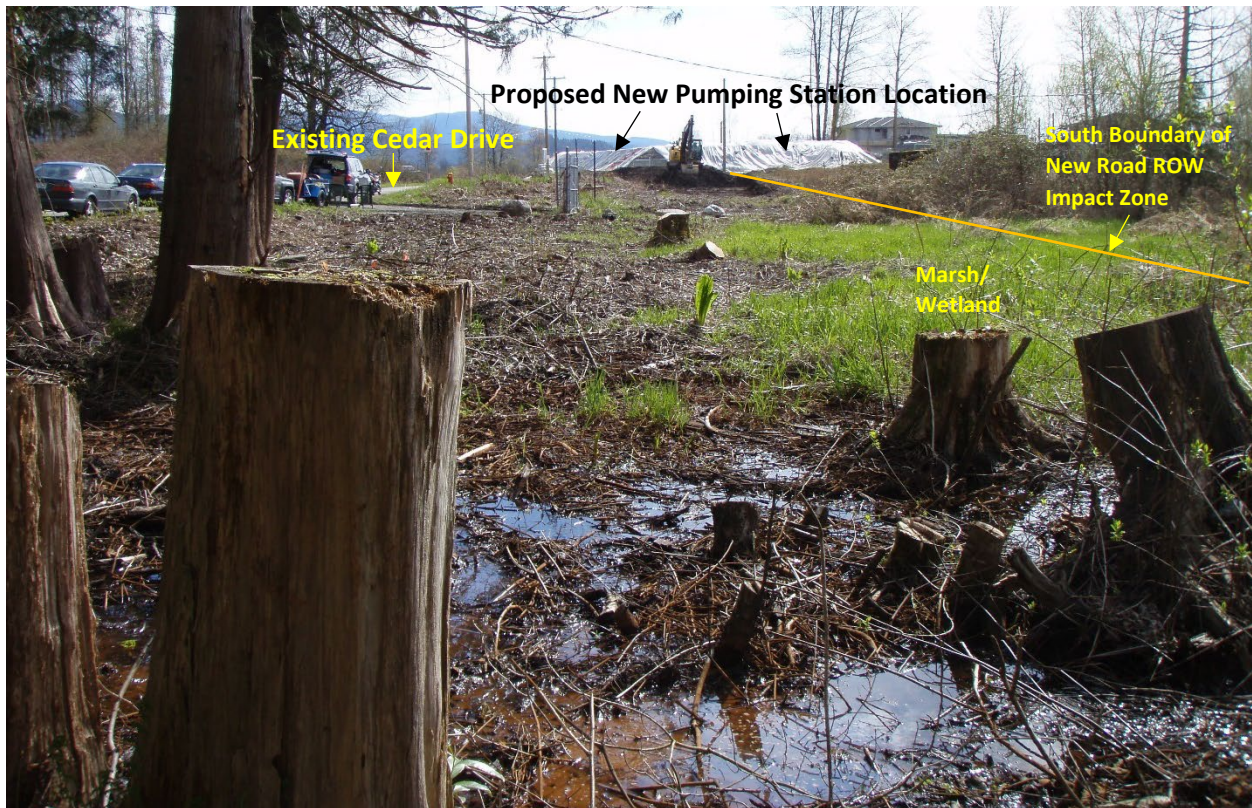
Figure 13. A general view of the proposed new road ROW lying between the south end of the proposed new road ROW (foreground) and the proposed pumping station (upper-center) at 4170 Cedar Drive, looking east. This marsh/wetland section in the foreground was saturated with water and thus was not subjected to any shovel or machine testing due to excessive water and assessed low archaeological site potential.

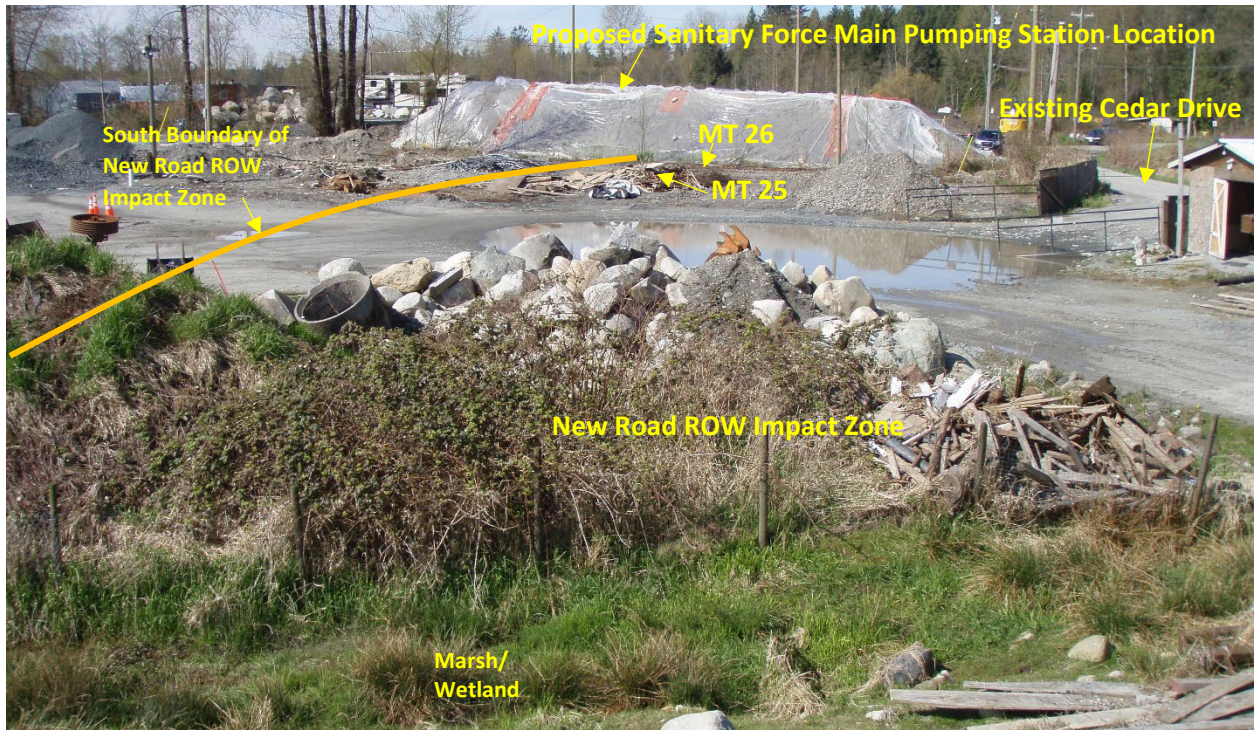
Figure 16. View of section of new road ROW in the southwestern aspect of the new road ROW through 4169 Cedar Drive showing location of proposed new sanitary force main pumping station (Development Area 5) and proposed impact zone, looking southwest. Locations of machine tests (MTs) 25 and 26 are also shown in upper center of photo. Most of this area was capped with imported sand and gravel fill. The non-capped natural ground surface is a soggy marsh/wetland. Some infilling of this area will be required before the sand/gravel preload road-bed can be placed over this area.

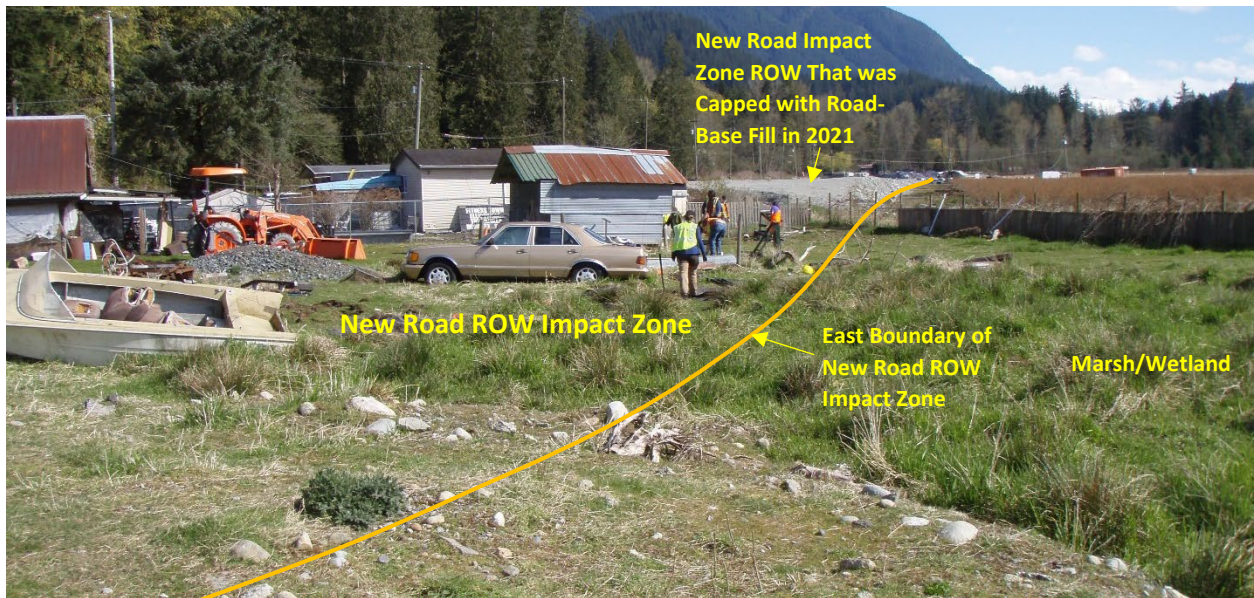
Figure 17. A general view of the northeastern yard/pasture at 4169 Cedar Drive showing shovel testing underway (center photo) in the low-lying accessible (uncapped) marsh/wetland deposits within the new road ROW, looking north. Note obvious fill deposits in foreground and around the structures. All the buildings and vehicles in the upper left will be removed and some levelling will occur prior to capping the ROW with imported road-base fill. This is expected to occur in mid-2022.

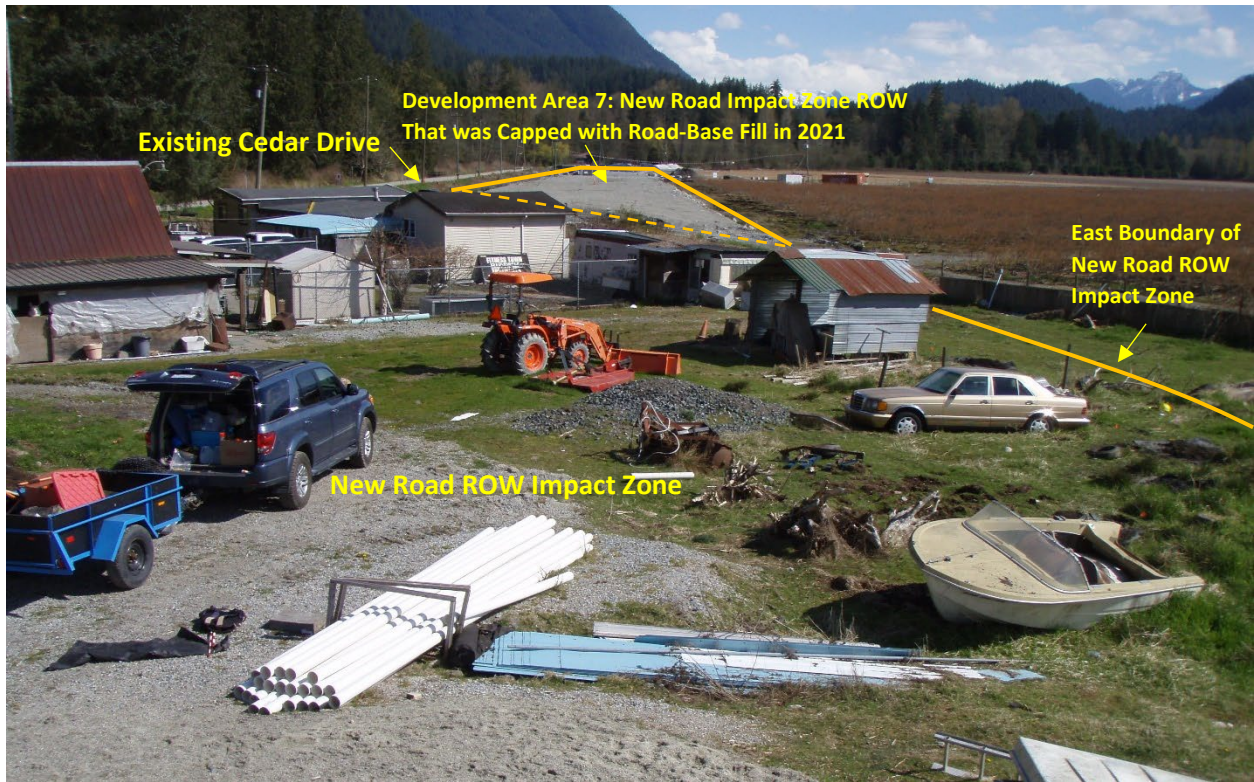
Figure 18. Another general view of the northeastern yard/pasture at 4169 Cedar Drive within the new road ROW, looking northeast. All the buildings and vehicles will be removed prior to some levelling and subsequent capping the ROW with imported road-base fill, which is expected to occur in mid-2022.

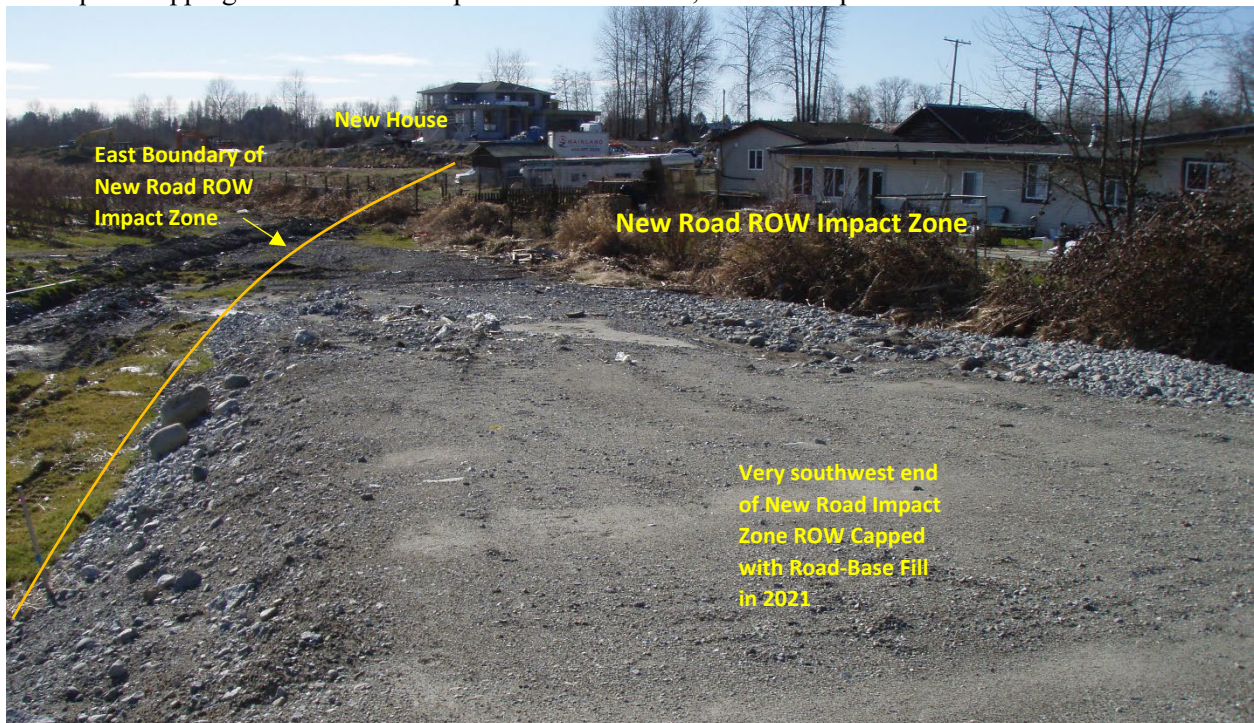
Figure 19. A view of the north end of the yard/pasture at 4169 Cedar Drive within the new road ROW (upper right), looking southwest from the very southwest end of the road-base fill (foreground). This area will be capped with road-base in mid-2022 after the buildings etc. are removed.

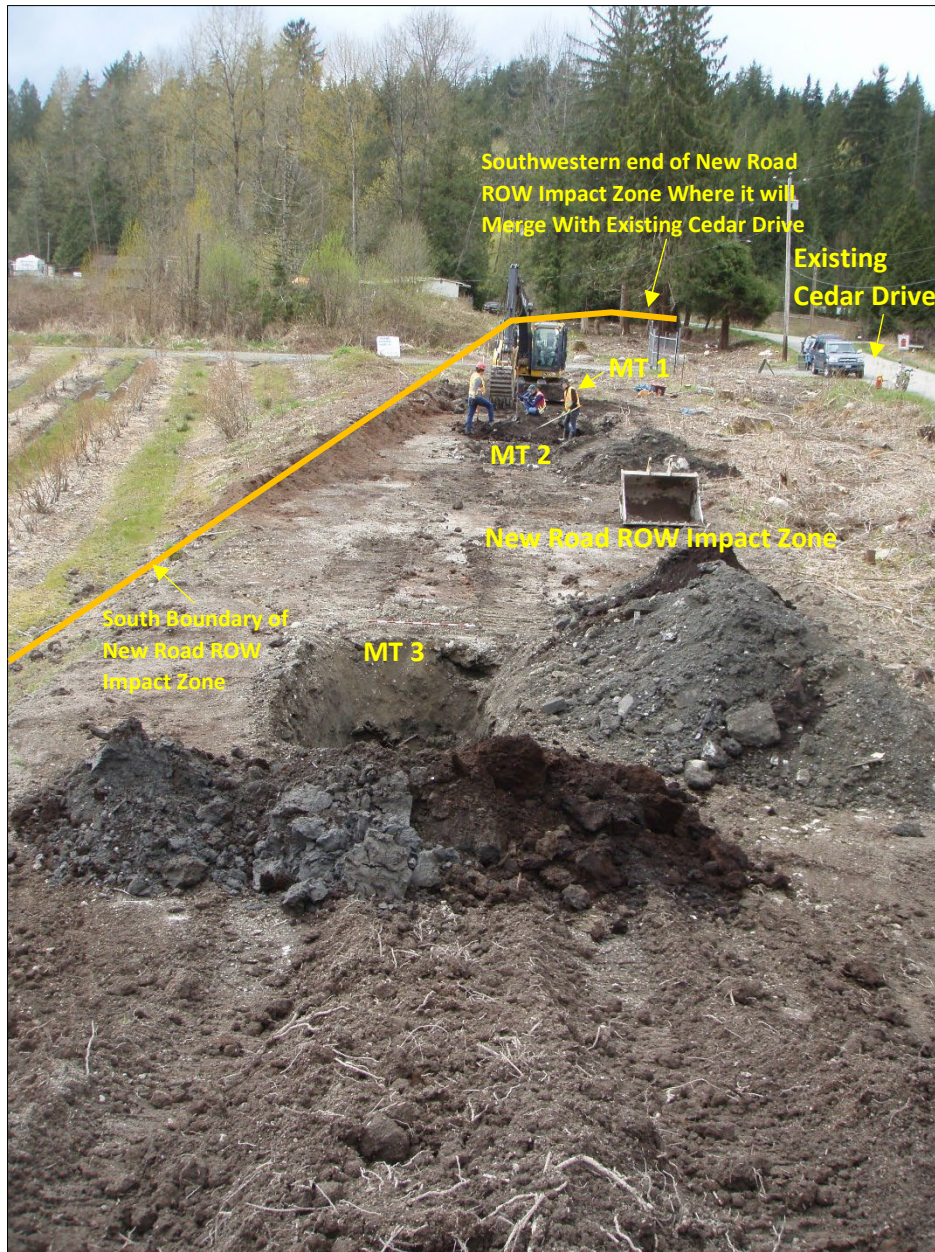
Figure 20. Location of machine tests (MT) 1 to 3 placed within area lying west of the proposed pumping station at the very southwestern end of the proposed new road bed construction at 4170 Cedar Drive, looking west from beside the proposed pumping station location towards the proposed merger of Cedar Drive and the new road ROW. Deep machine testing revealed an abandoned hard-packed farm access road bed lying on top of a very thick deposit of imported fill that rests on a deeply buried deposit of waterlogged peat and other organics consistent with a marshy/boggy environment (dark matrices). Archaeological site potential is considered to be low in this location, as it would have been a marshy/boggy low-land prior to being capped with imported fill. This section of new road ROW will be capped with sand/gravel road-base fill in mid-2022.

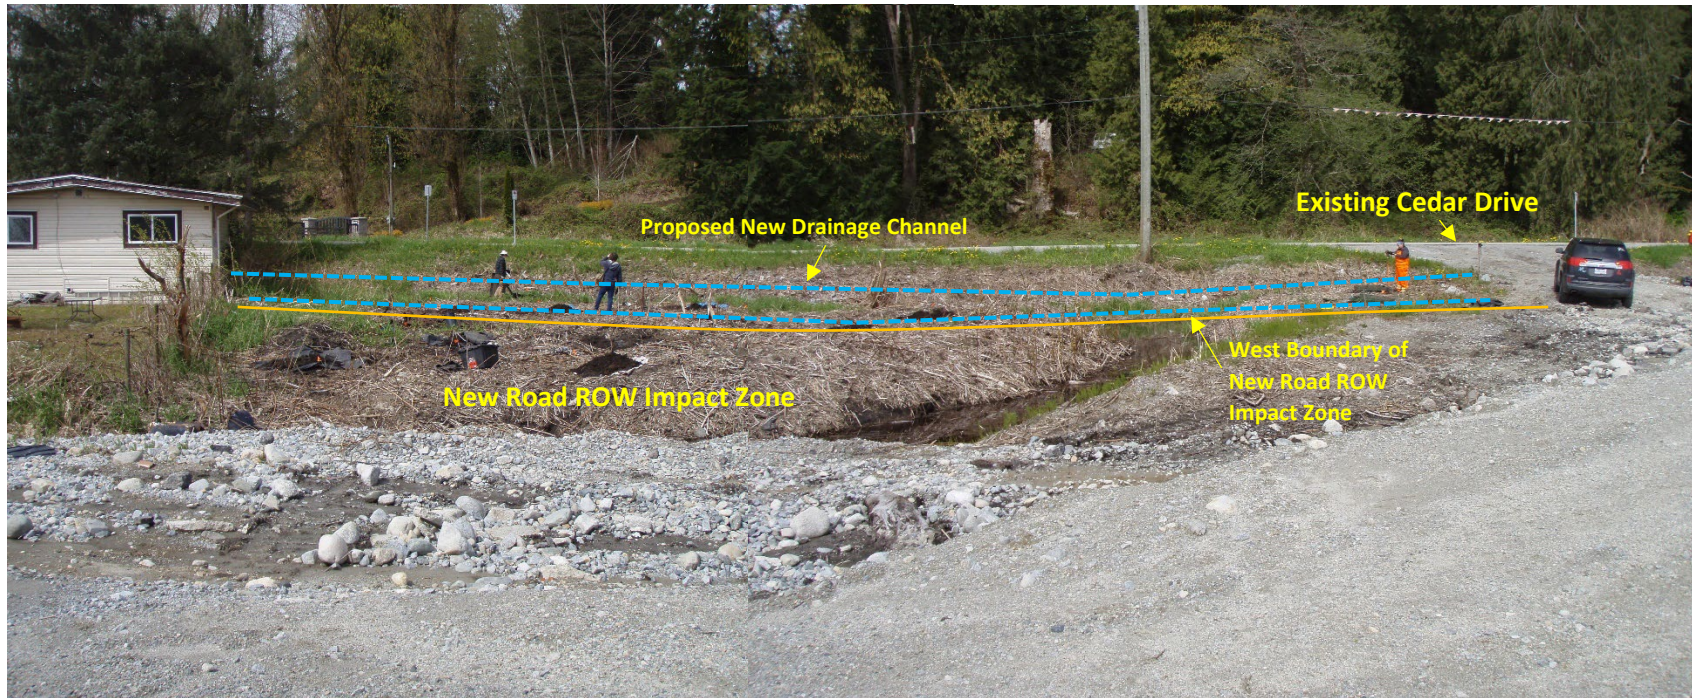
Figure 21. View of small area at the north end of 4169 Cedar Drive (left) and the south end of the road-base fill section of the ROW (right) with shovel testing in progress, looking west. Fifteen shovel tests (STs 53 to 67) were placed in this area, revealing that it is a former wet marshland that was built up by being capped with about 40 to 50 cm of imported fill containing a moderate quantity of domestic and industrial refuse. Note existing drainage ditch in the center of the photo. This location will be capped with road-base fill in mid-2022. See also Figure 15.

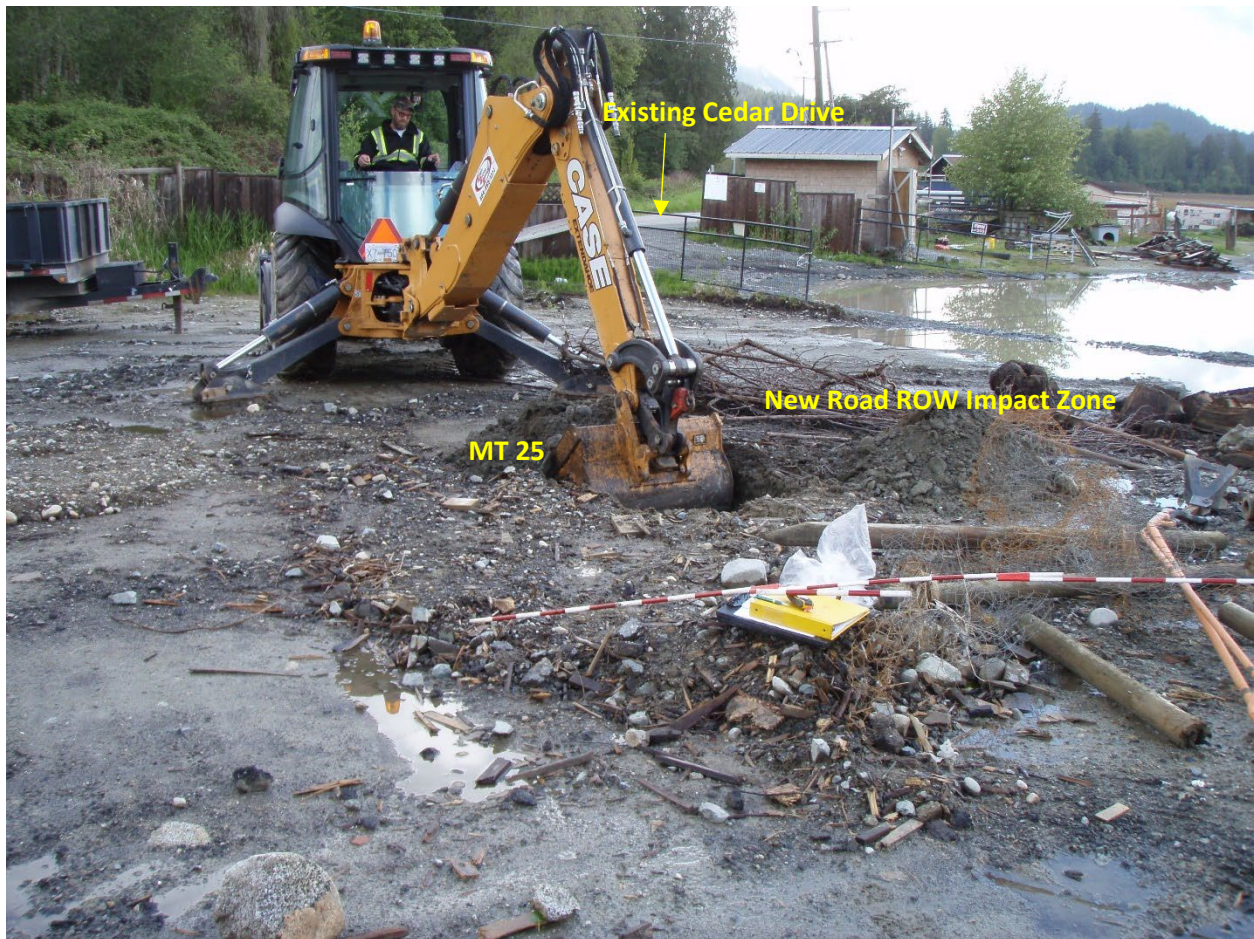
Figure 23. Excavation of MT 25 underway within the proposed new road ROW about 20 m east of the proposed sanitary force main pump station within the southwestern aspect of 4169 Cedar Drive, looking northeast. It is proposed that this area will be capped with road-base fill in mid-2022.

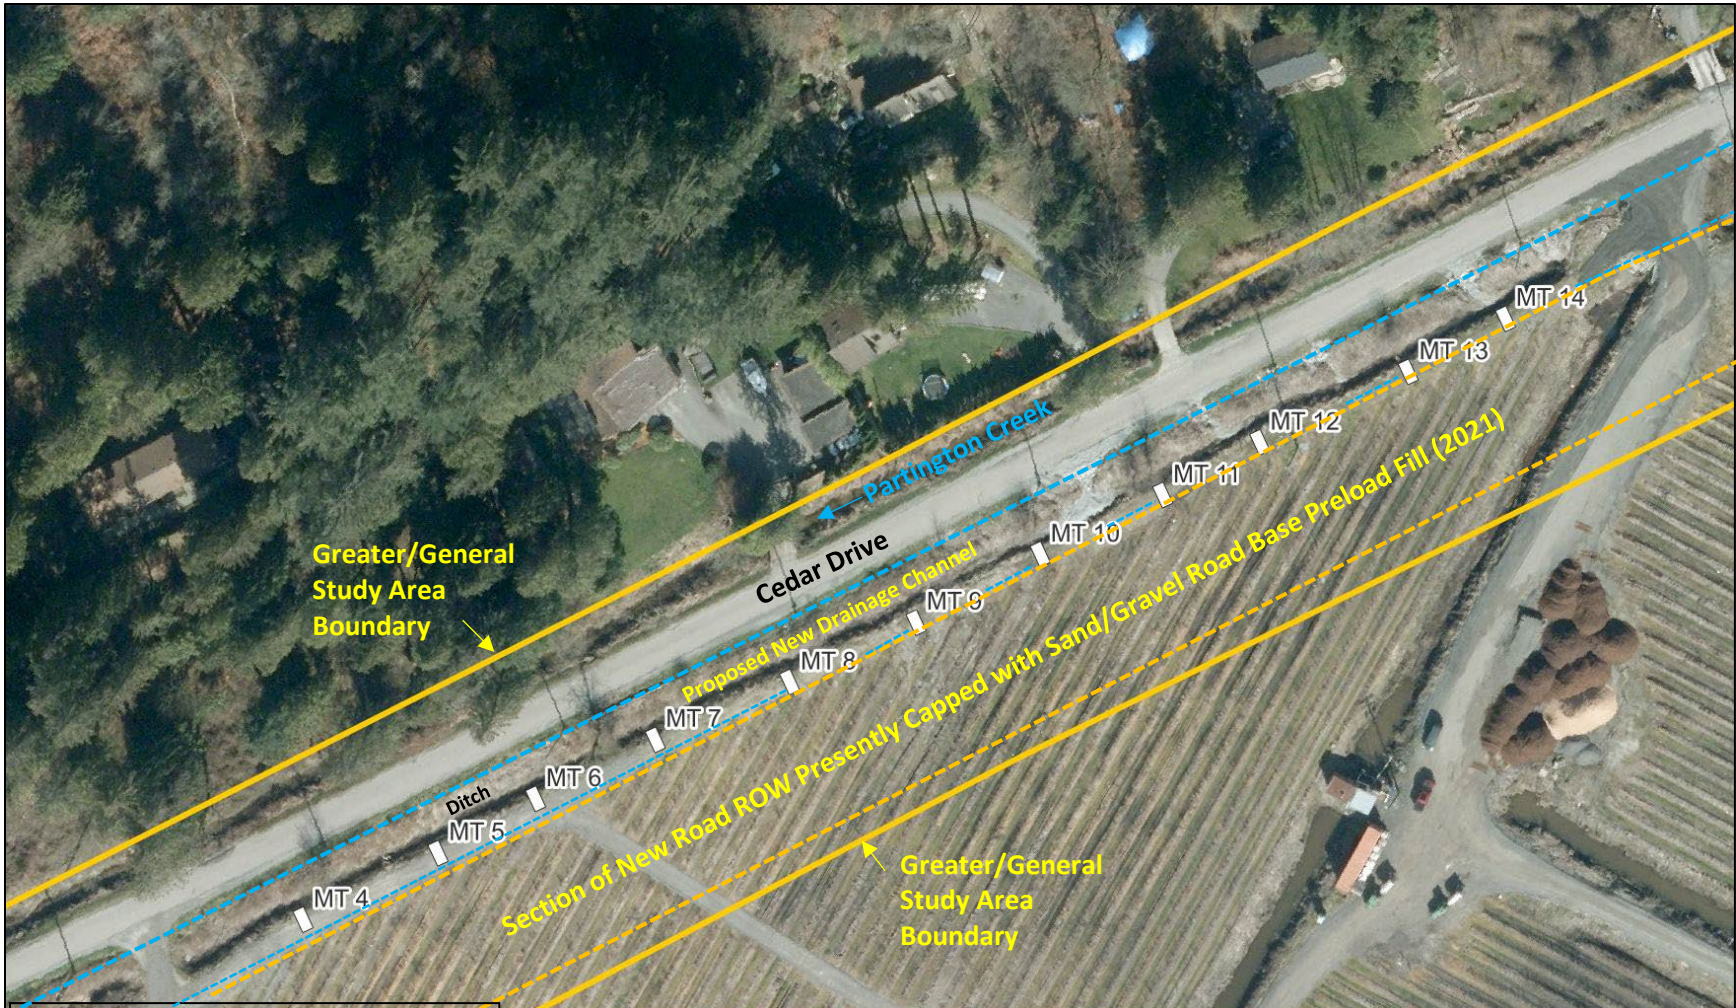
Figure 24. Aerial image map showing north-central section of Development Area 7 showing new road ROW capped with road-base pre-load in 2021 (not shown), proposed drainage channel impact zone, and location of Machine Tests 4 to 14. See also Figures 25 to 28.

Recommended Management in Development Area 7:

For Development Area 7 we suggest the following management recommendations.

fieldwork. Visual monitoring of land-altering activities is not recommended. However, the developer and contracting machine operators should be aware of, and participate in, a “chance find management protocol” procedure during land-altering activities in the event that something obvious is encountered (see Appendix V). Note that the north end of this new drainage channel will not extend to the natural channel of Partington Creek that lies 20 m to the north and is deemed to have medium archaeological site potential. Machine excavation of the drainage channel and installation of several culverts are scheduled to commence in mid-2022 or 2023.
