HCA Heritage Inspection Permit 2021-0396

Re: Interim Summary Results and Recommendations Report for Recently Investigated and Tested Sections of Impact Zones Related to Various Upgrades to a Section of Cedar Drive in Coquitlam, and Summary of Proposed Development Scheduled to Commence in mid-2022; HCA Permit 2021-0396

Introduction and Background

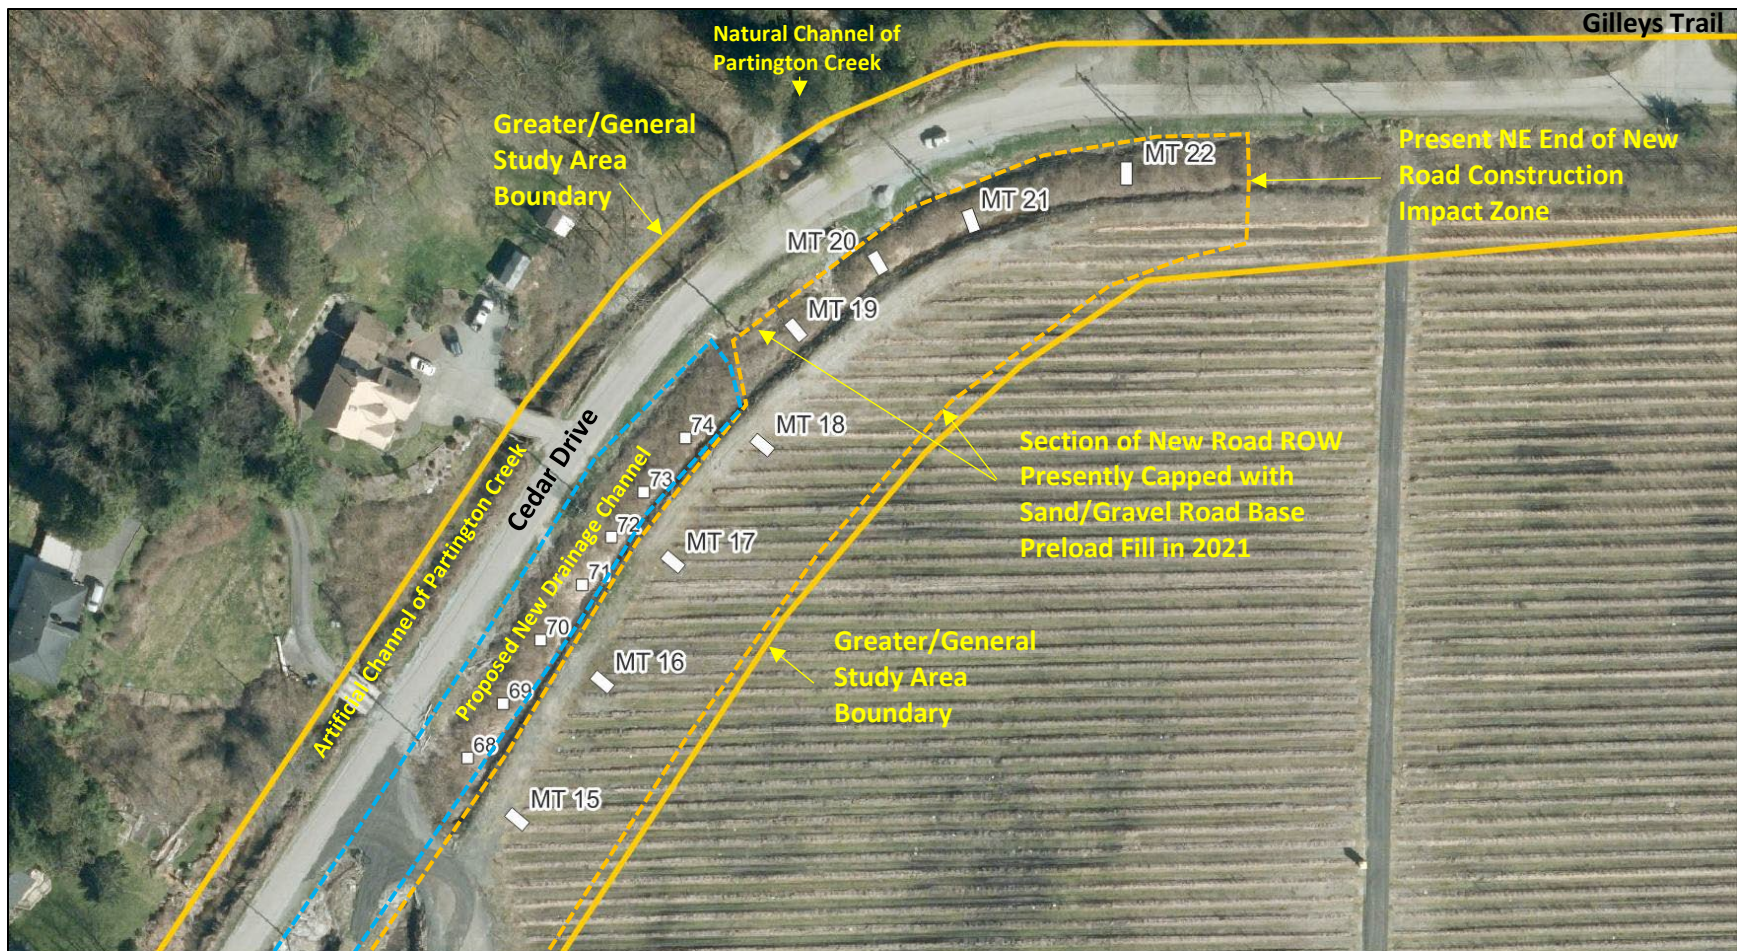
Figure 25. Aerial image map showing the NE section/end of the new road ROW in Development Area 7 that was capped with road-base pre-load in 2021 (not shown in photo), proposed drainage channel impact zone, Shovel Tests 68 to 74, and location of Machine Tests 4 to 14. See also Figures 29 and 30.

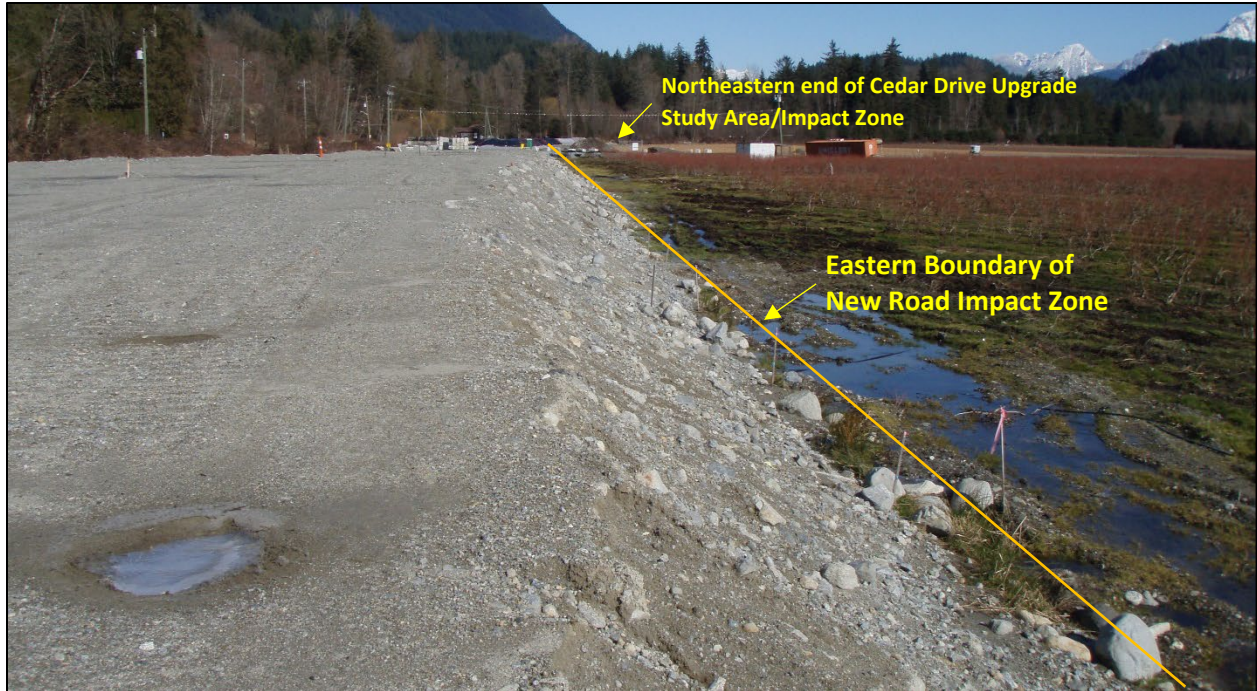
Figure 26. A February 22, 2022 general view of the east side of the northern 2/3 of new road ROW in Development Area 7 showing road-bed that was capped with sand/gravel road-bed pre-load fill in 2021, looking northeast. This section will be capped with an additional 1.0 m of road-base fill in mid-2022. Note standing water in saturated natural and imported fill deposits in lower right that indicate a high water table.

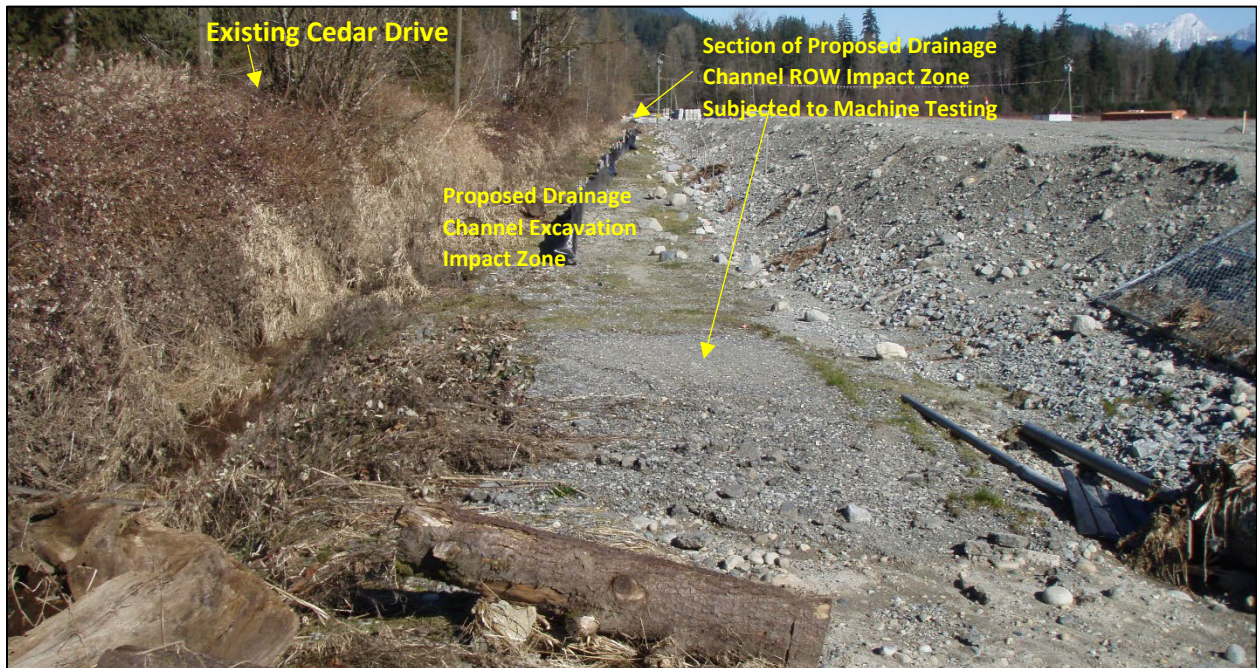
Figure 27. A February 22, 2022, general view of the west side of the north-central section new road ROW (upper right) in Development Area 7 showing section of new road-bed capped with pre-load fill in 2021 (right), looking northeast. This section will be capped with an additional 1.0 m of road-base fill in mid- to late 2022. A new drainage channel will be dug between existing Cedar Drive (upper left) and the new ROW. The area immediately west (left) of the road-bed in the center of the photo was subjected to machine testing (MTs 4 to 14) (Figures 24 and 25; Appendices III and IV).

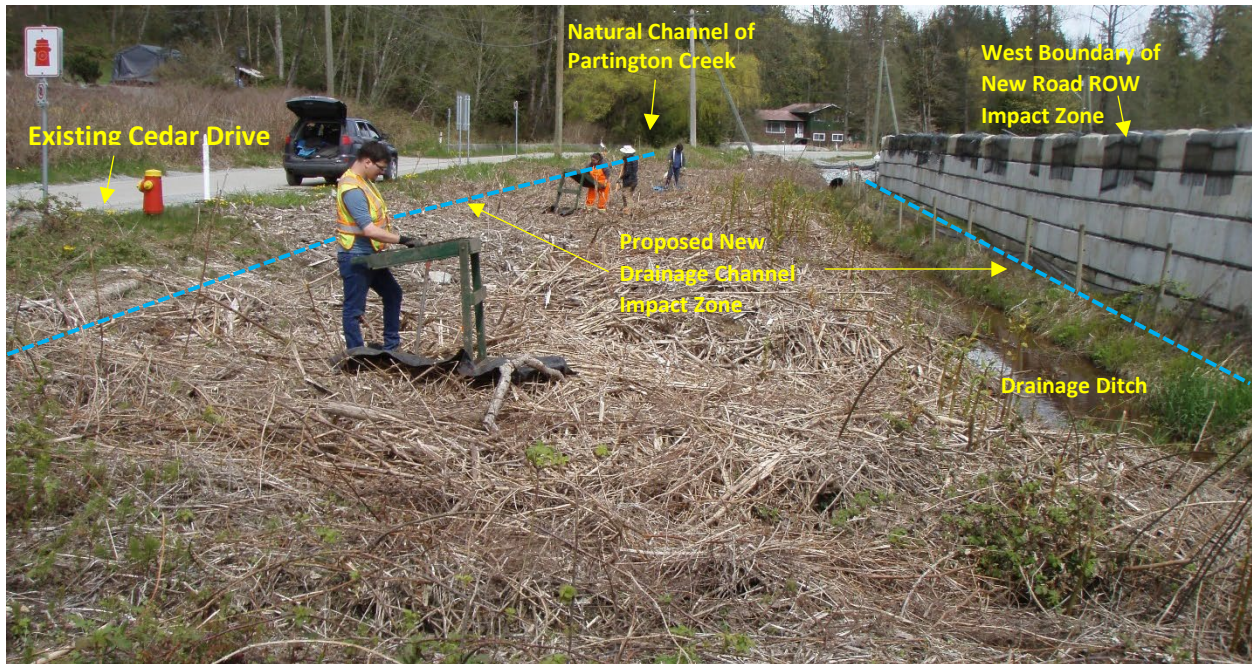
Figure 30. A view of April 20, 2022, shovel testing (STs 68 to 74) underway in a gently-sloping area near the northwestern end of Development Area 7 between existing Cedar Drive (upper left) and the new road ROW (upper right) where a proposed drainage channel will be machine excavated, looking northeast.

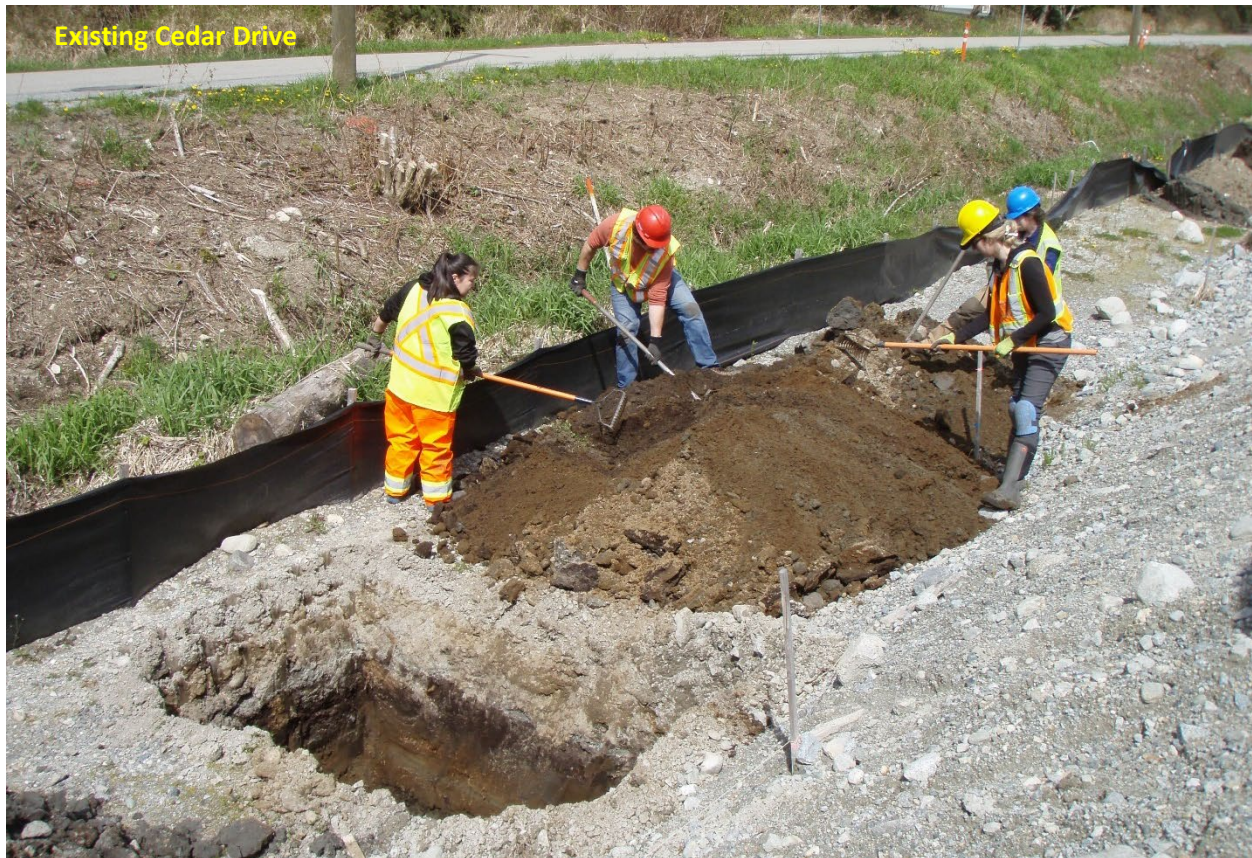
Figure 31. A view of hand-raking and close inspection of “natural” sand/silt and peat sediments removed from below the imported fill in machine test (MT) 4, looking north. Note uppermost thick layer of imported fill deposits and underlying natural peat and fluvially-lain sand and silt in the test hole. The majority of the natural sediments were closely visually scrutinized, although the potential for them to contain any pre-contact period cultural deposits was considered to be low.

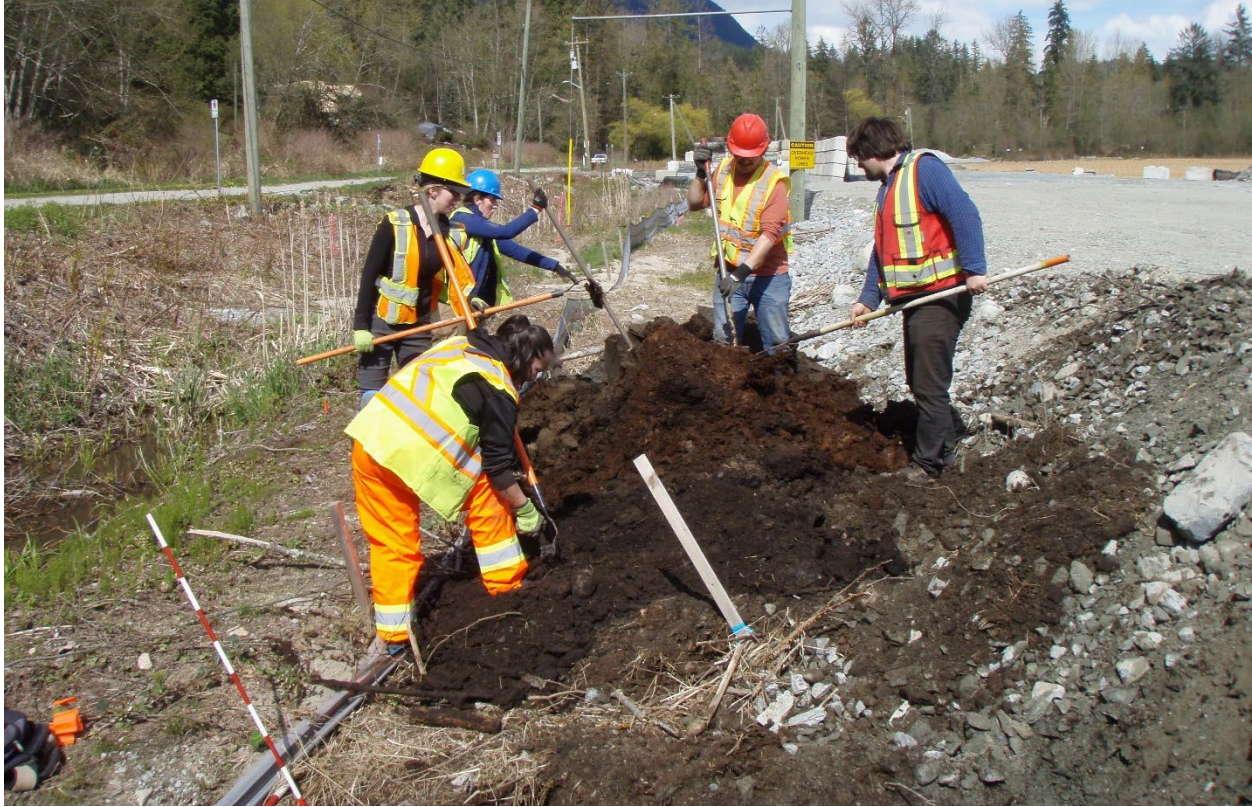
Figure 32. A view of hand-raking and close inspection of natural silt and peat sediments removed from machine test (MT) 12 in progress, looking northeast.

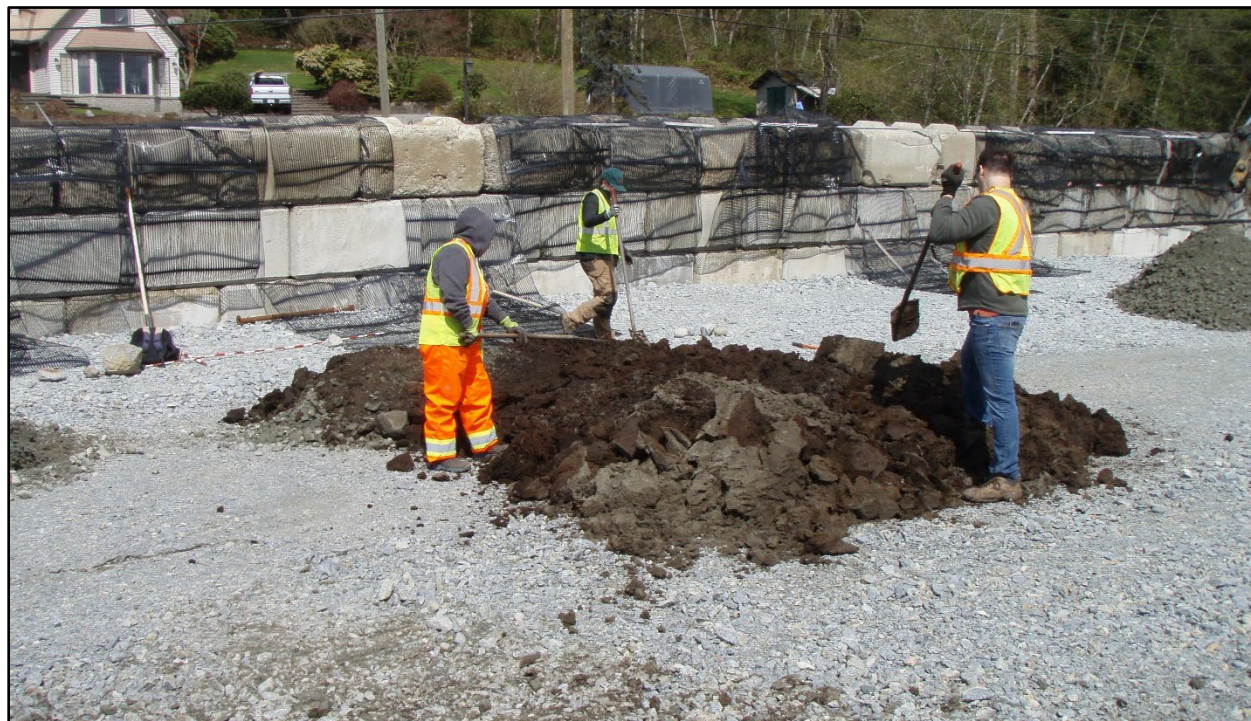
Figure 33. A view of hand-raking and close inspection of sub-fill “natural” silt and peat sediments removed from machine test (MT) 16 in progress within the new road ROW that was capped in 2021, looking north.

There was some variation between the nature and thicknesses of the strata encountered in MTs 15 to 22, but they all exhibited a basic similarity in composition, structure, and depositional history (see Appendices III and IV). Note that stratum depth measurements were taken from the pre-2021 ground level below recently deposited sand/gravel road fill pre-load, and thicknesses varied from 70 to 150 cm depending on location. Specific descriptions, details and photos for each machine test are provided in Appendices III and IV. Generally, from 0 to 40/60 cm BS the uppermost deposit is a loose grey brown mix of silt, sandy silt that is clearly imported fill that relates to construction of Cedar Drive in the early 1900s; from 40/60 to 110/120 cm BS there is the distinctive brown/black/orange peat zone containing random sticks, branches and tree roots that was hand-raked and closely inspected; from 110/130 to 150/170 cm BS there is a firm well-sorted, relatively homogenous brown fluvial sand and silt mix that was hand-raked and closely inspected; and from 150/170 to 180/200 cm BS there is a hard grey marine/late glacial clay. This general stratigraphic pattern closely resembles those observed in MTs 4 to 14 to the south, and again attests that fluvial sand and silts carried in a low-energy fluvial environment were deposited over sterile glacial clay during the initial half of the Holocene, and a boggy/marshland forest succeeded and thrived in this locality for the latter half. Most of the tests leaked groundwater below about 50 to 100 cm BS, and the bottoms of some tests filled rapidly due to the wet and boggy nature of the local landscape.

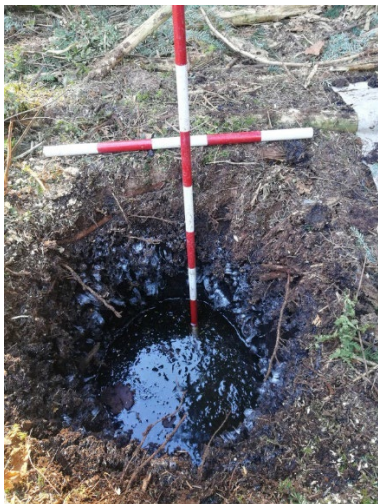
Figure 49. ST 16.

ST 15	February 22, 2022	45cm	60cm BS	0 to 35cm BS: compact dark brown - black silt with very high organic content (screened) lots of broken glass associated; 35 to 60 cm BS: Medium grey brown silty clay (screened). Bottom of test filled with water during and after being dug.	Placed in area to be impacted by a temporary traffic diversion lane and pipe line drill rig station. No pre-contact period cultural deposits.	Figures 6, 48.
ST 16	February 22, 2022	45cm	60cm BS	0 to 35cm BS: compact dark brown - black silt with very high organic content (screened); 35 to 60 cm BS: Medium grey brown silty clay (screened). Bottom of test filled with water during and after being dug.	Placed in area to be impacted by a temporary traffic diversion lane and pipe line drill rig station. No pre-contact period cultural deposits.	Figures 6, 49.

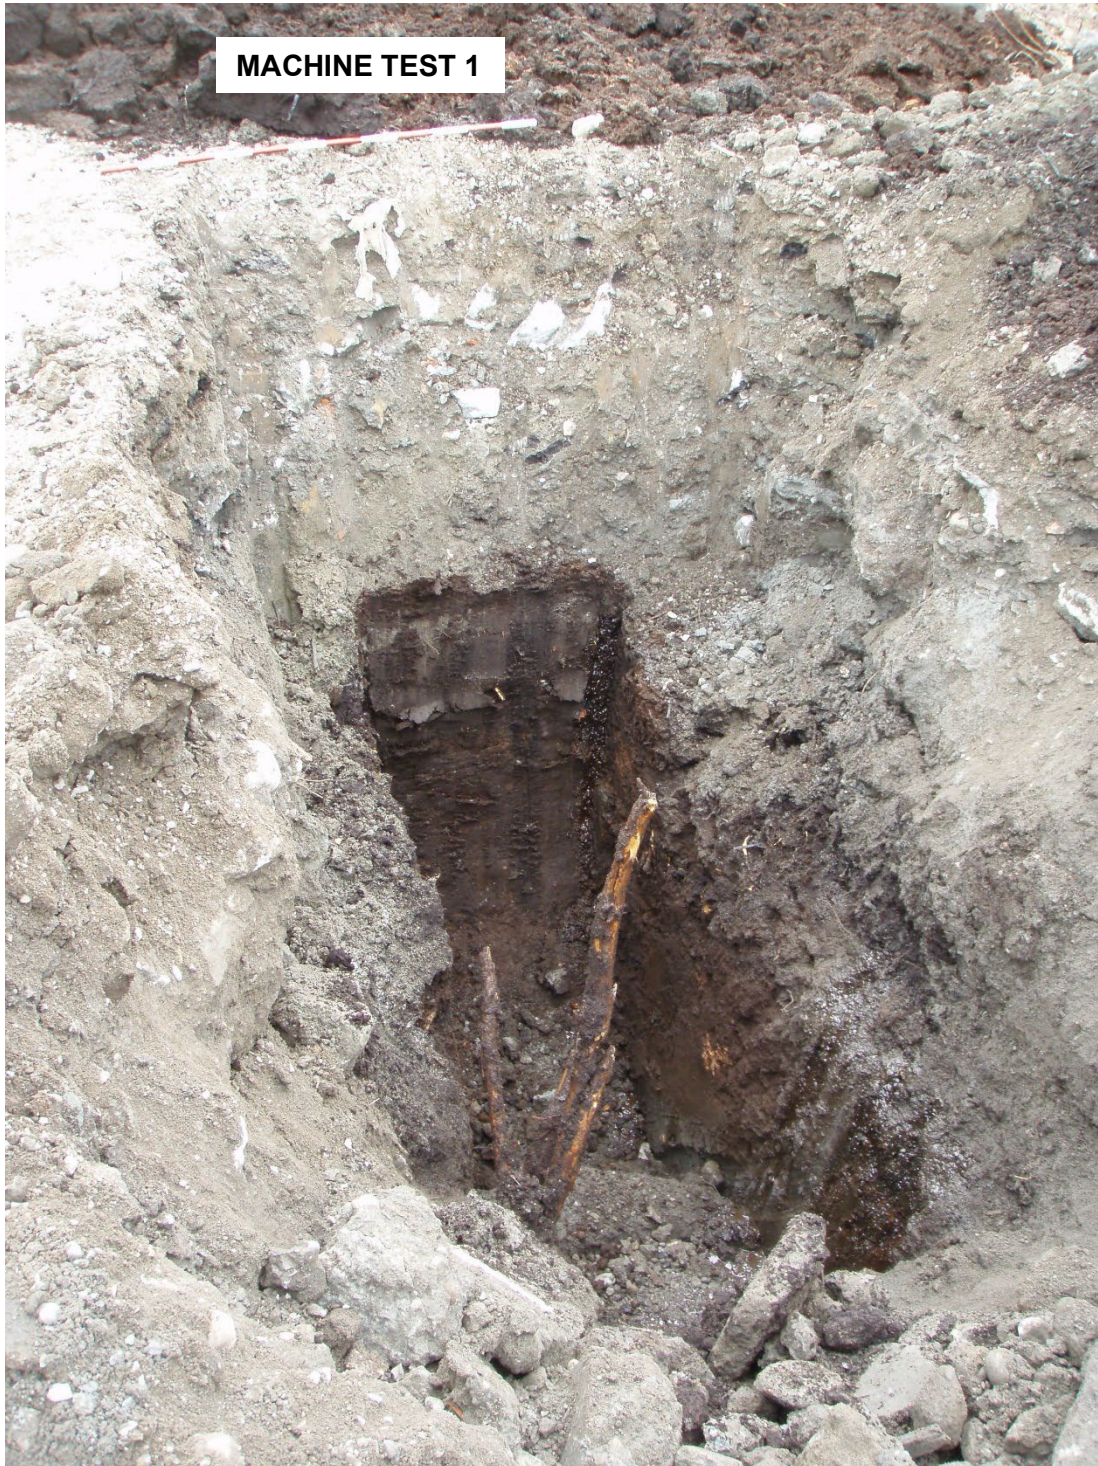
Figure 88. View of Machine Test (MT) # 1 looking west. Test location is shown in Figures 11, 14 and 20.

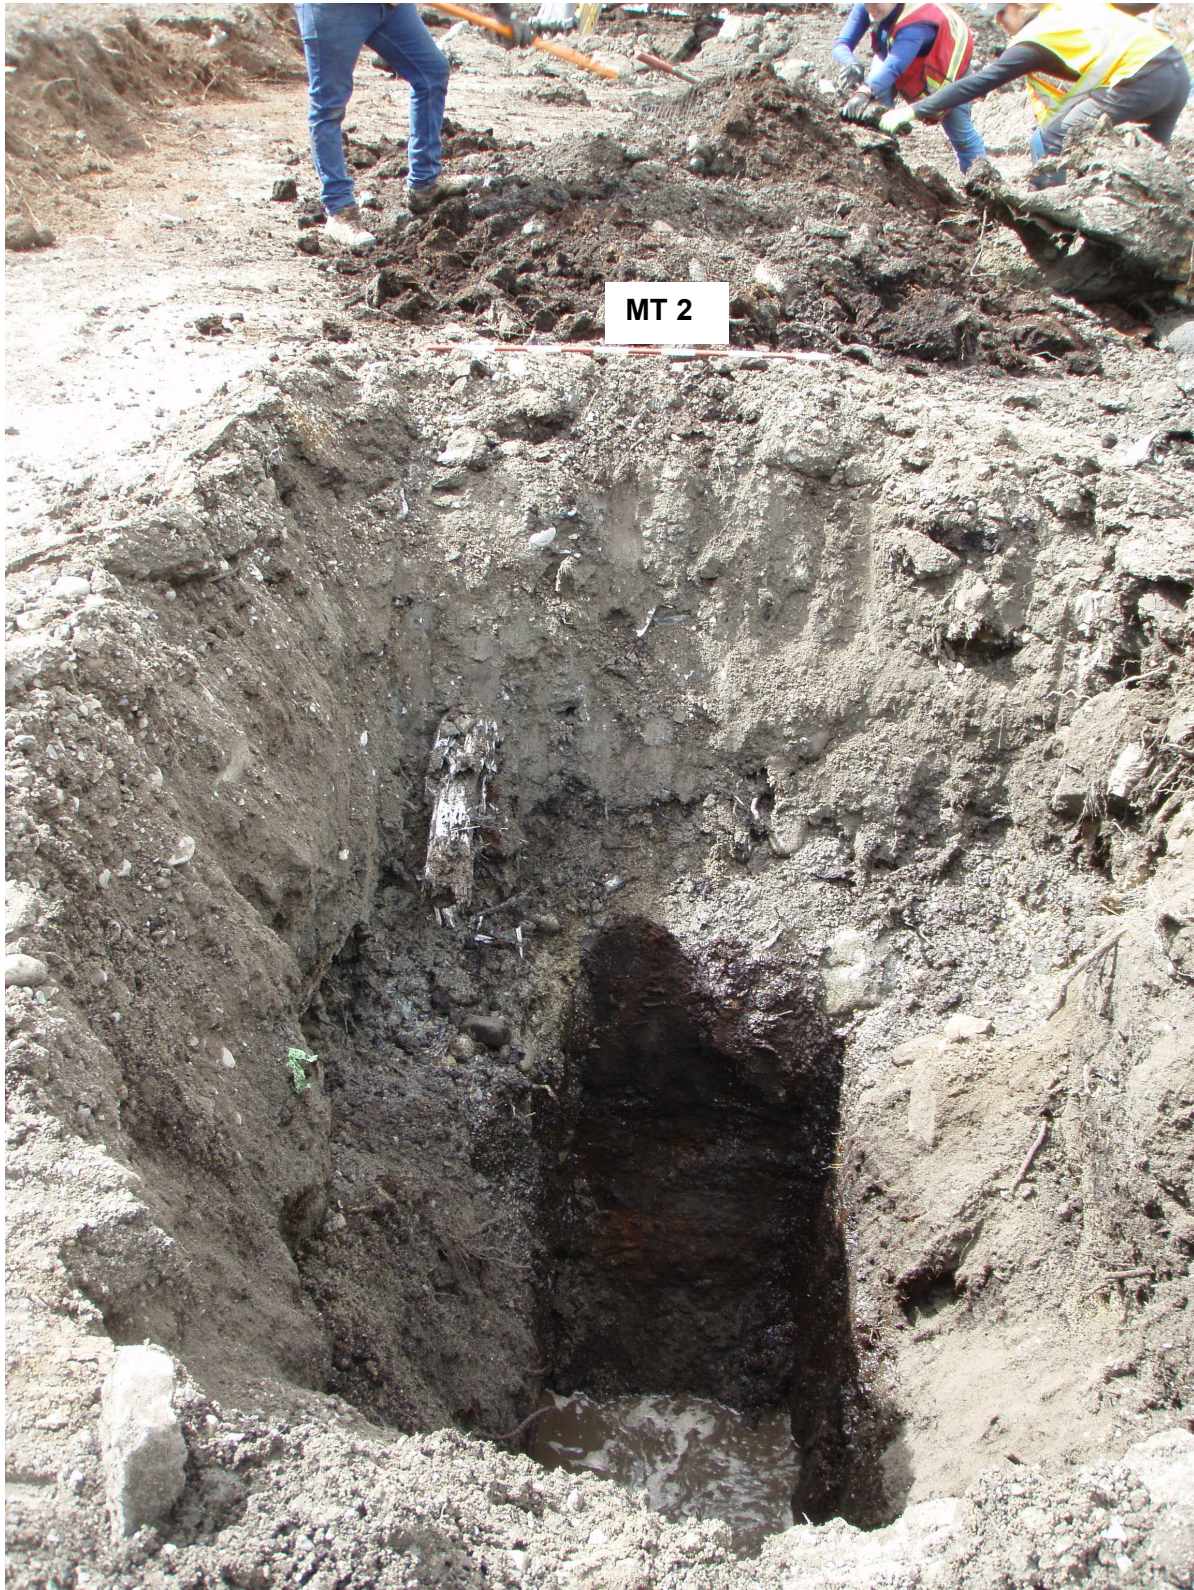
Figure 89. View of Machine Test (MT) 2 looking west. Test location is shown in Figures 11, 14 and 20.

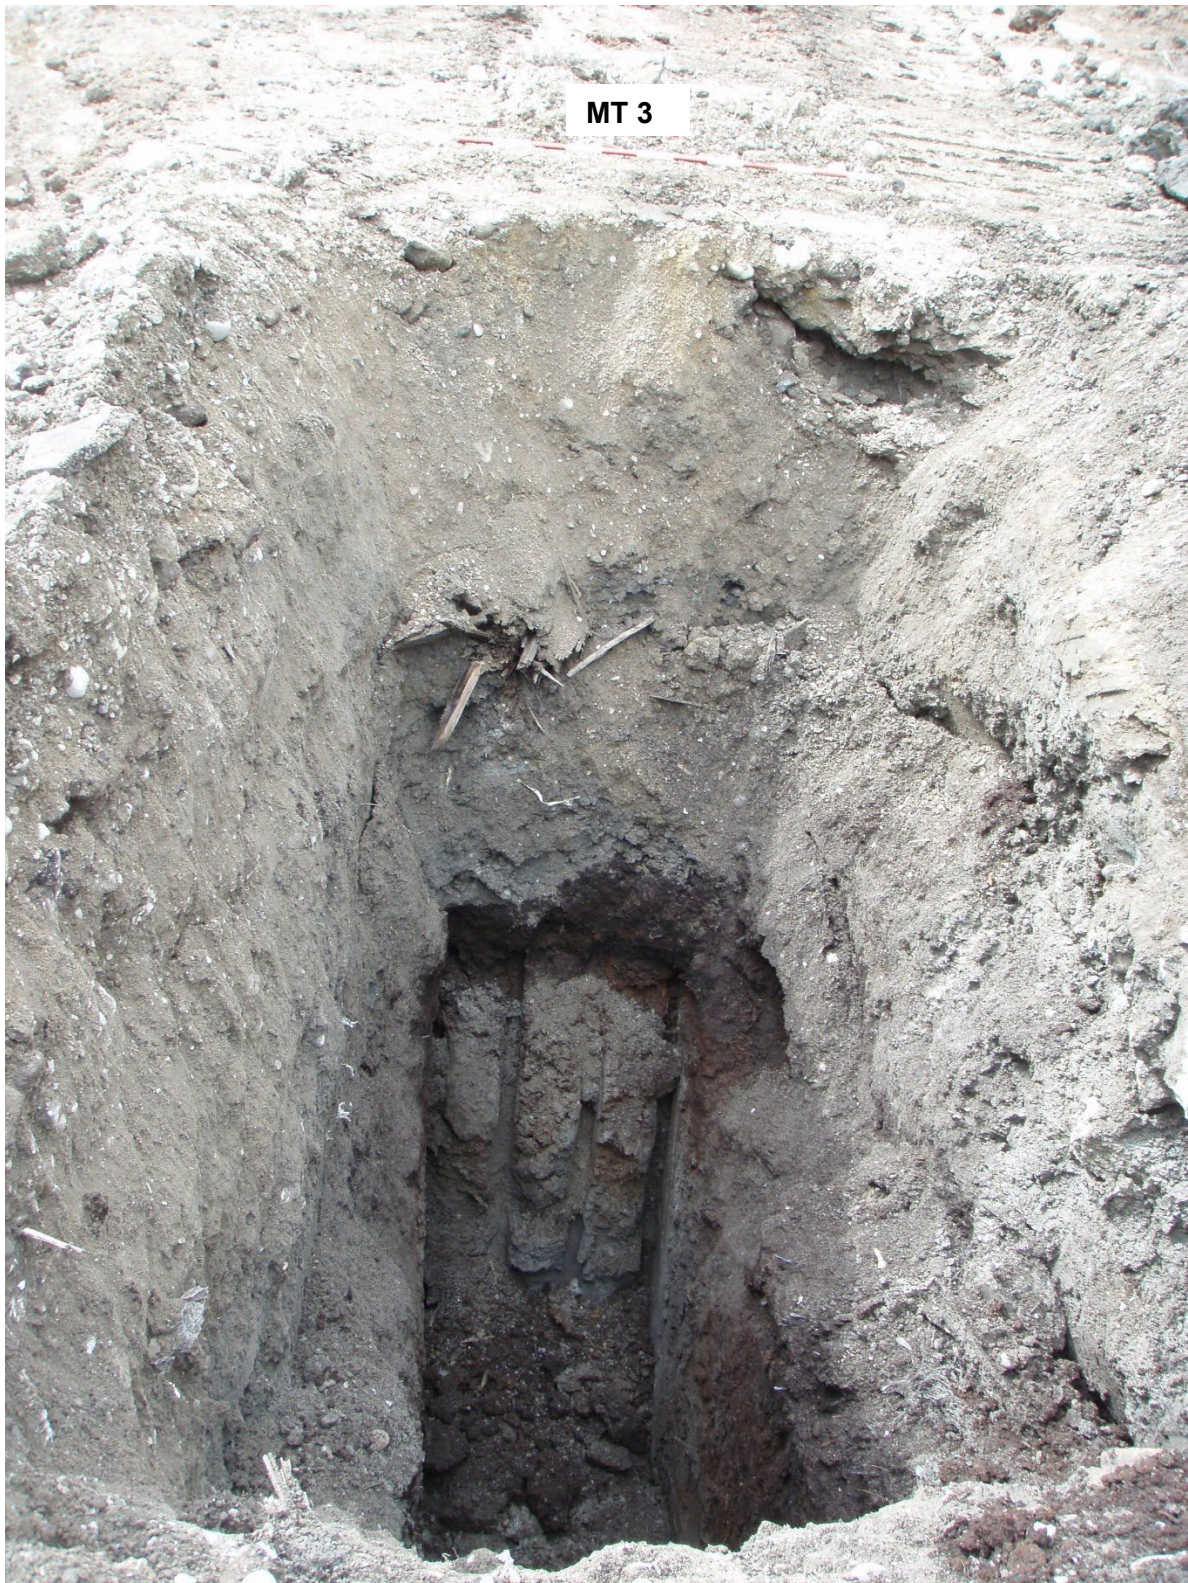
Figure 90. View of Machine Test (MT) 3 looking west. Test location is shown in Figures 11, 14 and 20.

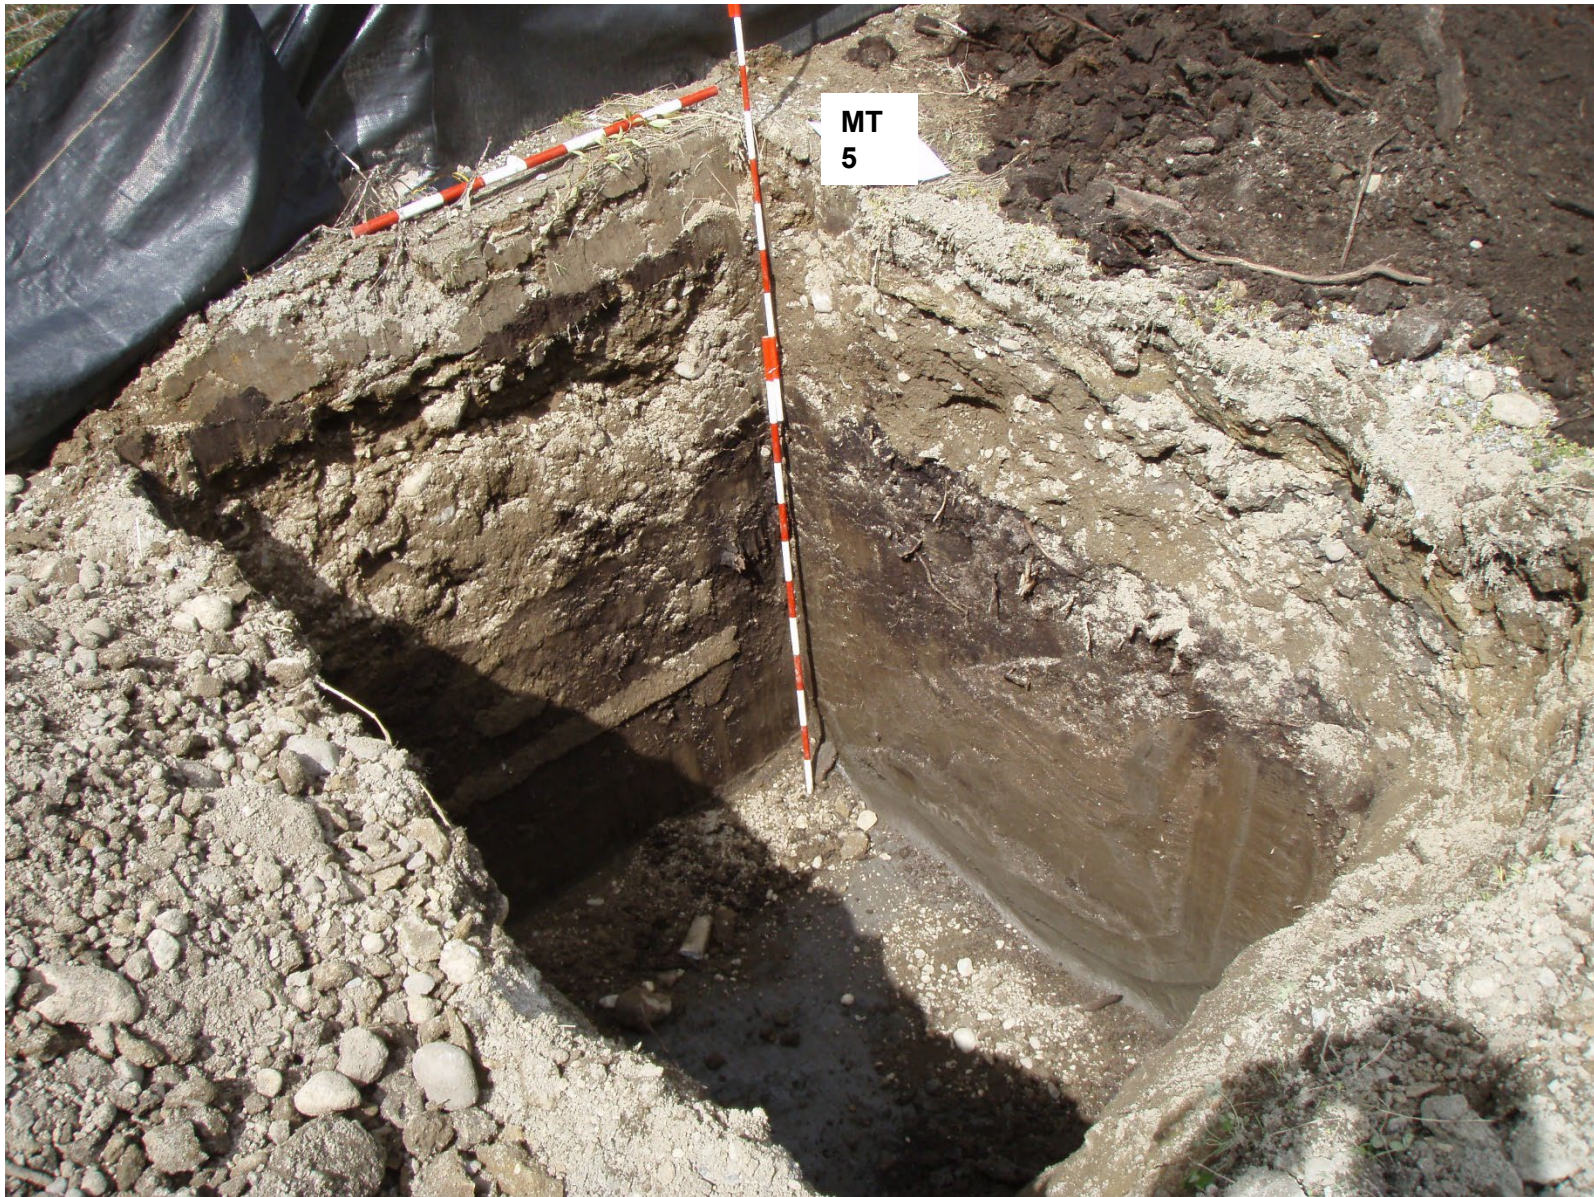
Figure 91. View of Machine Test (MT) 4 looking north. Test location is shown in Figure 24.

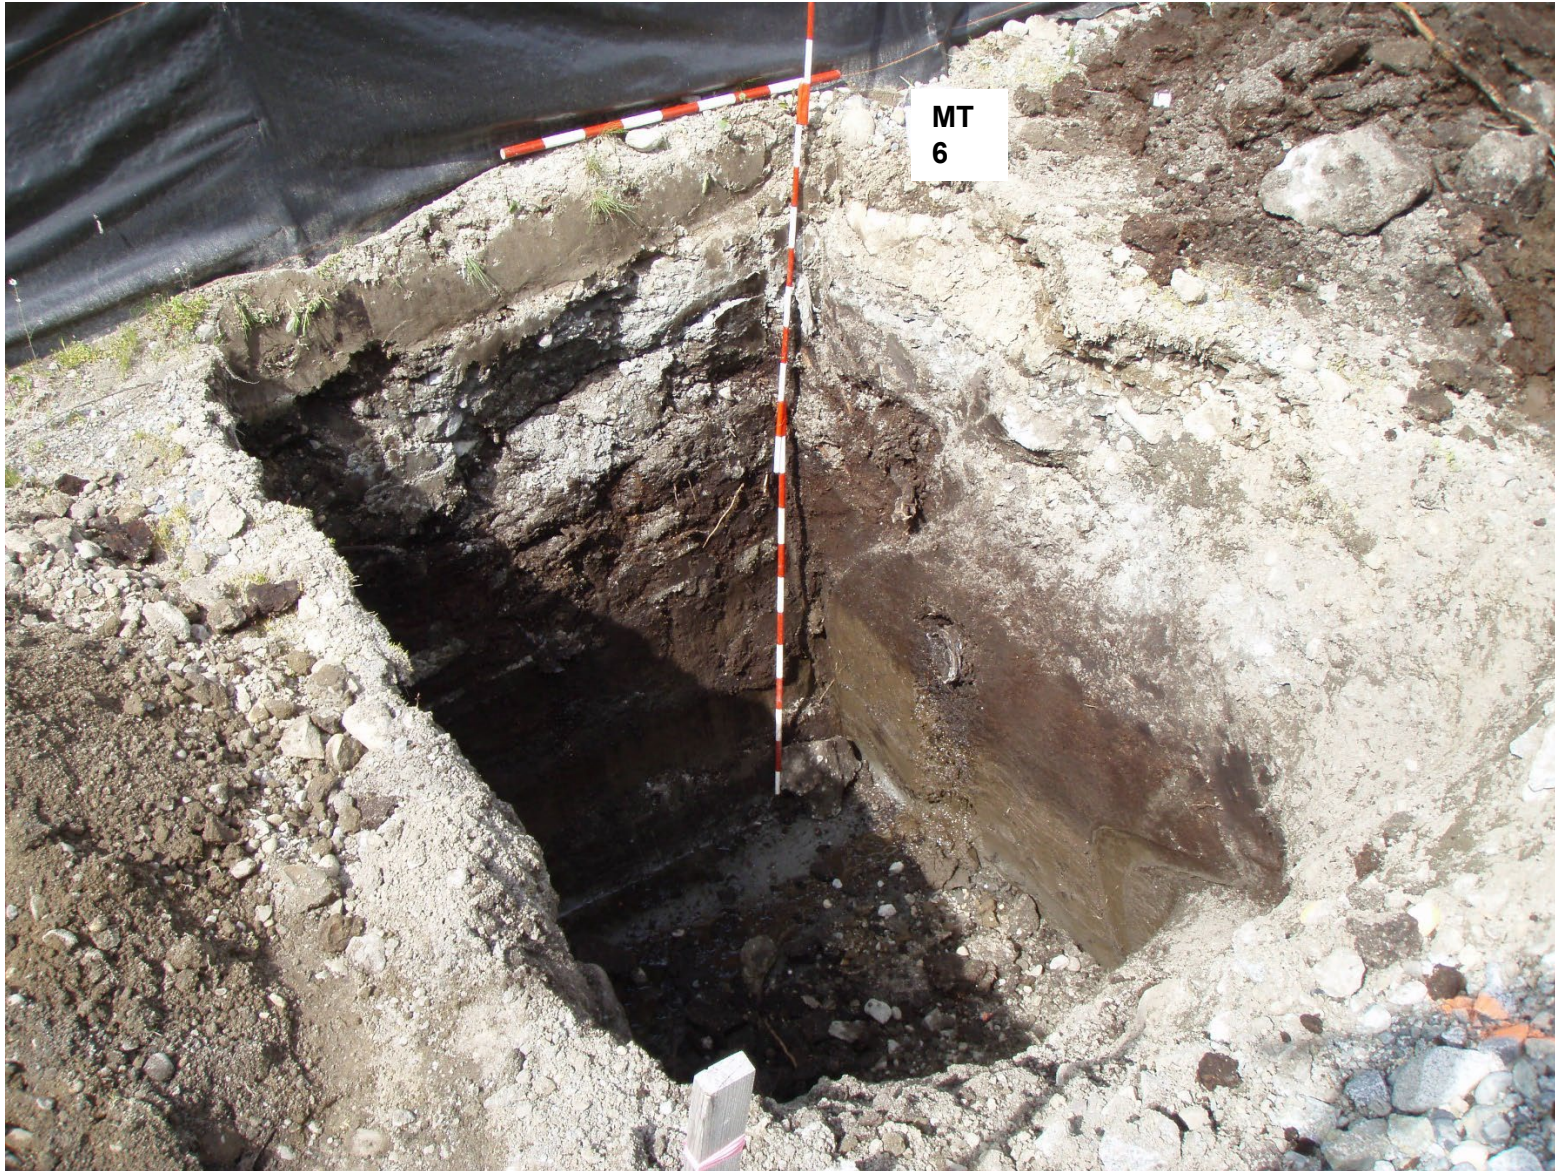
Figure 92. View of Machine Test (MT) 5 looking north. Test location is shown in Figure 24.

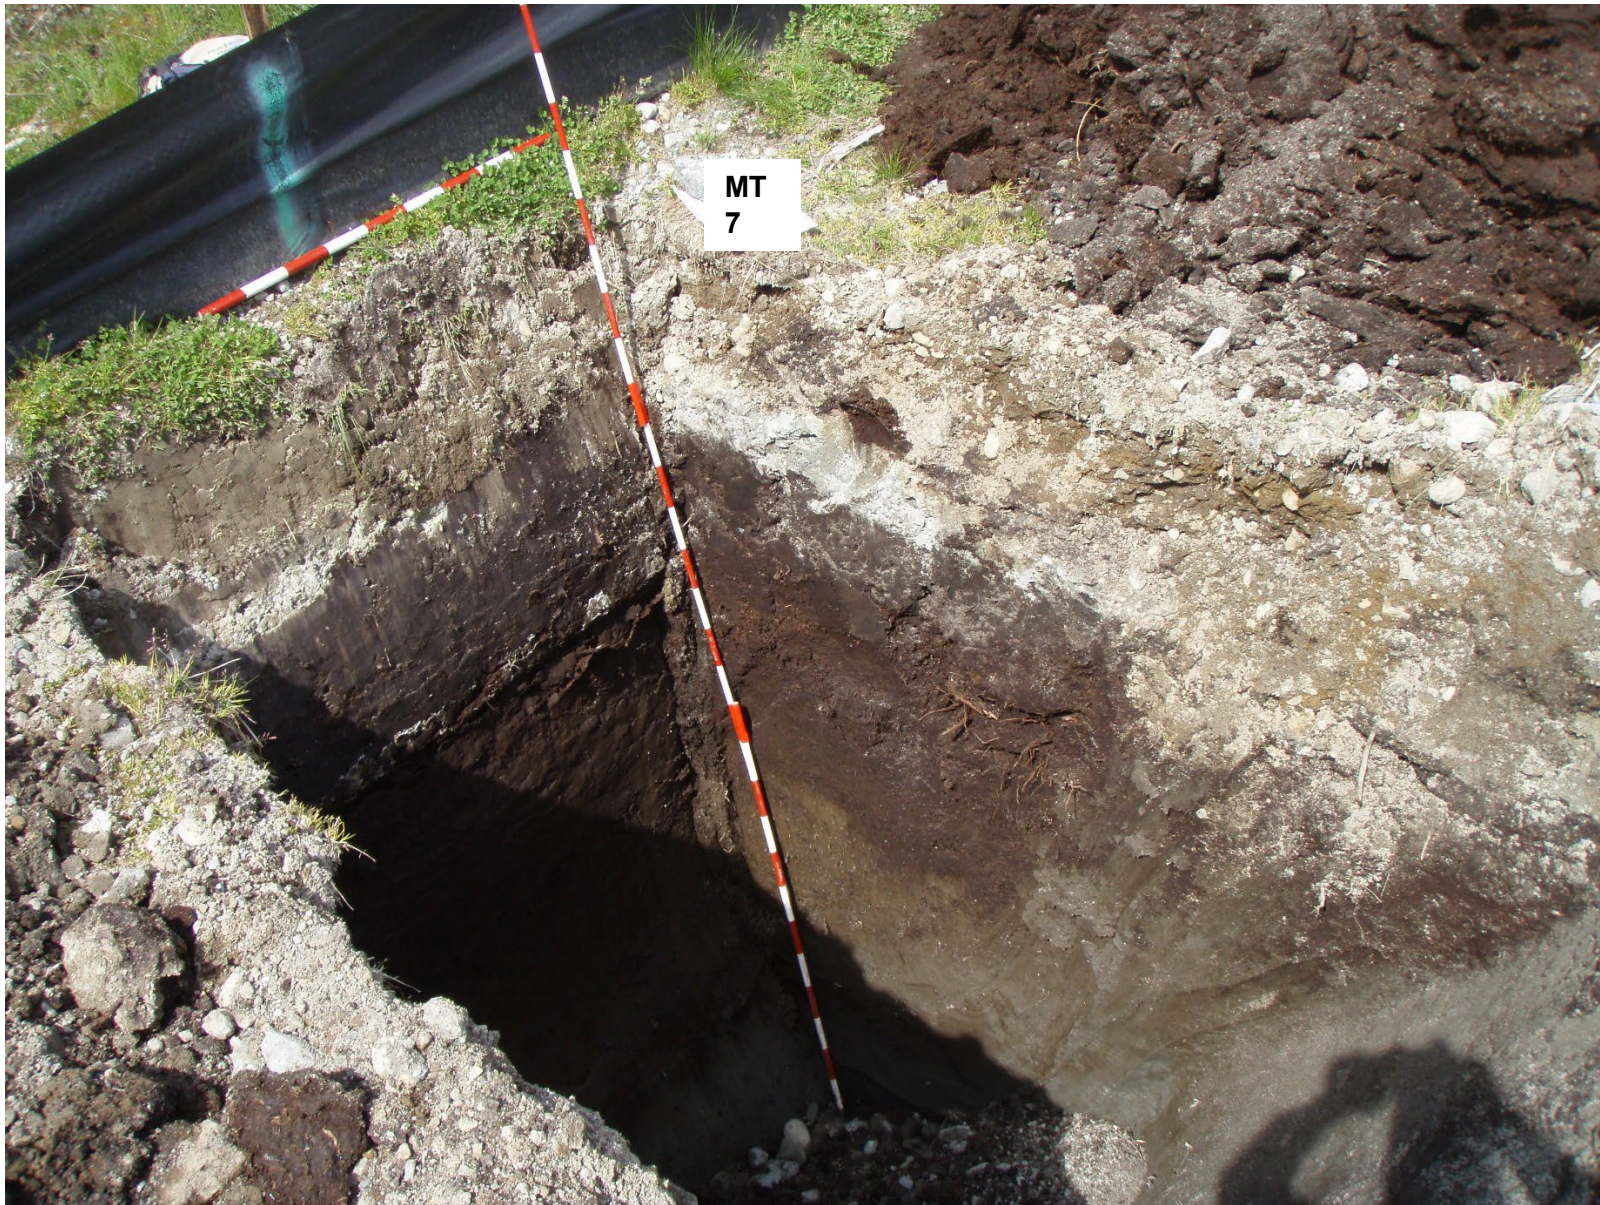
Figure 93. View of Machine Test (MT) 6 looking north. Test location is shown in Figure 24.

Machine Test Number	UTM Waypoint	Dimension and Max Depth (BS)	Excavation Date	Stratigraphic Unit Descriptions	Comments	Photo/Figure
MT 6	10U; 0520224E; 5459750N	2.5m NS x 2.0m EW x 2.0m BS	April 14, 2022	0 to 60cm BS: Compact grey mix of silt, sand, gravel, cobbles (imported fill with concrete slabs); 60 to 130cm BS: brown/black/orange peat zone that was hand-raked and closely inspected; 130 to 180cm BS: loose orange-brown sand and silt mix that was hand -raked and closely inspected; 180 to 200cm BS: hard grey marine/late glacial clay.	Test placed on N side of the SW end of new road ROW preload area within proposed channel impact zone; No Pre-Contact period archaeological deposits.	Figures 24, 93.
MT 7	10U; 0520231E; 5459771N	2.5m NS x 1.75m EW x 2.3m BS	April 14, 2022	0 to 40cm BS: Compact grey/brown mix of silt, sand, gravel, cobbles (imported fill); 40 to 120cm BS: brown/black/orange peat zone that was hand-raked and closely inspected; 120 to 180cm BS: loose orange-brown sand and silt mix that was hand -raked and closely inspected; 180 to 230cm BS: hard grey marine/late glacial clay.	Test placed on N side of the SW end of new road ROW preload area within proposed drainage channel impact zone; No Pre-Contact period archaeological deposits.	Figures 24, 94.

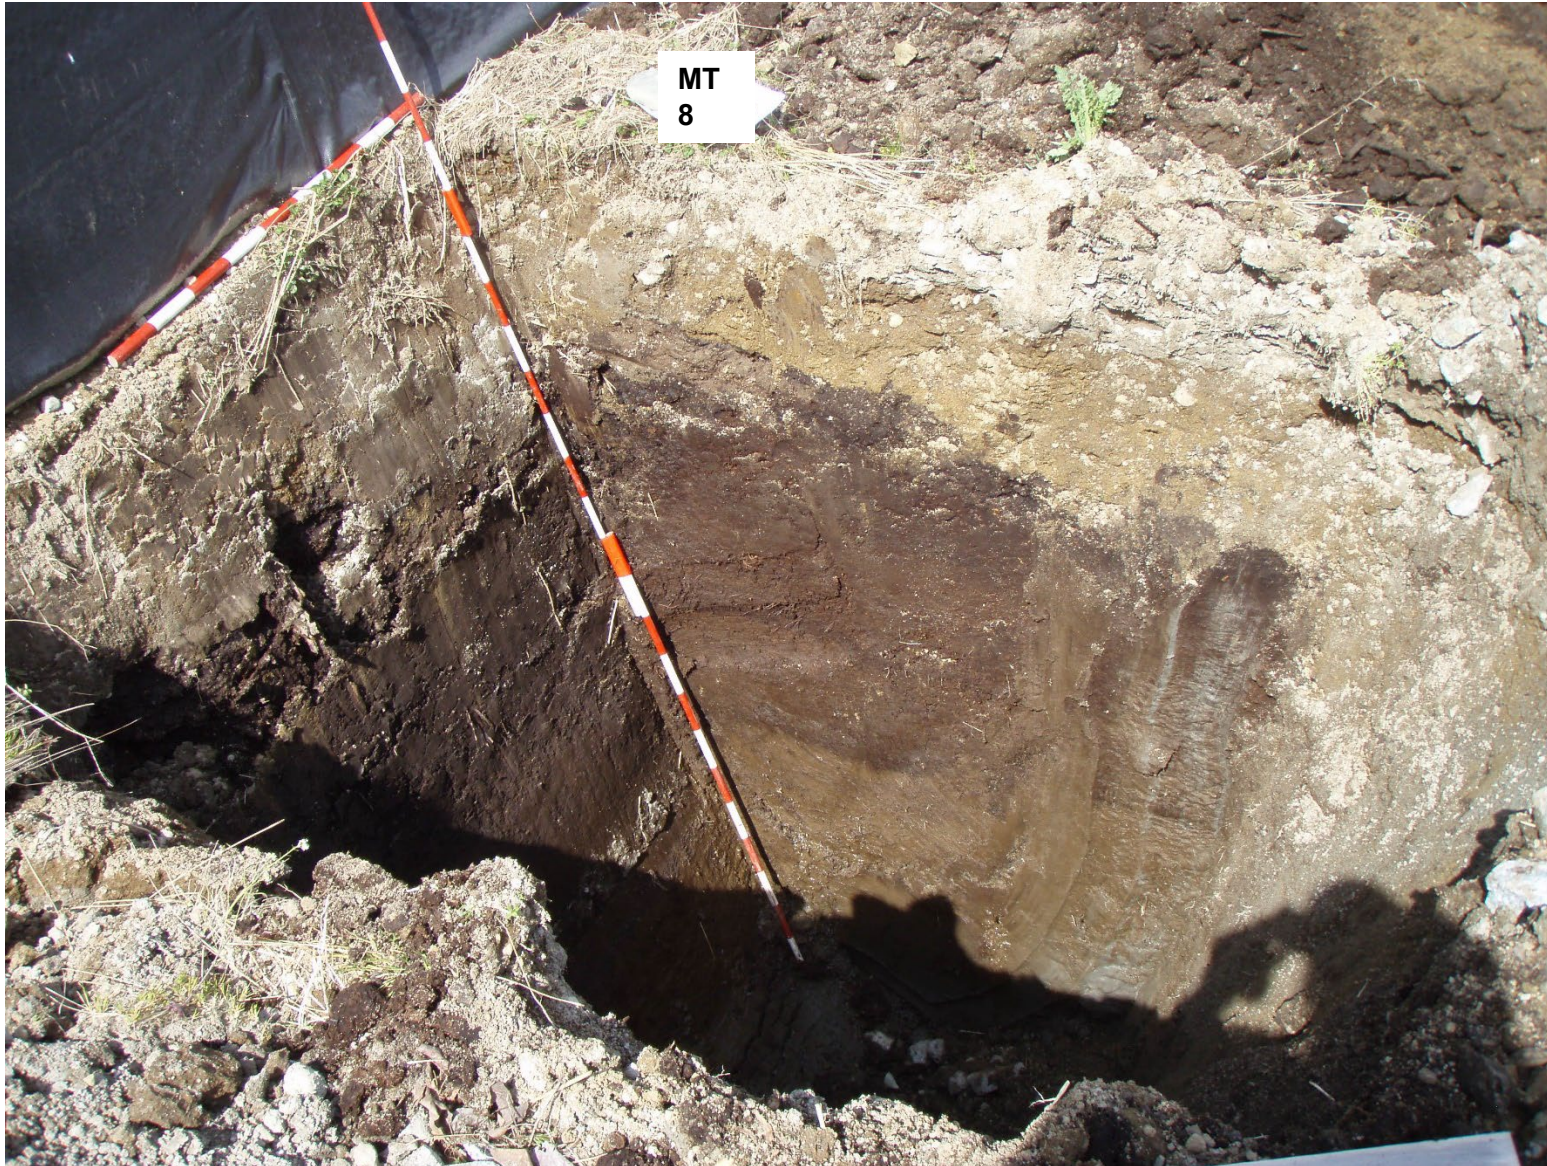
Figure 94. View of Machine Test (MT) 7 looking north. Test location is shown in Figure 24.
