HCA Heritage Inspection Permit 2021-0396

Re: Interim Summary Results and Recommendations Report for Recently Investigated and Tested Sections of Impact Zones Related to Various Upgrades to a Section of Cedar Drive in Coquitlam, and Summary of Proposed Development Scheduled to Commence in mid-2022; HCA Permit 2021-0396

Introduction and Background

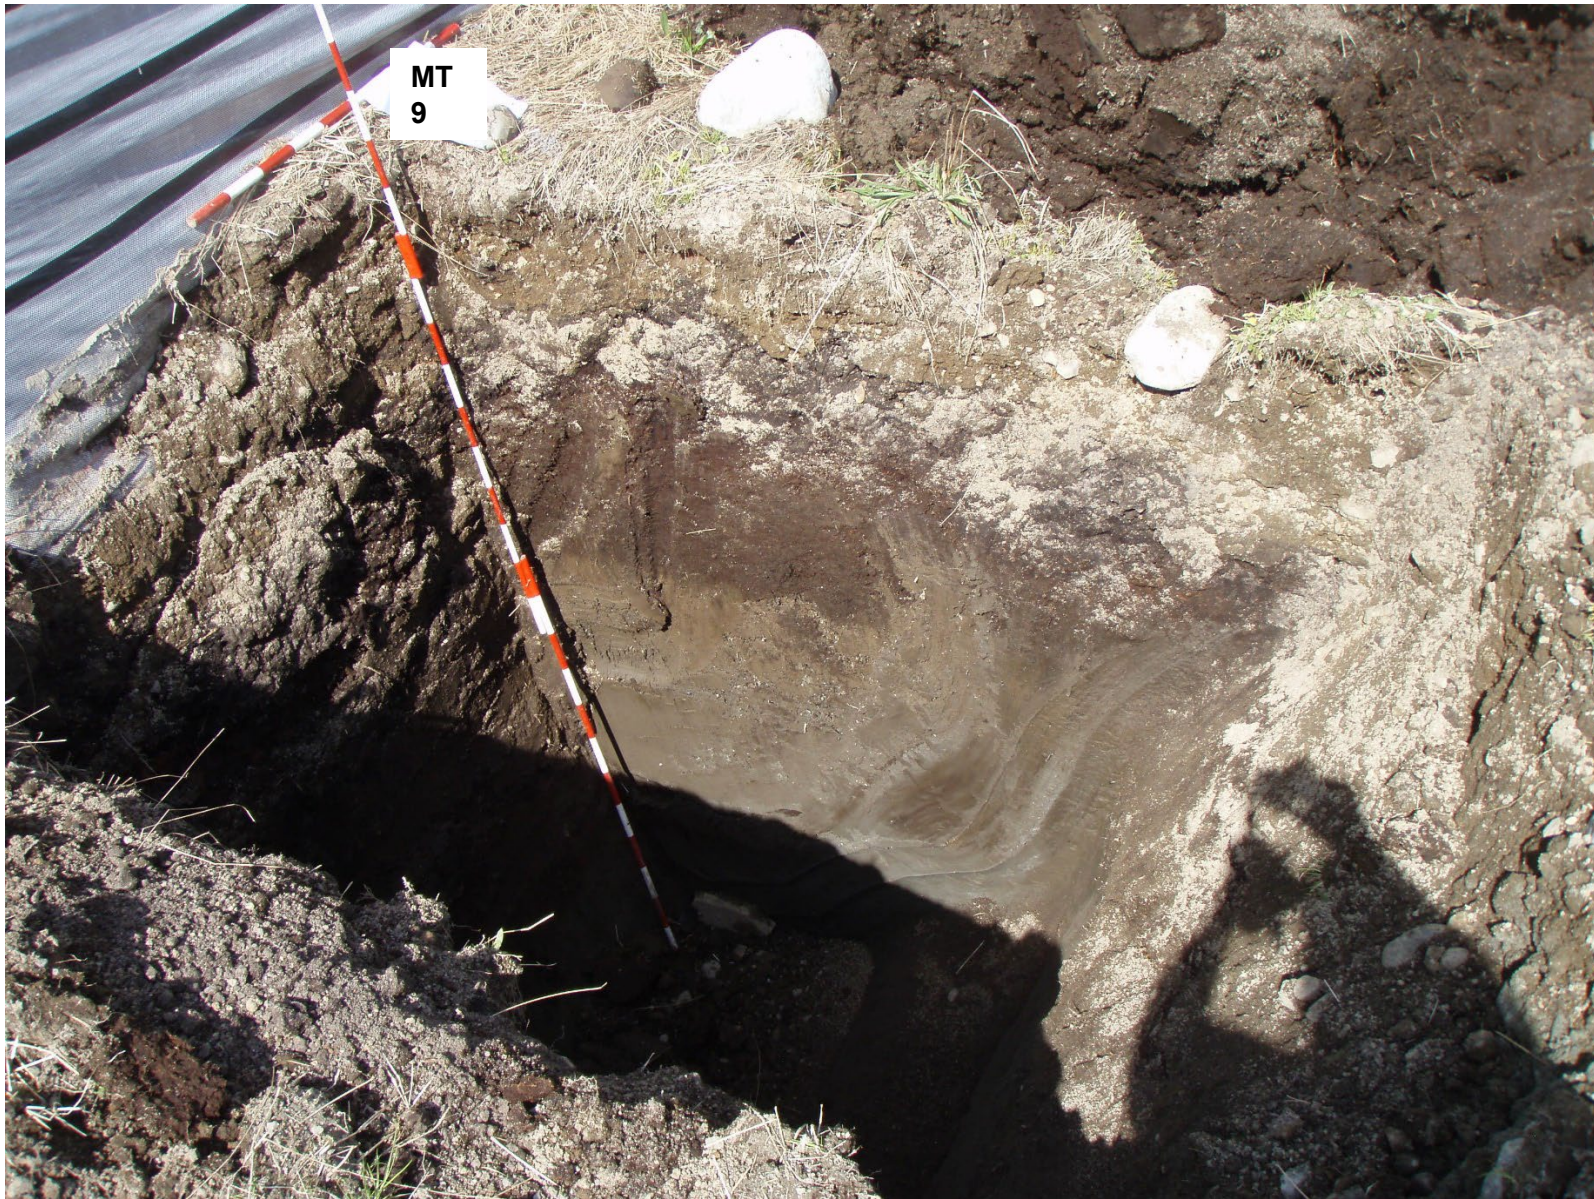
Figure 95. View of Machine Test (MT) 8 looking north. Test location is shown in Figure 24.

MT 8	10U; 0520245E; 5459792N	2.5m NS x 1.75m EW x 2.0m BS	April 14, 2022	0 to 40cm BS: Compact grey/brown mix of silt, sand, gravel, cobbles (imported fill); 40 to 120cm BS: brown/black/orange peat zone that was hand-raked and closely inspected; 120 to 180cm BS: loose orange-brown sand and silt mix that was hand -raked and closely inspected; 180 to 200cm BS: hard grey marine/late glacial clay.	Test placed on N side of the SW end of new road ROW preload area within proposed channel impact zone; No Pre-Contact period archaeological deposits.	Figures 24, 95.
MT 9	10U; 0520261E; 5459809N	2.0m NS x 1.75m EW x 2.0m BS	April 14, 2022	0 to 30cm BS: Compact grey/brown mix of silt, sand, gravel, cobbles (imported fill); 30 to 90cm BS: brown/black/orange peat zone that was hand-raked and closely inspected; 90 to 160cm BS: loose grey-brown sand and silt mix that was hand -raked and closely inspected; 160 to 200cm BS: hard grey marine/late glacial clay.	Test placed on N side of the SW end of new road ROW preload area within proposed channel impact zone; No Pre-Contact period archaeological deposits.	Figures 24, 96.

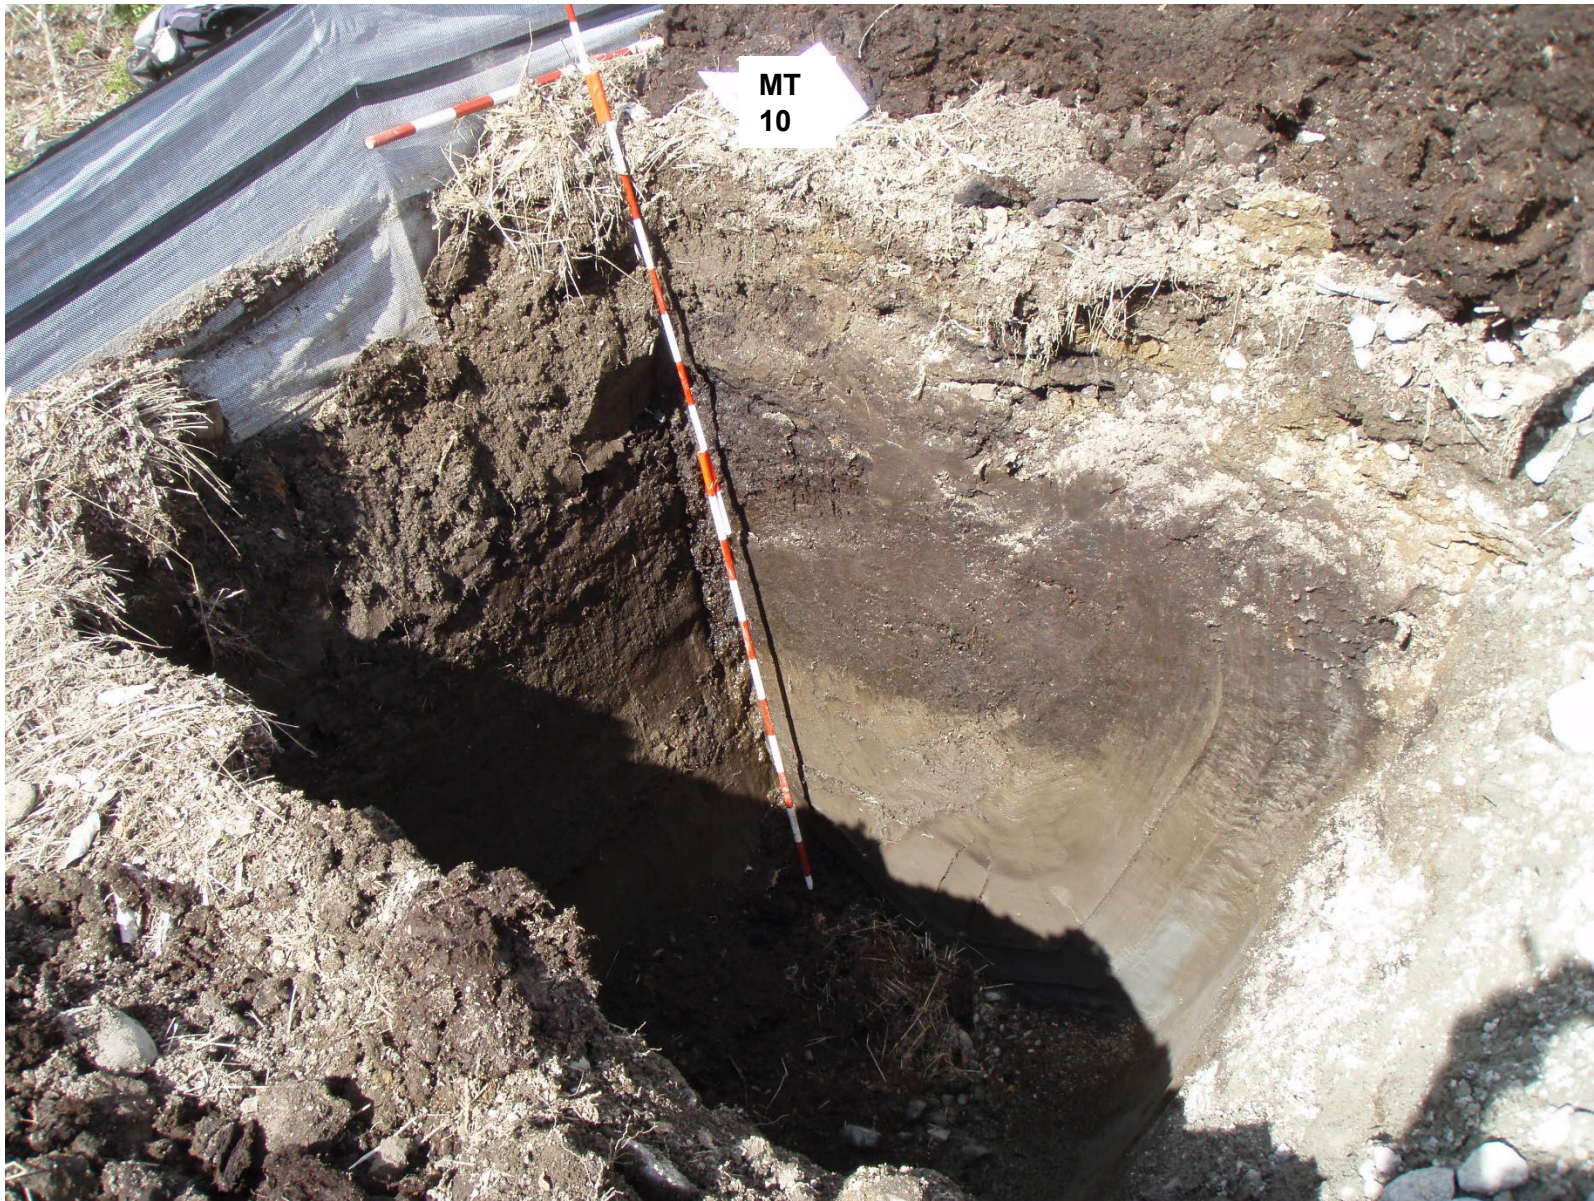
Figure 96. View of Machine Test (MT) 9 looking north. Test location is shown in Figure 24.

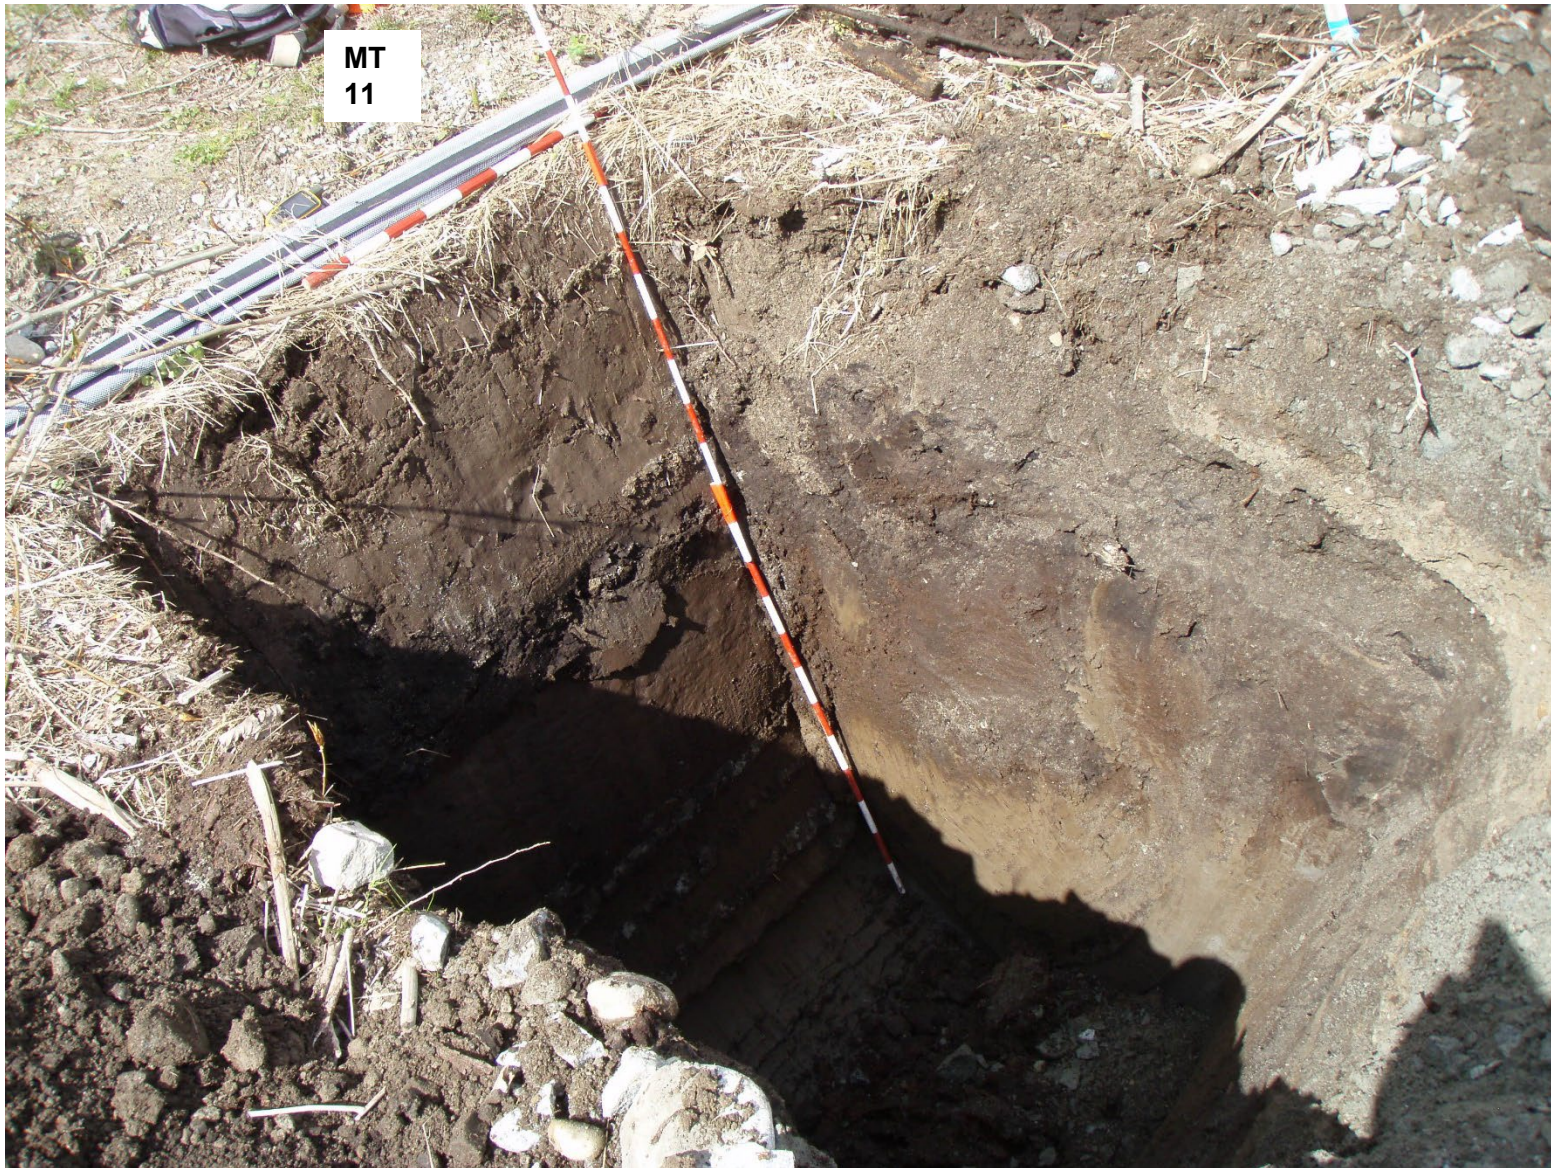
Figure 97. View of Machine Test (MT) 10 looking north. Test location is shown in Figure 24.

MT 10	10U; 0520275E; 5459828N	2.0m NS x 1.75m EW x 1.9m BS	April 14, 2022	0 to 30cm BS: Compact grey/brown mix of silt, sand, gravel, cobbles (imported fill); 30 to 120cm BS: brown/black peat zone that was hand-raked and closely inspected; 120 to 150cm BS: loose grey-brown sand and silt mix that was hand -raked and closely inspected; 150 to 190cm BS: hard grey marine/late glacial clay.	Test placed on N side of the SW end of new road ROW preload area within proposed channel impact zone; No Pre-Contact period archaeological deposits.	Figures 24, 97.
MT 11	10U; 0520291E; 5459846N	2.0m NS x 1.75m EW x 1.8m BS	April 14, 2022	0 to 40cm BS: Compact grey/brown mix of silt, sand, gravel, cobbles (imported fill); 40 to 120cm BS: brown/black peat zone that was hand-raked and closely inspected; 120 to 160cm BS: loose orange-brown sand and silt mix that was hand -raked and closely inspected; 160 to 180cm BS: hard grey marine/late glacial clay.	Test placed on N side of the new road ROW preload area within proposed channel impact zone; No Pre-Contact period archaeological deposits.	Figures 24, 98.

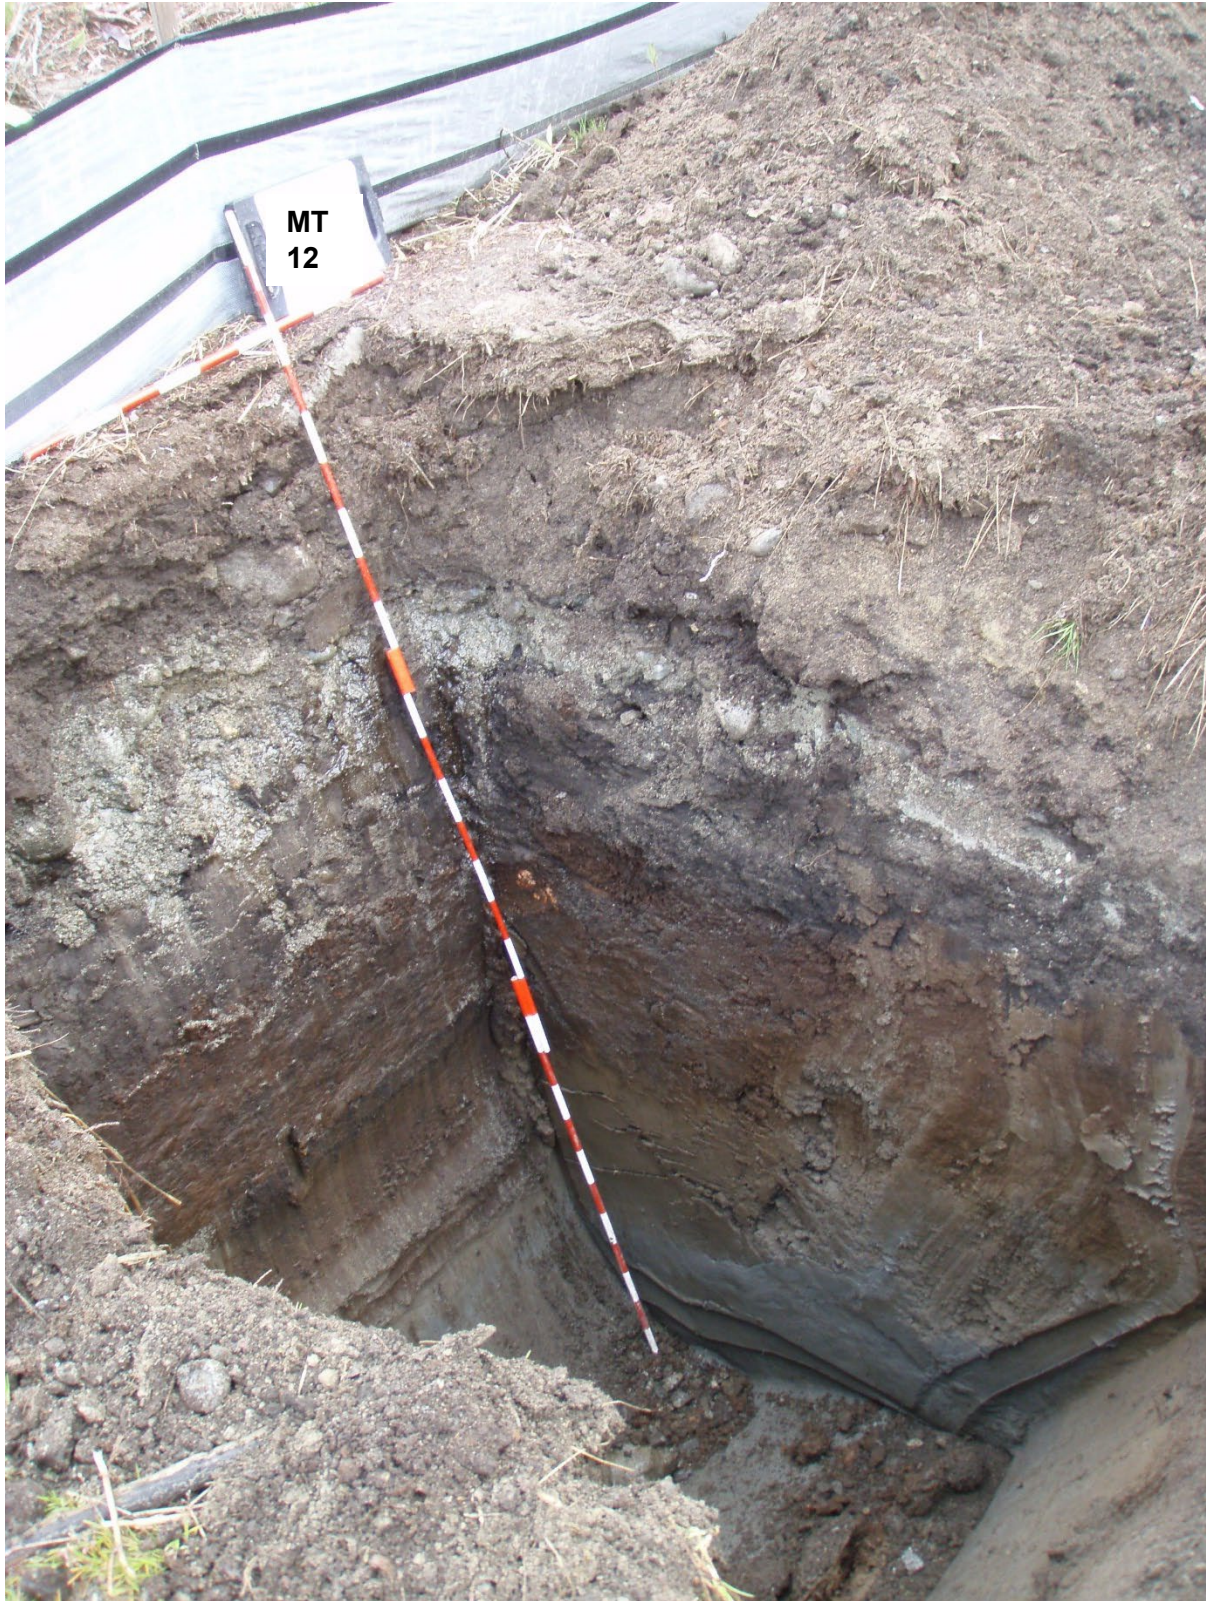
Figure 98. View of Machine Test (MT) 11 looking north. Test location is shown in Figure 24.

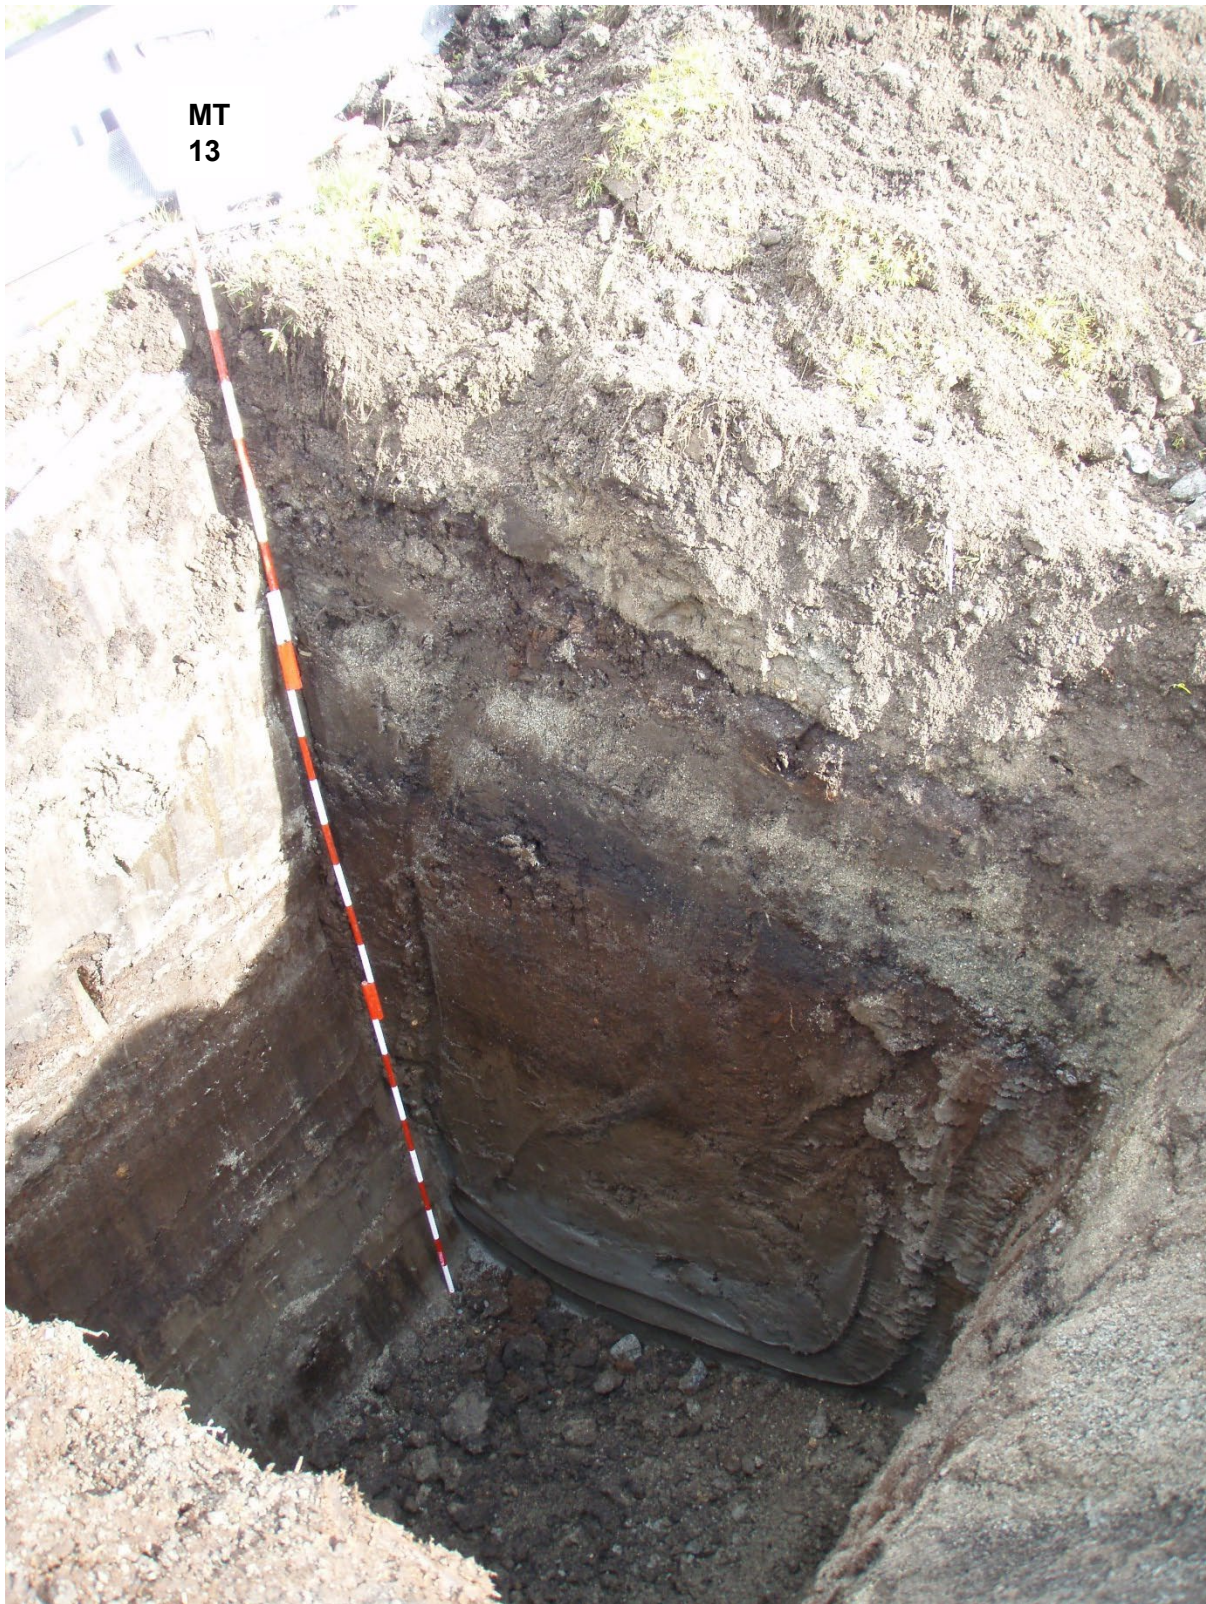
Figure 99. View of Machine Test (MT) 12 looking north. Test location is shown in Figure 24.

Machine Test Number	UTM Waypoint	Dimension and Max Depth (BS)	Excavation Date	Stratigraphic Unit Descriptions	Comments	Photo/Figure
MT 12	10U; 0520298E; 5459865N	2.0m NS x 1.5m EW x 2.4m BS	April 19, 2022	0 to 50cm BS: Compact grey/brown mix of silt, sand, gravel, cobbles (imported fill) with some recent refuse included; 50 to 65cm BS: loose grey sand and gravel (imported fill); 65 to 160cm BS: brown/black/orange peat zone with some silt and sand from 150 to 160cm BS that was hand-raked and closely inspected; 160 to 240cm BS: hard grey marine/late glacial clay.	Test placed on N side of the new road ROW preload area within proposed drainage channel impact zone; No Pre-Contact period archaeological deposits.	Figures 24, 99.
MT 13	10U; 0520314E; 5459890N	2.5m NS x 1.75m EW x 2.5m BS	April 19, 2022	0 to 40cm BS: Compact grey/brown mix of silt, sand, gravel, cobbles (imported fill) with some recent refuse included; 40 to 70cm BS: loose grey sand and gravel (imported fill); 70 to 160cm BS: brown/black/orange peat zone that was hand-raked and closely inspected; 160 to 200cm BS: moderately compact fluvial grey-brown sand and silt mix with some clay that was hand-raked and closely inspected; 200 to 250 cm BS: hard grey marine/late glacial clay.	Test placed on N side of the new road ROW preload area within proposed drainage channel impact zone; No Pre-Contact period archaeological deposits encountered.	Figures 24, 100.

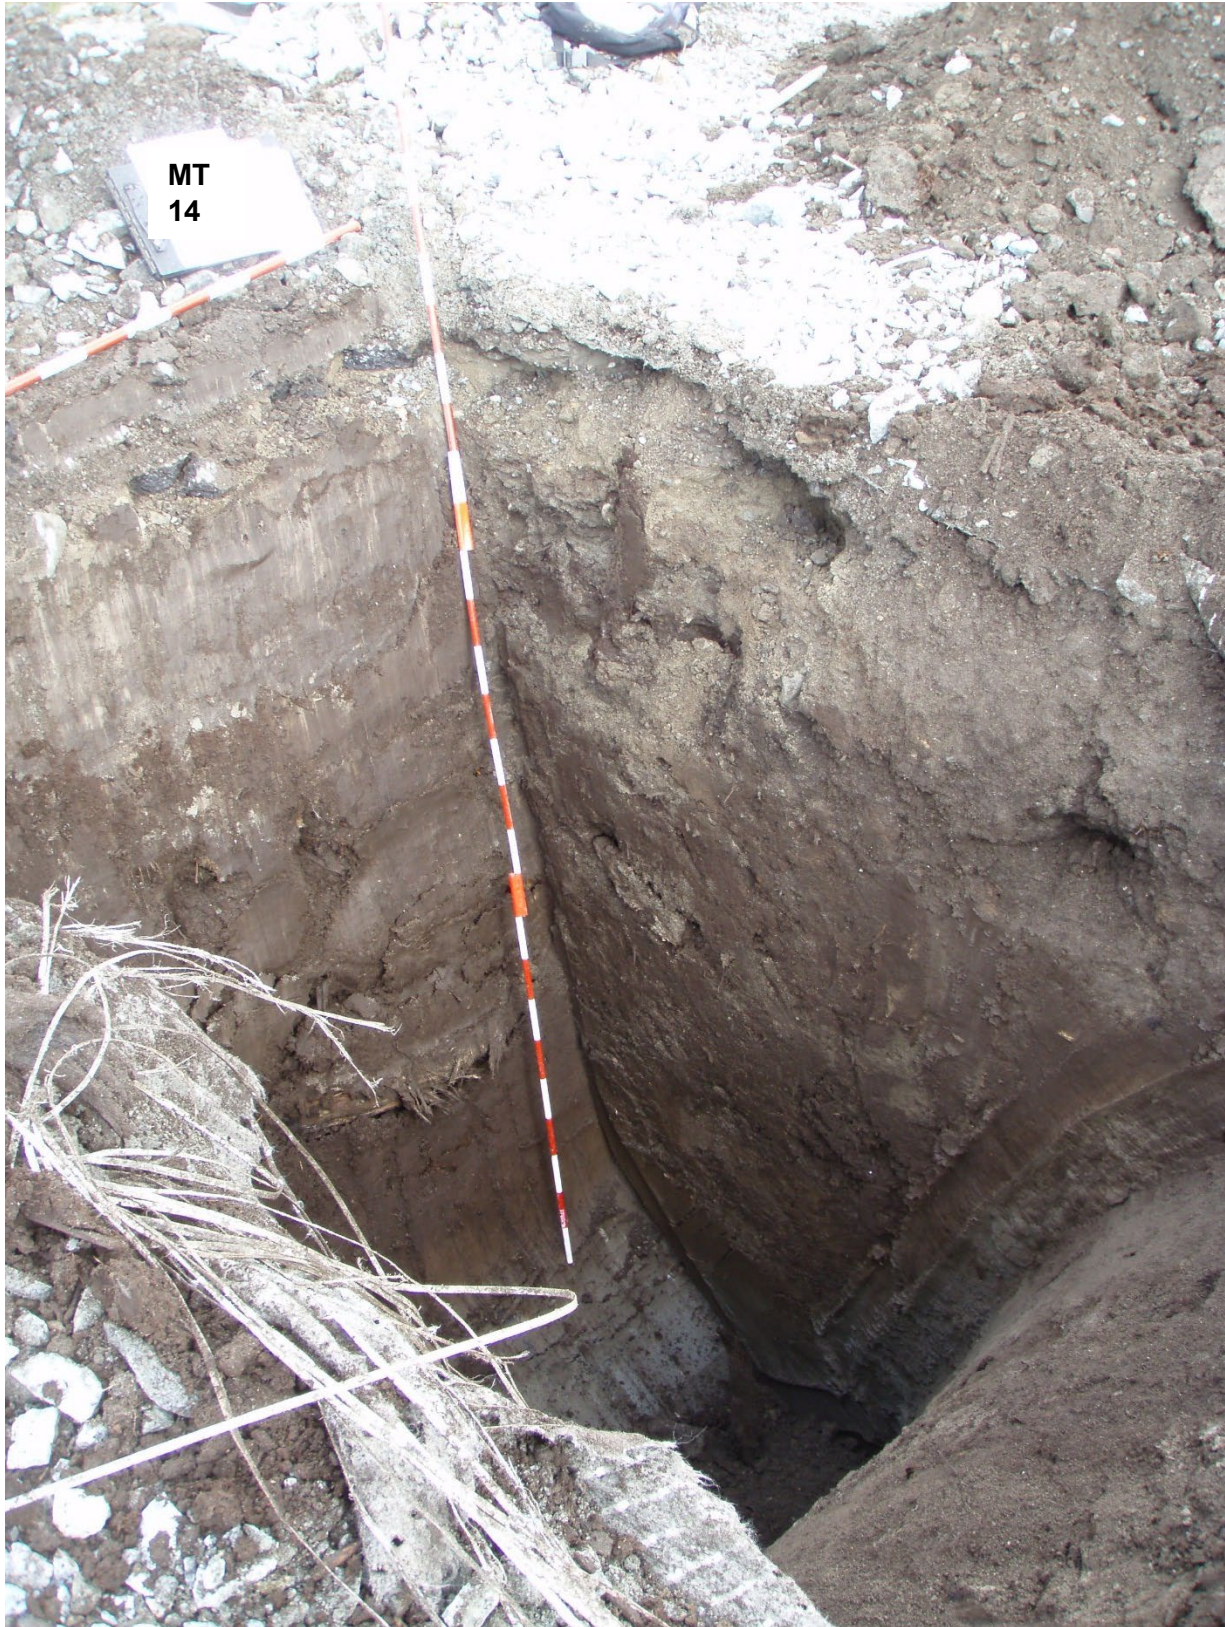
Figure 100. View of Machine Test (MT) 13 looking north. Test location is shown in Figure 24.

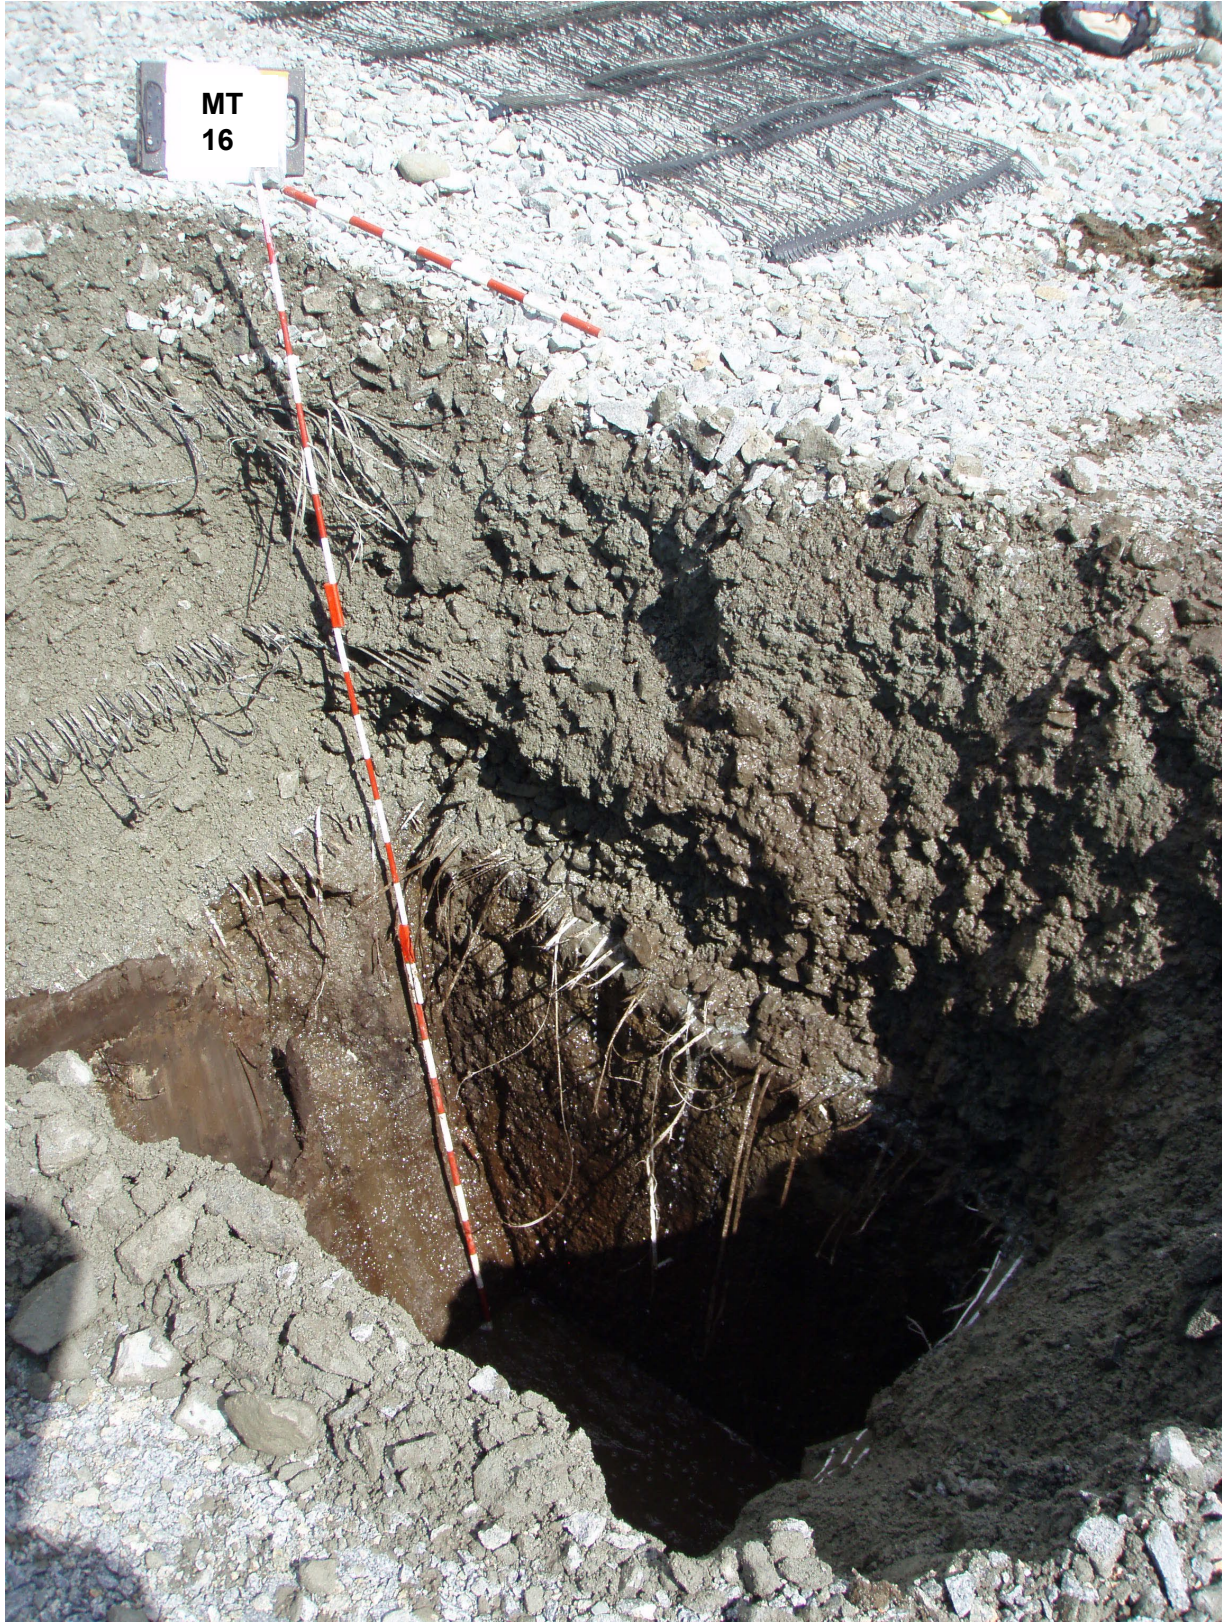
Figure 102. View of Machine Test (MT) 15 looking north. Test location is shown in Figure 25.

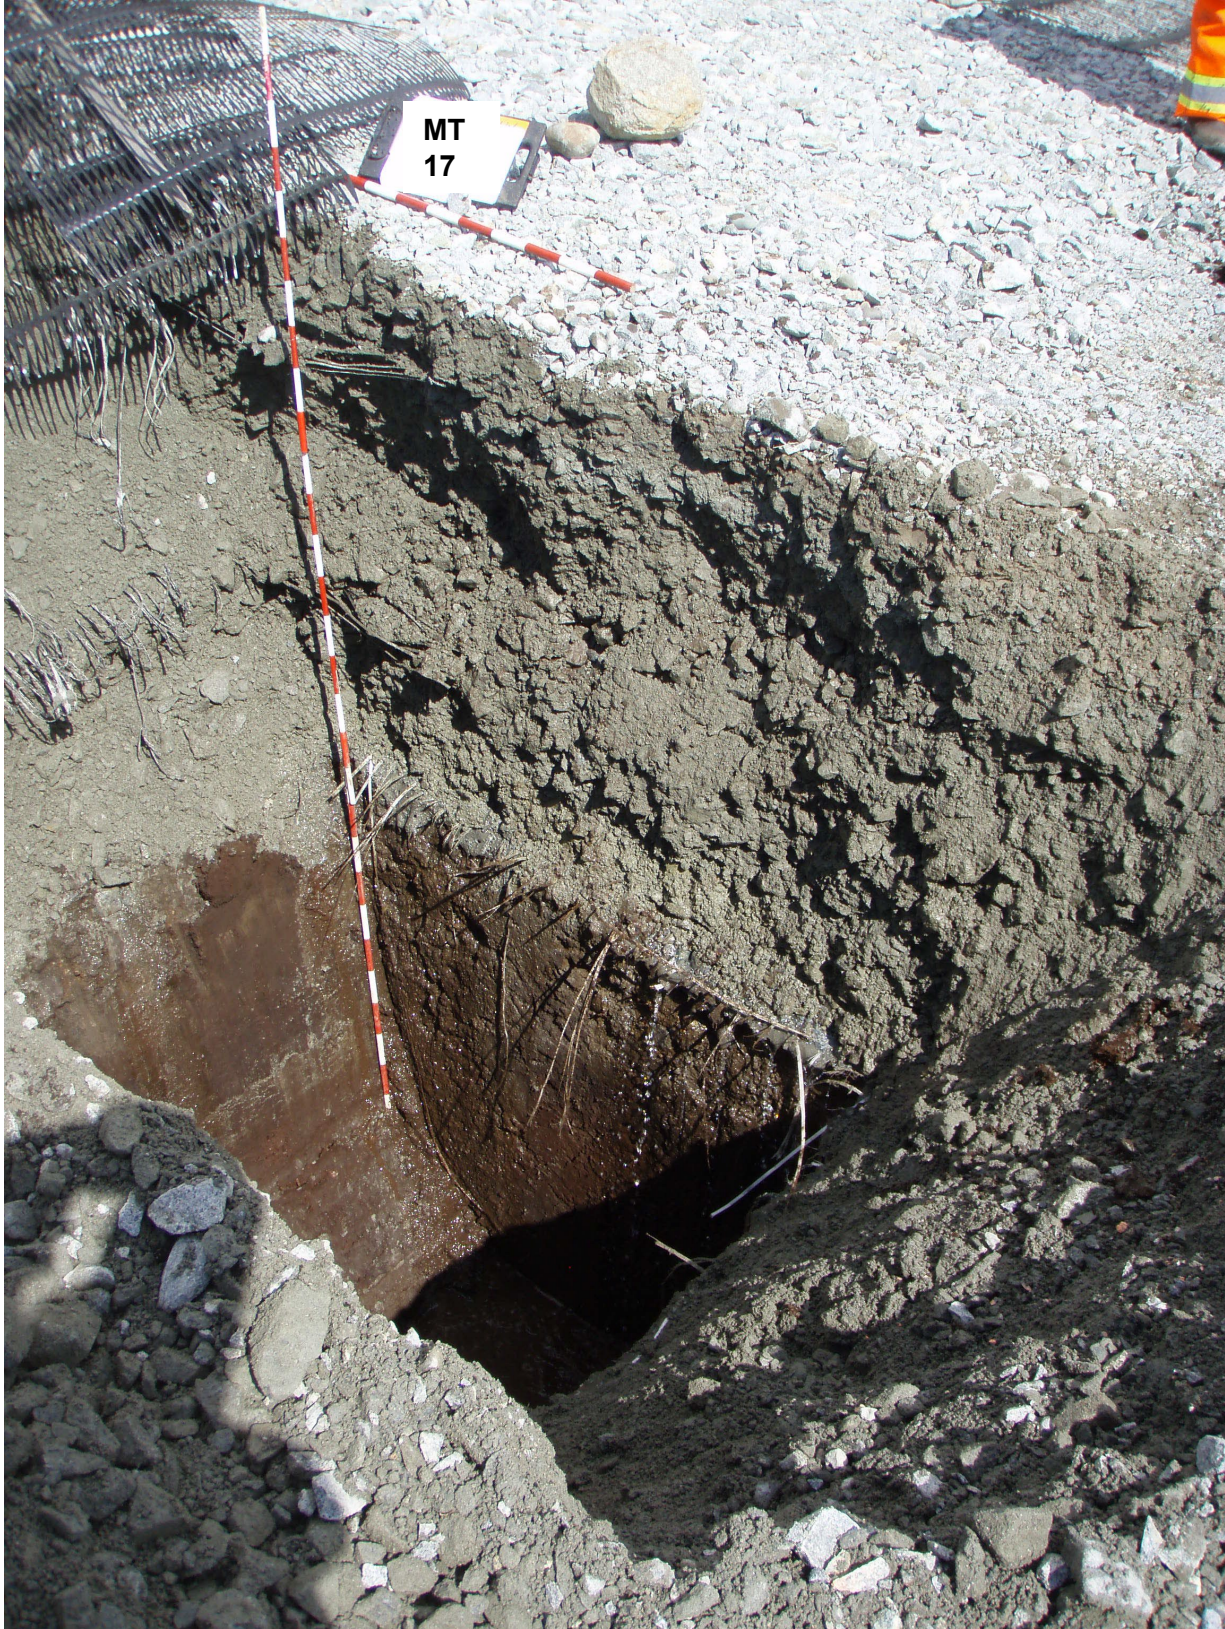
Figure 103. View of Machine Test (MT) 16 looking north. Test location is shown in Figure 25.

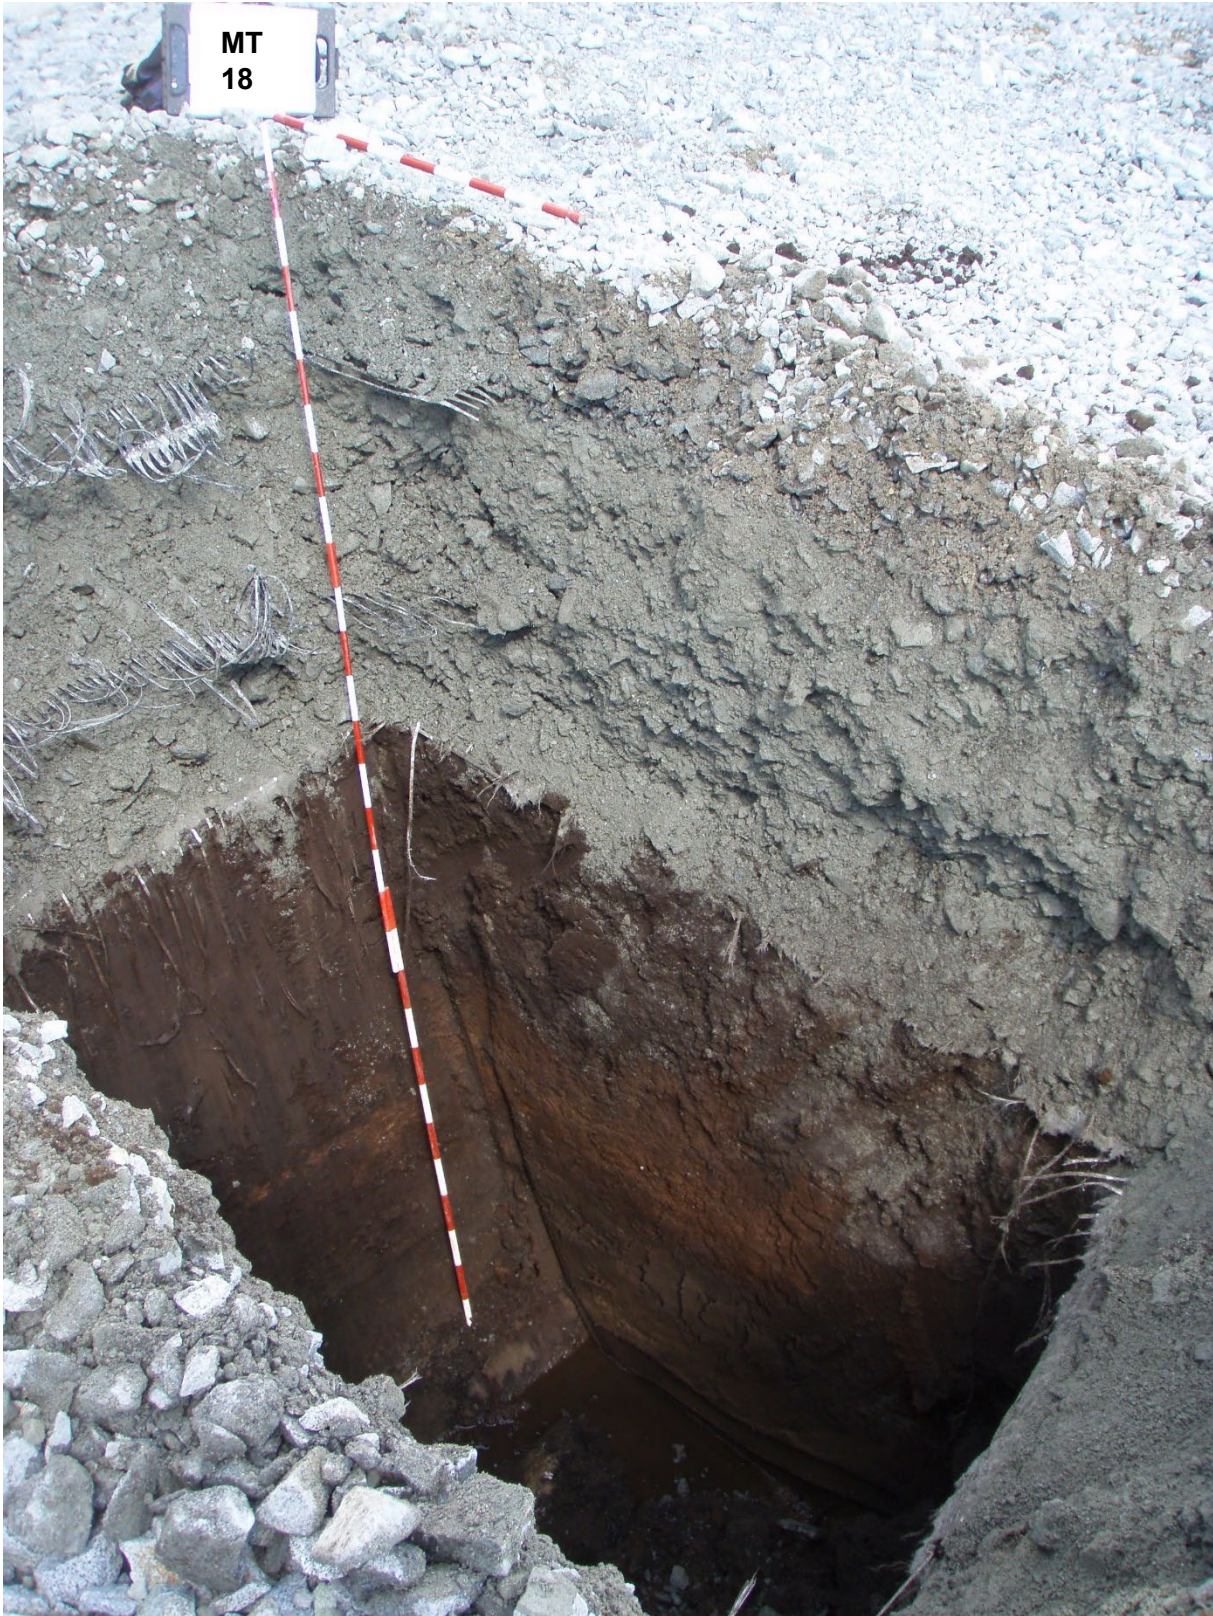
Figure 104. View of Machine Test (MT) 17 looking north. Test location is shown in Figure 25.

Machine Test Number	UTM Waypoint	Dimension and Max Depth (BS)	Excavation Date	Stratigraphic Unit Descriptions	Comments	Photo/Figure
MT 17	10U; 0520376E; 5459966N	2.0m NS x 1.75m EW x 2.0m BS	April 19, 2022	Measurements taken from below recently deposited road fill preload, which was 140 cm thick. 0 to 30cm BS: loose grey/brown mix of silt, sand, gravel, cobbles (imported fill); 30 to 120cm BS: brown/black/orange peat zone that was hand-raked and closely inspected; 120 to 170cm BS: compact medium brown fluvial sand and silt mix that was hand-raked and closely inspected; 170 to 200 cm BS: hard grey marine/late glacial clay.	Test placed on the NE aspect new road ROW preload area within new road ROW impact zone; No Pre-Contact period archaeological deposits	Figures 25, 104.
MT 18	10U; 0520382E; 5459986N	2.0m NS x 1.75m EW x 2.0m BS	April 19, 2022	Measurements taken from below recently deposited road fill preload, which was 130 cm thick. 0 to 70cm BS: loose dark brown mix of silt, sandy silt (imported fill); 70 to 130cm BS: brown/black/orange peat zone with random sticks and branches that was hand-raked and closely inspected; 130 to 160cm BS: compact medium brown fluvial sand and silt mix that was hand-raked and closely inspected; 160 to 200 cm BS: hard grey marine/late glacial clay.	Test placed on the NE aspect new road ROW preload area within new road ROW impact zone; No Pre-Contact period archaeological deposits	Figures 25, 105.

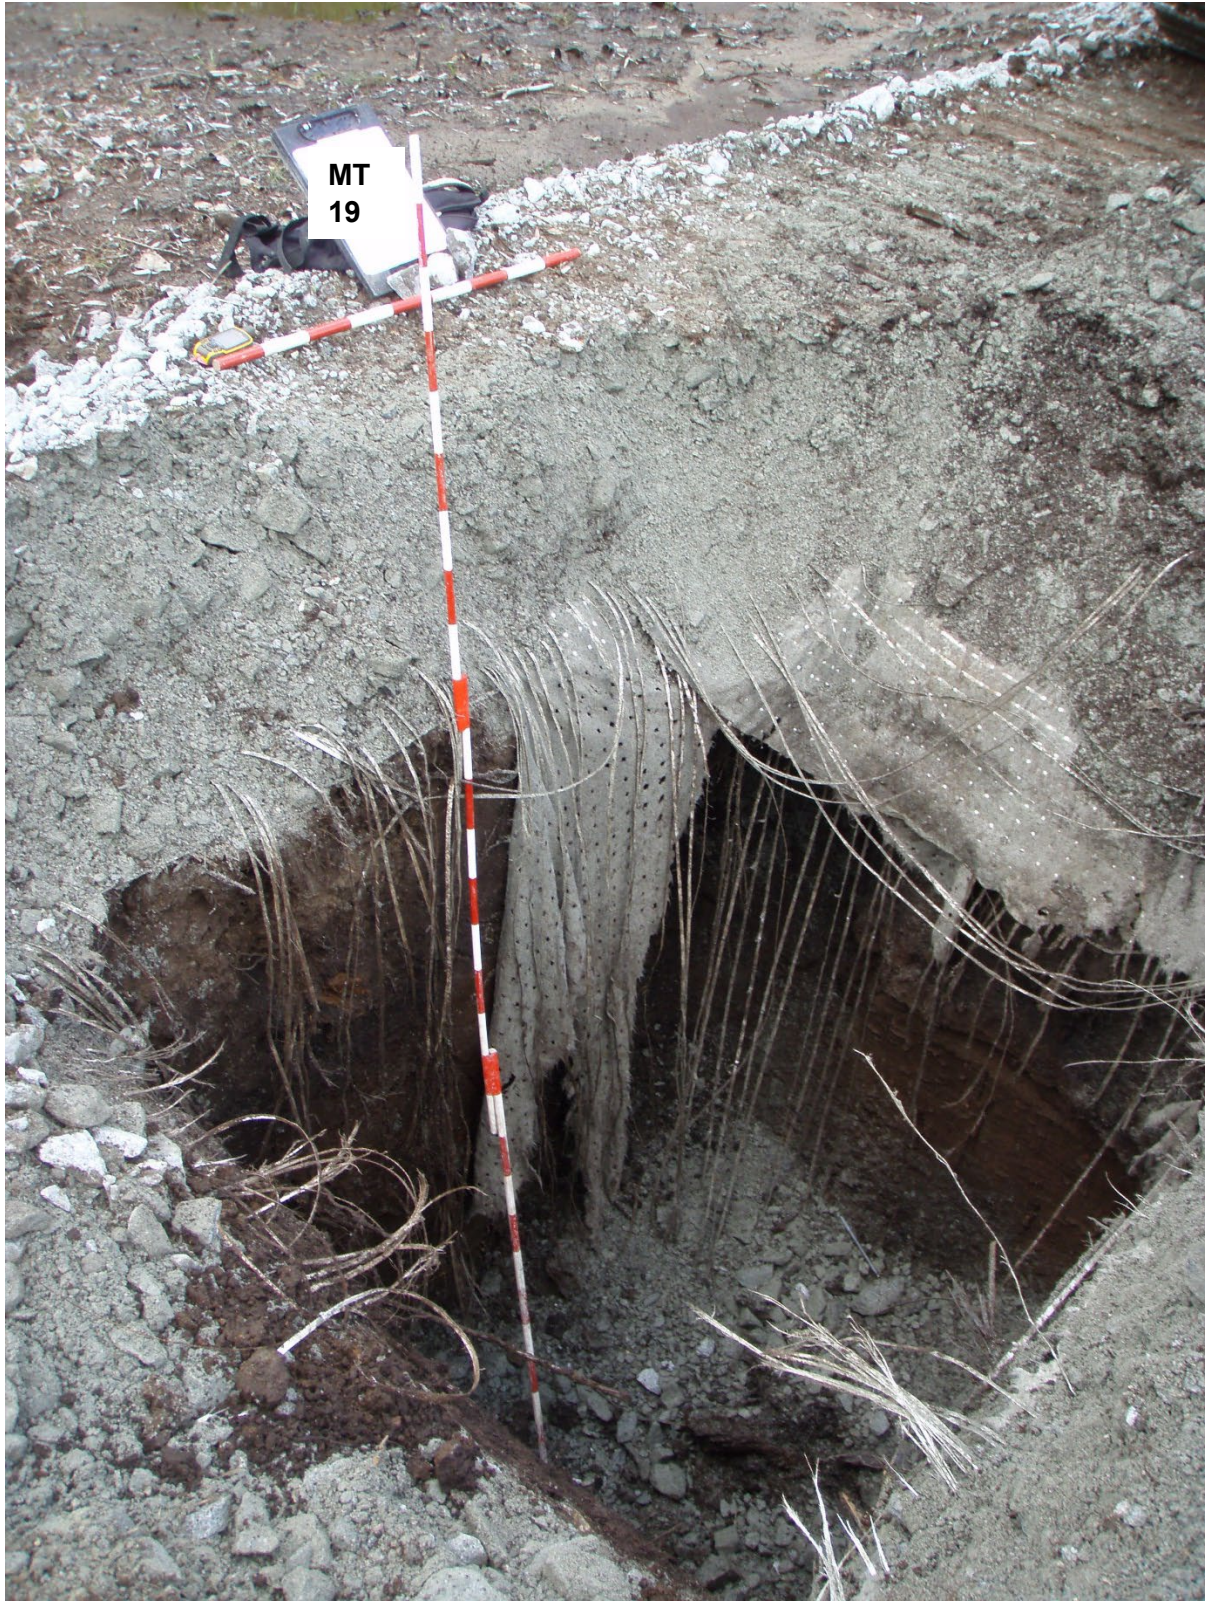
Figure 105. View of Machine Test (MT) 18 looking north. Test location is shown in Figure 25.
