HCA Heritage Inspection Permit 2021-0396

Re: Interim Summary Results and Recommendations Report for Recently Investigated and Tested Sections of Impact Zones Related to Various Upgrades to a Section of Cedar Drive in Coquitlam, and Summary of Proposed Development Scheduled to Commence in mid-2022; HCA Permit 2021-0396

Introduction and Background

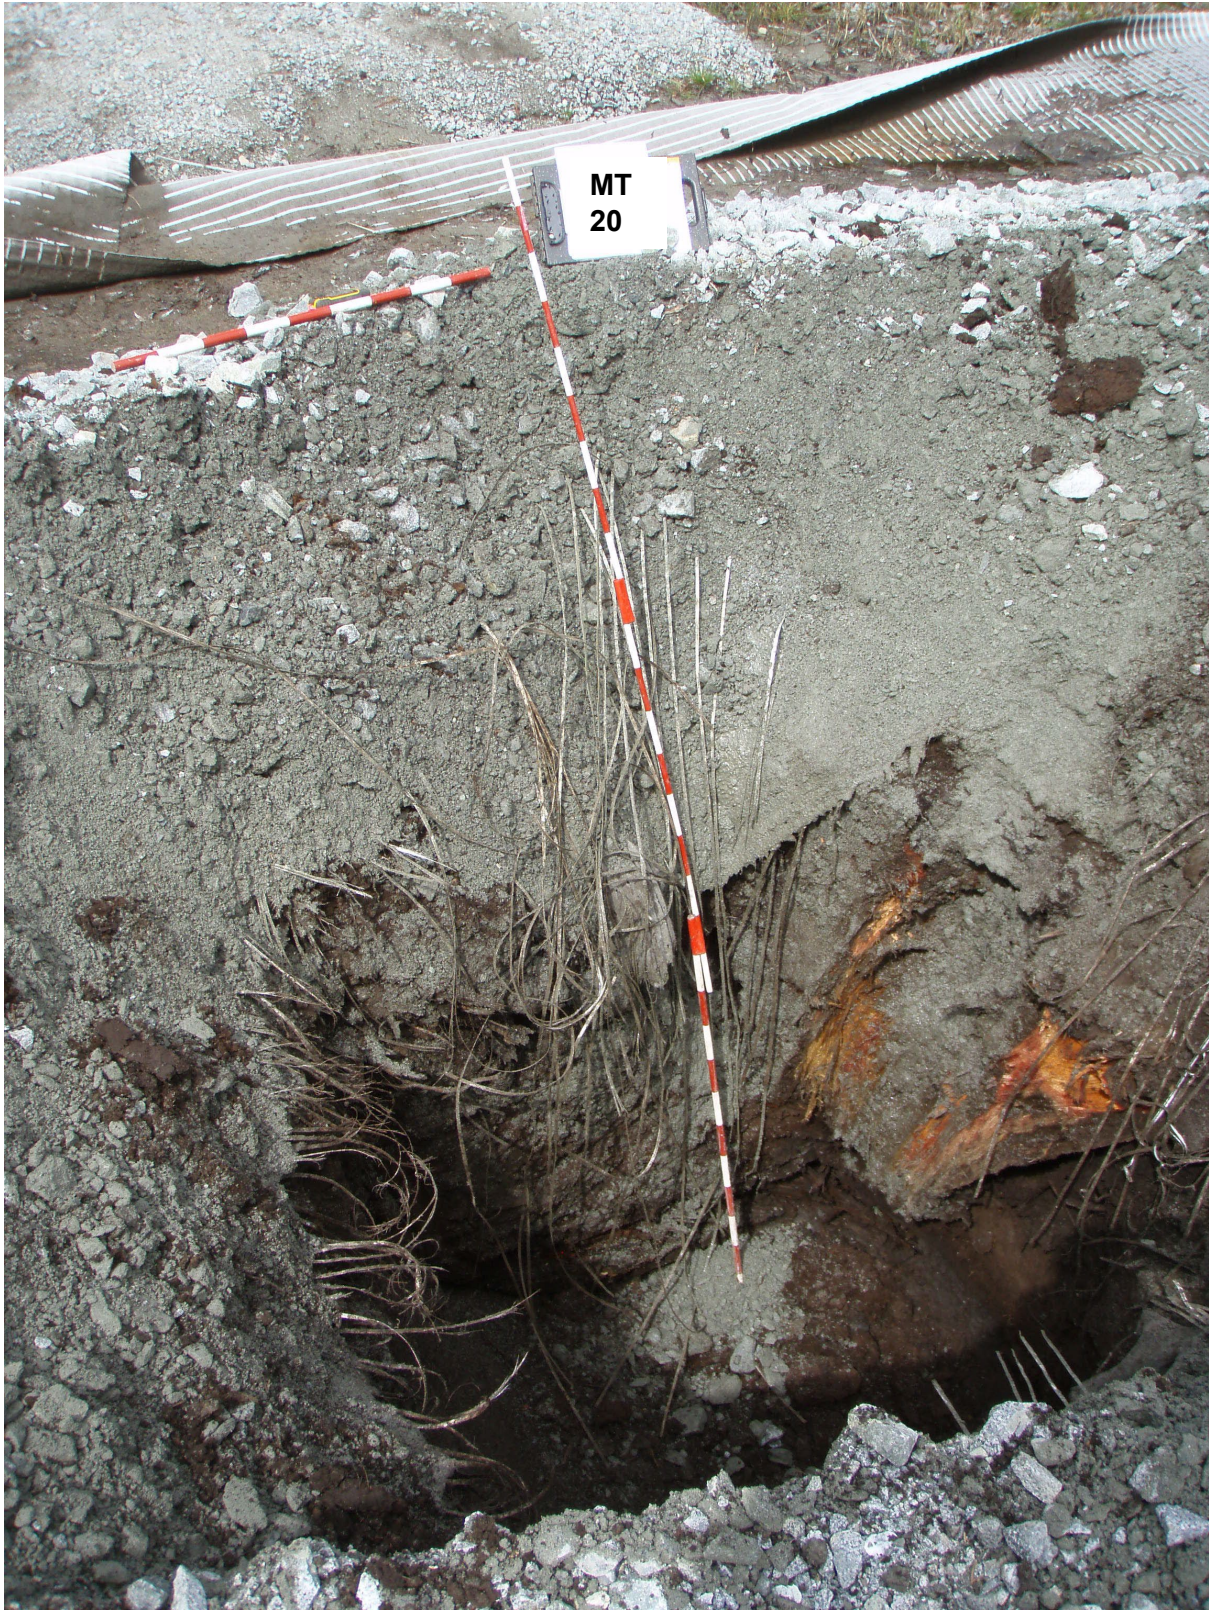
Figure 106. View of Machine Test (MT) 19 looking north. Test location is shown in Figure 25.

MT 19	10U; 0520408E; 5460022N	2.0m NS x 2.0m EW x 2.0m BS	April 19, 2022	Measurements taken from below recently deposited road fill preload, which was 70 cm thick. 0 to 30cm BS: loose dark brown mix of silt, sandy silt (imported fill); 30 to 110cm BS: brown/black/orange peat zone with random sticks and branches and tree roots that was hand-raked and closely inspected; 110 to 160cm BS: loose medium grey- brown fluvial sand and silt mix that was hand-raked and closely inspected; 160 to 200 cm BS: hard grey marine/late glacial clay.	Test placed on the north edge of the very NE aspect new road ROW preload area; No Pre-Contact period archaeological deposits encountered.	Figures 25, 106.
MT 20	10U; 0520421E; 5460035N	2.0m NS x 2.0m EW x 1.6m BS	April 19, 2022	Measurements taken from below recently deposited road fill preload, which was 150 cm thick. 0 to 40cm BS: loose grey brown mix of silt, sandy silt (imported fill); 40 to 100cm BS: brown/black/orange peat zone with random sticks and branches and tree roots that was hand-raked and closely inspected; 100 to 140cm BS: firm brown fluvial sand and silt mix that was hand-raked and closely inspected; 140 to 160 cm BS: hard grey marine/late glacial clay.	Test placed on the north edge of the very NE aspect new road ROW preload area; No Pre-Contact period archaeological deposits encountered.	Figures 25, 107.

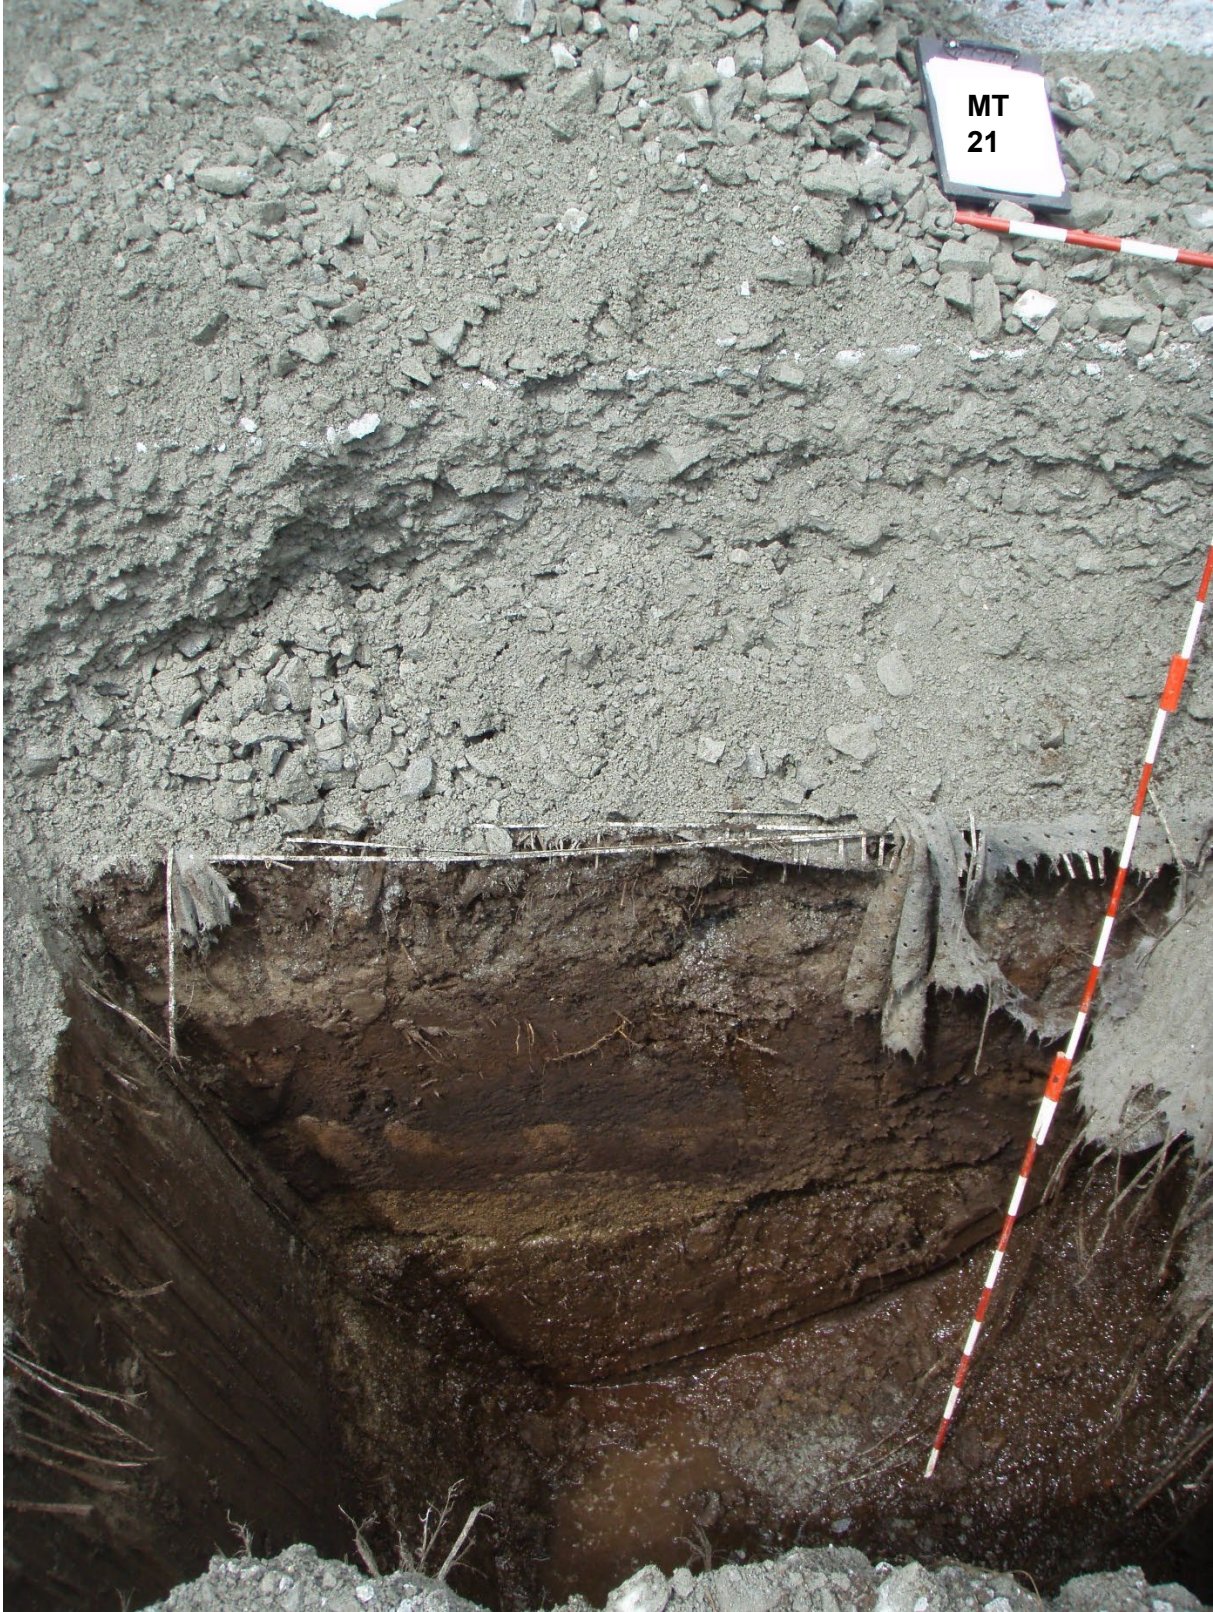
Figure 107. View of Machine Test (MT) 20 looking north. Test location is shown in Figure 25.

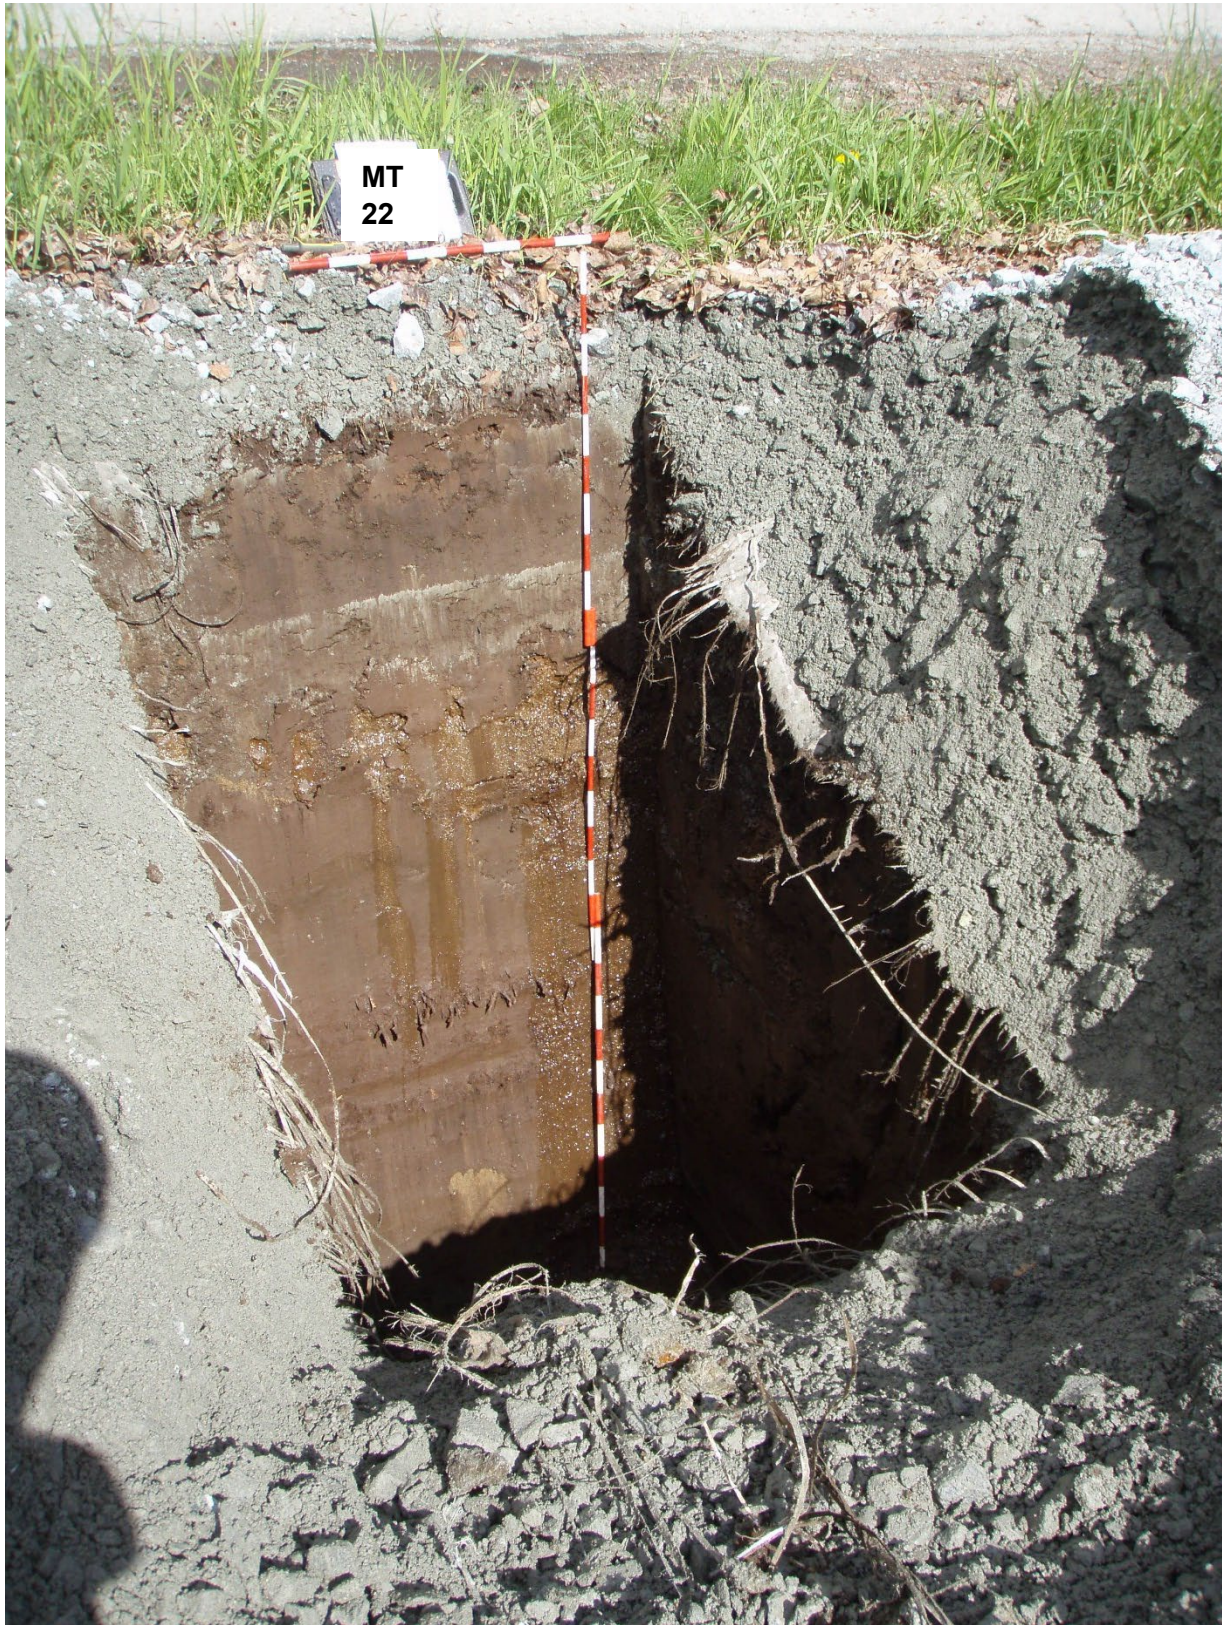
Figure 108. View of Machine Test (MT) 21 looking north. Test location is shown in Figure 25.

MT 21	10U; 0520437E; 5460046N	2.0m NS x 2.0m EW x 1.6m BS	April 19, 2022	Measurements taken from below recently deposited road fill preload, which was 150 cm thick. 0 to 30cm BS: loose grey brown mix of silt, sandy silt (imported fill); 30 to 60cm BS: compact medium brown sandy silt (imported fill); 60 to 90cm BS: loose orange grey fluvial sand that was hand-raked and closely inspected; 90 to 140cm BS: brown/black/orange peat that was hand-raked and closely inspected; 140 to 160 cm BS: hard grey marine/late glacial clay.	Test placed on the north edge of the very NE aspect new road ROW preload area; No Pre-Contact period archaeological deposits encountered.	Figures 25, 108.

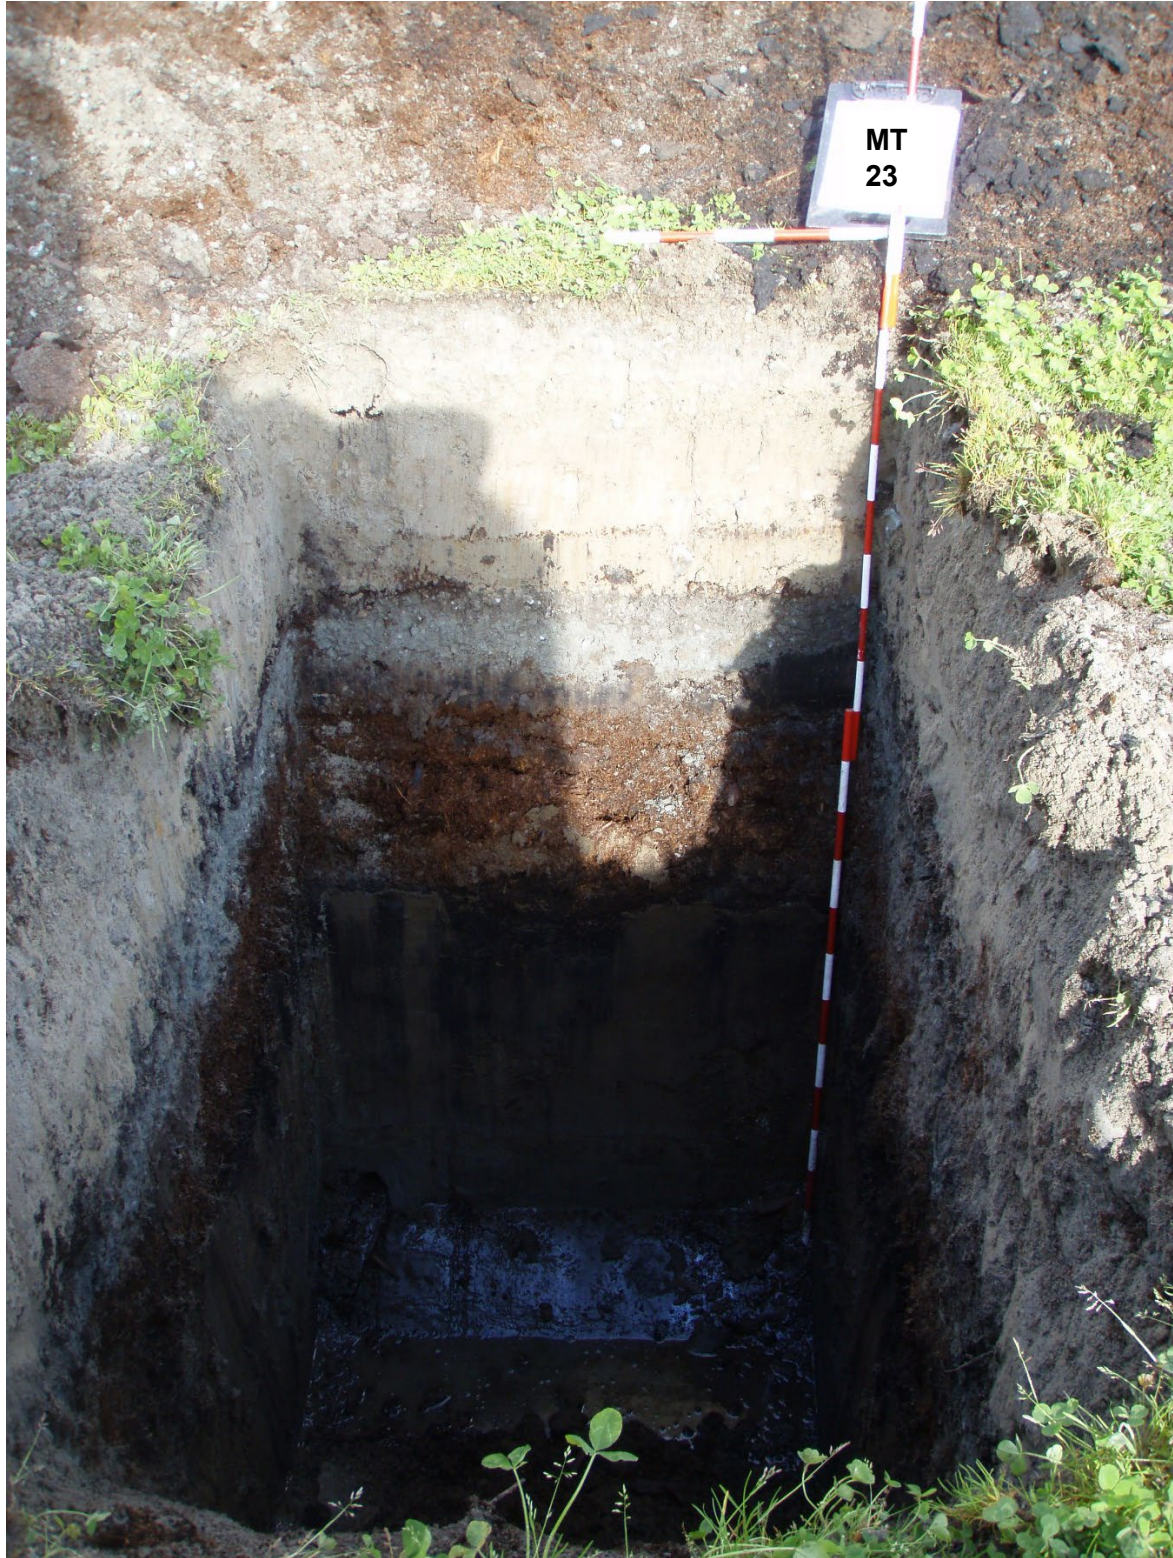
Figure 109. View of Machine Test (MT) 22 looking north. Test location is shown in Figure 25.

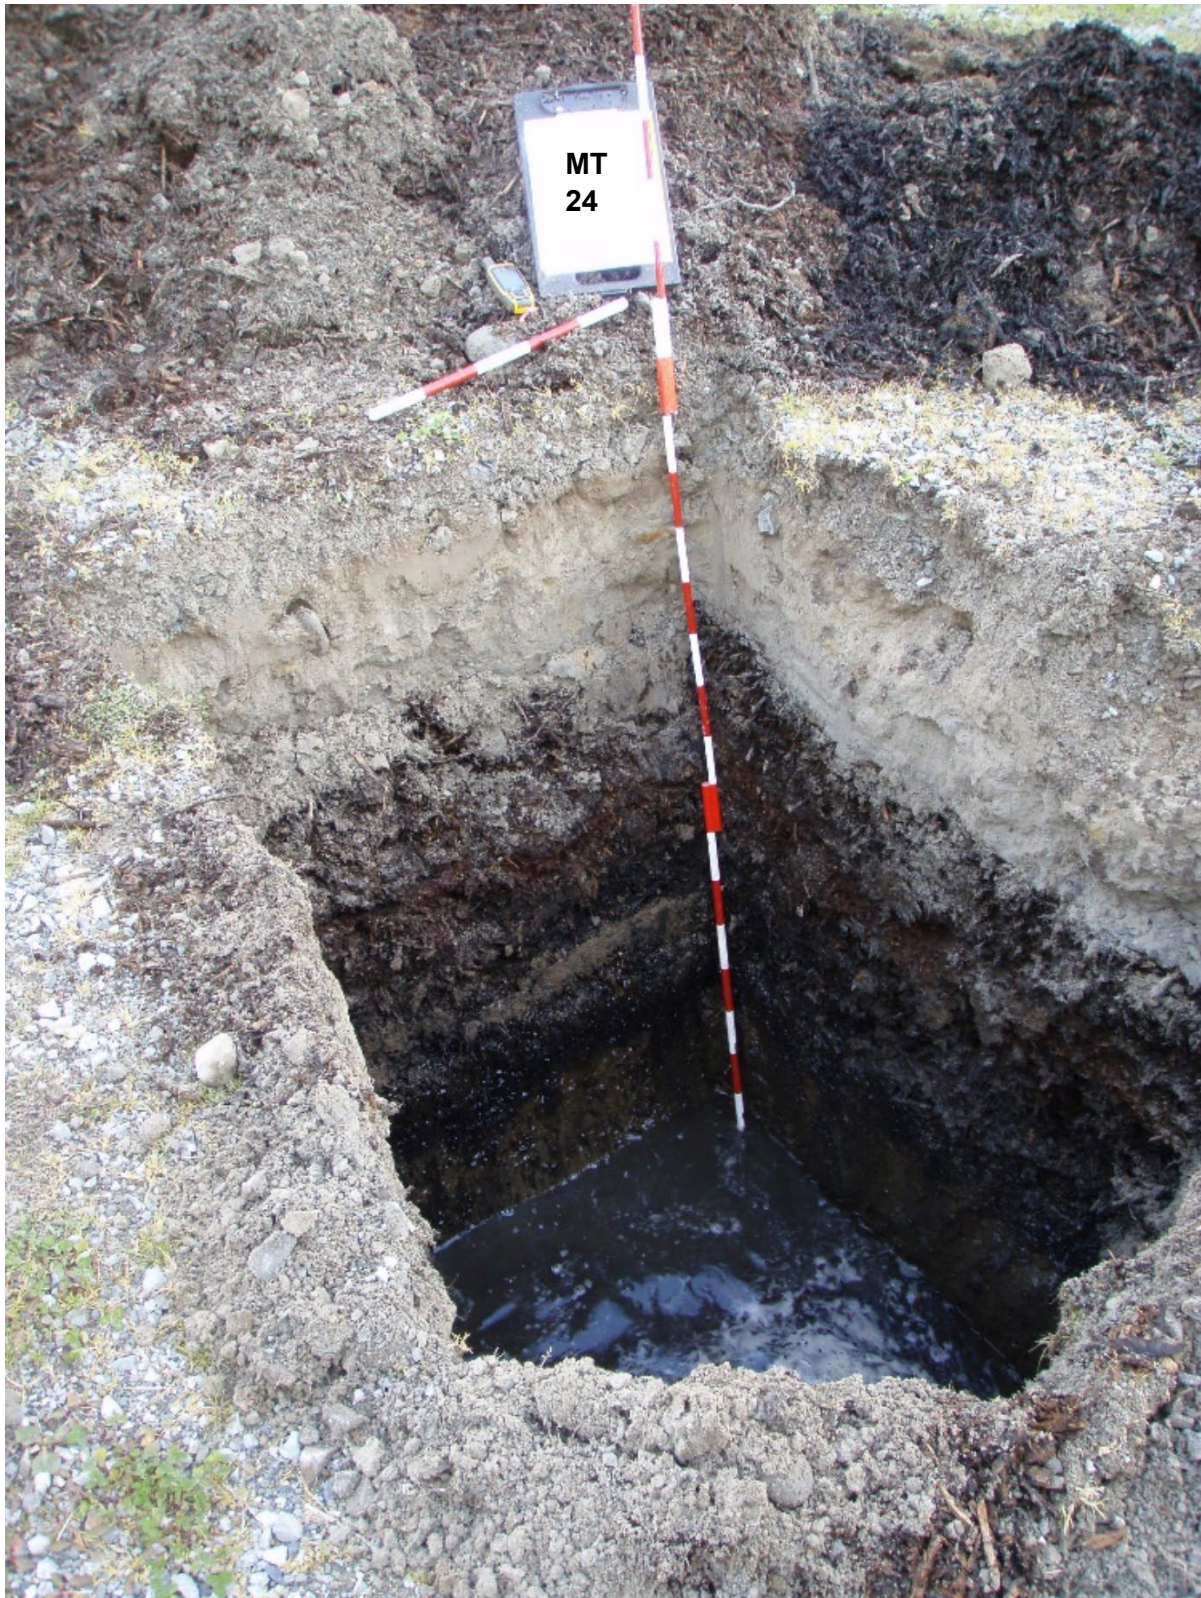
Figure 110. View of Machine Test (MT) 23 looking north. Test location is shown in Figures 15 and 22.

MT 23	10U; 0520132E; 5459601N	2.0m NS x 1.25m EW x 1.8m BS	May 13, 2022	0 to 50cm BS: moderately loose yellow-grey sand (imported fill); 50 to 60 cm BS: moderately loose organic silts and sand (hand-raked and closely inspected); 60 to 120cm BS: loose orange brown sawdust fill; 120 to 160cm BS: moderately loose brown-black silty sand with some organics (hand-raked and closely inspected); 160 to 180cm BS: compact grey marine/late glacial clay.	Test placed south of the existing preloaded road ROW in center of ROW within pasture/yard; No pre-contact period deposits.	Figures 15, 22, 110.
MT 24	10U; 0520122E; 5459590N	2.0m NS x 1.25m EW x 1.7m BS	May 13, 2022	0 to 40cm BS: moderately loose yellow-grey sand and gravel (imported fill); 40 to 120 cm BS: loose orange brown sawdust fill; 120 to 160cm BS: moderately loose orange-brown silty sand (hand-raked and closely inspected); 160 to 170cm BS: compact grey marine/late glacial clay.	Test placed south of the existing preloaded road ROW in center of ROW within pasture/yard; No pre-contact period deposits.	Figures 15, 22, 111.

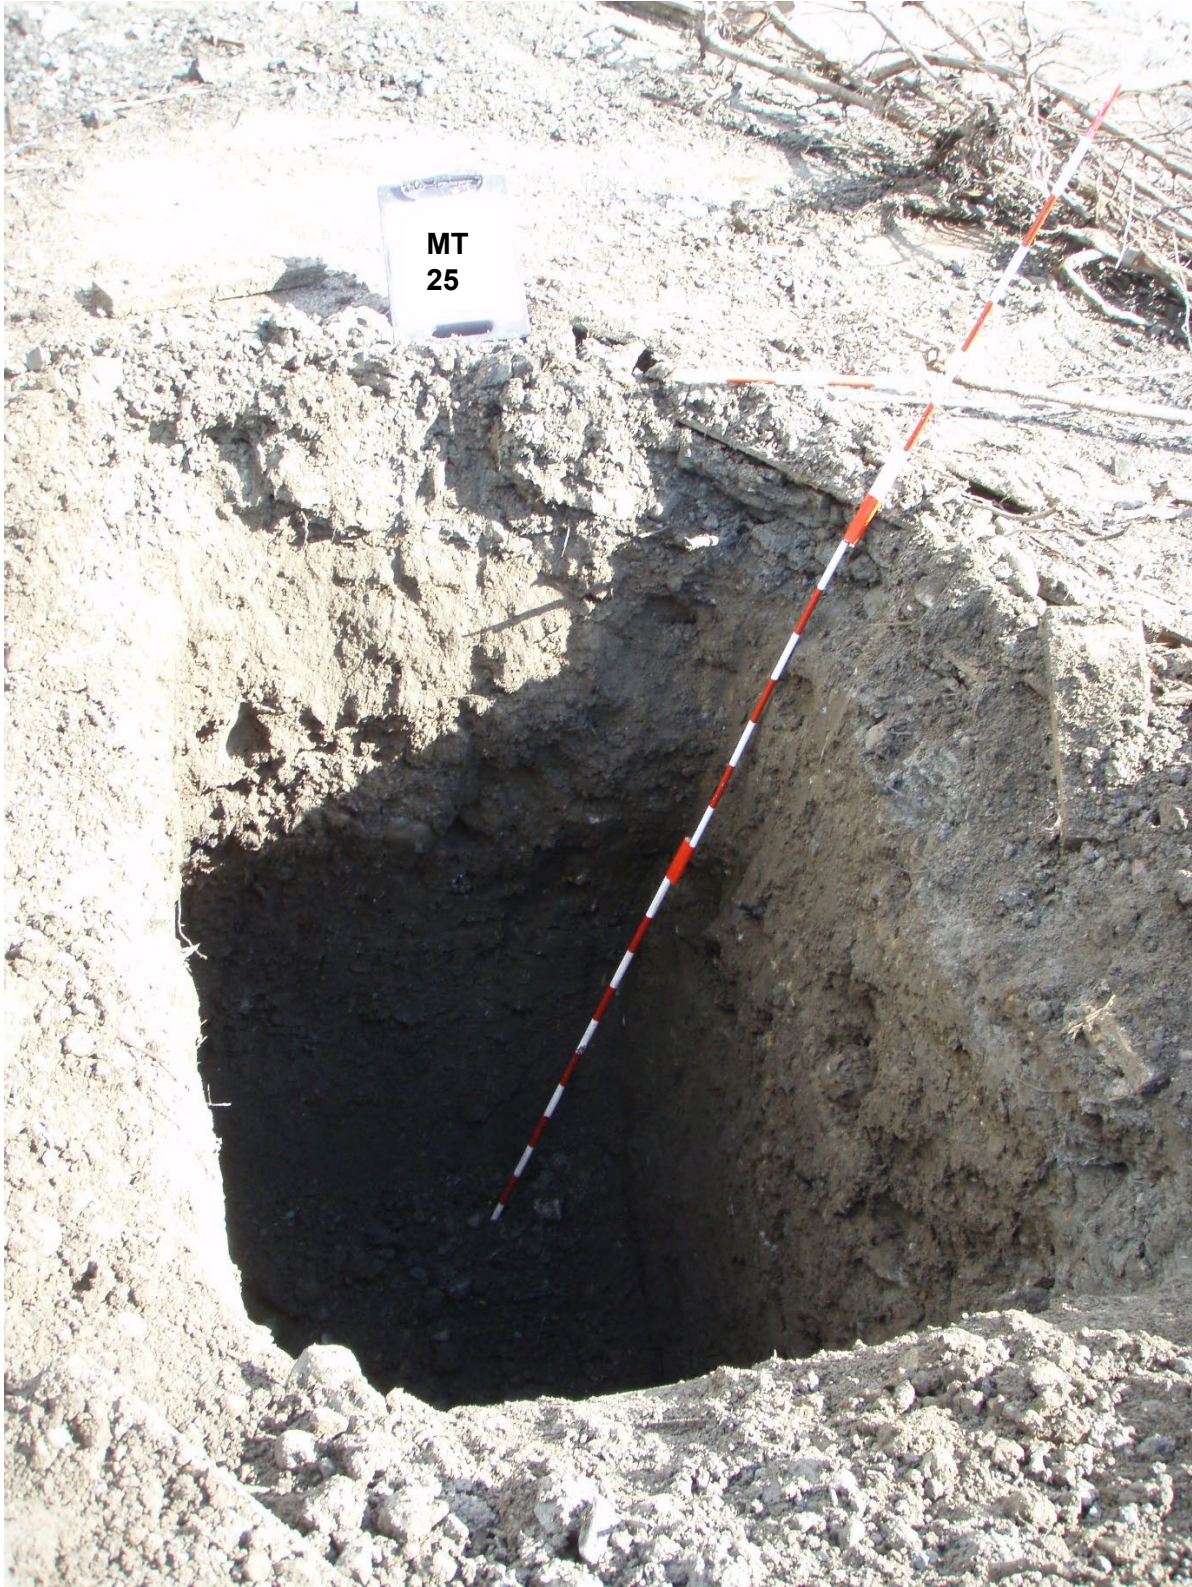
Figure 111. View of Machine Test (MT) 24 looking north. Test location is shown in Figure 15 and 22.

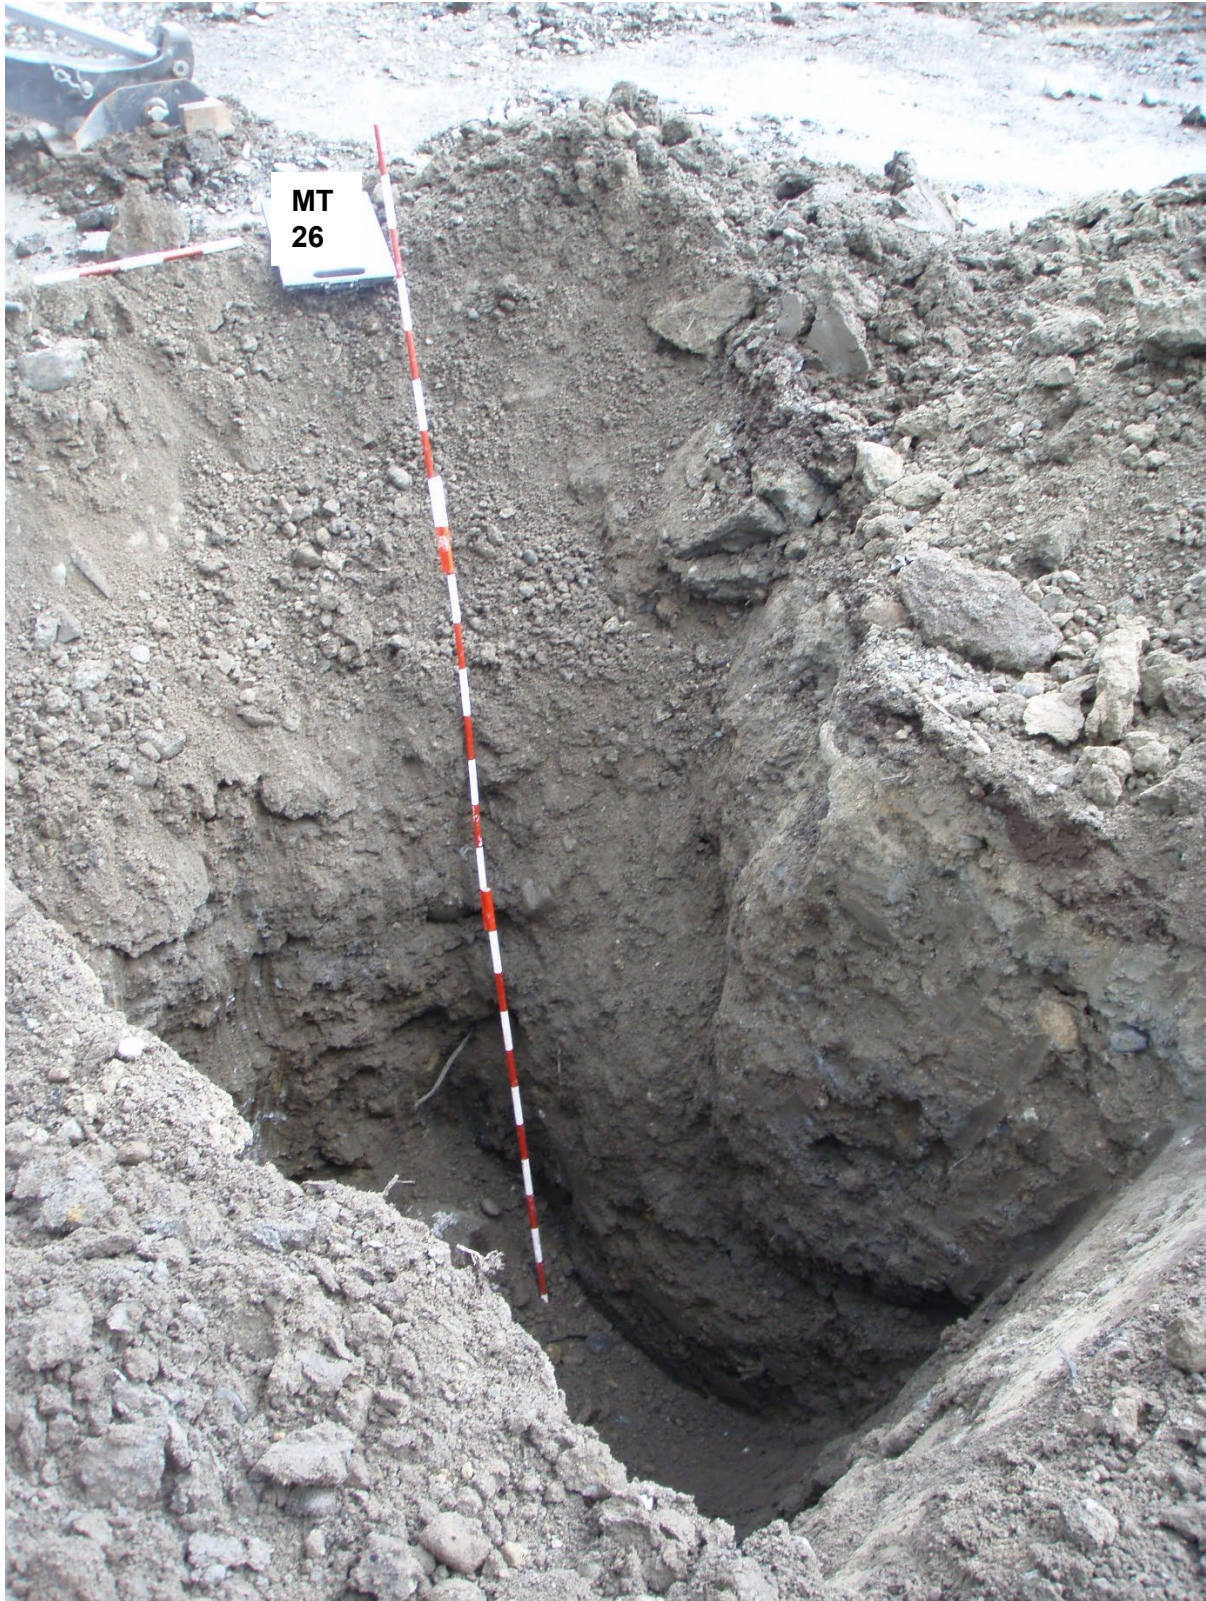
Figure 112. View of Machine Test (MT) 25 looking north. Test location is shown in Figures 15, 16 and 23.

MT 25	10U; 0520067E; 5459552N	2.0m NS x 1.25m EW x 2.0m BS	May 13, 2022	0 to 190cm BS: moderately loose grey sand, gravel, cobbles (imported fill); 190 to 200cm BS: compact grey marine/late glacial clay. No sediments were suitable for close inspection; all imported fill on top of sterile clay.	Test placed in center of road ROW about 15 m east of the pump house preload pile; No pre-contact period deposits.	Figures 15, 16, 23, 112.
MT 26	10U; 0520058E; 5459550N	2.5m NS x 1.25m EW x 2.8m BS	May 13, 2022	0 to 270cm BS: moderately loose grey sand, gravel, cobbles and boulders (imported fill); 270 to 280cm BS: compact grey marine/late glacial clay. No sediments were suitable for close inspection; all imported fill on top of sterile clay.	Test placed in center of road ROW about 8 m east of the pump house preload pile; No pre-contact period deposits.	Figures 15, 16, 23, 113.

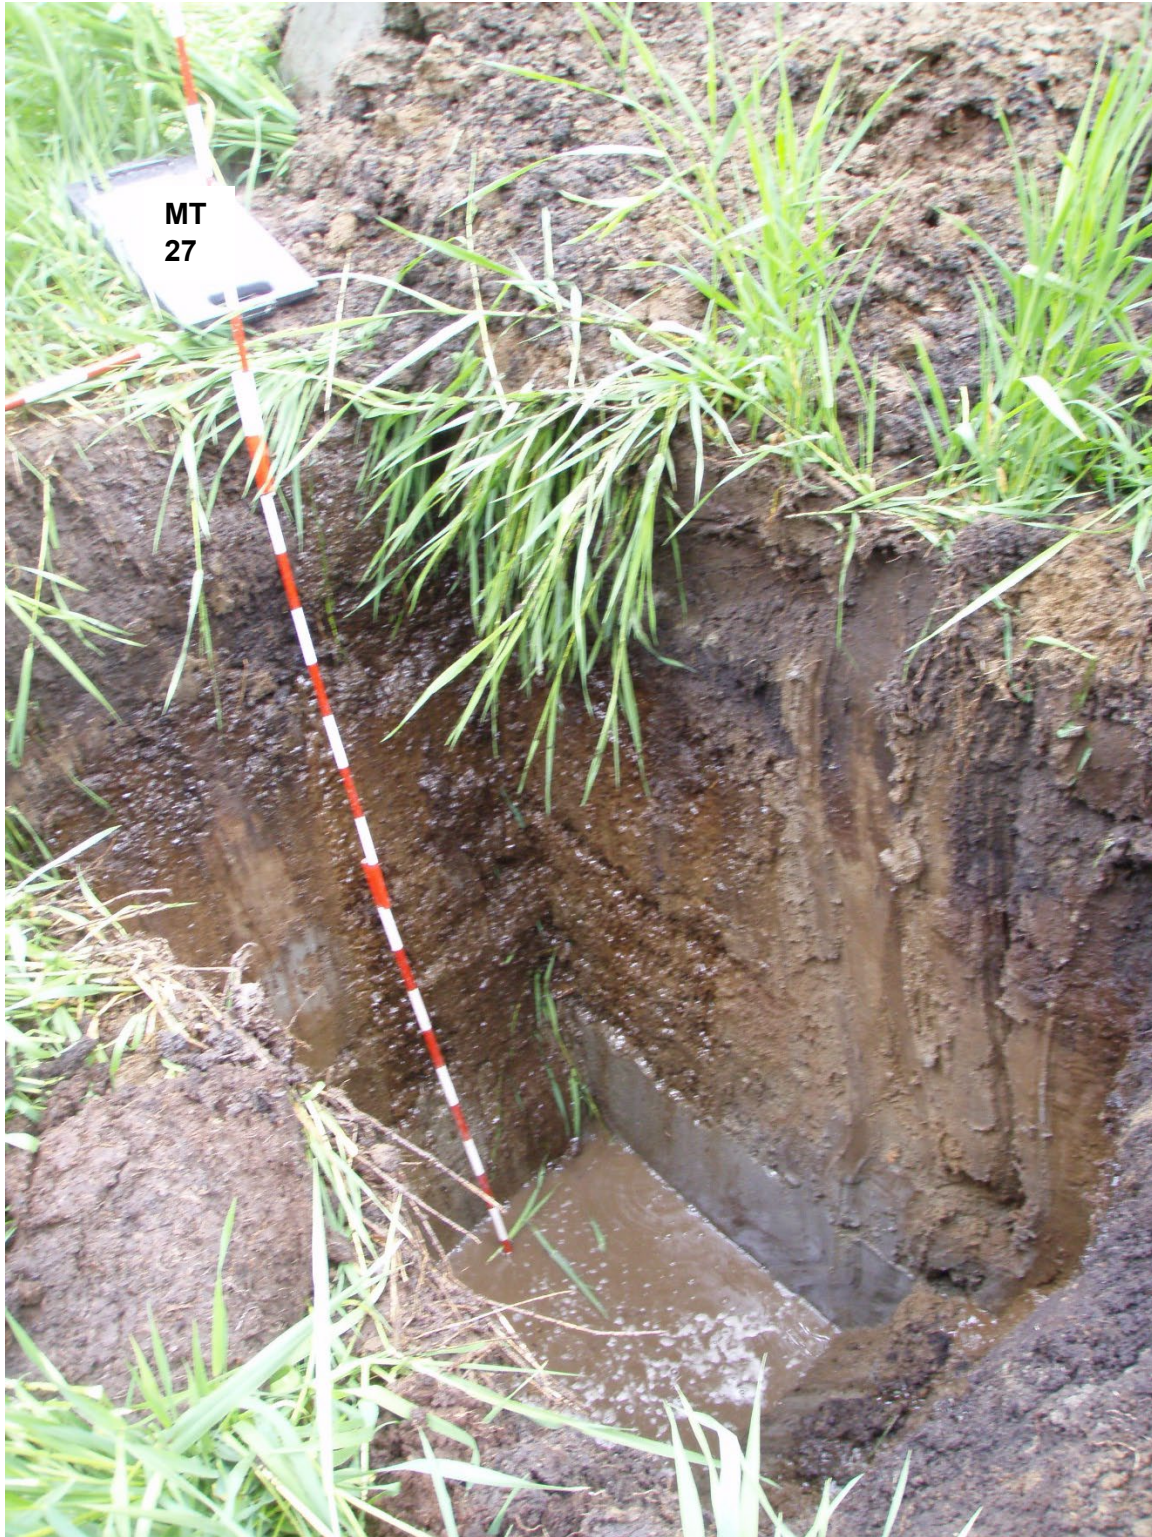
Figure 114. View of Machine Test (MT) 27 looking north. Test location is shown in Figures 2 and 5.

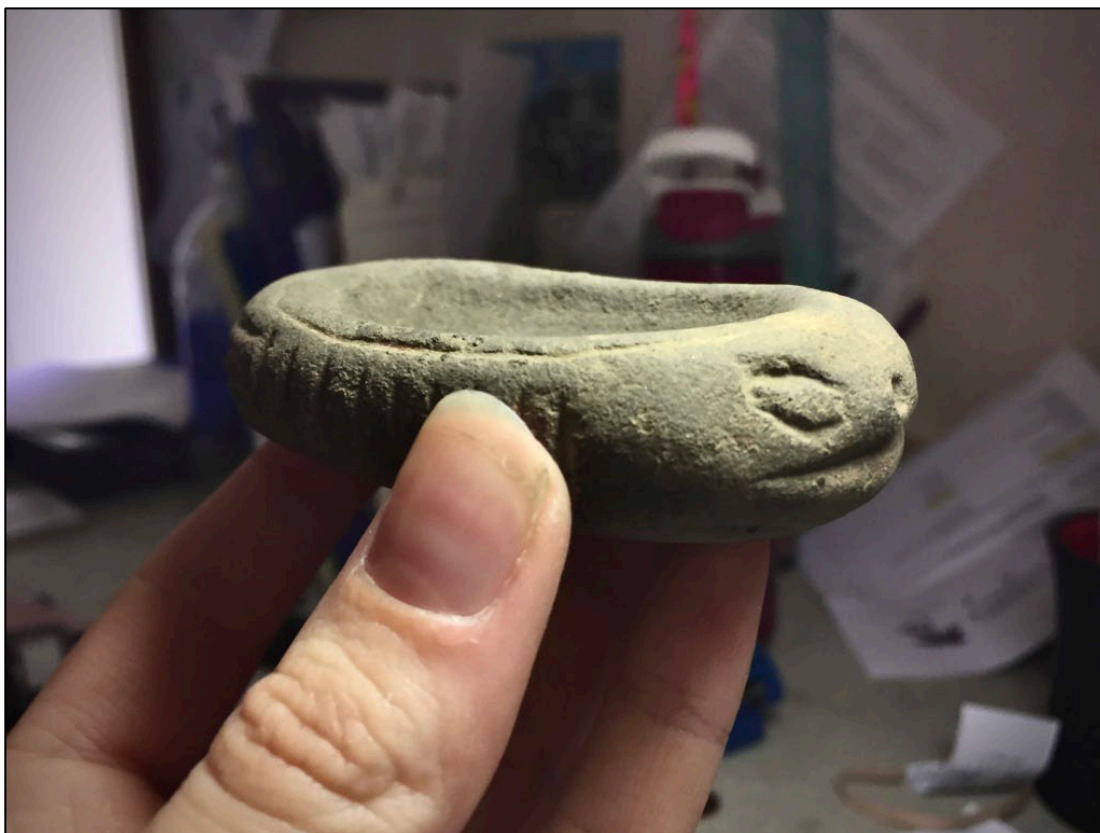
Figure 2. Small carved stone bowl found during construction monitoring at a site in 2018.

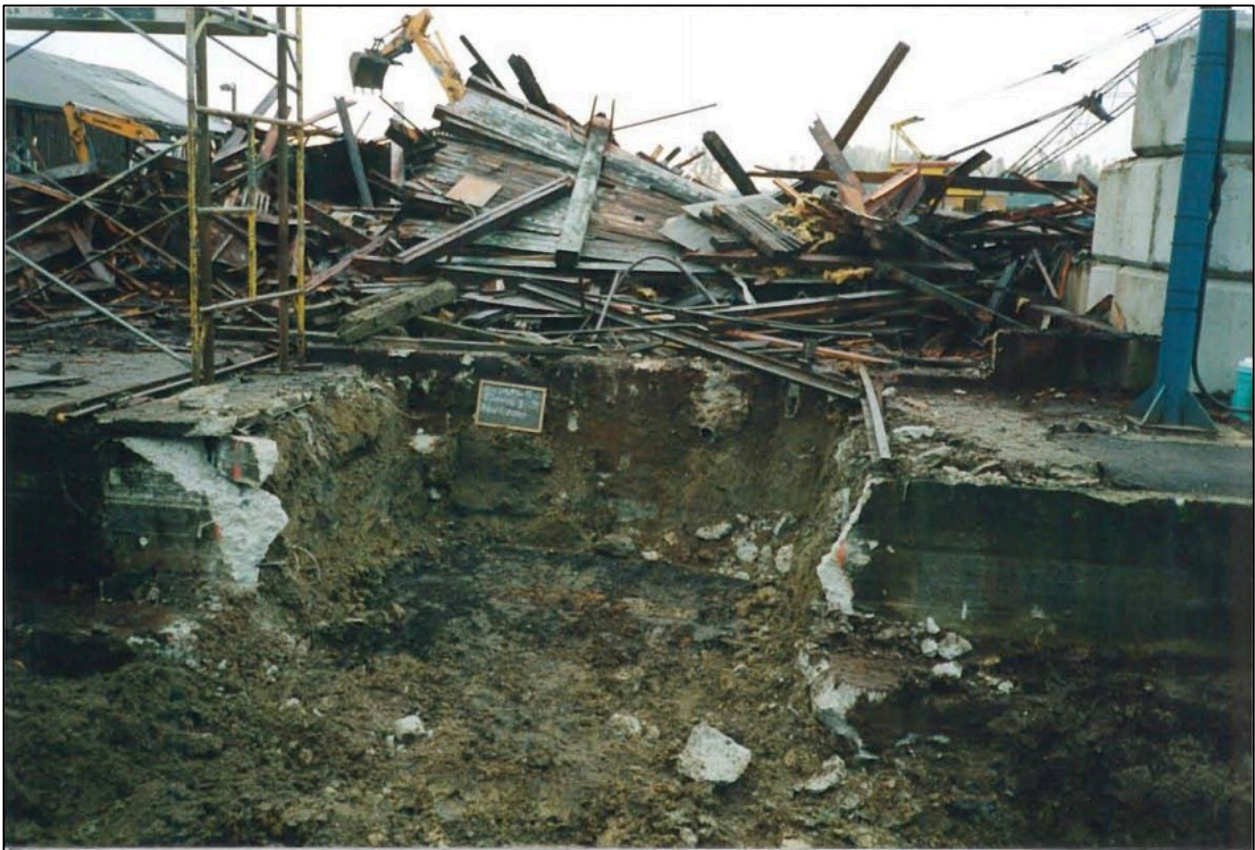
Figure 3. Significant archaeological village site deposits (dark soil) found under a deconstructed industrial building in Maple Ridge (Photo Credit: Antiquus, 2000).

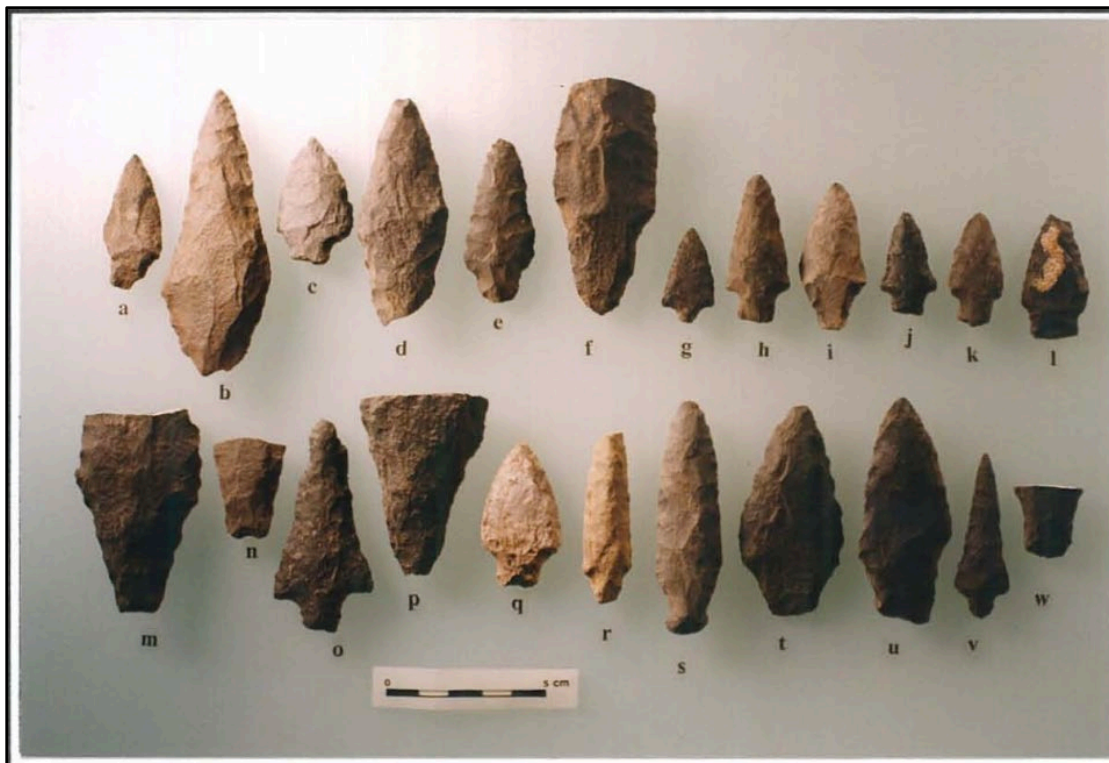
Figure 4. Some of the more obvious artifacts that may be seen during disturbances are projectile points. Used as spears, knives, or perforators, they are an interesting find and quite recognizable. They are important tools in dating archaeological sites because projectile points changed in design throughout the years.

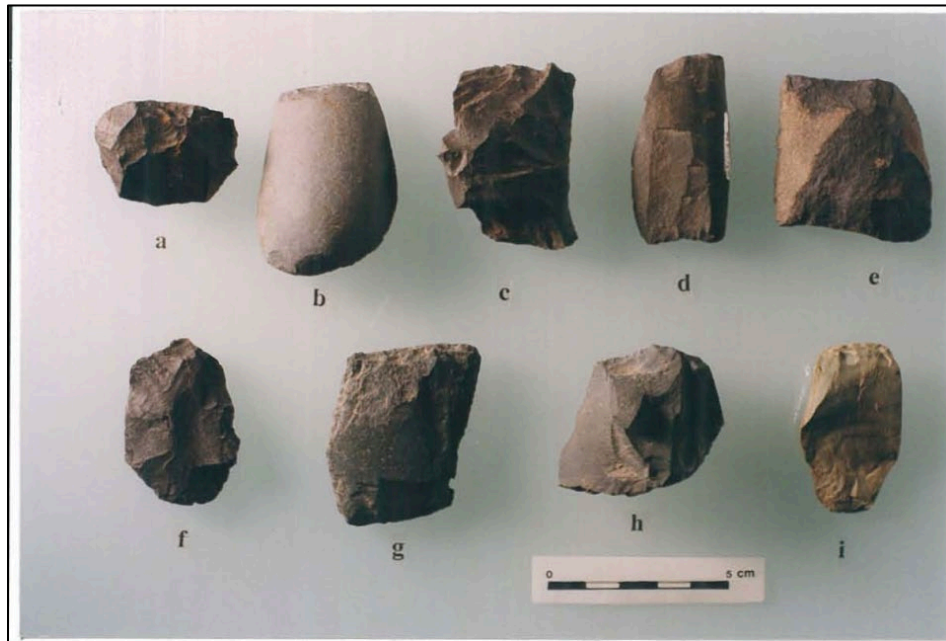
Figure 5. Sometimes archaeological lithics can look like gravel crush. These bipolar core fragments often look like rocks you might see on the side of the road. To the discerning eye, the specific crushing and flaking is indicative of intentional flake and tool production.

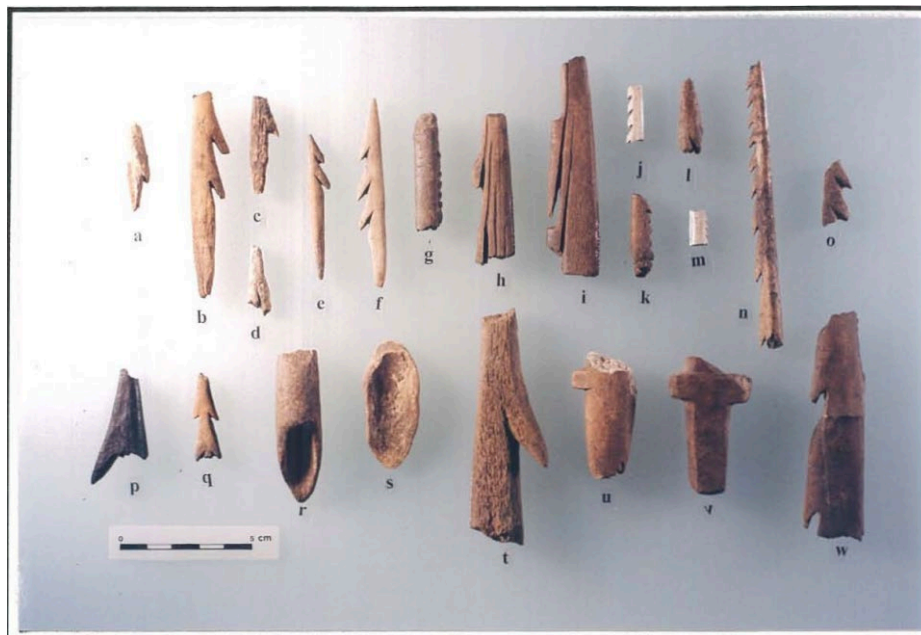
Figure 6. Complete and fragmented bone and antler harpoon points. Rare, but significant finds. Usually found beside bodies of water as they were used as fishing tools.

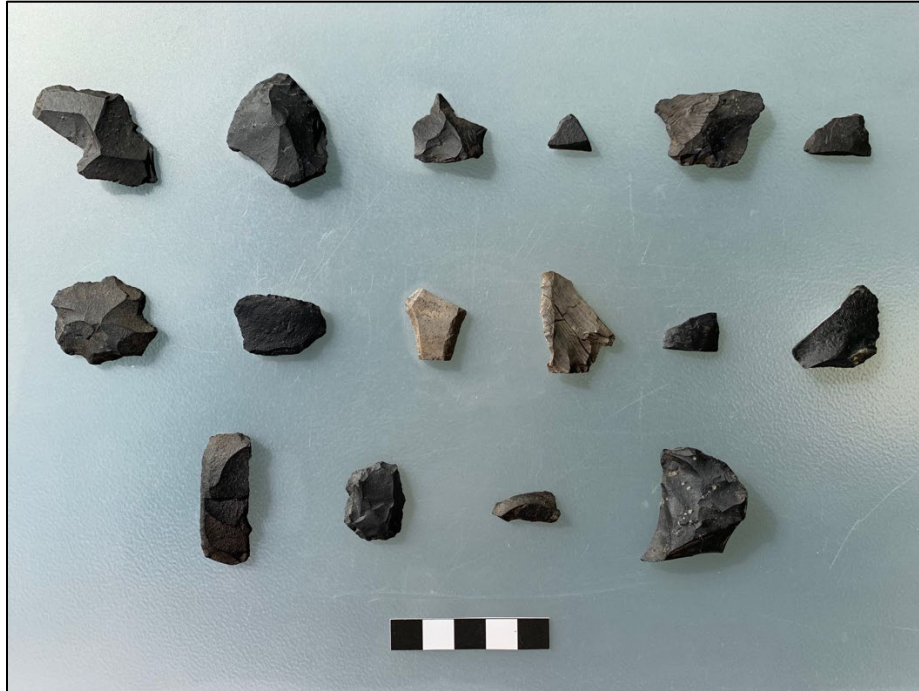
Figure 7. Additional examples of utilized flakes and chipped stone tools that may be encountered during ground excavations. A good indication that you are looking at a lithic or a waste flake is if you notice sharp, chipped edges, and ripples (from impact of hammer stone) along the bottom (ventral) side of the stone flake.

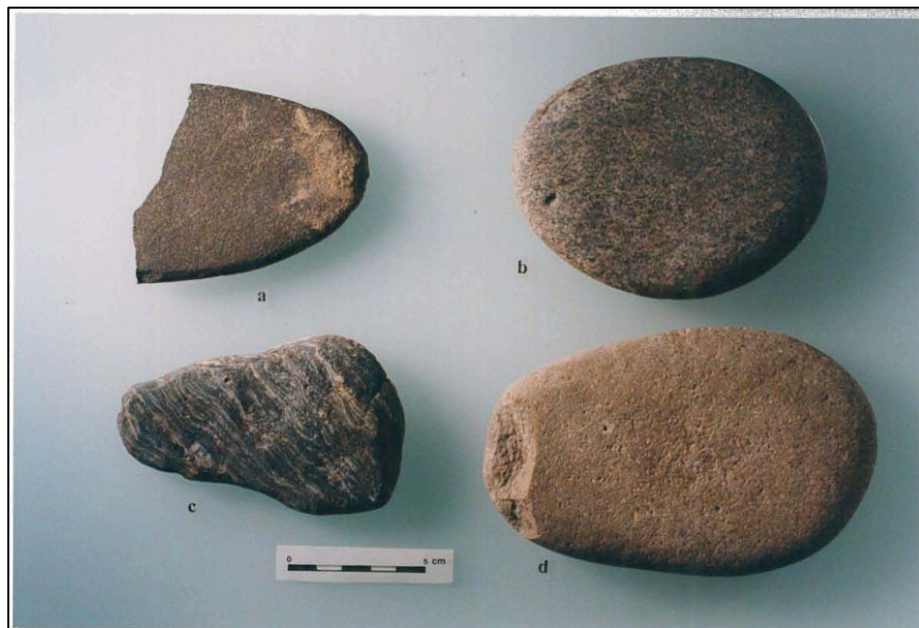
Figure 8. Examples of larger ground stone tools. If you notice a cobble with obvious battering on one or more sides, or evidence of grinding and rounding along the sides, this may in fact be a tool.

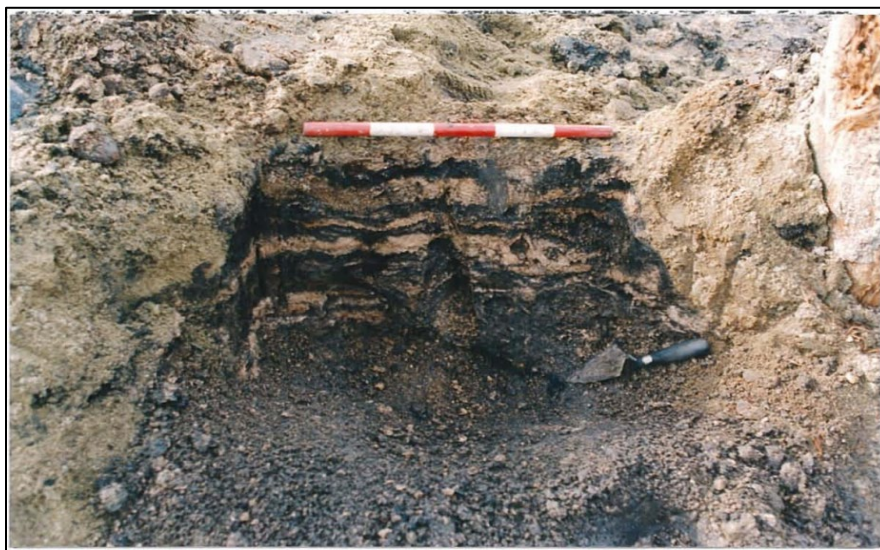
Figure 10. Archaeological features such as hearths and individual house floors, are evident in the stratigraphy (Antiquus 2000).

(3) Buried archaeological “features” (e.g., dark-stained mottled and lensed soils containing artifacts and other cultural materials, hearths and fire-pits, food storage and processing pits, dwelling foundations and floor deposits, scatters of fire-altered rock, etc.) that become exposed in the stratigraphy during the course of machine activities (Figure 10). These features are often conspicuous by their “non-natural” appearance, and association with dark-stained organic-rich soil horizons, lithic artifacts, fire-altered rock, and faunal remains (animal bones and/or mollusc shells).
