Site Observation Form

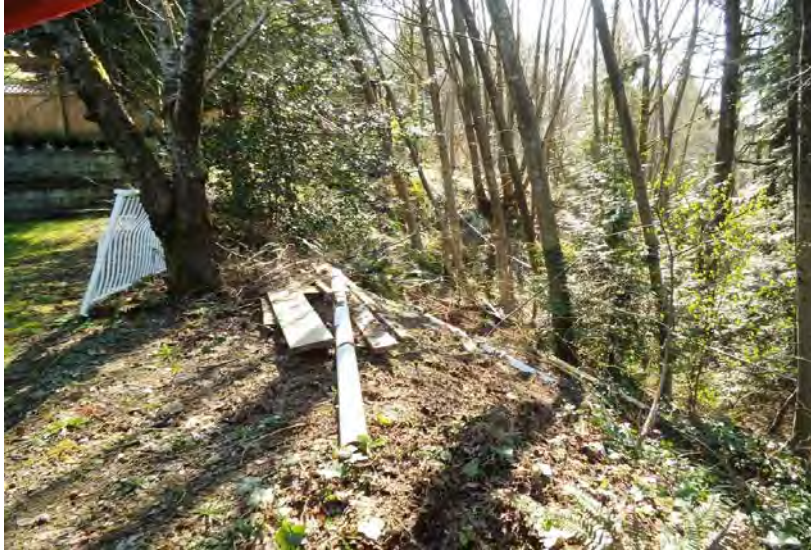
Slope Below Back Yard

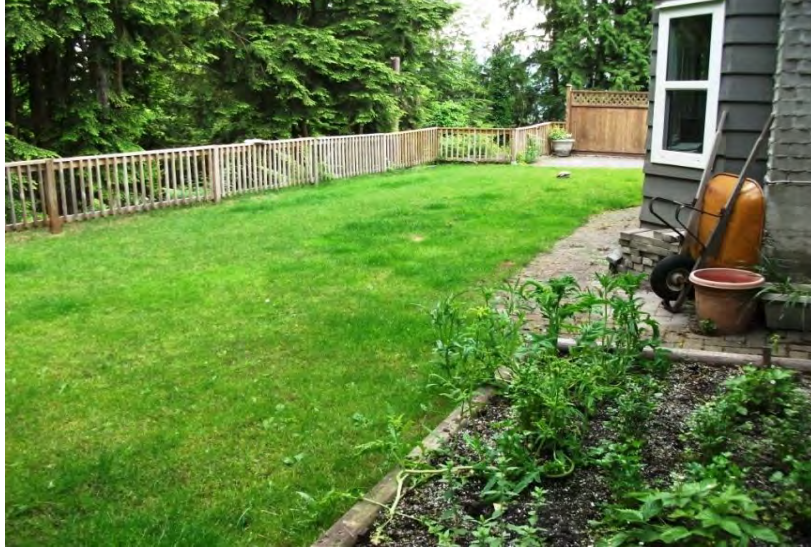
Small Wood Tie Retaining Wall, Lower Right

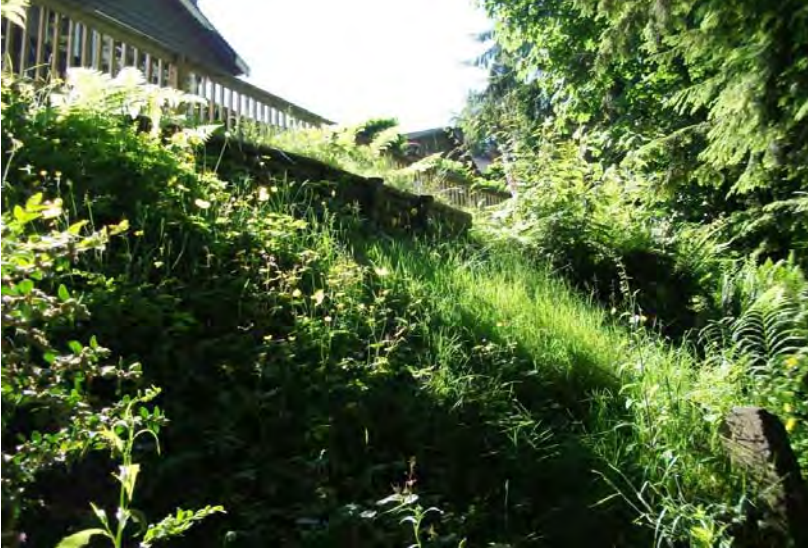
984 Corona Drive

Size	Condition
Timber crib	Y	Tipping downslope
Stacked blocks	N	
Concrete	N	
Rock / mortar	N	
Engineered	N

Small Retaining Walls of Wood Ties Below Crest

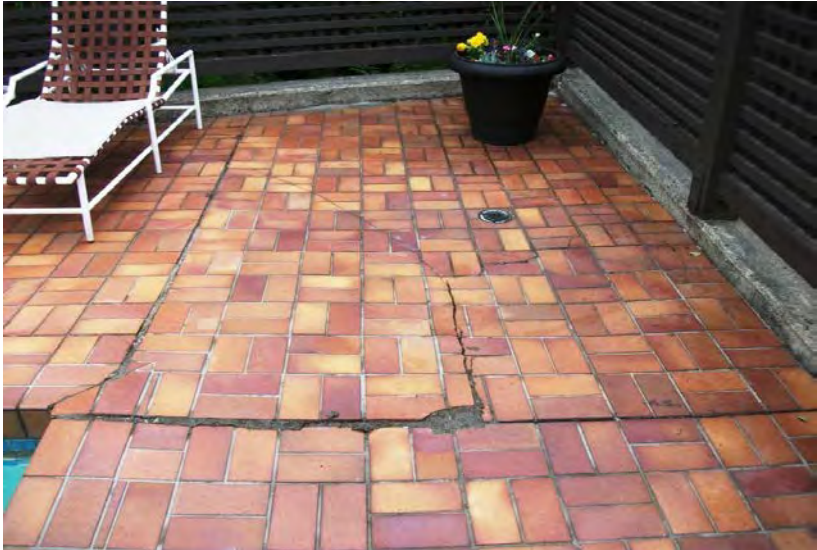
Pool With Repaired Cracks

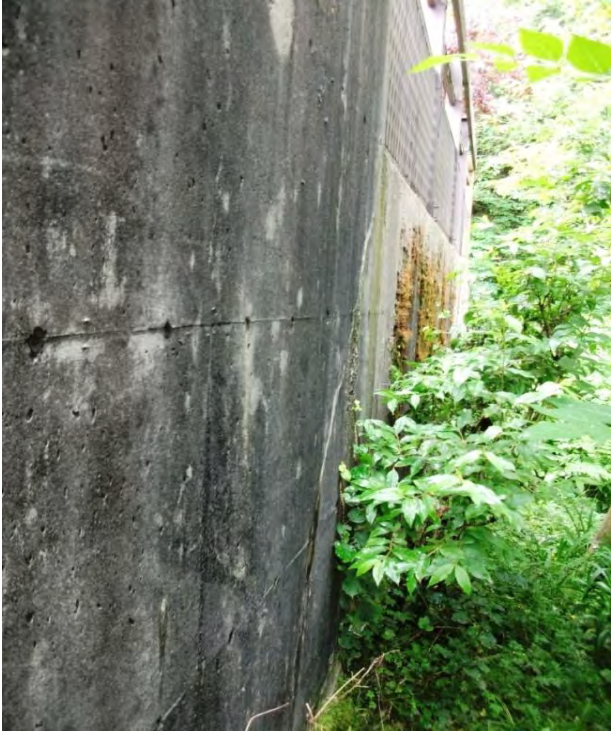
One of Five Drainage Pipes From Toe Of Wall

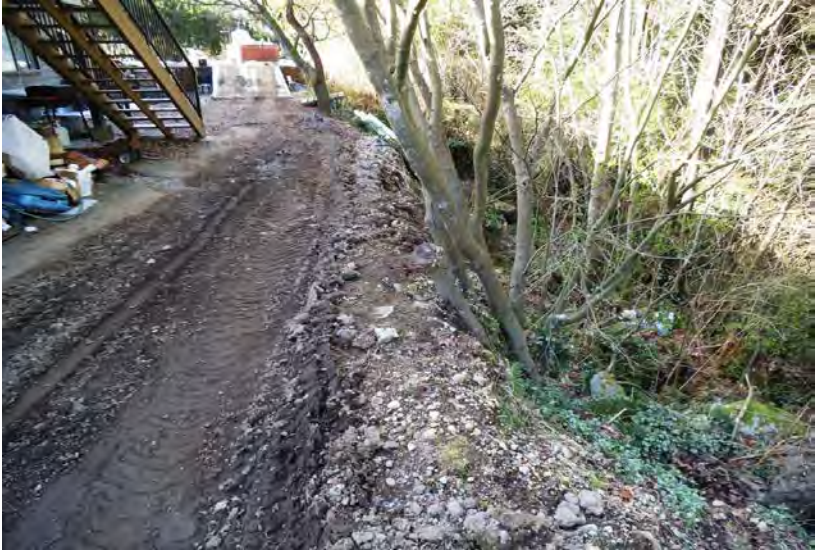
Fill Along Lane Behind House

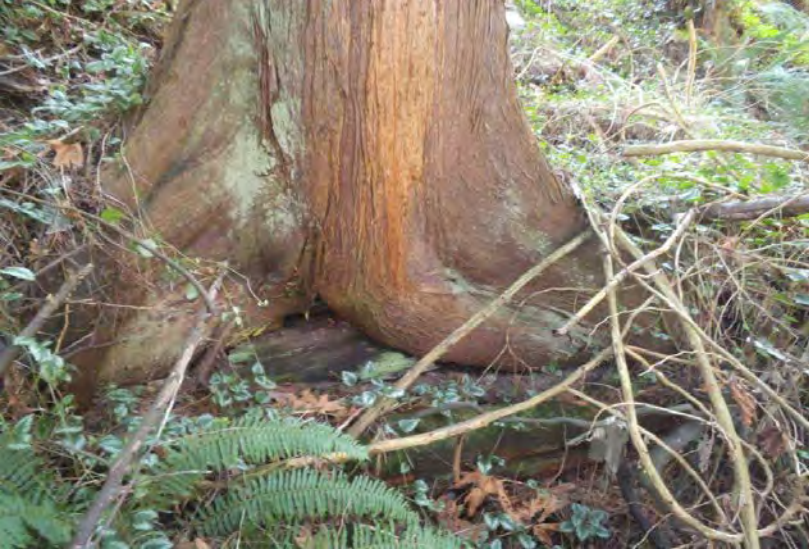
Cedar Growing on Logs From Original Land Clearing or Logging

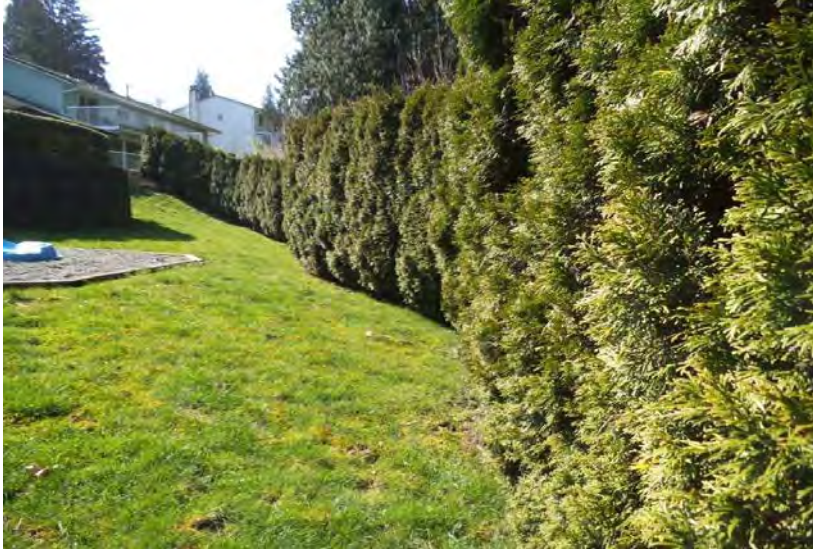
Lower Wall At Crest

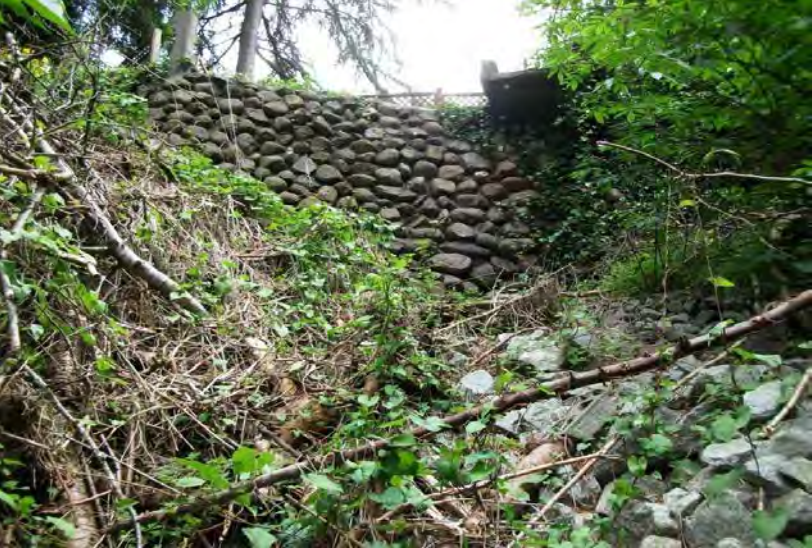
Comments
City storm pipe outflow has rock/broken toilet pieces as armour.

Storm Sewer Outlet With Riprap

A geotechnical assessment of the concrete retaining wall at the storm sewer outlet is recommended.

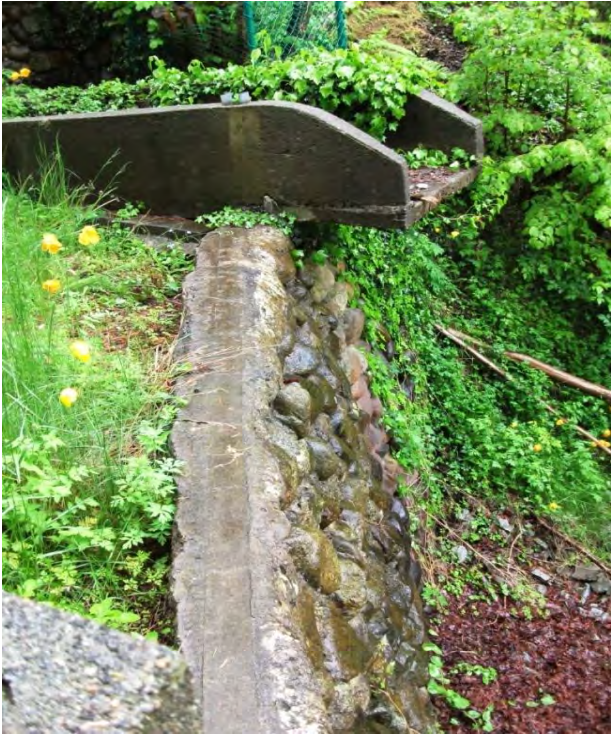
Gully below stormwater outlet, July 2011

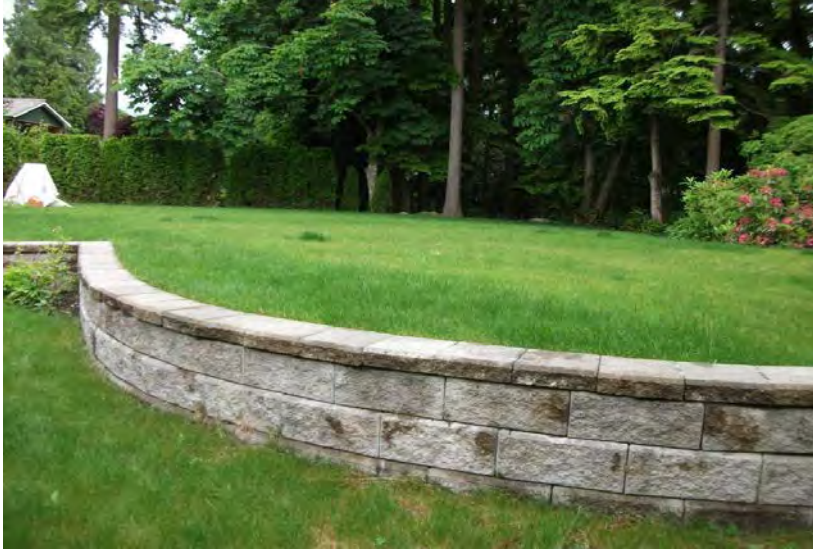
1777 Harbour Drive

Back Yard

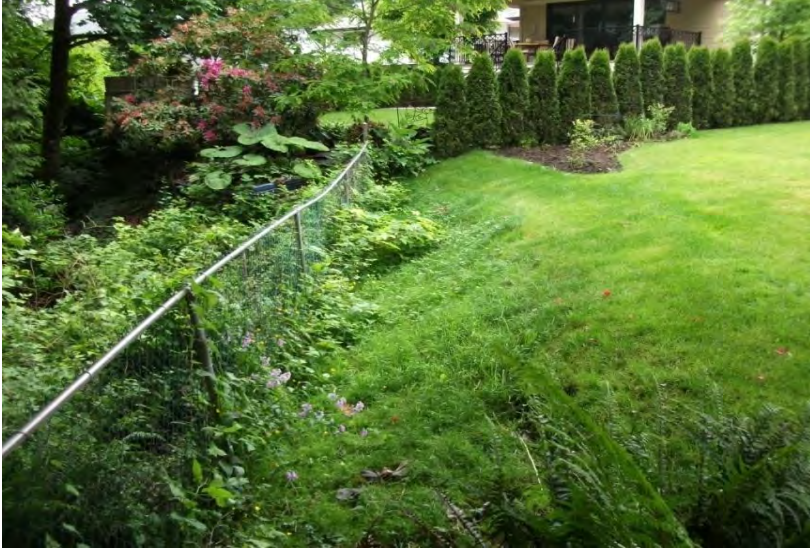
1781 Harbour Drive

Back Yard

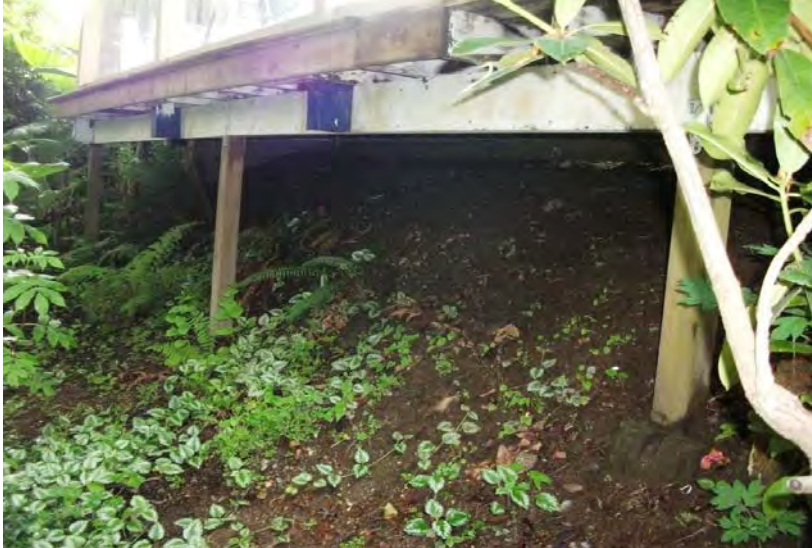
1785 Harbour Drive

Comments: Wooden patio sits on uprights on loose concrete blocks above gabions. Does not appear secure.

Deck Uprights On Concrete Blocks On Unknown Soil.

A review of the patio footings in the ravine slope area is recommended.

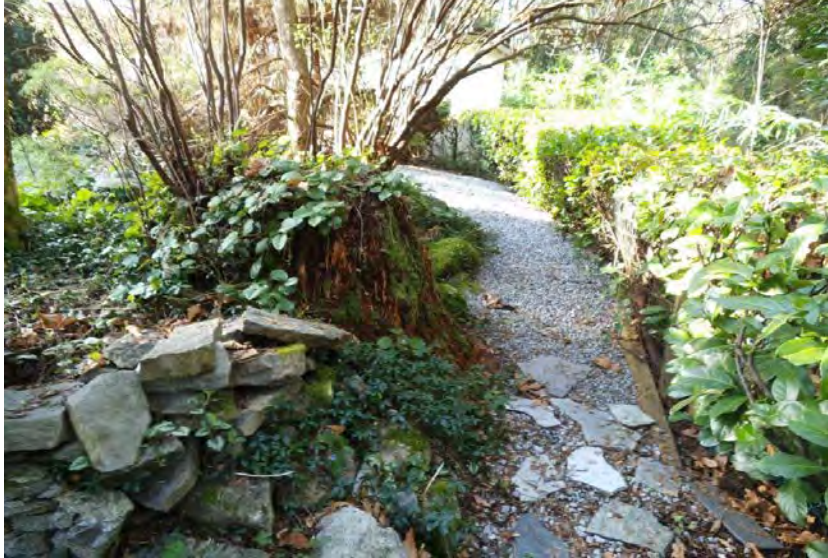
1793 Harbour Drive

Crest Area in Yard with Old Stump

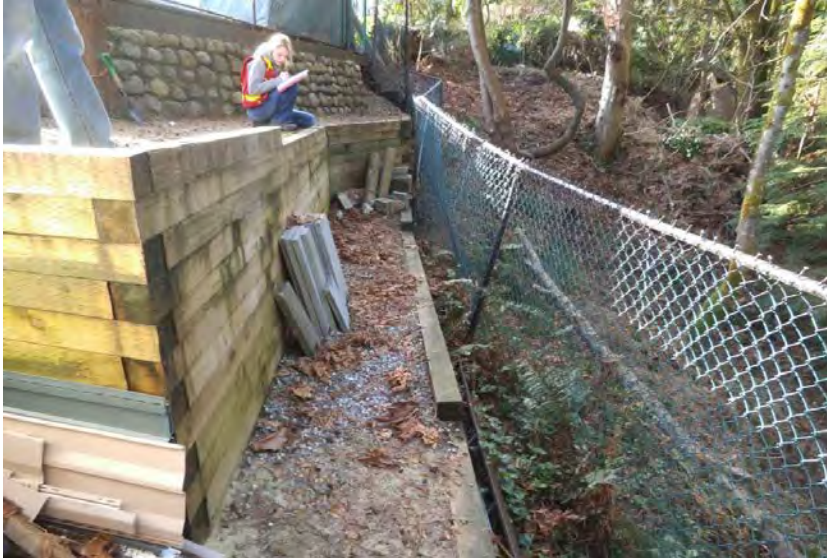
South Edge of Swale Below Crest With Damaged Maple Trees

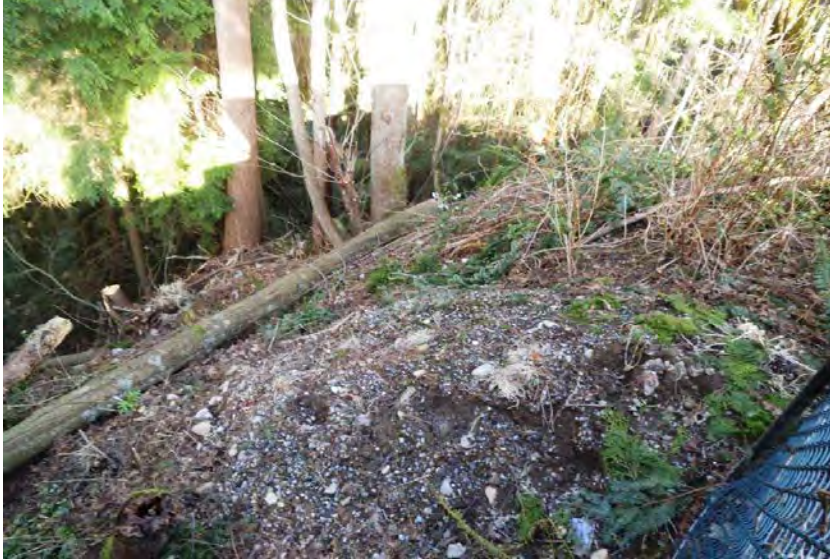
1797 Harbour Drive

View Across Centre of Crest Area With New Soil Fill

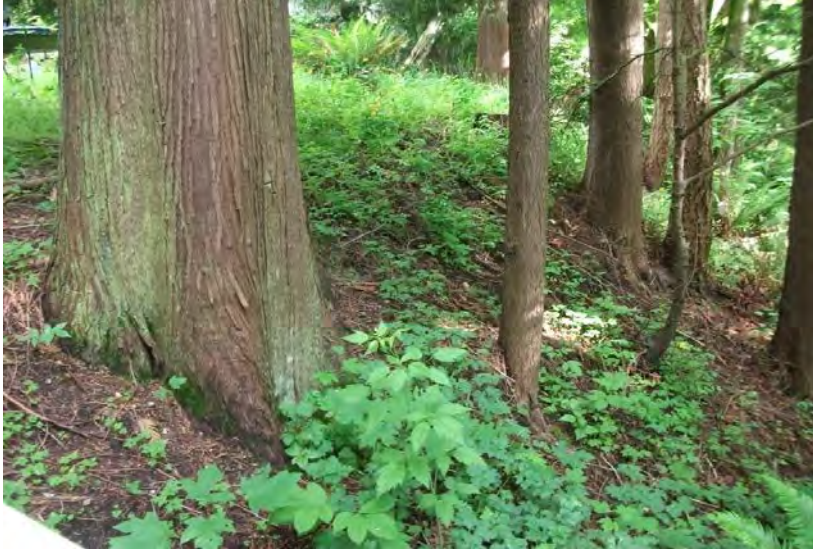
1805 Harbour Drive

Back Yard And Crest

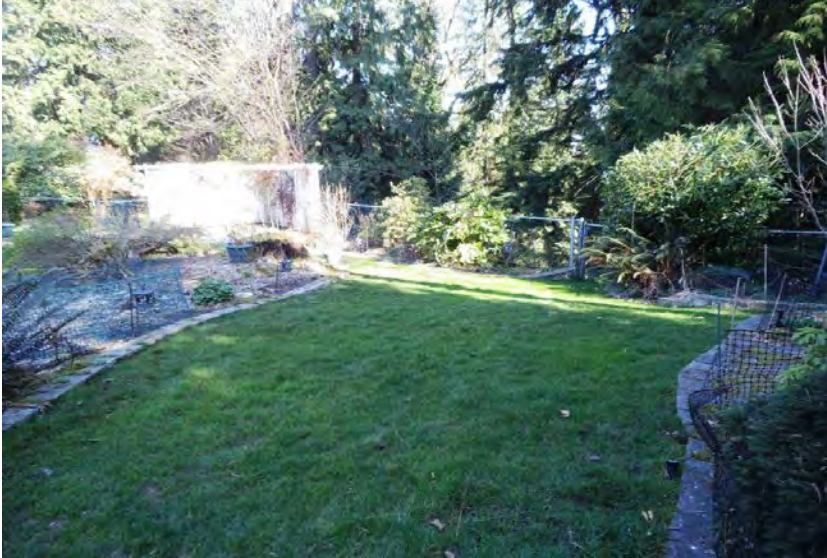
Back Yard

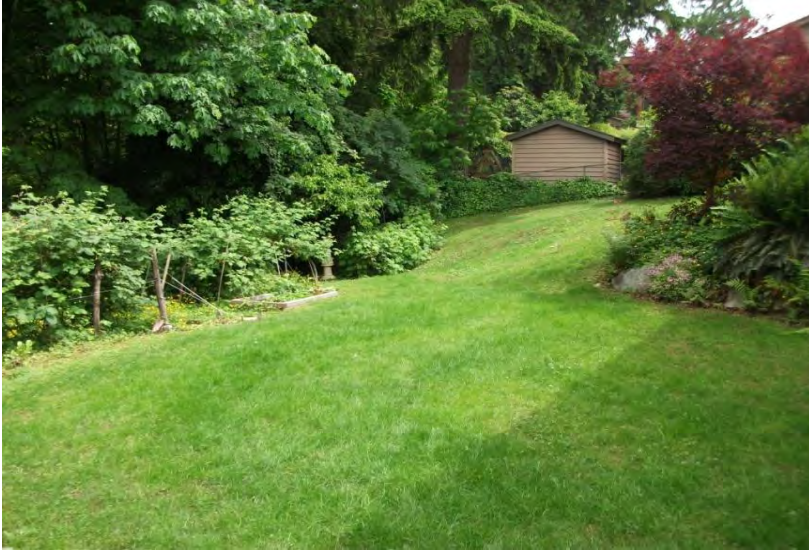
Size	Condition
Timber crib	N	
Stacked blocks	N	
Concrete	Y just below crest	old, not engineered
Rock / mortar	N	
Engineered	N

Old Concrete Wall Below Crest

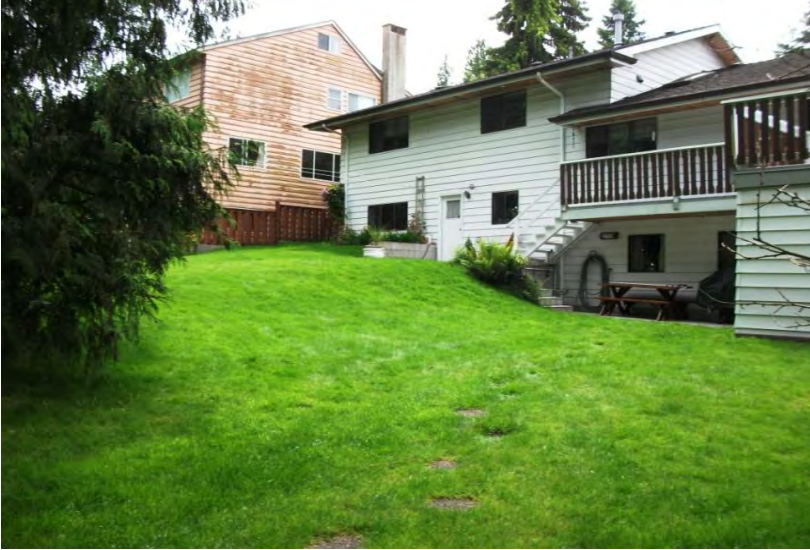
Backyard

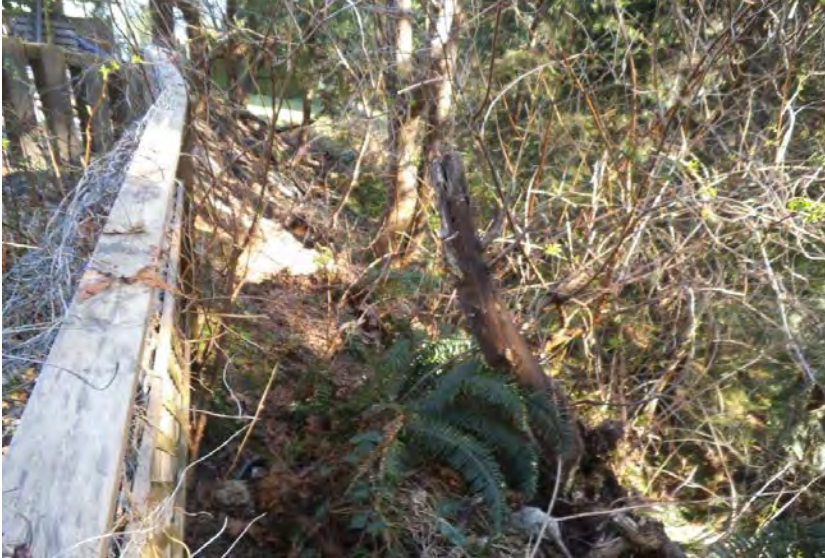
Ravine Slope Crest

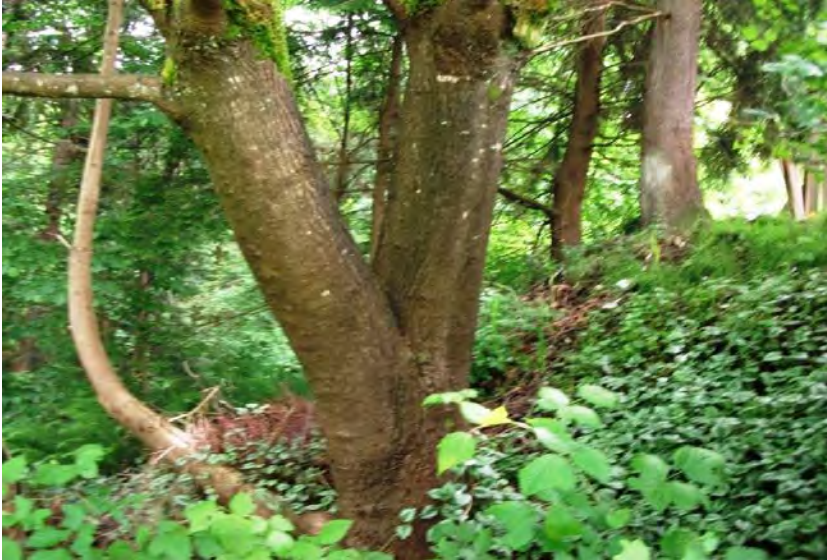
Crest Area, March 2013 During Construction, With Drain Pipe

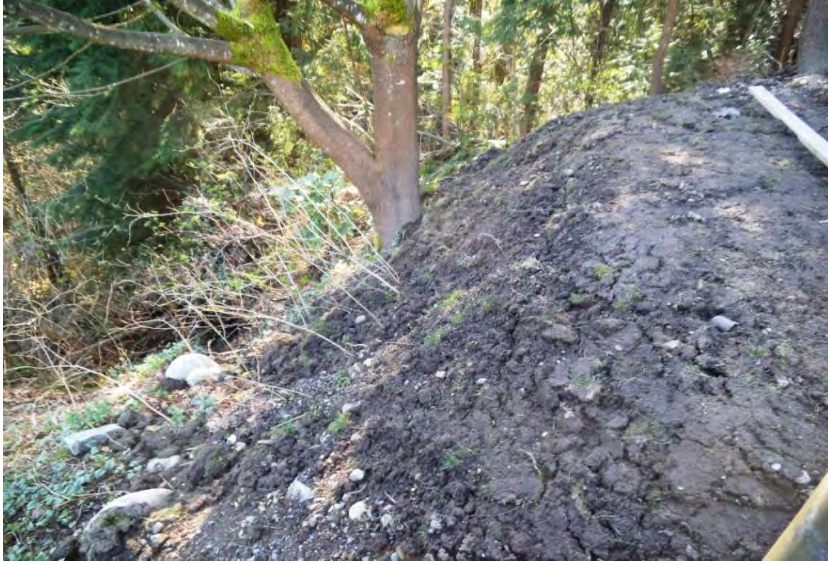
View Up Fill Slope With Water Track

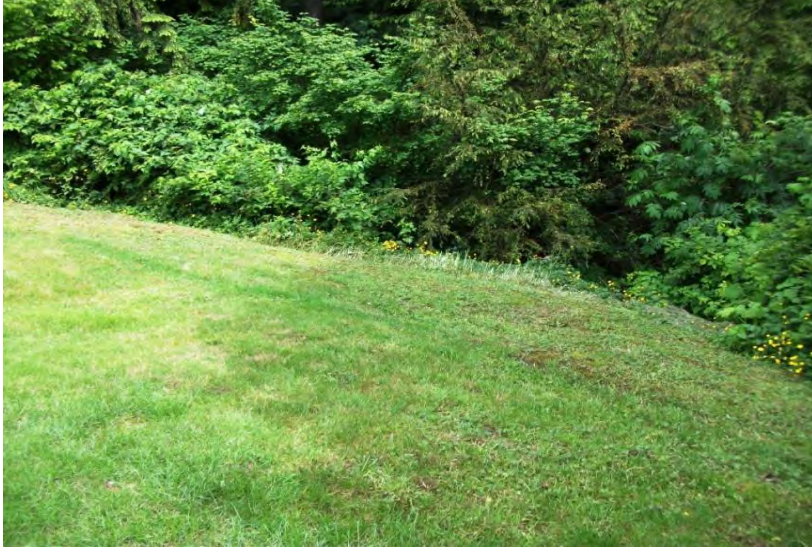
Back Yard And Crest With Subsidence

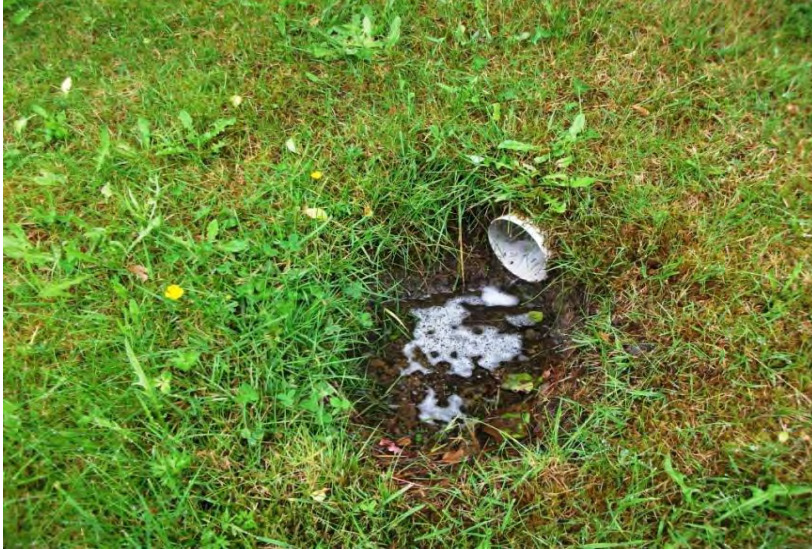
1015 Blue Mountain

End of Blue Mountain with Potential Water Flow Past Grate to Slopes Below

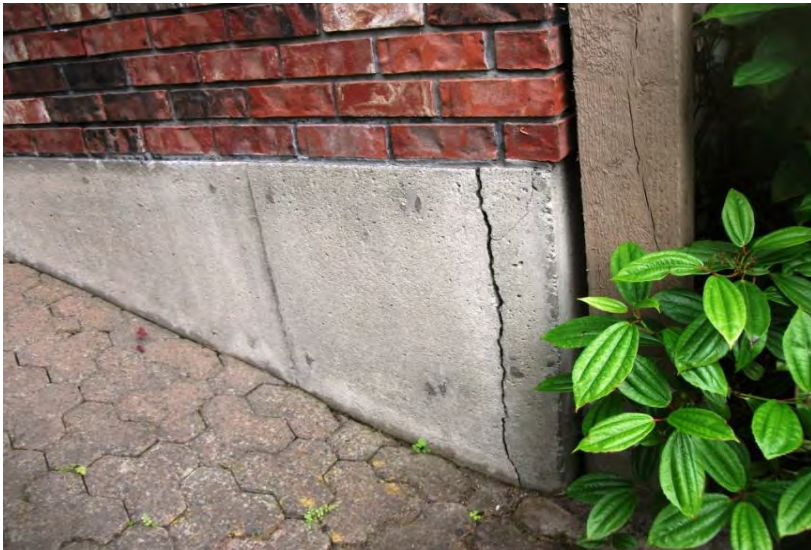
1020 Blue Mountain

Crack In North Side Foundation

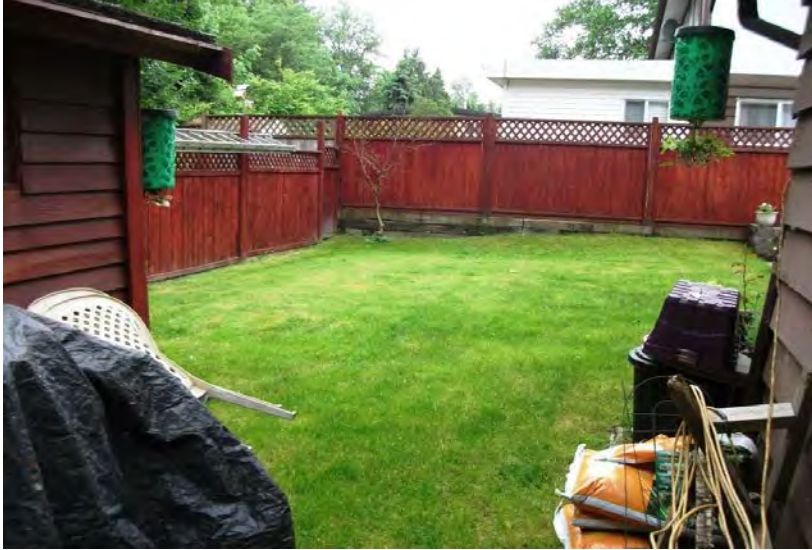
830 Ingersoll Ave.

Backyard, With Varying Fill Thickness, Subsidence

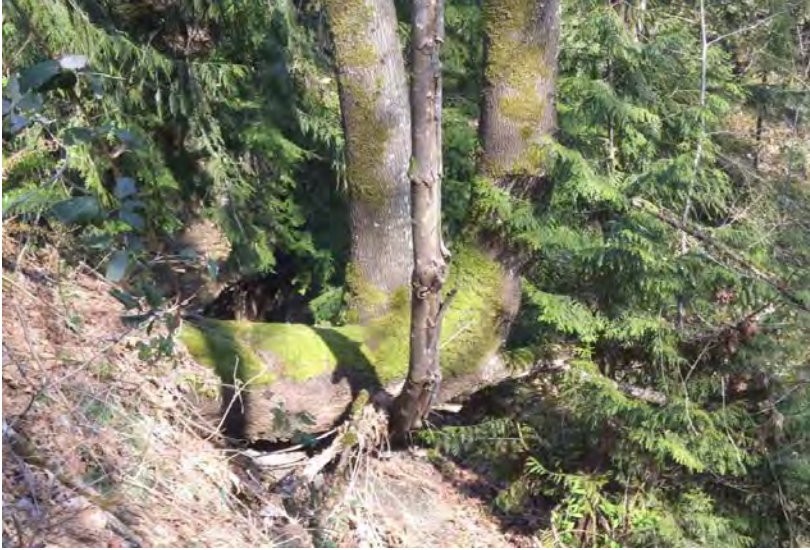
View Down Fill On South Edge of Parcel Area

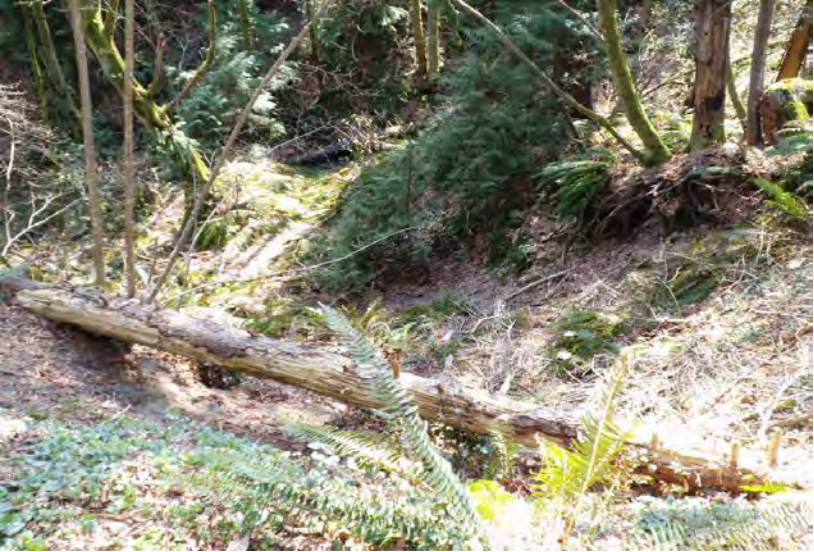
Concrete Debris and Fill on Surface East of Tennis Courts

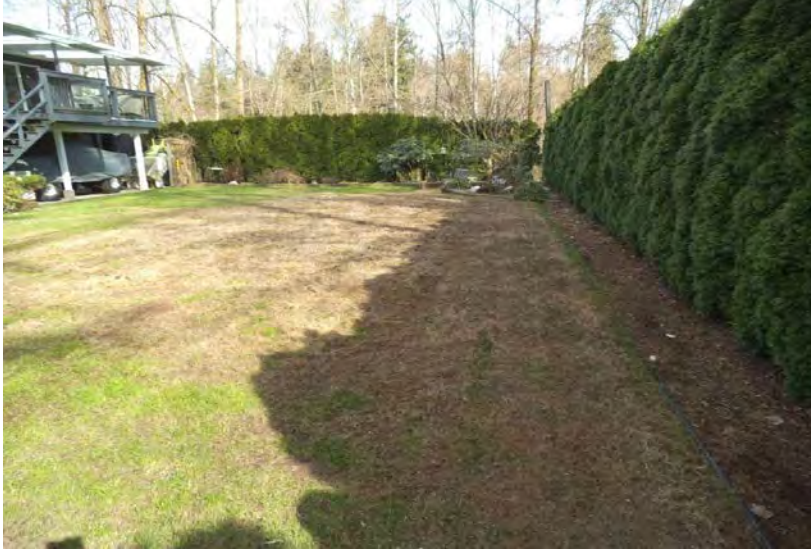
Subsidence Area In Park

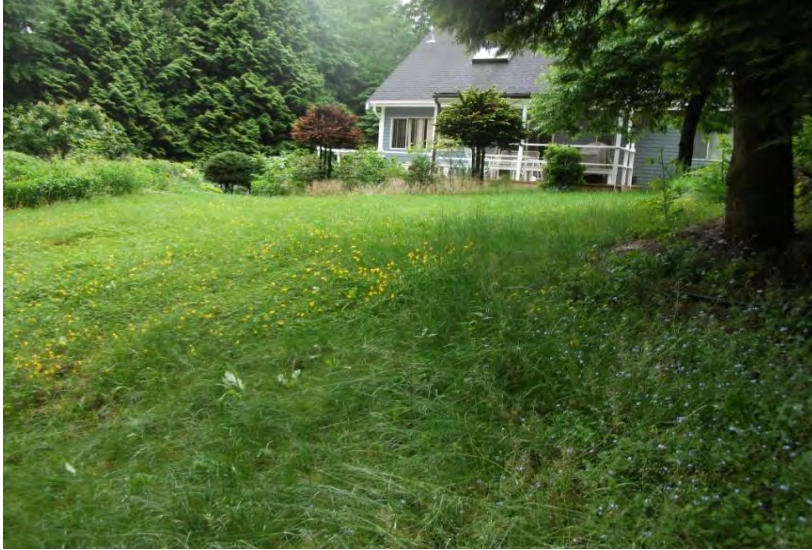
Small Lobes of Fill Near Fill Pile Edge

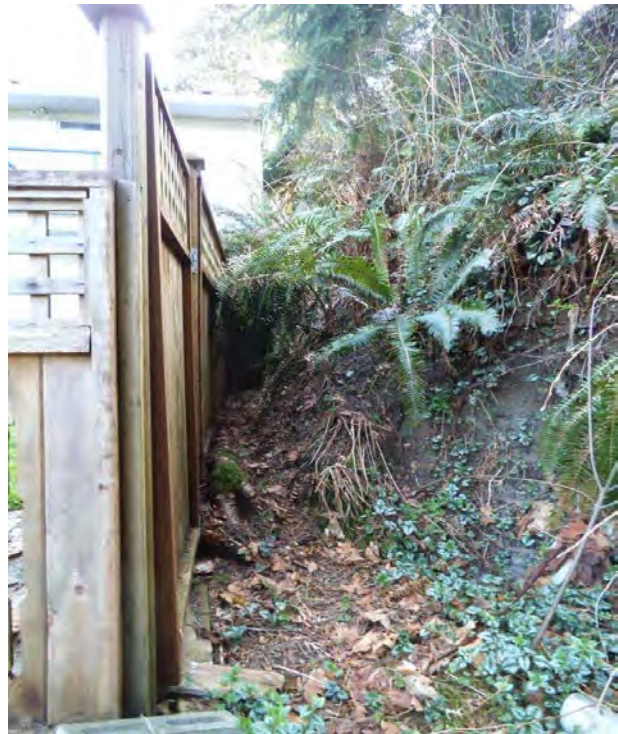
Steep Unsupported Soil Face Southwest Corner of Yard
