GEOTECHNICAL INVESTIGATION AND STABILITY ASSESSMENT

Corona Crescent Area, Coquitlam, BC

Report Number: 1314470330-001-R-Rev1

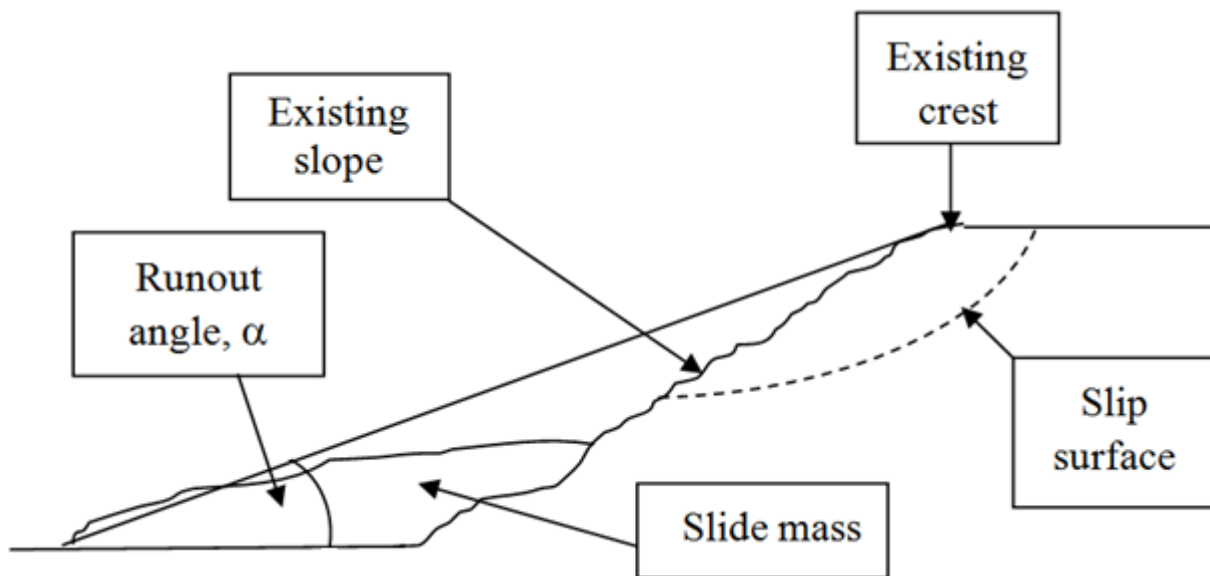
Figure 1: Schematic Illustration of Runout Angle

As described in BGC 2008, significant structural damage is considered likely or probable to occur to dwellings located within the slide path at runout angles greater than 25°. At progressively shallower angles (21° to 25°), the amount of slide material decreases dramatically, as does structural damage. At angles below 23°, the runout was limited to those events including flooding and organic soils. The above noted study assigned a range of angles from 19° to 25° to assess the possible extent of travel for potential landslide events for their analysis. Review of the historical slide events along the Chines escarpment indicates that the majority of the slides were relatively shallow, wet, flow slide events, rather than soil slumps involving generally unsaturated granular soils. Similarly, the hypothetical events modelled in the runout analysis were considered to have flow-like behaviour.

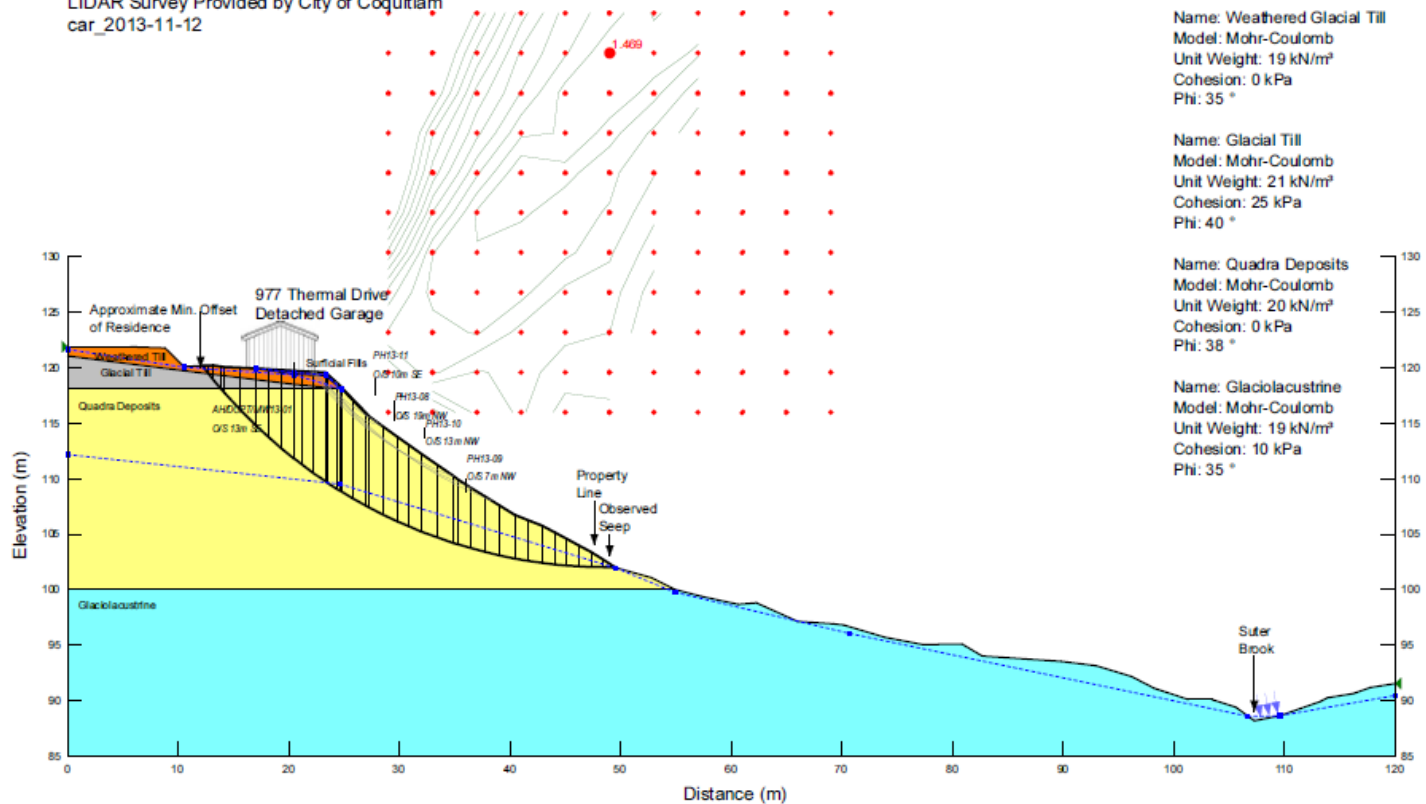
PROJECT No. 13-1447-0330			PHASE No. 3000		
DESIGN	CAR	12NOV13	SCALE	NTS	REV.
CADD					
CHECK	MGB	29NOV13	FIGURE 4A		
REVIEW	RCB	29NOV13

The results of the analyses for the four sections (A-A', B-B', C-C', and D-D') indicate that the factor of safety against slope failures directly impacting residences are generally in excess of 1.3 as summarized in Table 7. However, factors of safety for decks, detached garages, and other portions of the properties closer to or downslope of the crest of the ravine slopes are generally lower than those potential slope failure planes extending to the residences. Notably, the garage and carport located at 977 Thermal Drive has FoS values of less than 1.1 (Figure 4B). Decks and patios extending at or close to the ravine crest at 976, 984, and 992 Corona Crescent are also anticipated to have FoS values significantly lower than those of the residences, particularly for those not founded on dense native materials. These factors of safety are consistent with observations on site, where leaning and "pistol-butted" trees were noted during the field reconnaissance suggesting creep-type movements within the surficial soils.

The results of our analysis generally confirm those of previous studies carried out along the Suter Brook ravine properties. Under static conditions, the factors of safety against major, deep seated slope movements through the existing dense till-like and pre-Vashon deposits, with failure scarps impacting the residences are generally greater than 1.3, which is consistent with DNV criteria for acceptable risk of existing residential development, for all of the properties previously rated as high to very high risk, with the exception of 992 Corona Crescent where failure surfaces intersecting the residence were nominally below 1.3.

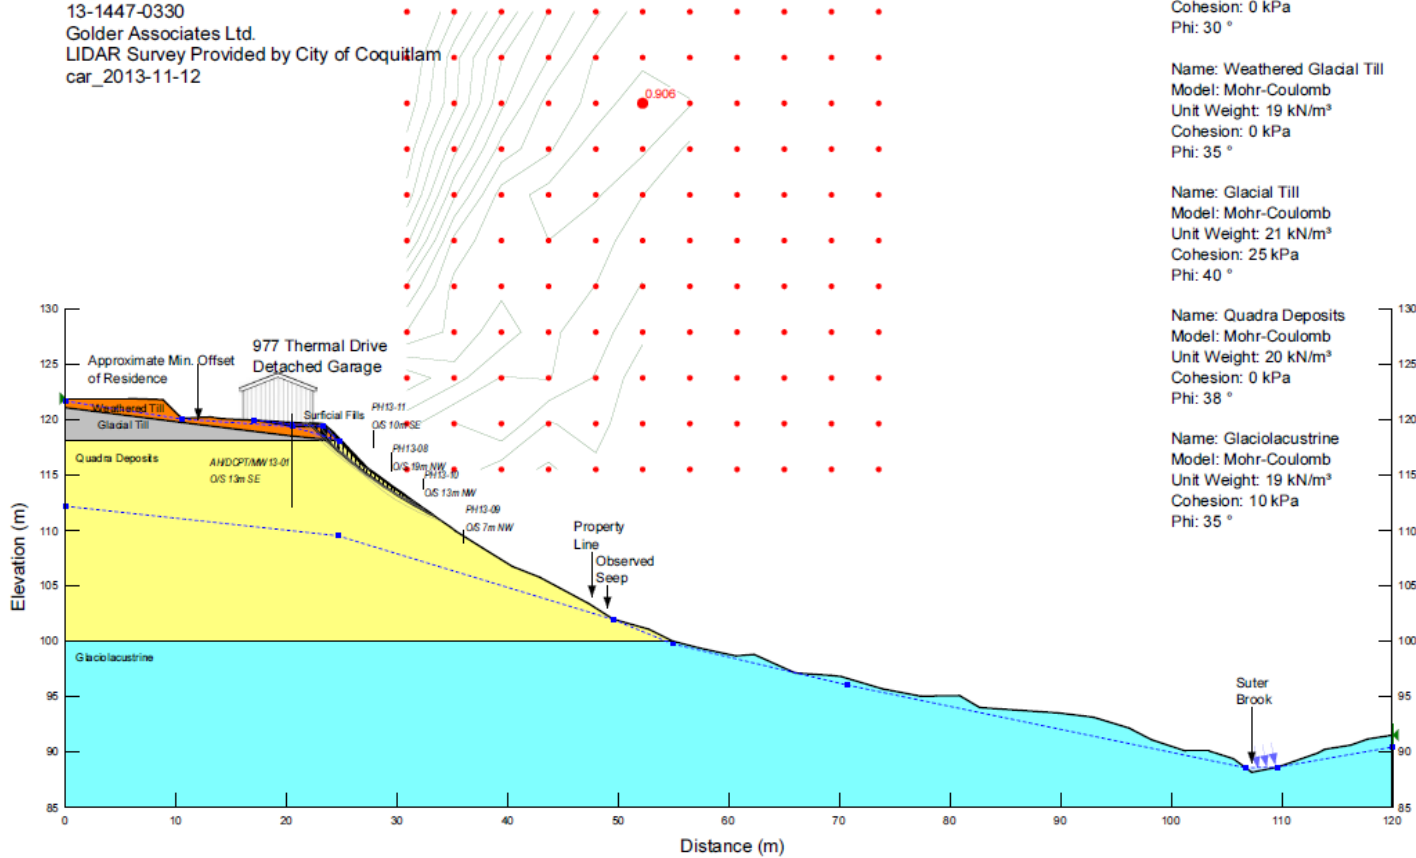
PROJECT No. 13-1447-0330			PHASE No. 3000		
DESIGN	CAR	12NOV13	SCALE	NTS	REV.
CADD					
CHECK	MGB	29NOV13	FIGURE 8B		
REVIEW	RCB	29NOV13

However, minimum factors of safety less than 1.0 were found for shallower failure scarps not extending to the crest residences, but impacting landscaped portions of properties, detached garages, decks, and other non-residential structures near the crest of the slopes (Figure 8B). Consequently, the risk of damage to, or loss of these non-habitable portions of the residential properties is considered high to very high.
