City of Coquitlam
500 Mariner Way
Coquitlam, BC
V3B 7N2

December 13, 2023
File: 23549
R0

**Re: Geotechnical Investigation Report – Miller Park Field Upgrades
900 Oakview Street, Coquitlam, BC**

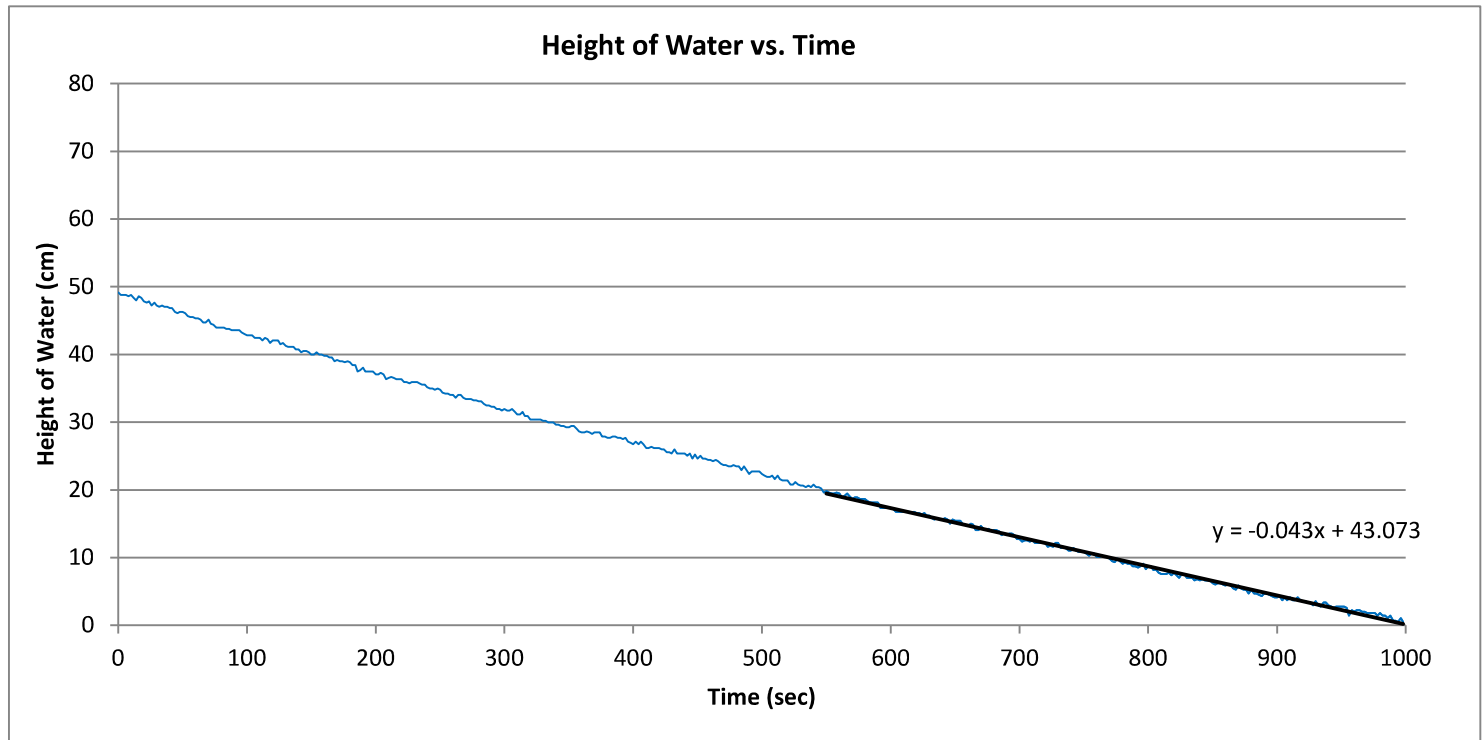
CLIENT:	CITY OF COQUITLAM	PROJECT #:	23549
PROJECT NAME:	MILLER PARK FIELD UPGRADES	DATE:	29-Nov-2023 9:00
PROJECT LOCATION:	900 OAKVIEW STREET, COQUITLAM	TEST NO.:	DRIT23-01

**DOUBLE RING
INFILTRATION TEST
(ASTM D3385)**

ESTIMATED FIELD SATURATED INFILTRATION RATE: 1546.9 mm/Hr

TEST INFORMATION					
LIQUID USED:	WATER	AREA INNER CYLINDER:	72965.63 mm ²	DEPTH OF TEST BELOW CURRENT SITE GRADE (m):	1.2
LIQUID pH:	7.1	ANNULAR AREA:	209777.71 mm ²		
SOIL DESCRIPTION:	SAND	CYLINDER ACCURACY:	± 0.5 mm	INFILTRATION RATE (cm/sec):	4.297E-02
SOIL TYPE:	NATIVE	LIQUID DEPTH INNER:	49.2 cm		
WEATHER ON SITE:	CLEAR	LIQUID DEPTH OUTER:	N/A	DEPTH TO WATER TABLE:	UNKNOWN

Infiltration rate of 1546.9 mm/hr at 1.2 m.

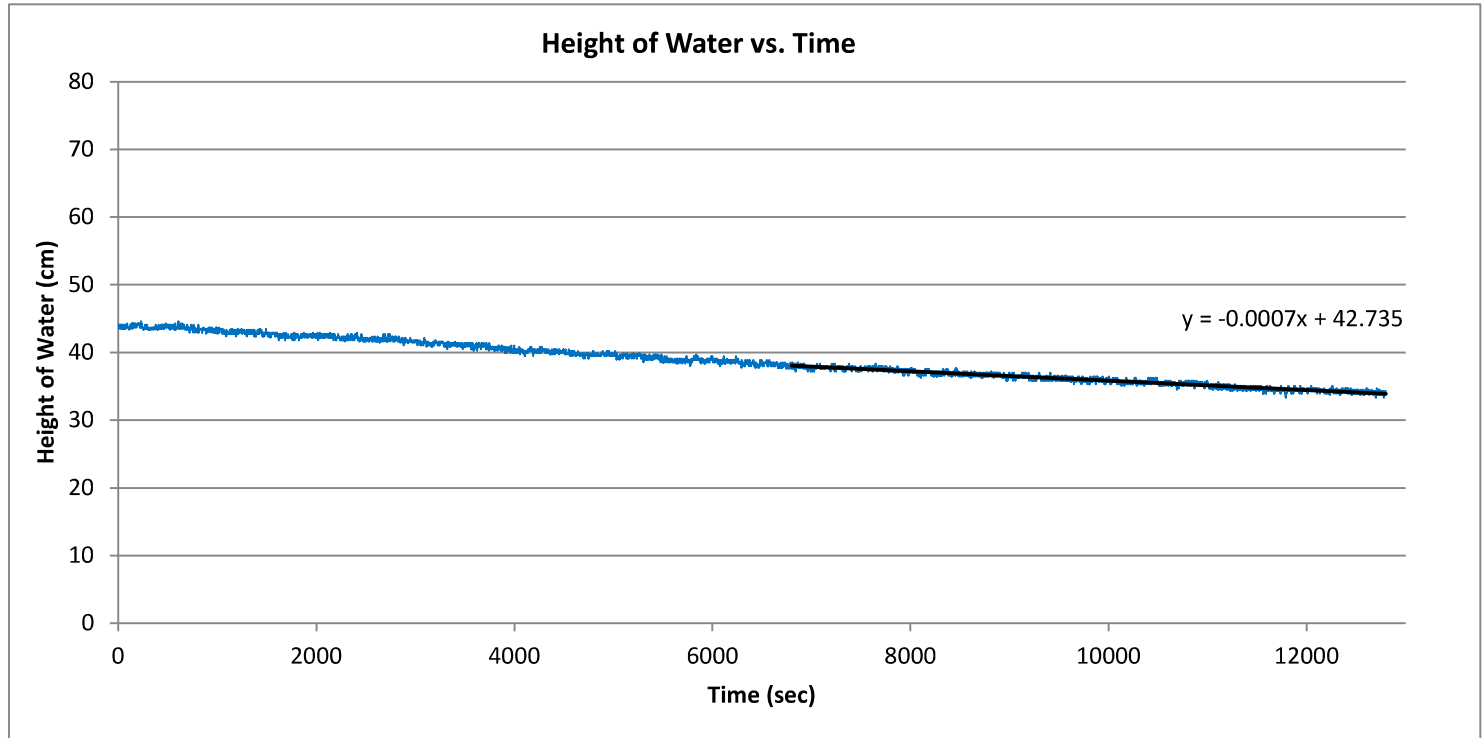
CLIENT:	CITY OF COQUITLAM	PROJECT #:	23549
PROJECT NAME:	MILLER PARK FIELD UPGRADES	DATE:	29-Nov-2023 9:15
PROJECT LOCATION:	900 OAKVIEW STREET, COQUITLAM	TEST NO.:	DRIT23-02

**DOUBLE RING
INFILTRATION TEST
(ASTM D3385)**

ESTIMATED FIELD SATURATED INFILTRATION RATE: 24.9 mm/Hr

TEST INFORMATION					
LIQUID USED:	WATER	AREA INNER CYLINDER:	72965.63 mm ²	DEPTH OF TEST BELOW CURRENT SITE GRADE (m):	1.5
LIQUID pH:	7.1	ANNULAR AREA:	209777.71 mm ²		
SOIL DESCRIPTION:	SILT, TRACE SAND	CYLINDER ACCURACY:	± 0.5 mm	INFILTRATION RATE (cm/sec):	6.912E-04
SOIL TYPE:	NATIVE	LIQUID DEPTH INNER:	44.7 cm		
WEATHER ON SITE:	CLEAR	LIQUID DEPTH OUTER:	N/A	DEPTH TO WATER TABLE:	UNKNOWN

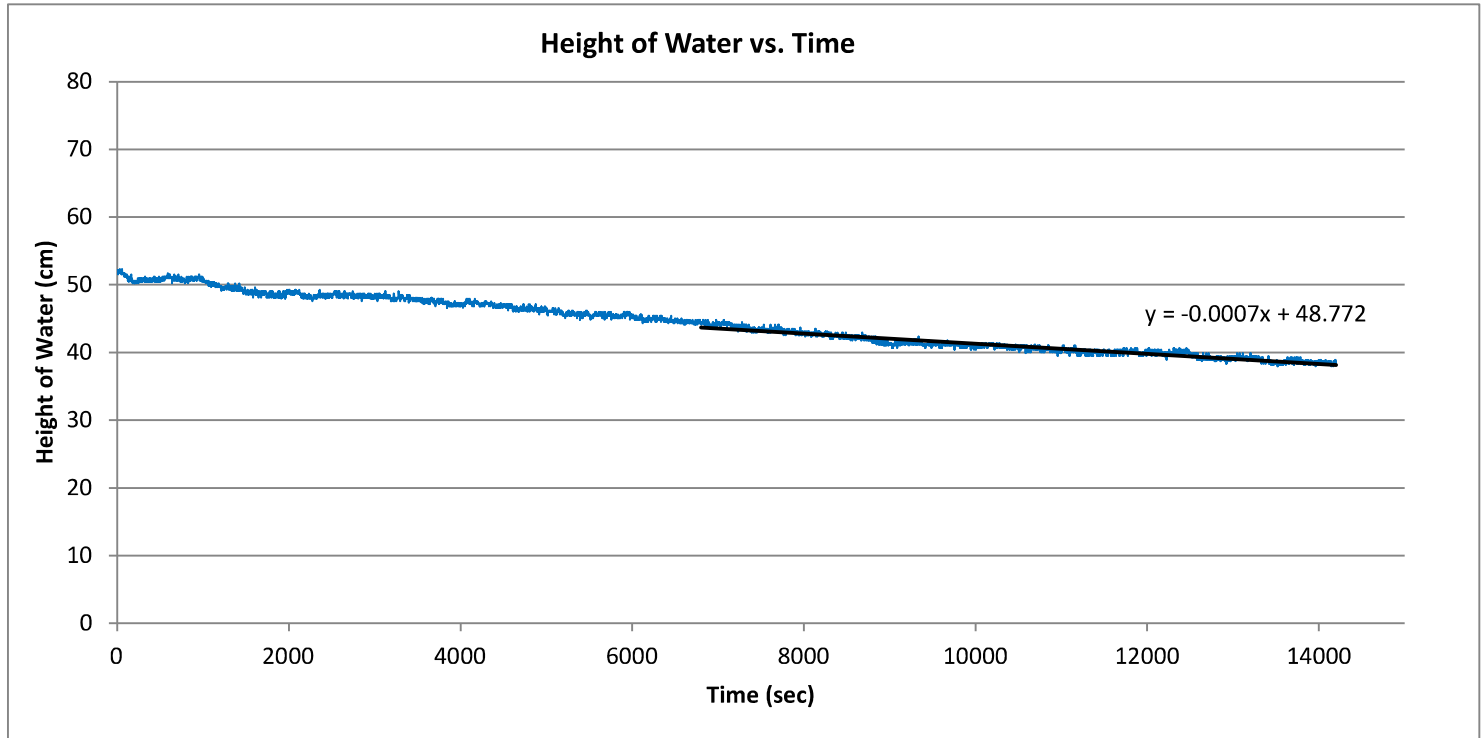
CLIENT:	CITY OF COQUITLAM	PROJECT #:	23549
PROJECT NAME:	MILLER PARK FIELD UPGRADES	DATE:	29-Nov-2023 9:30
PROJECT LOCATION:	900 OAKVIEW STREET, COQUITLAM	TEST NO.:	DRIT23-03

DOUBLE RING
INFILTRATION TEST
(ASTM D3385)

ESTIMATED FIELD SATURATED INFILTRATION RATE: 27.0 mm/Hr

TEST INFORMATION					
LIQUID USED:	WATER	AREA INNER CYLINDER:	72965.63 mm ²	DEPTH OF TEST BELOW CURRENT SITE GRADE (m):	1.2
LIQUID pH:	7.1	ANNULAR AREA:	209777.71 mm ²		
SOIL DESCRIPTION:	SILT, TRACE SAND	CYLINDER ACCURACY:	± 0.5 mm	INFILTRATION RATE (cm/sec):	7.490E-04
SOIL TYPE:	NATIVE	LIQUID DEPTH INNER:	52.3 cm		
WEATHER ON SITE:	CLEAR	LIQUID DEPTH OUTER:	N/A	DEPTH TO WATER TABLE:	UNKNOWN
