HERITAGE INVENTORY | Maillardville

Originally developed in 1986 by Foundation Group Design Ltd.

Revised in 2007 by City of Coquitlam Community Planning Division

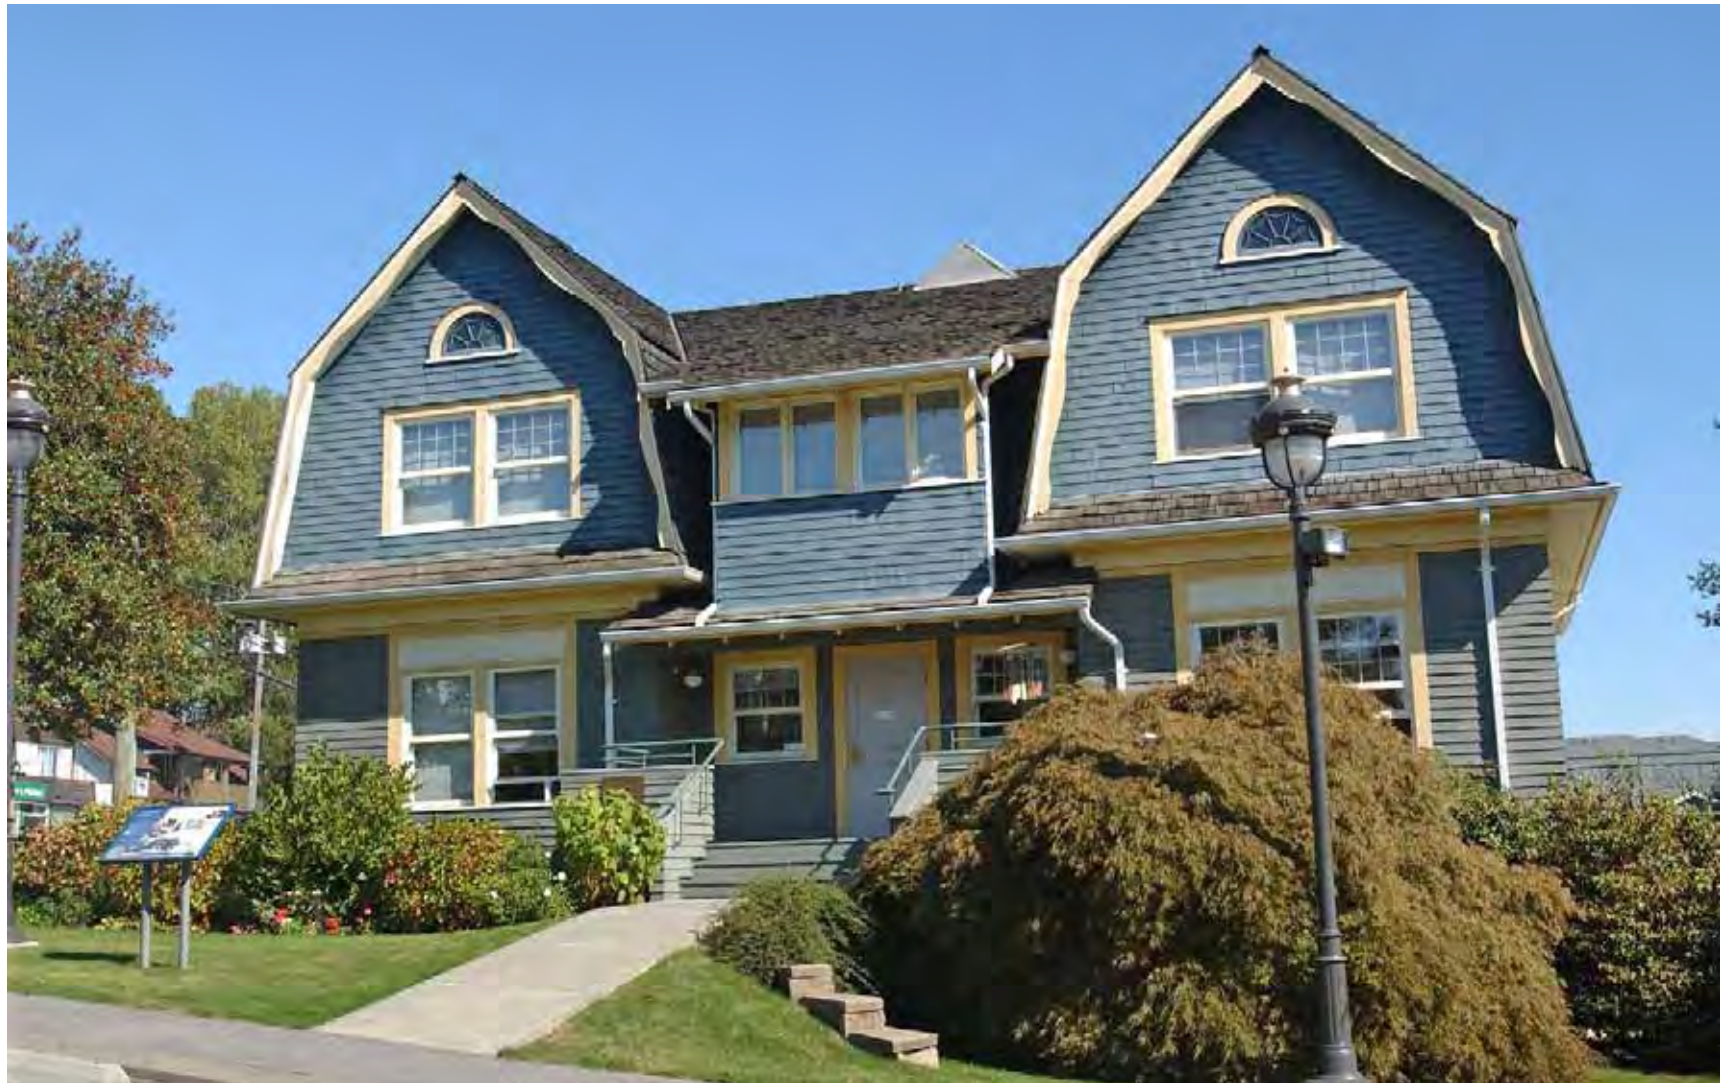
1120 BRUNETTE AVENUE

Design Description: Symmetrical massing, with unique roof configuration. Unusual carved verge-boards. Entry porch completely altered. Garage, faced with drop siding, at side rear, oriented to Brunette Avenue.

Condition: Deterioration evident in gutters and wood surfaces; requires repair and maintenance. Entry has been completely altered with the construction of an unsympathetic addition. The character of the building has been compromised by the alterations and additions. New steps at front, and fire escapes at side. New addition at rear, with concrete block foundation. New structure joined at south side.

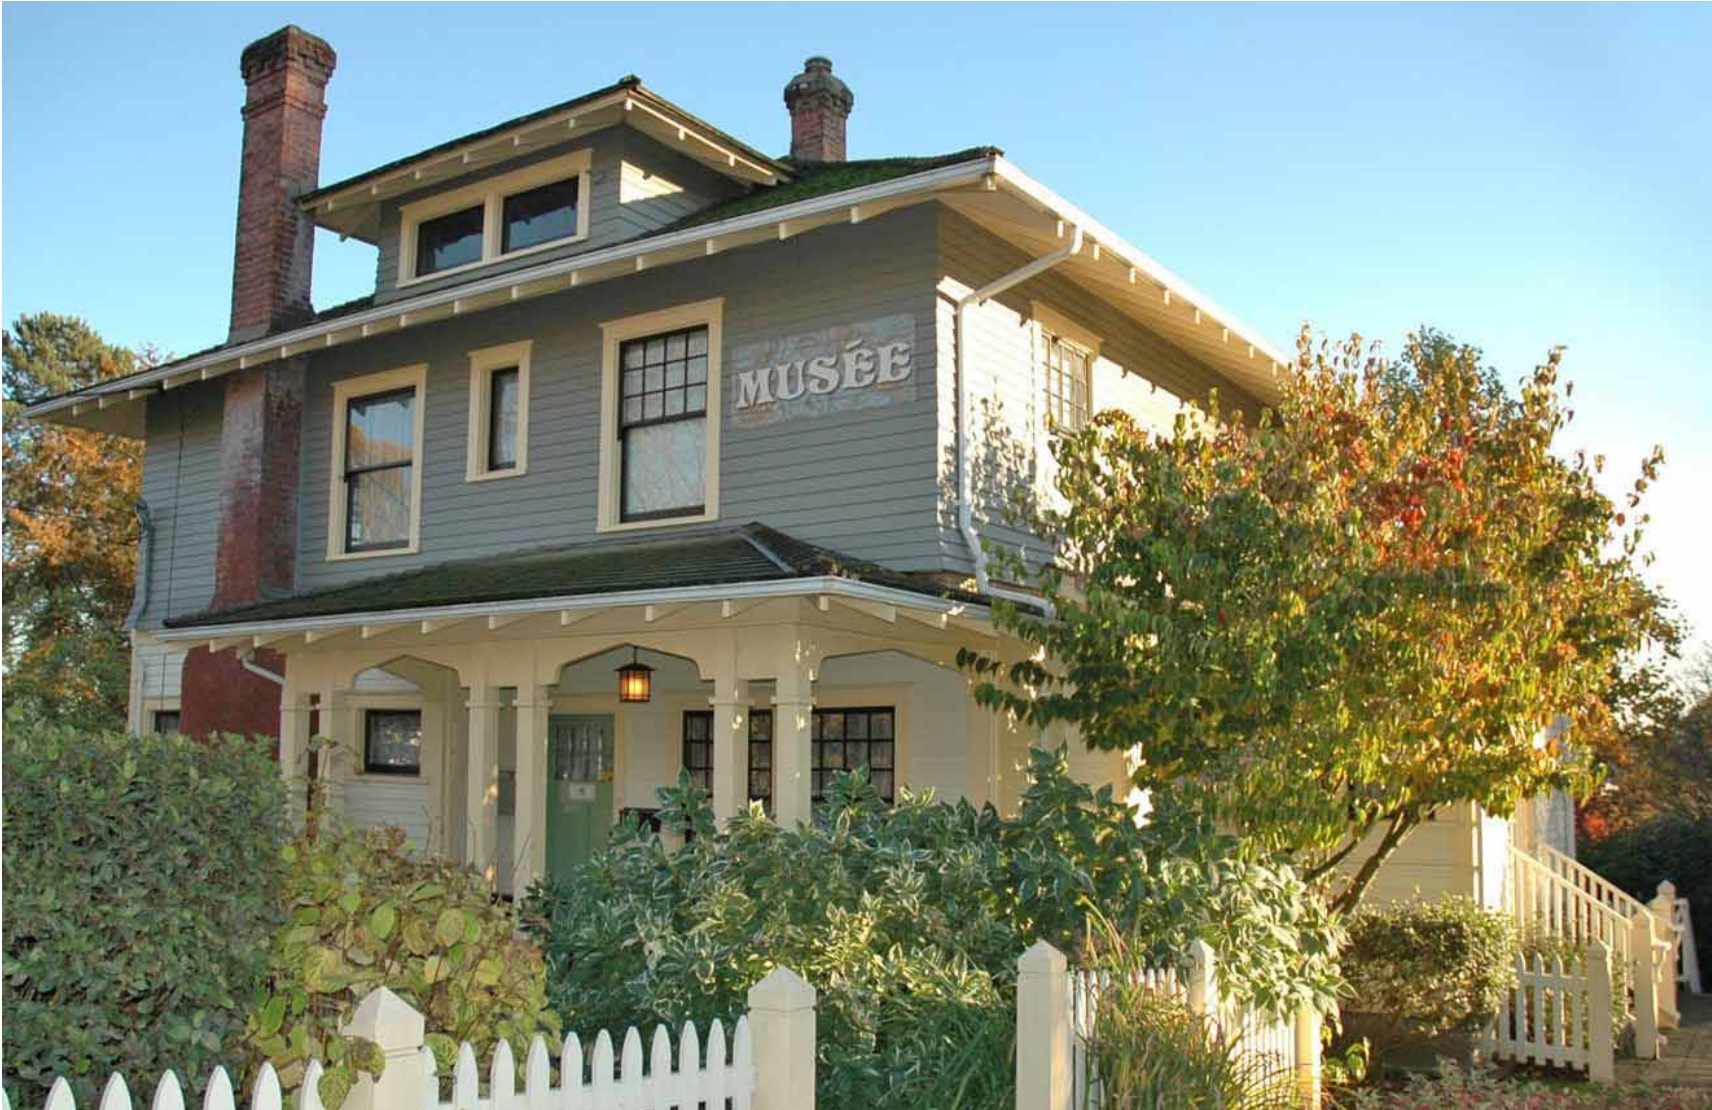
1120 BRUNETTE AVENUE

Condition: Well maintained; in good repair. Some chimney bricks have spalled, and mortar appears to be in poor condition. The entire southern part of the house is a later addition.

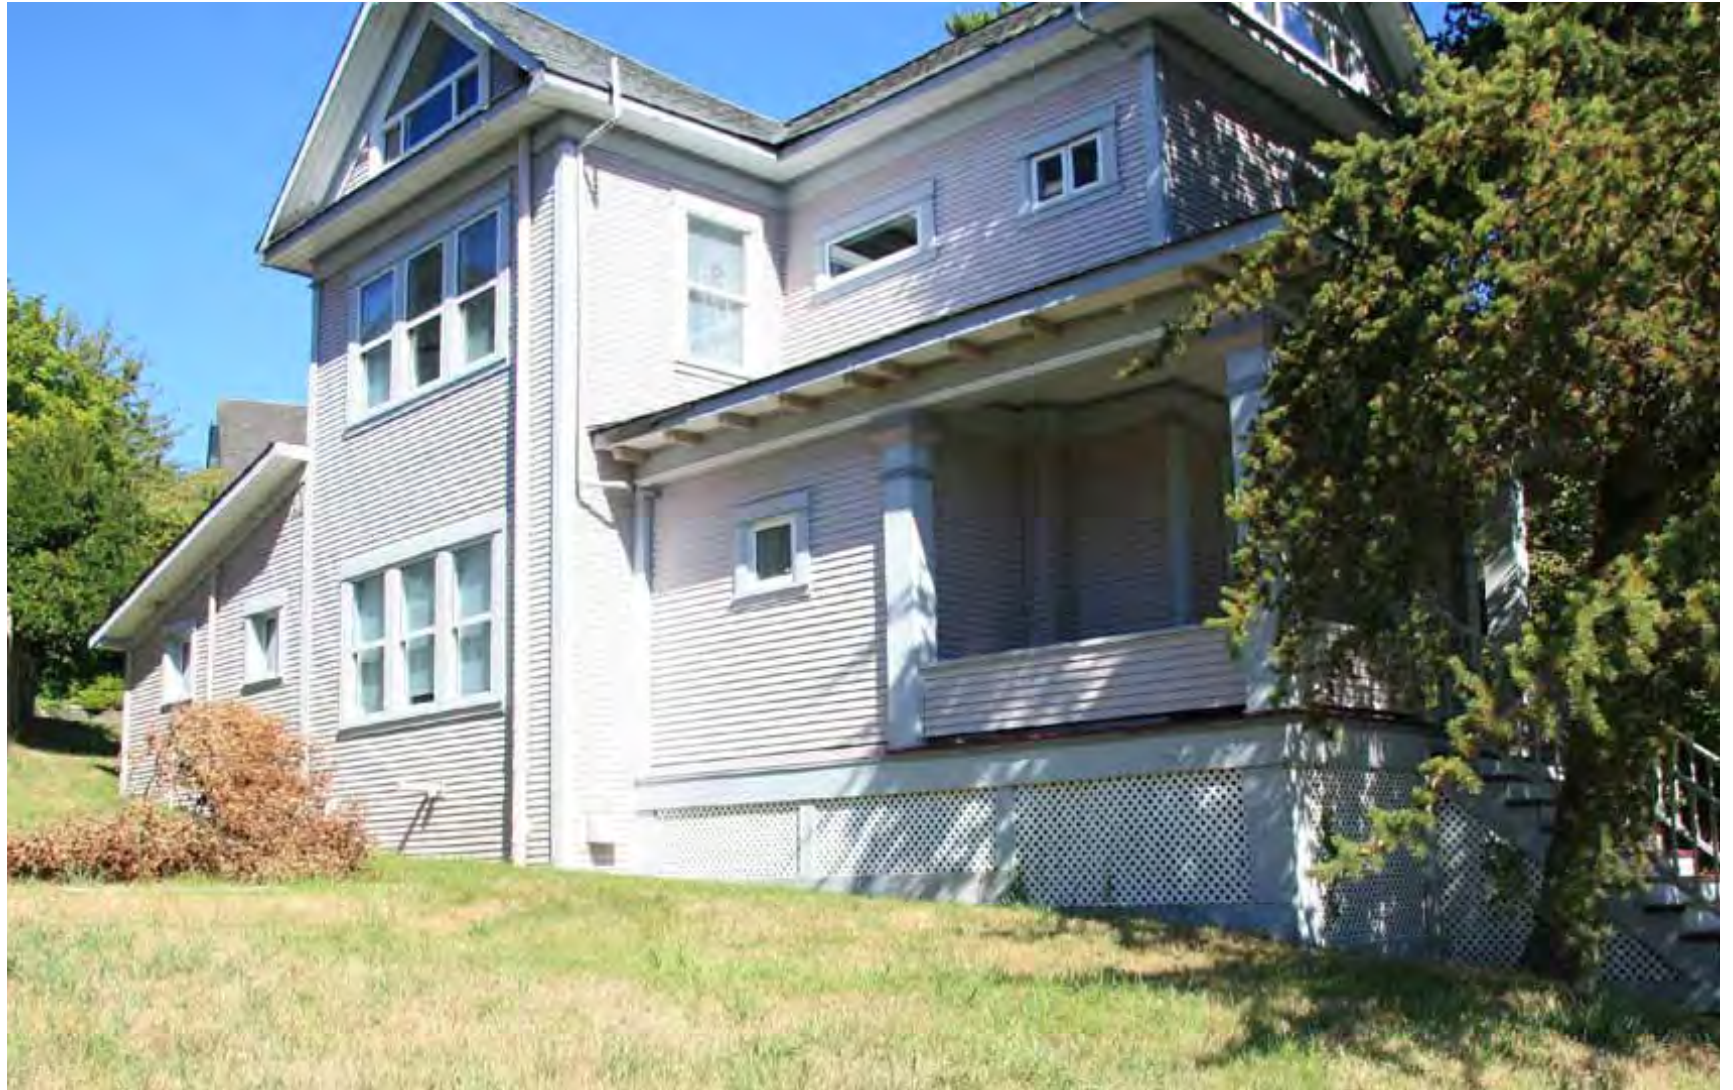
1319 BRUNETTE AVENUE

Condition: In very good repair; recently refurbished. Slight
alterations to front steps. One storey addition at rear,
with shed roof. Inappropriate shutters have been
added.

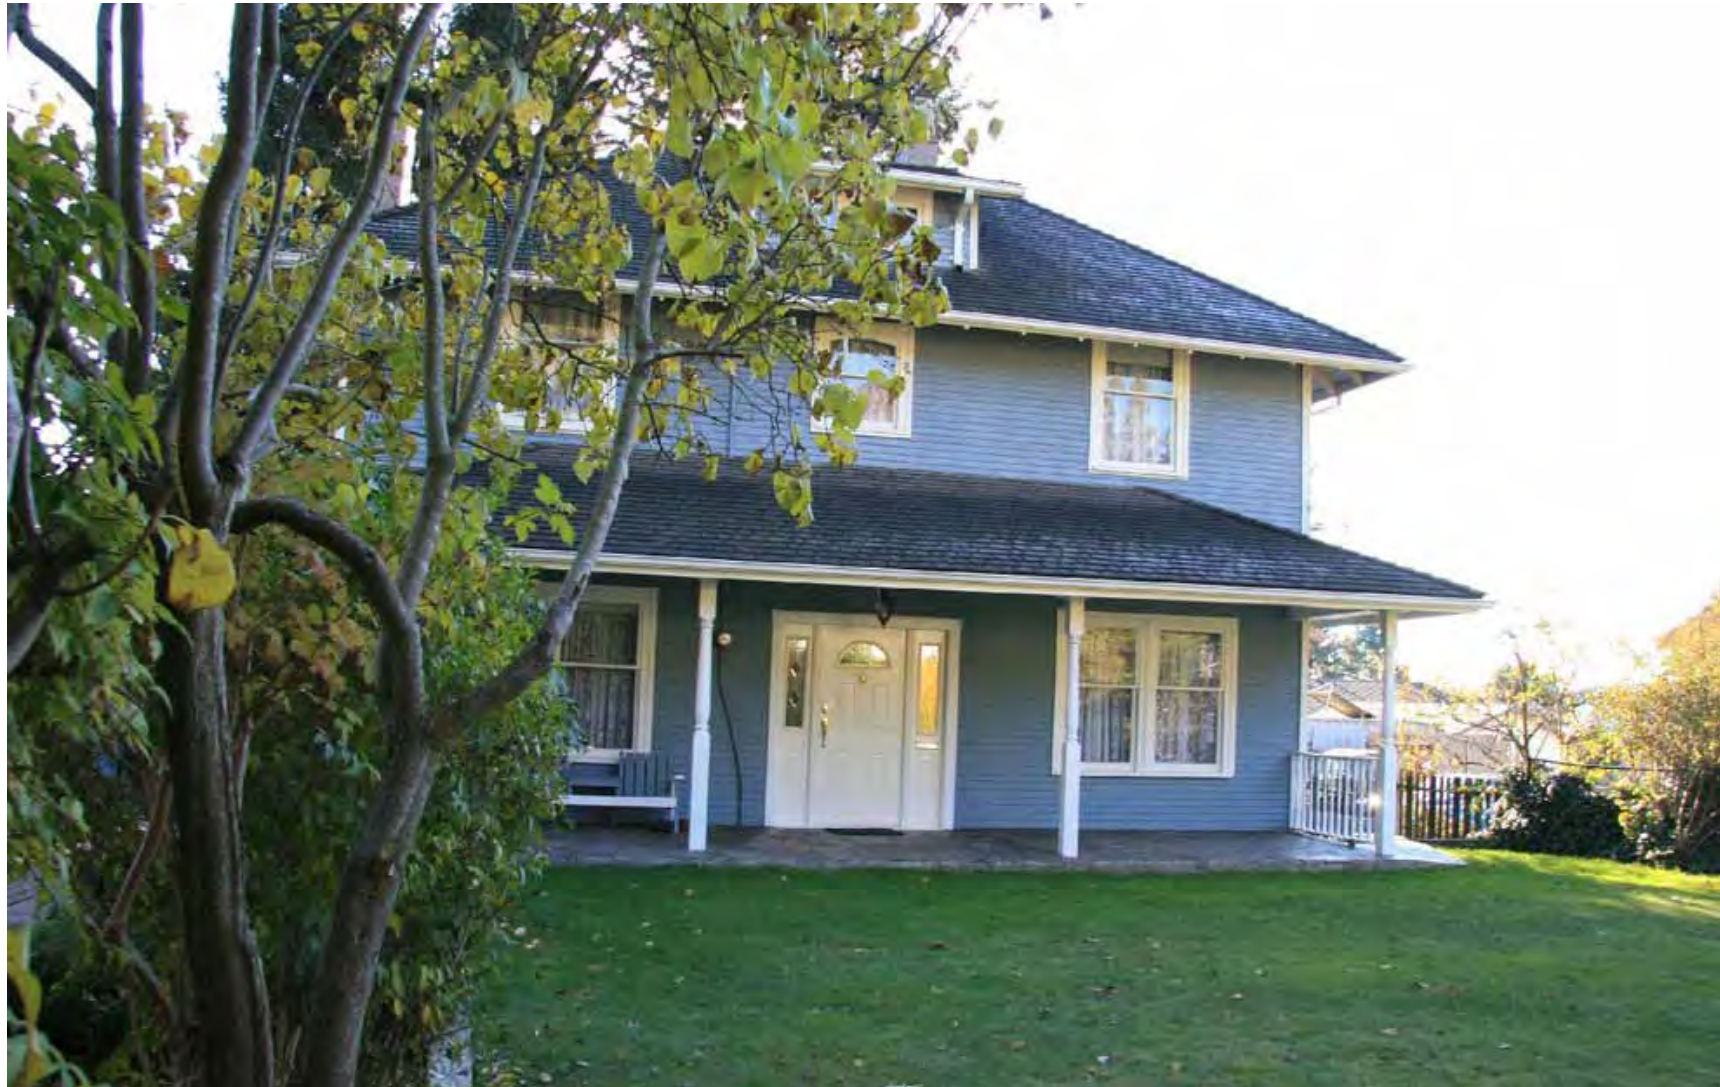
1746 BRUNETTE AVENUE

Condition: In good repair; condition of original siding unknown due to later coverings. Front porch posts and railings altered, and lattice work added.

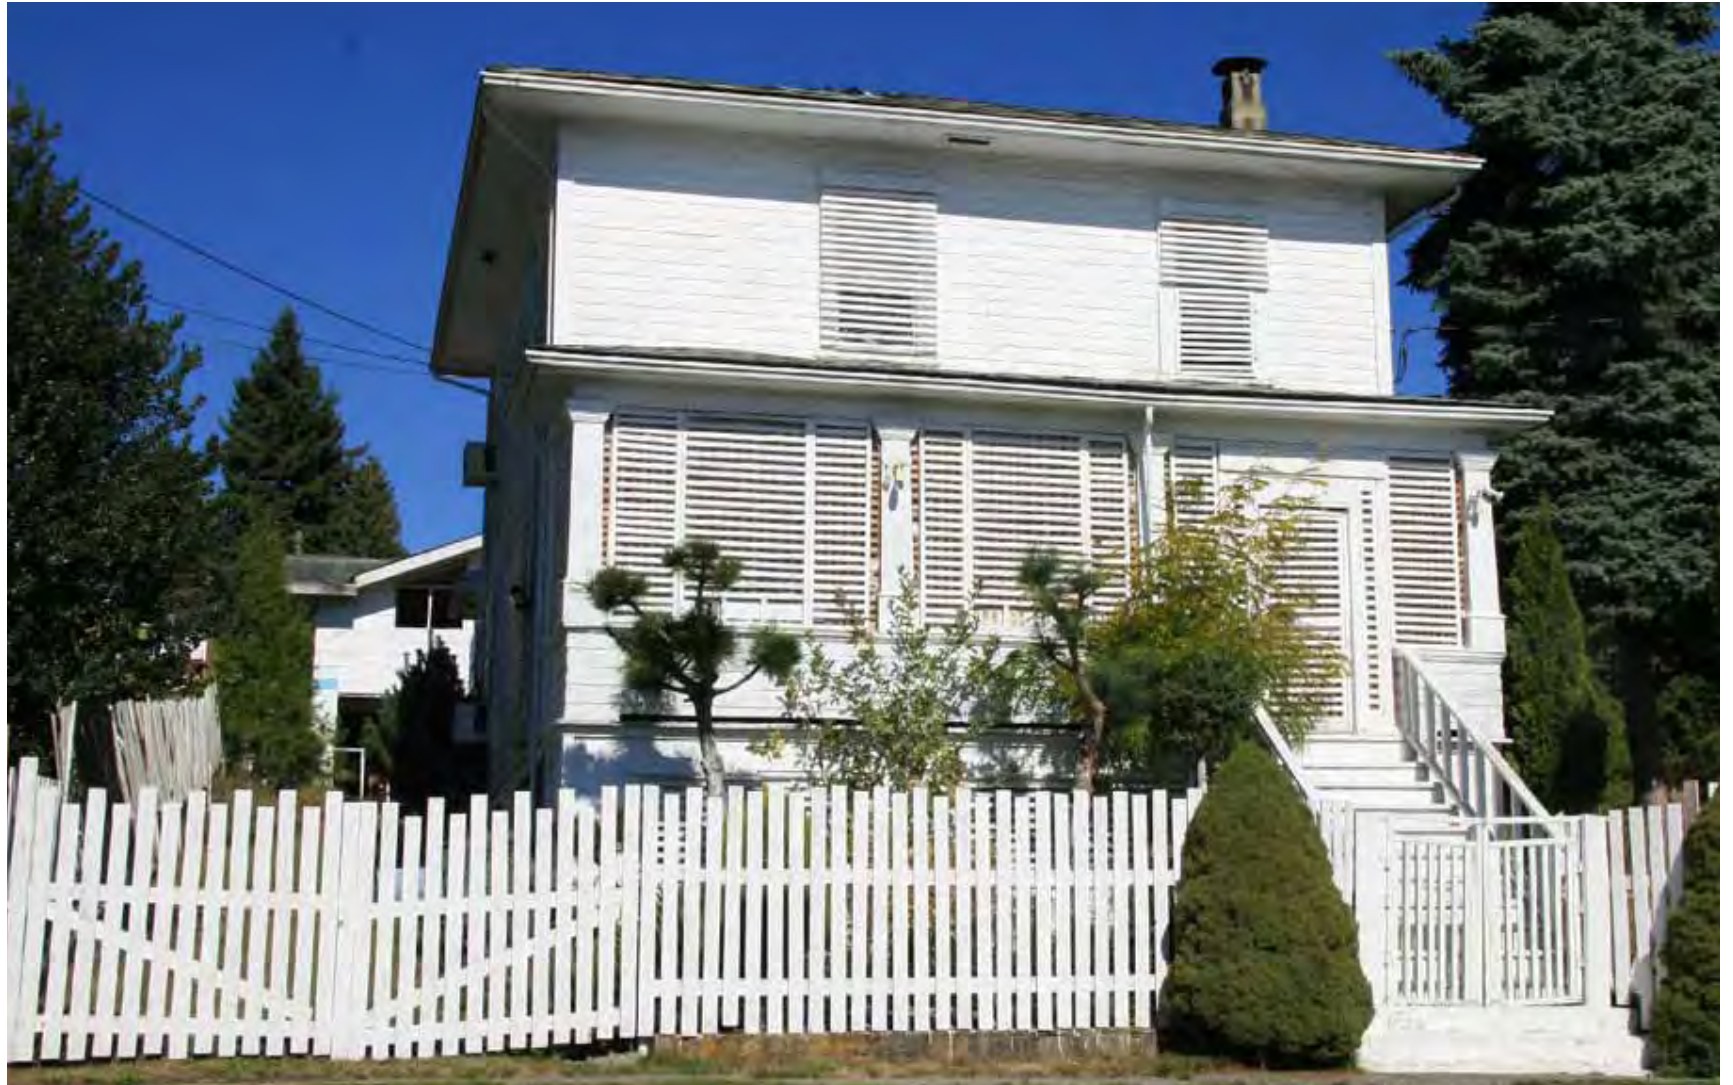
1313 CARTIER AVENUE

Condition: In very good repair; well maintained. Requires some minor repairs and maintenance. Front steps and skirting altered.

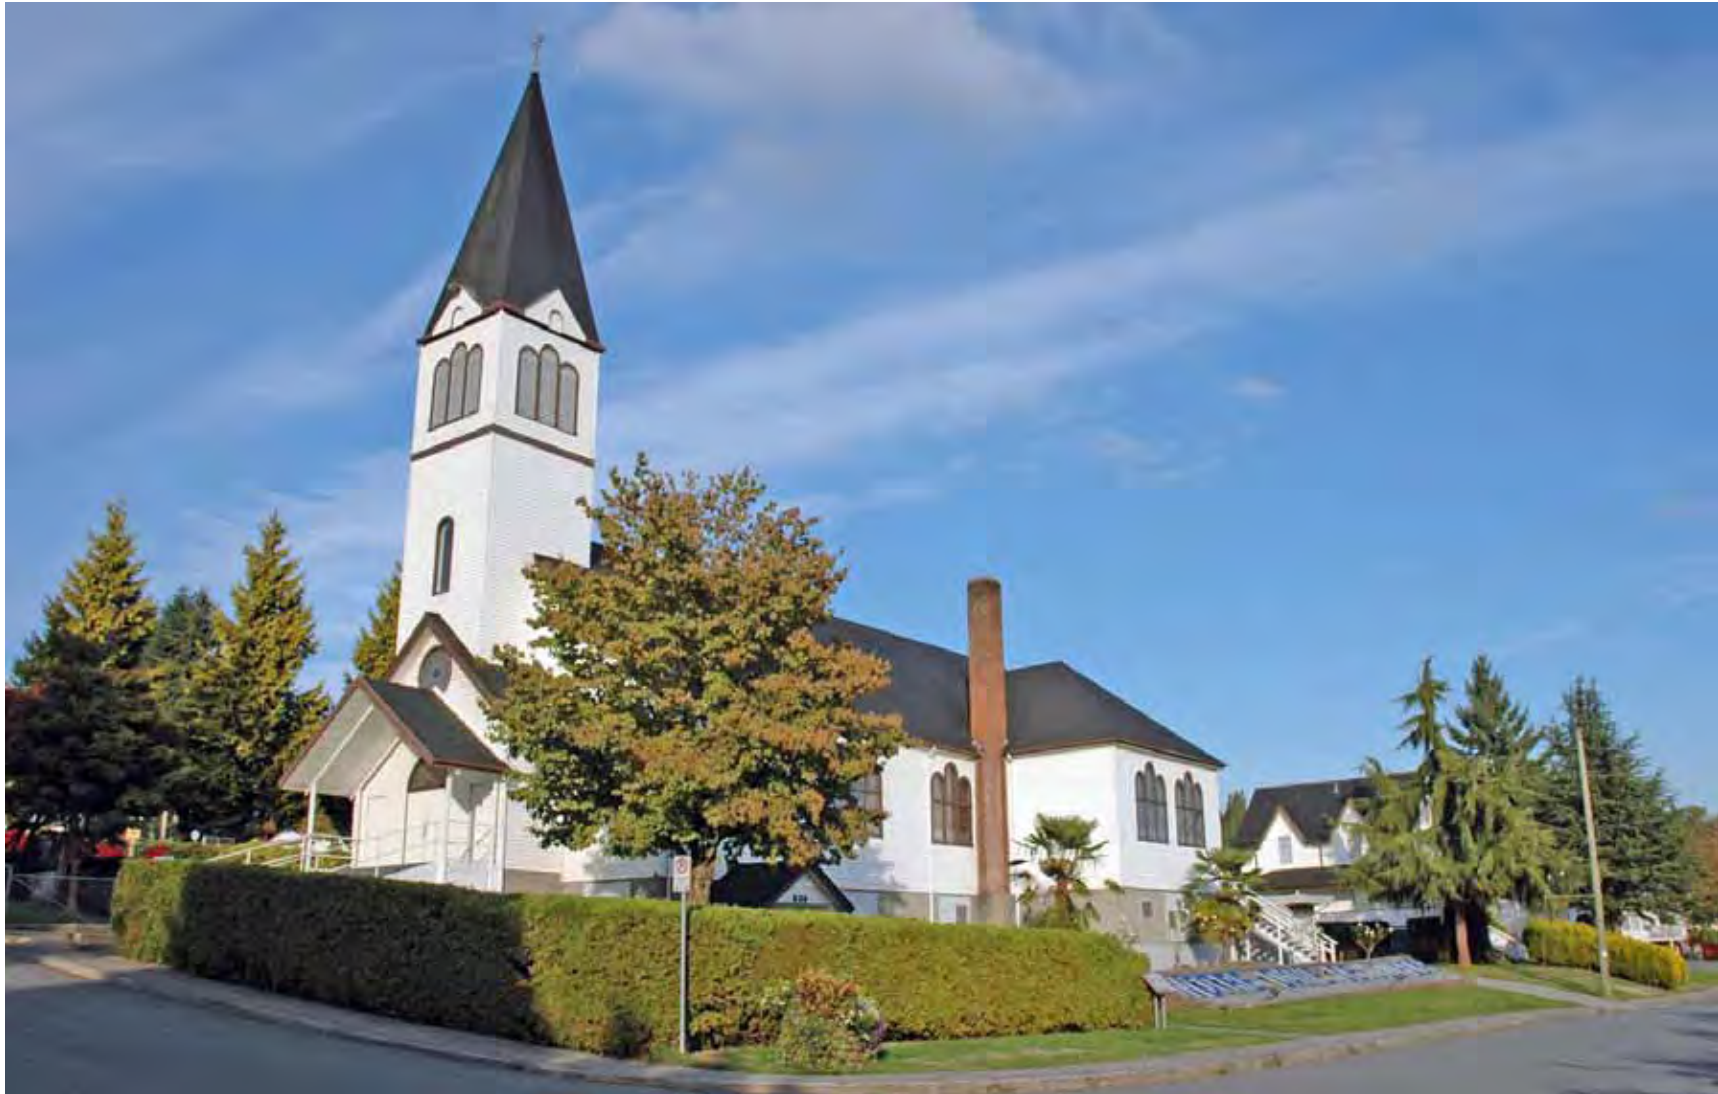
830 LAVAL SQUARE

Design Description: Cross-axial plan, with flat-roofed tower at front. Tower has statue niche, and triple-arched louvre vents. 1910 inscribed in concrete at front foundation. Church faces west.

Condition: Generally in good repair; requires some paint and maintenance. Some deterioration on wood surfaces; some paint scaling. Front doors, steps and railings altered. Basement windows boarded up. New entry porches at north, south and west sides.

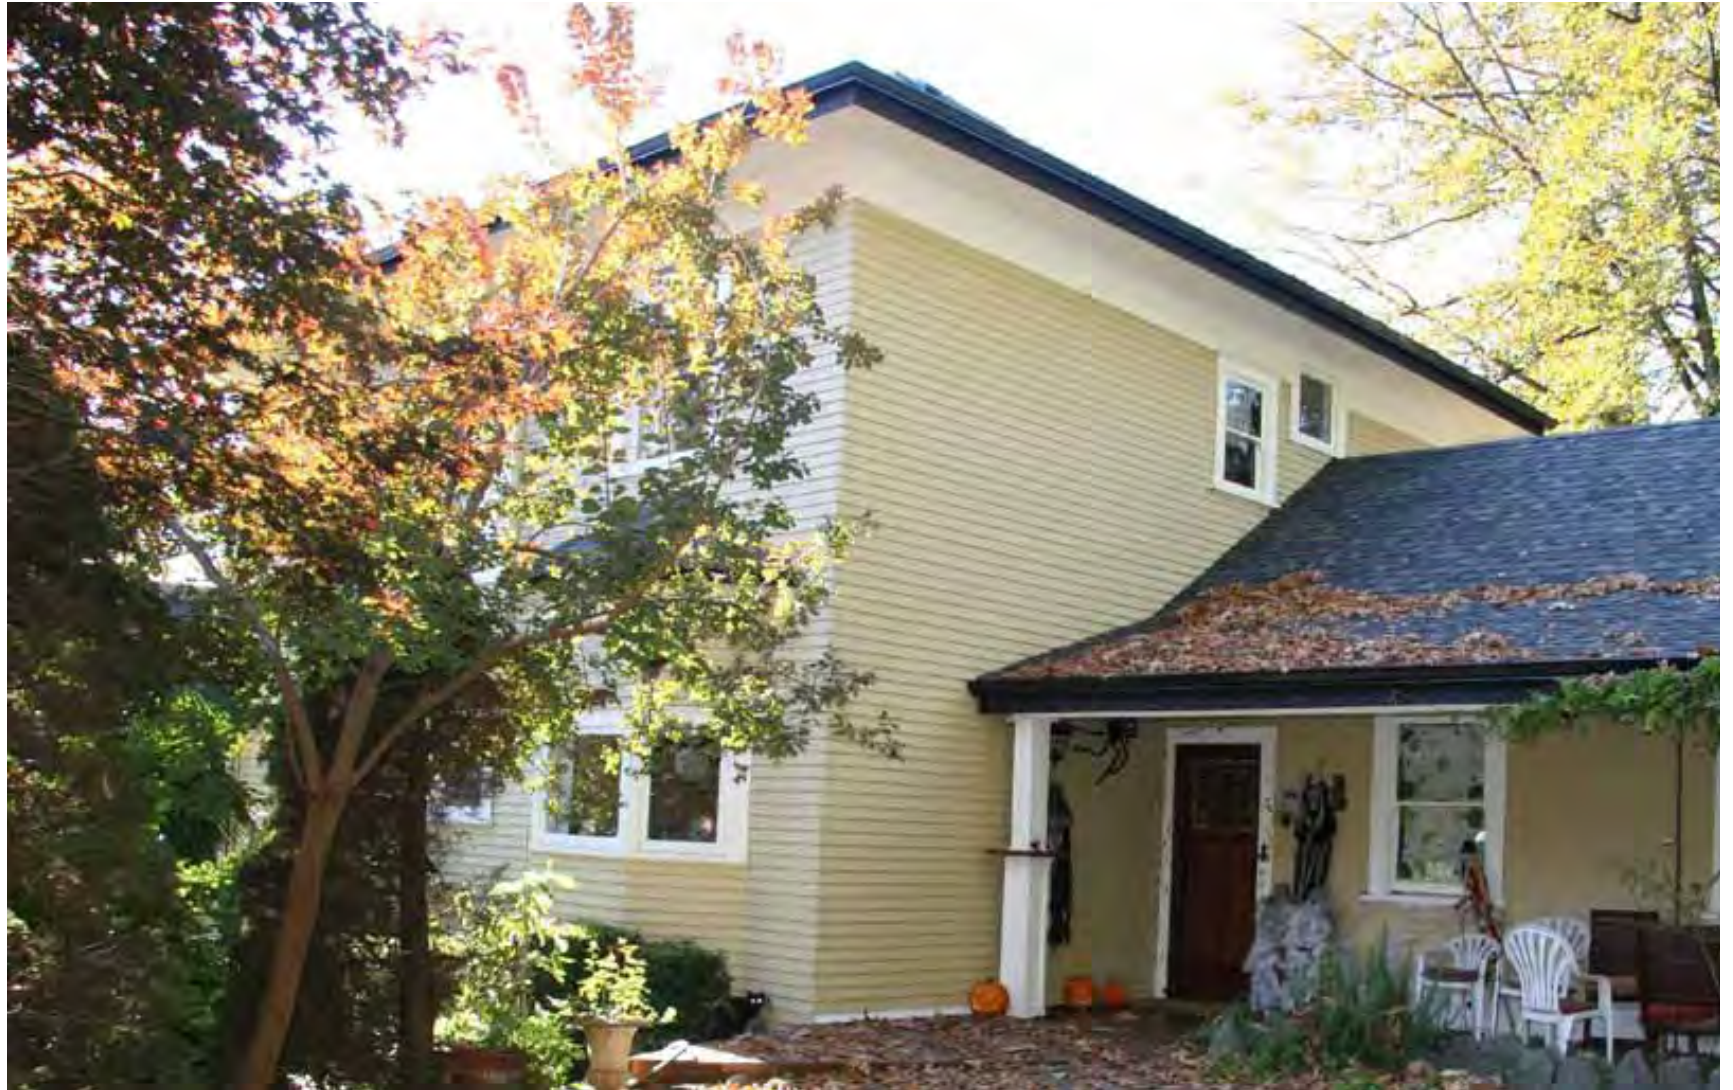
310 MARATHON COURT

Design Description: Tall house, square in plan; sits on prominent rise of land. Hipped roof over porch. Almost all of the house is in original condition.

Condition: In very good repair.; no major deterioration evident. Large deck and carport added at rear.

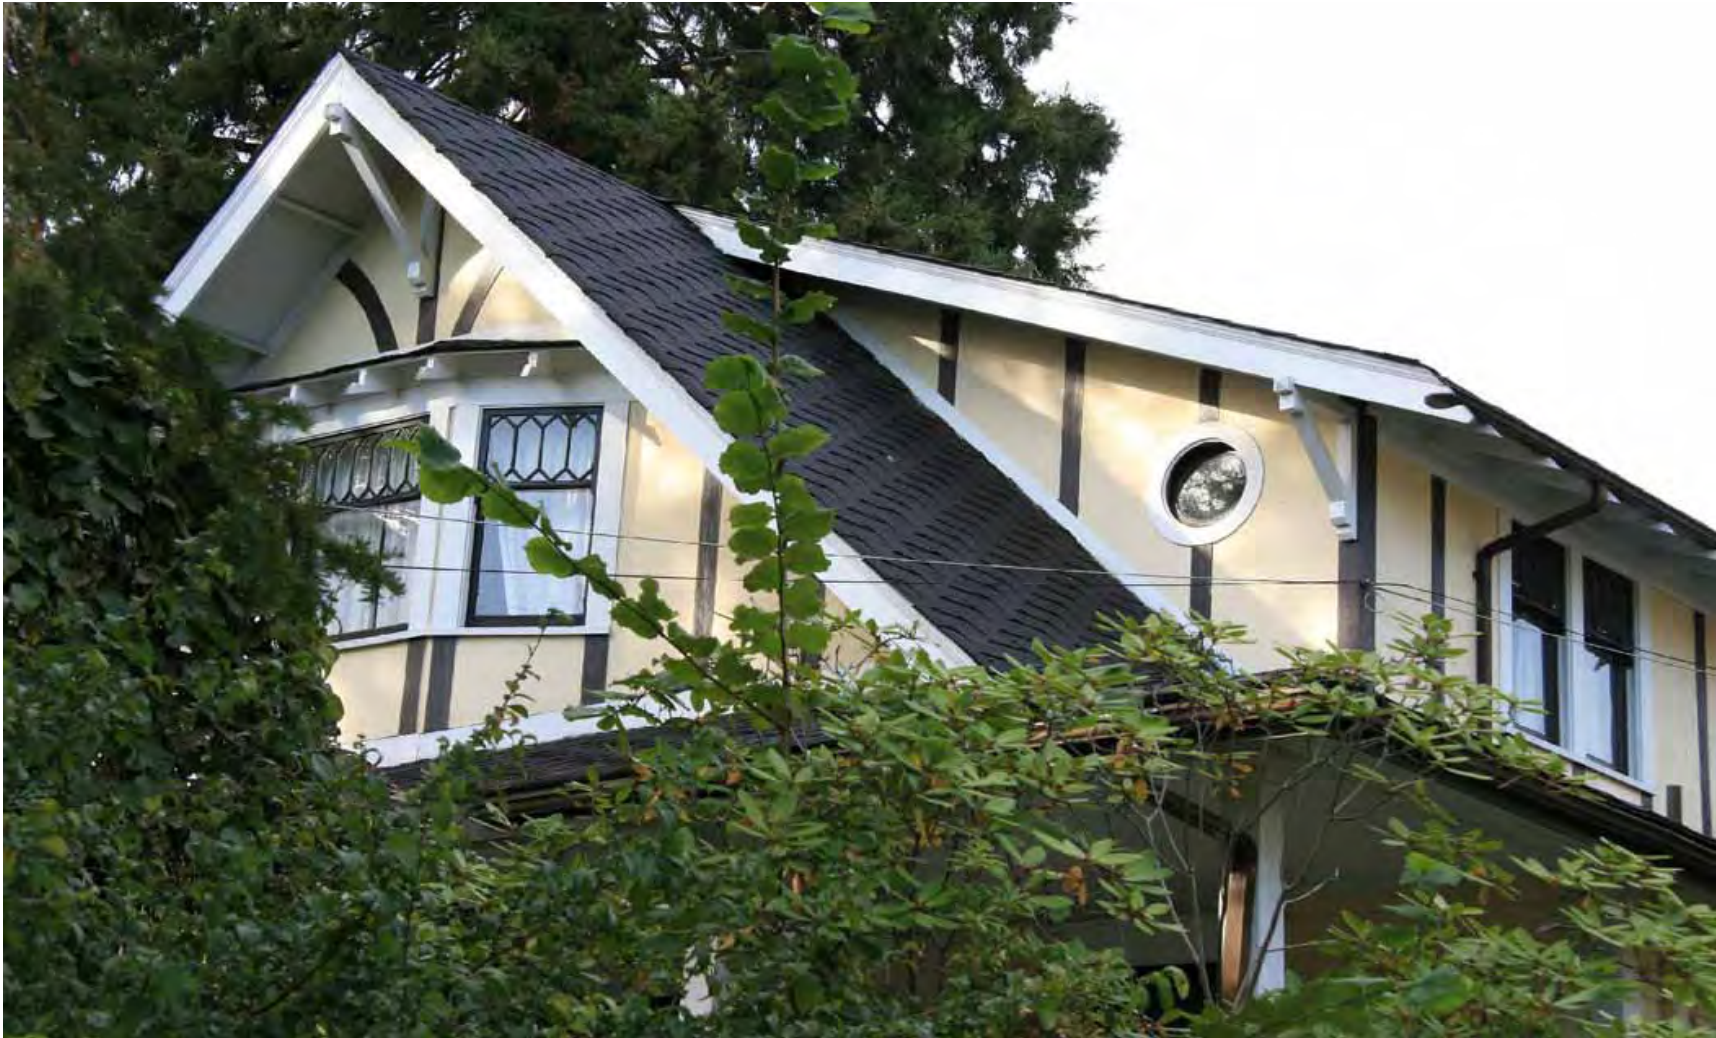
609 ROCHESTER AVENUE

Condition: Well maintained; in good repair. Minor alterations only.

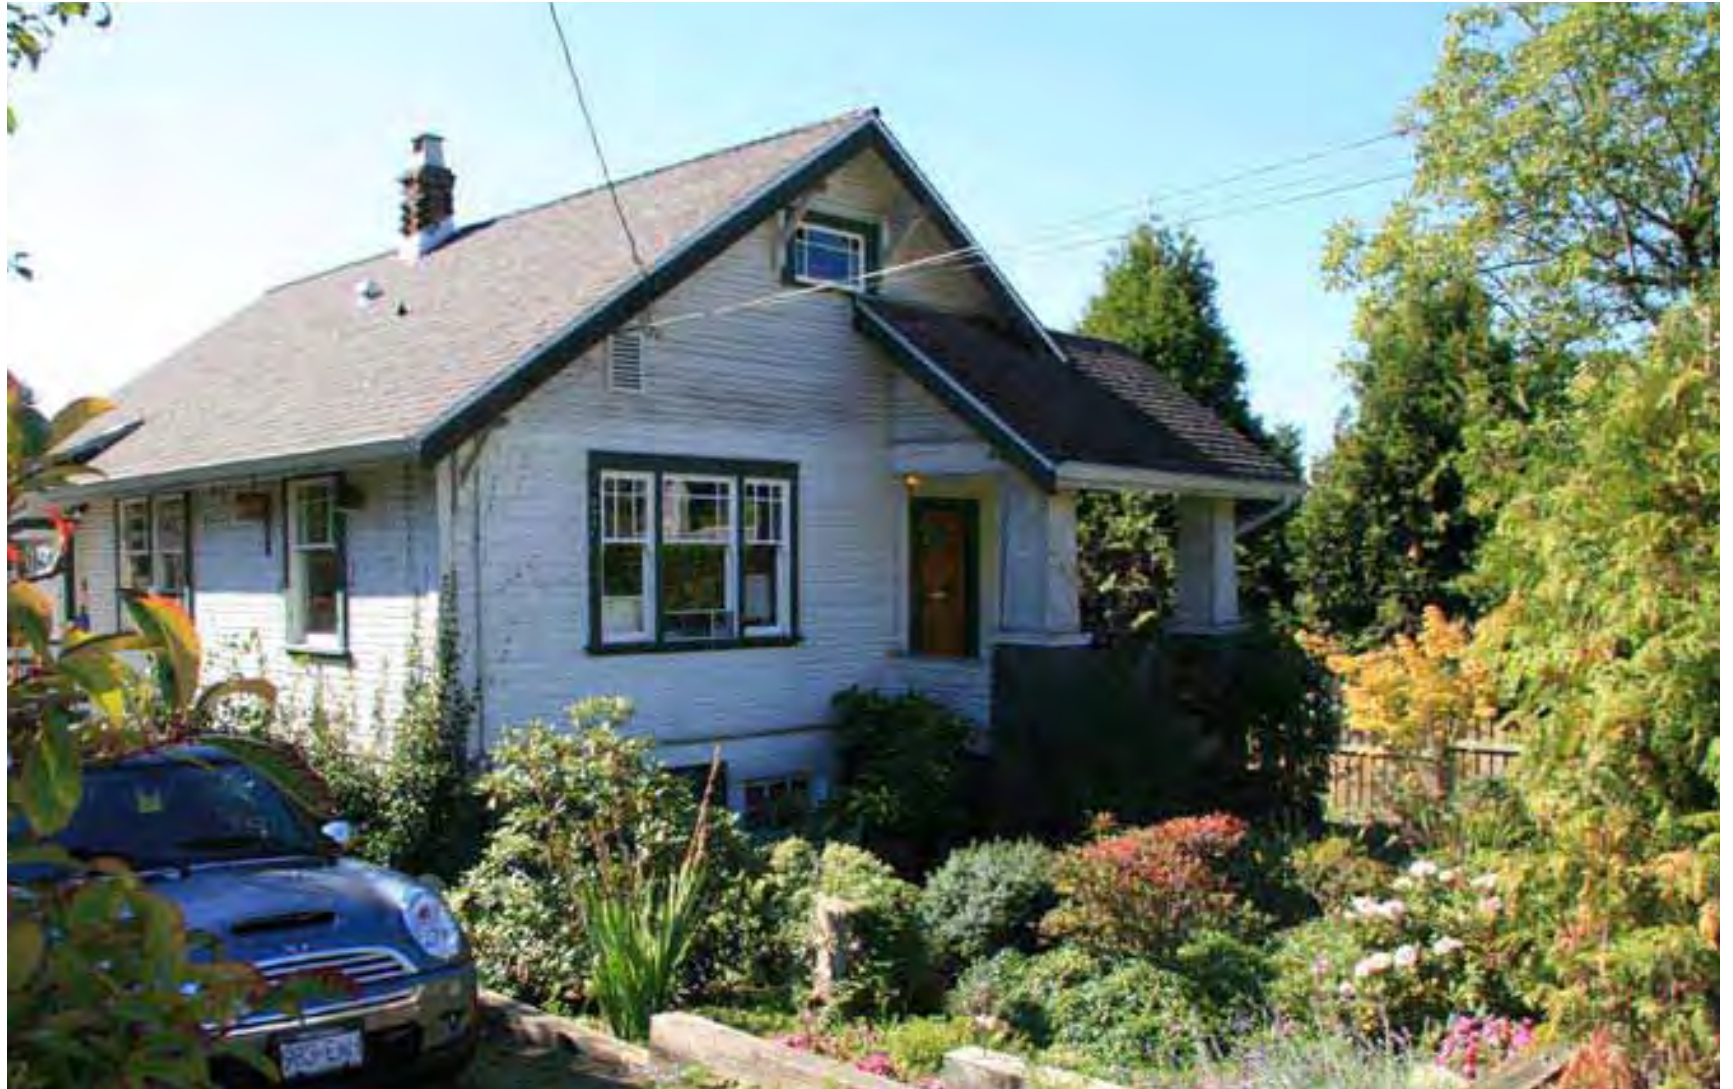
746 ALDERSON AVENUE

Condition: Some deterioration evident on verge-boards and other wooden surfaces. No settling evident. Minor alterations only.

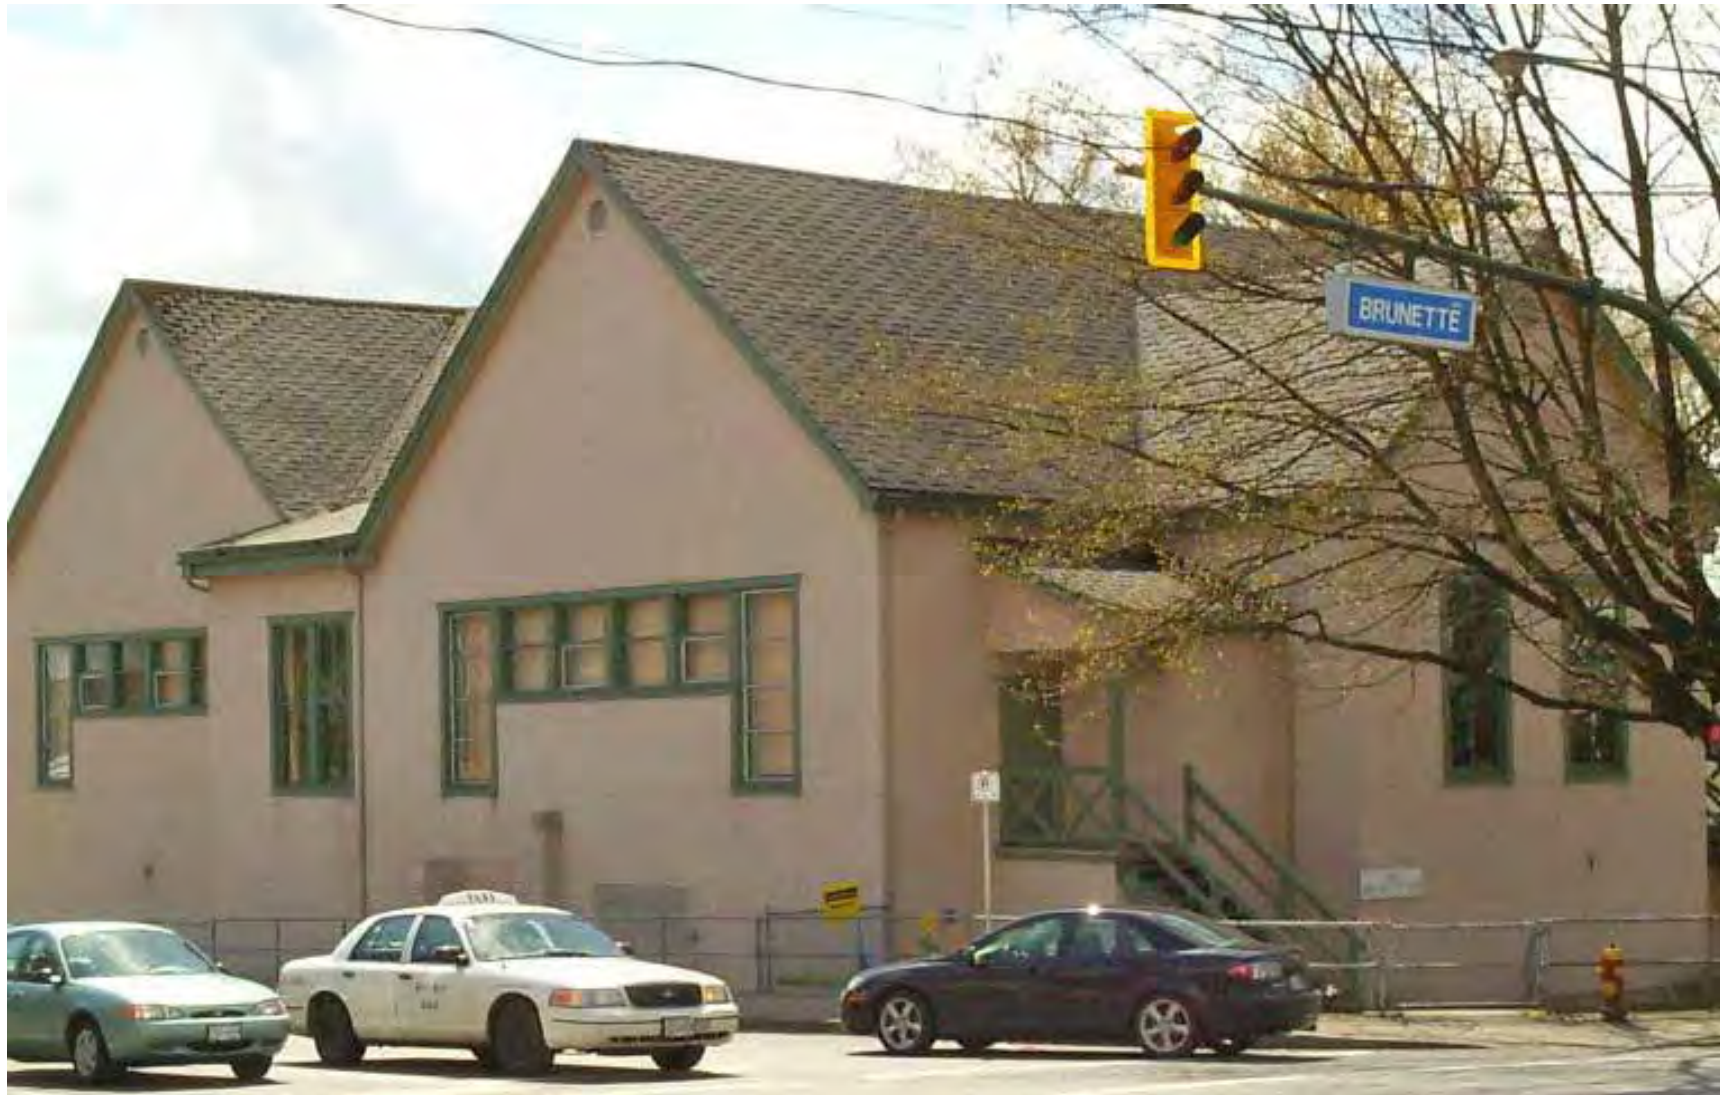
1432 BRUNETTE AVENUE

Condition: Difficult to ascertain due to later sidings; no apparent settling or major deterioration. Chimney in need of repair.

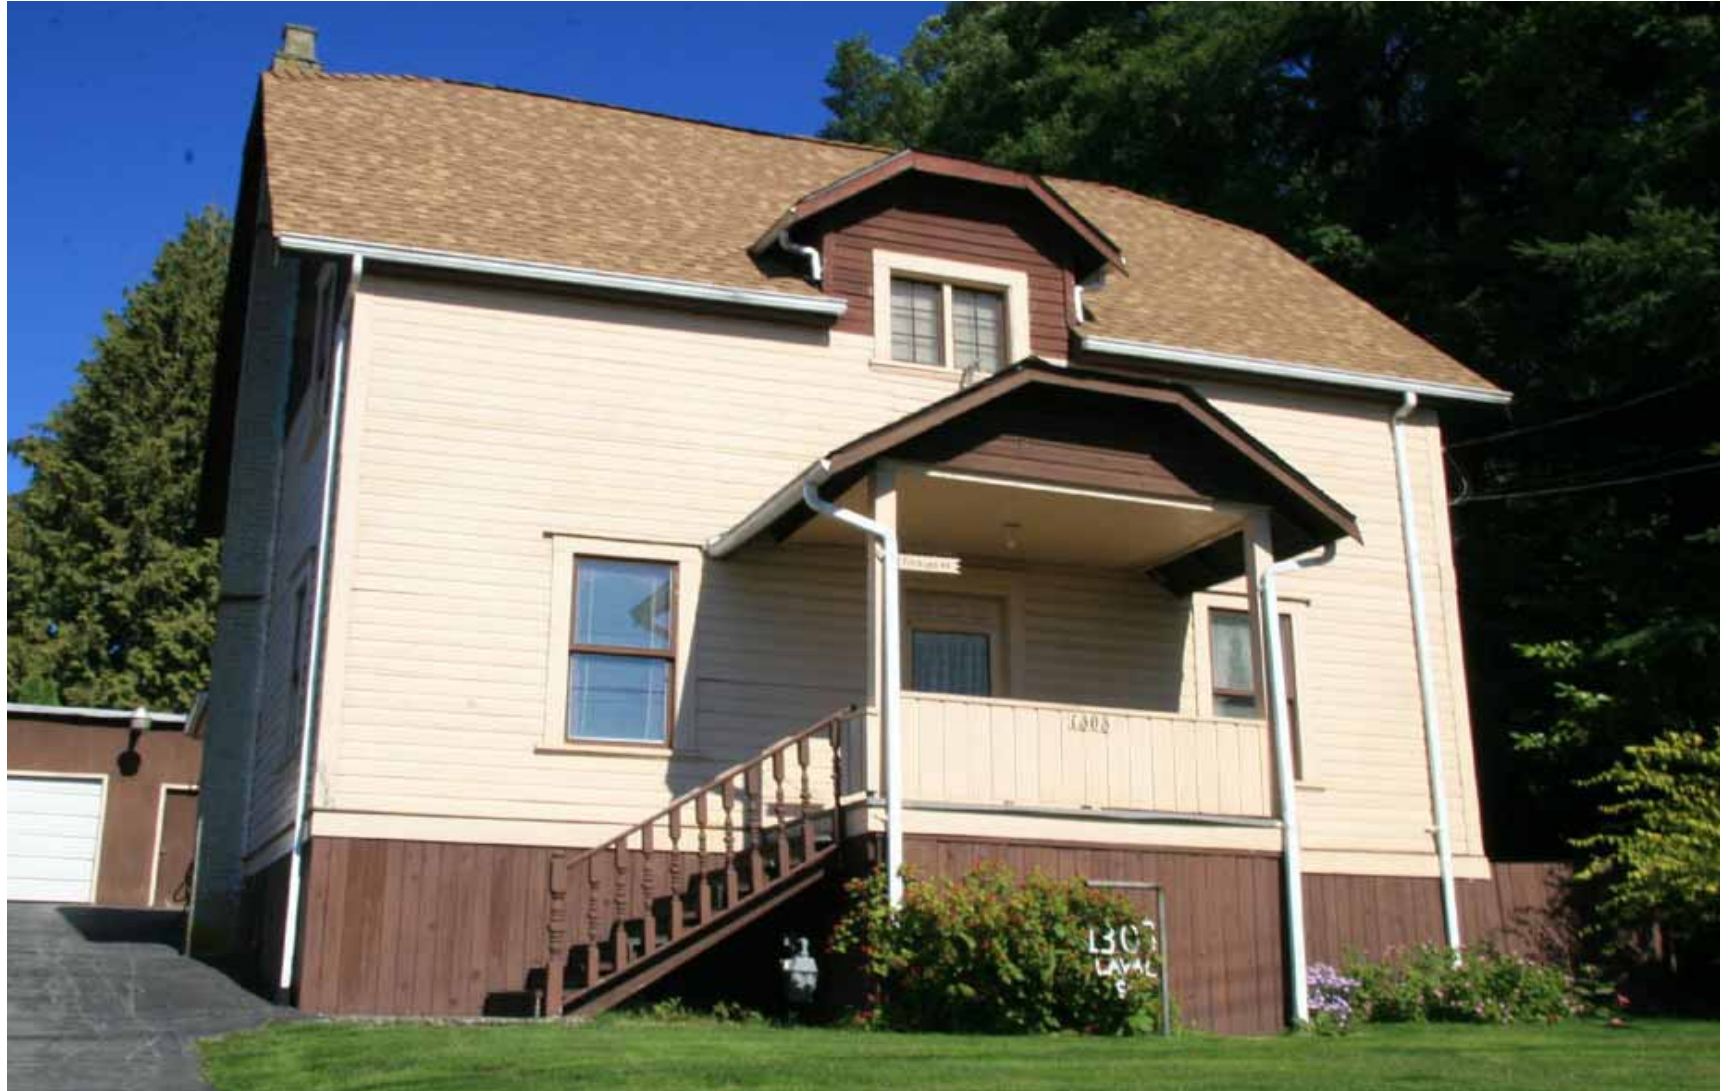
1303 LAVAL SQUARE

Condition: In good repair; minor deterioration on wood surfaces that require some remedial attention. Front steps and porch railings altered. One storey addition at rear.

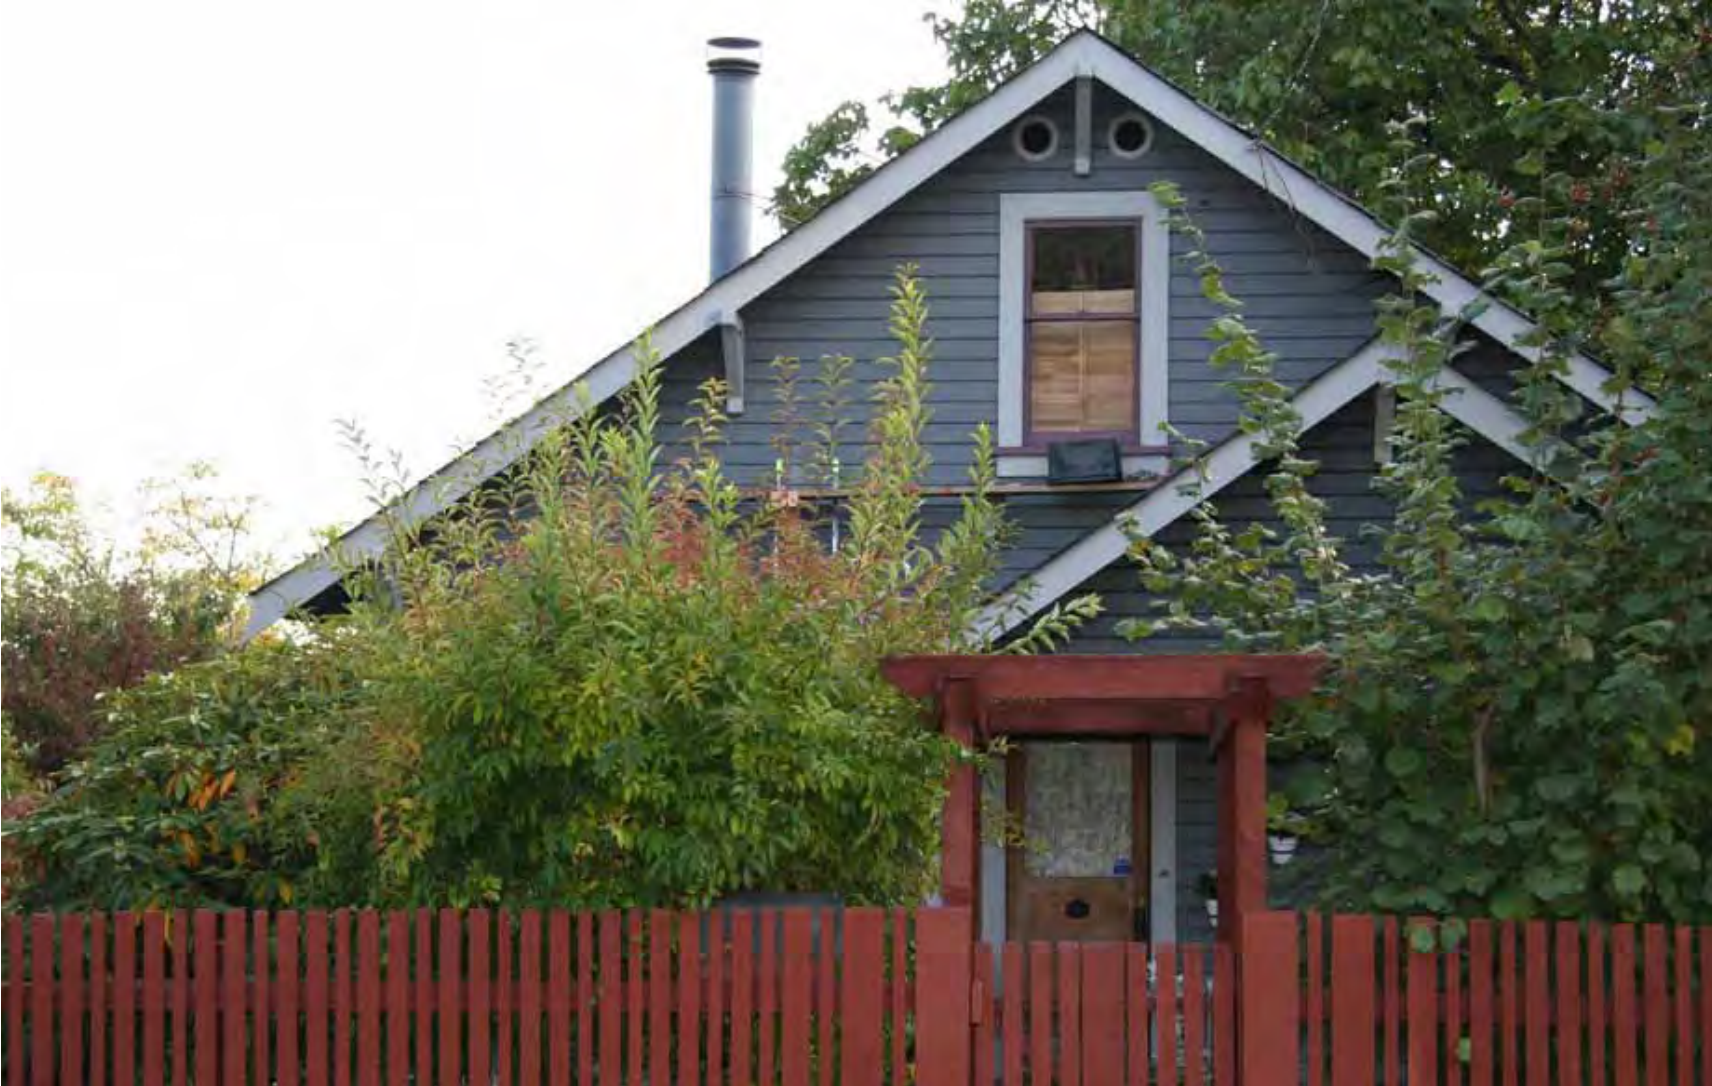
910 QUADLING AVENUE

Design Description: Simple bungalow with Craftsman detailing; triangular roof brackets and pointed verge-board ends. Glassed-in porch at rear. Early single car garage at rear; in good condition.

Condition: In very good repair; recently refurbished.
