HERITAGE INVENTORY | Maillardville

Originally developed in 1986 by Foundation Group Design Ltd.

Revised in 2007 by City of Coquitlam Community Planning Division

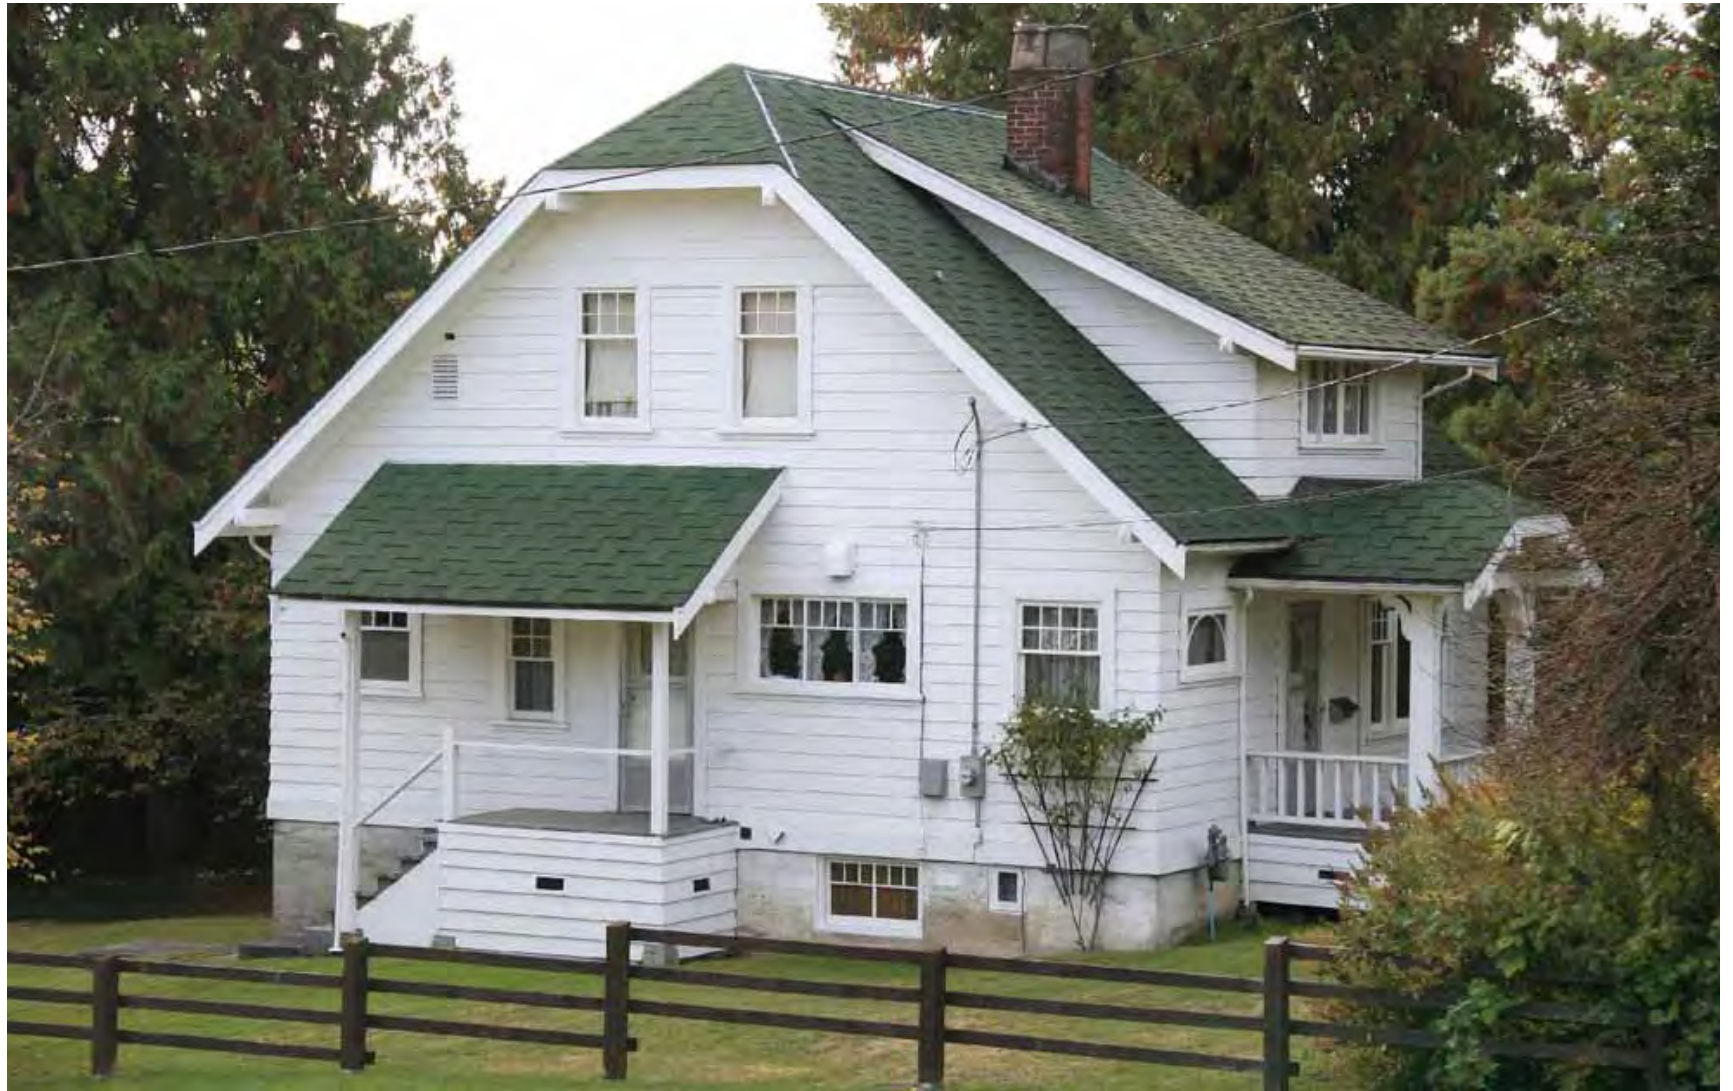
562 ROCHESTER AVENUE

Condition: Has been very well maintained; in good repair. Slight alterations to porch at side.

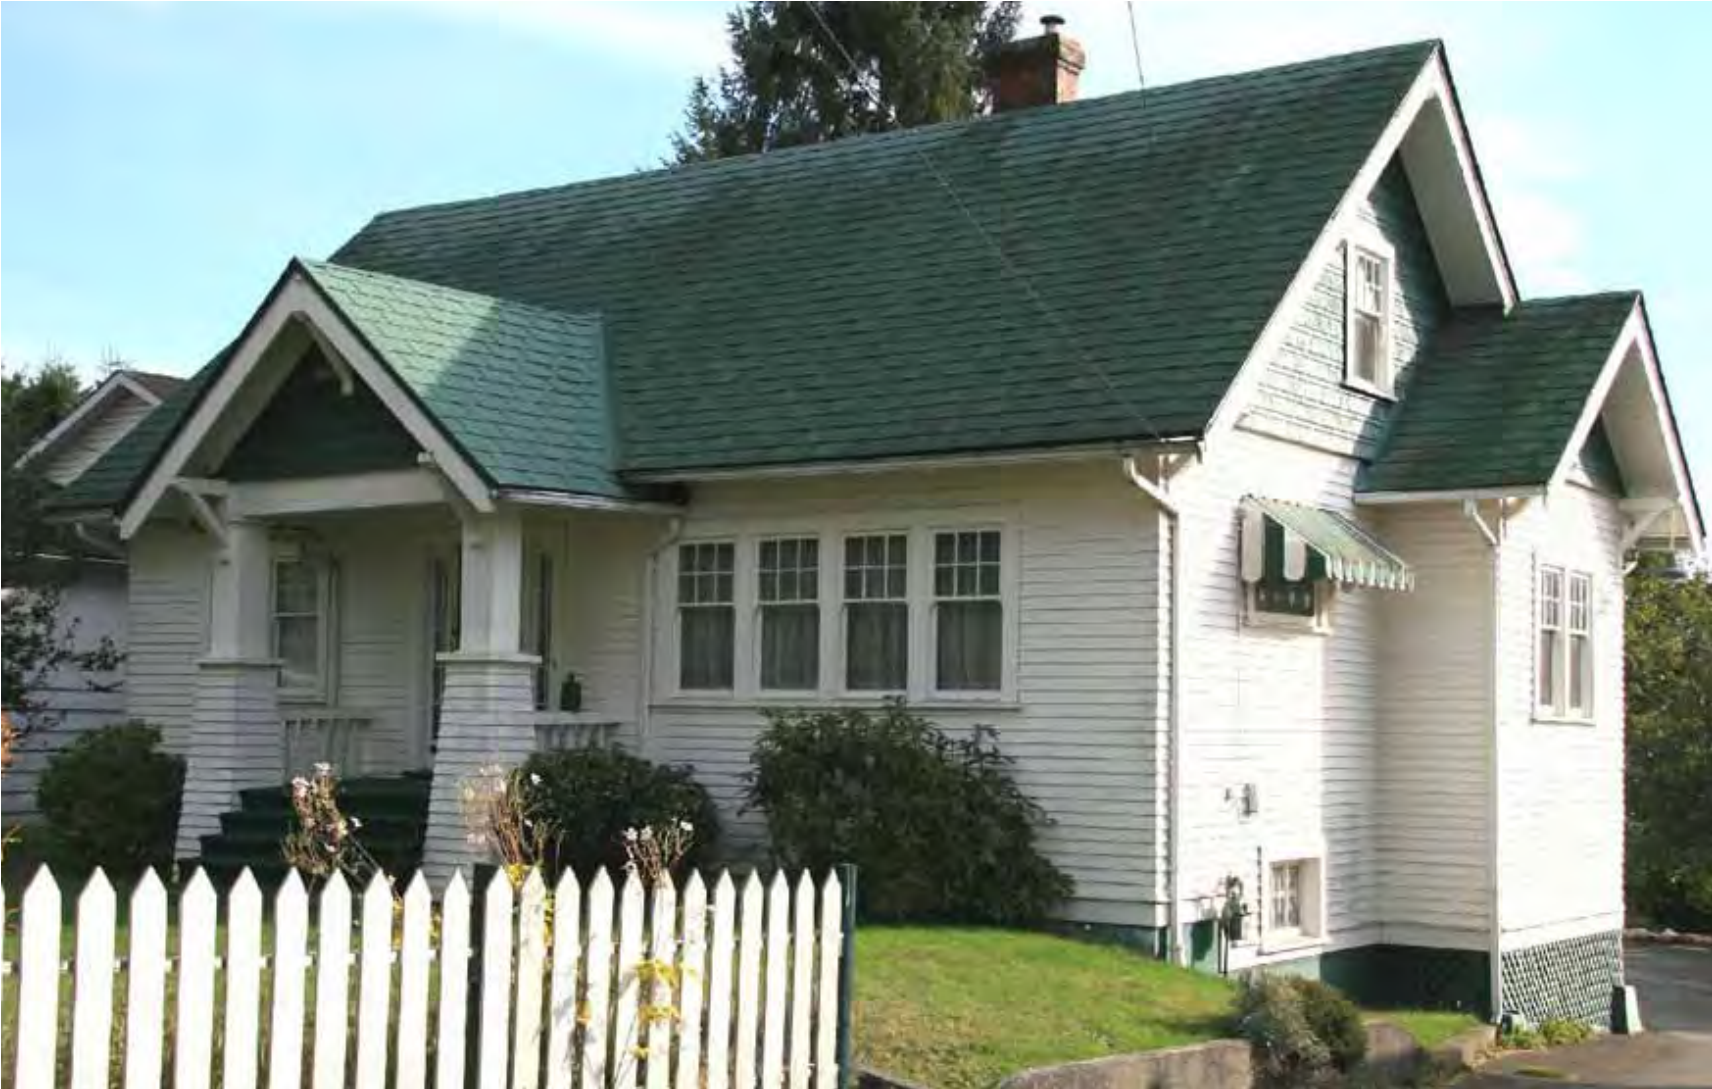
604 ROCHESTER AVENUE

Design Description: Simple Craftsman-styled bungalow with tapered porch piers. Square porch columns and triangular knee brackets. Front door has sidelights. Brick chimney with corbelled top. Stained glass window on main floor, west side. Triangular roof brackets on second floor. Older garage at rear with drop siding, and hip on gable roof.

Condition: In very good repair; well-maintained. Minor alterations only. Inappropriate metal canopy at side.

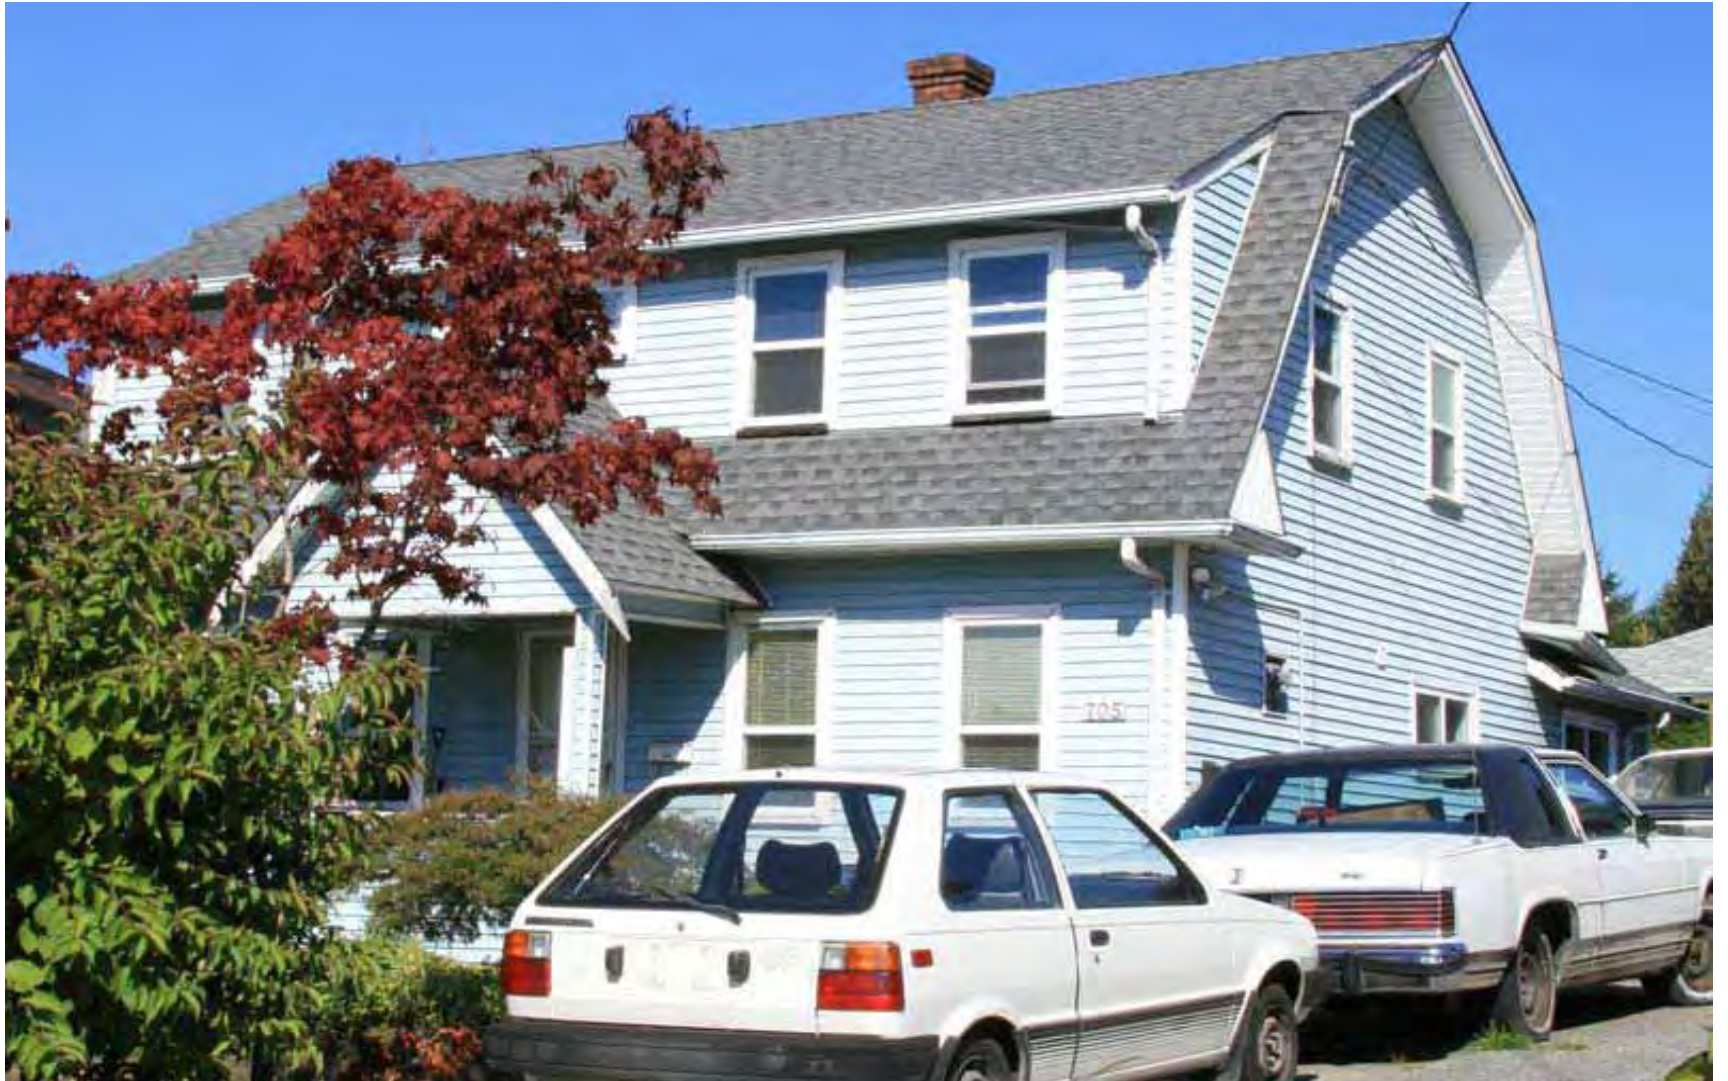
705 ALDERSON AVENUE

Prominent side gambrel roof; early garage at side. Has been re-sided with vinyl siding but windows and other details are intact. In good condition.

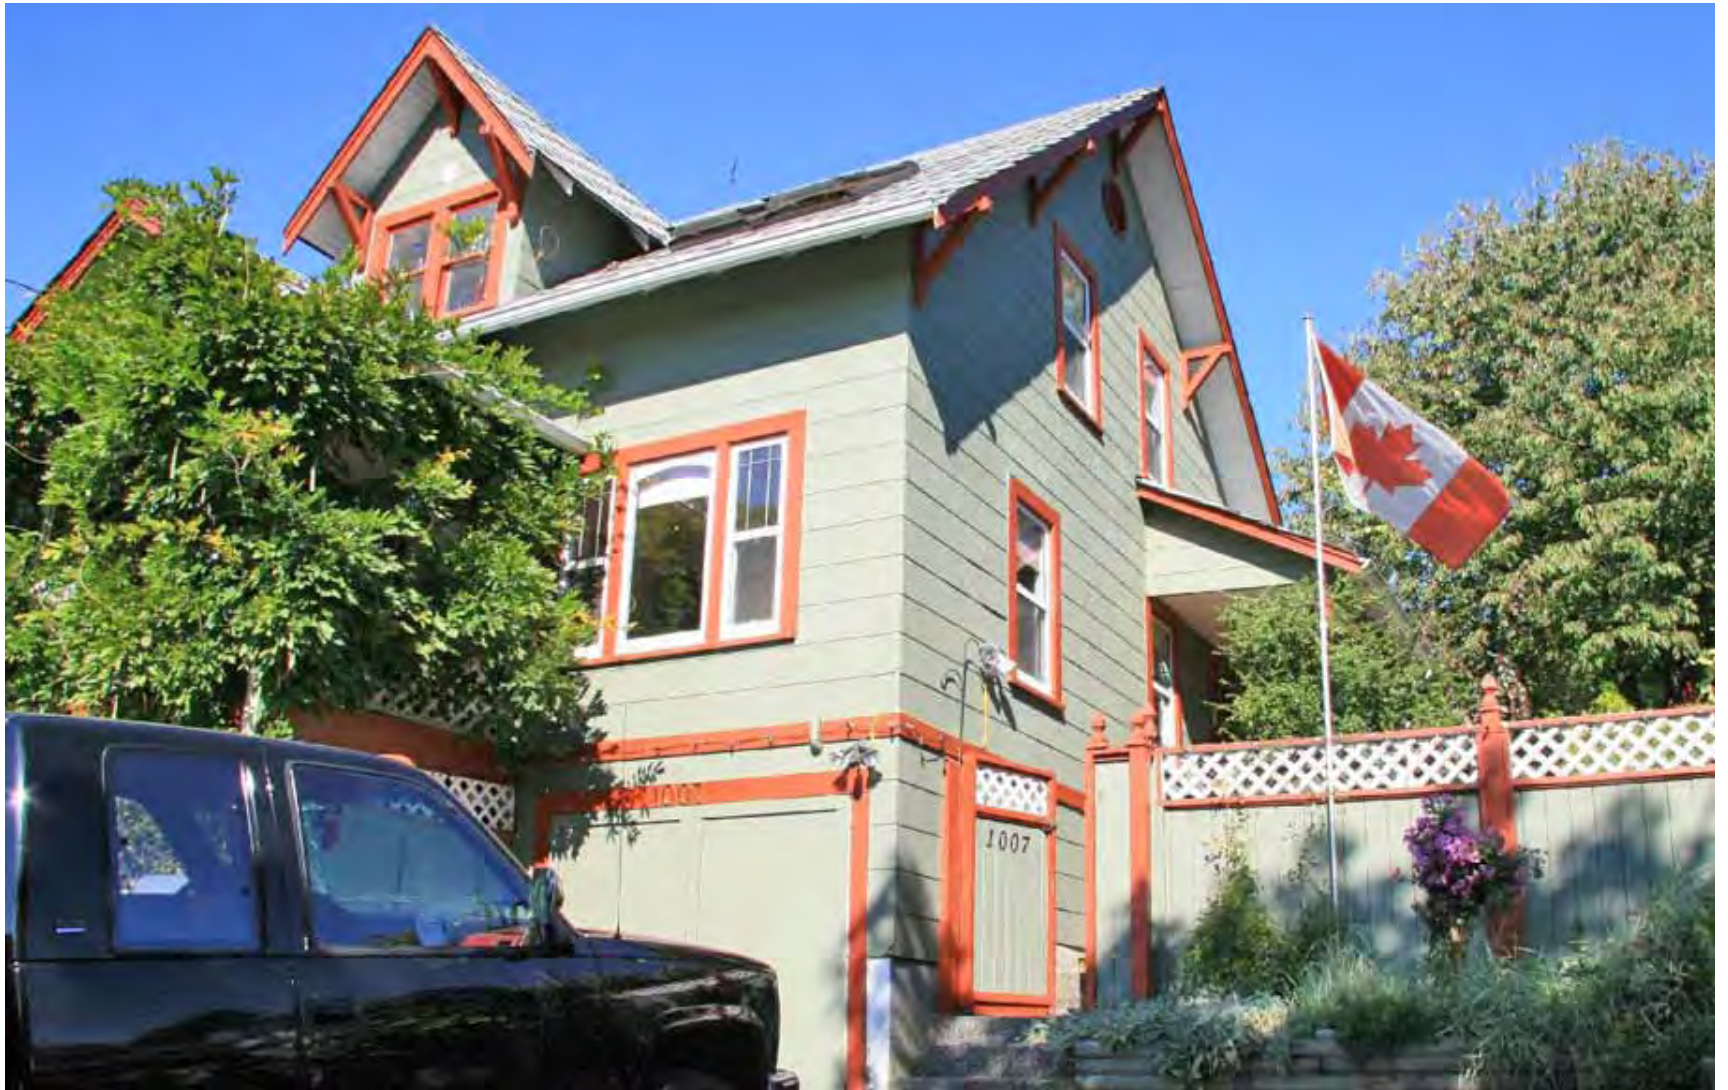
1007 ALDERSON AVENUE

A large prominent house on a corner lot; highly visible in the neighbourhood. Has suffered from inappropriate renovations - has been stuccoed, and altered to accommodate a number of rental suites.

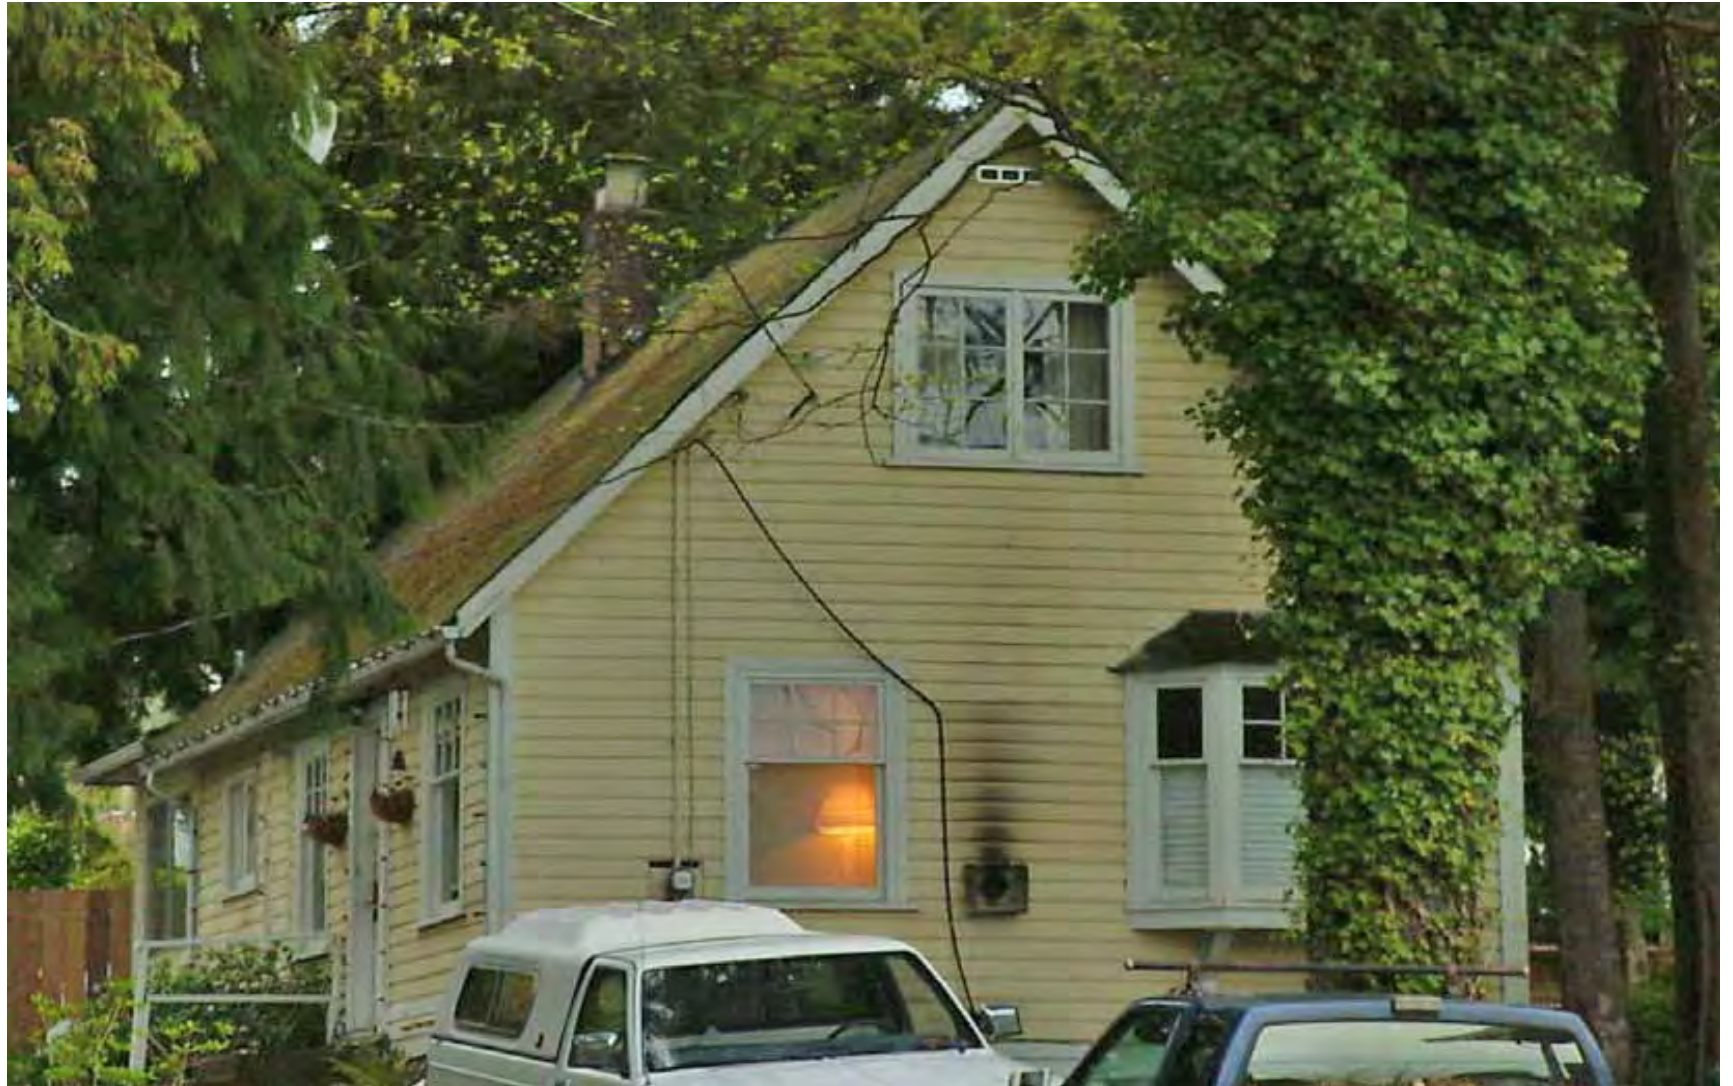
1401 AUSTIN AVENUE

Small house in good condition. Front gable roof with projecting front bay. Generous sideback from Austin Avenue. Mature trees on site.

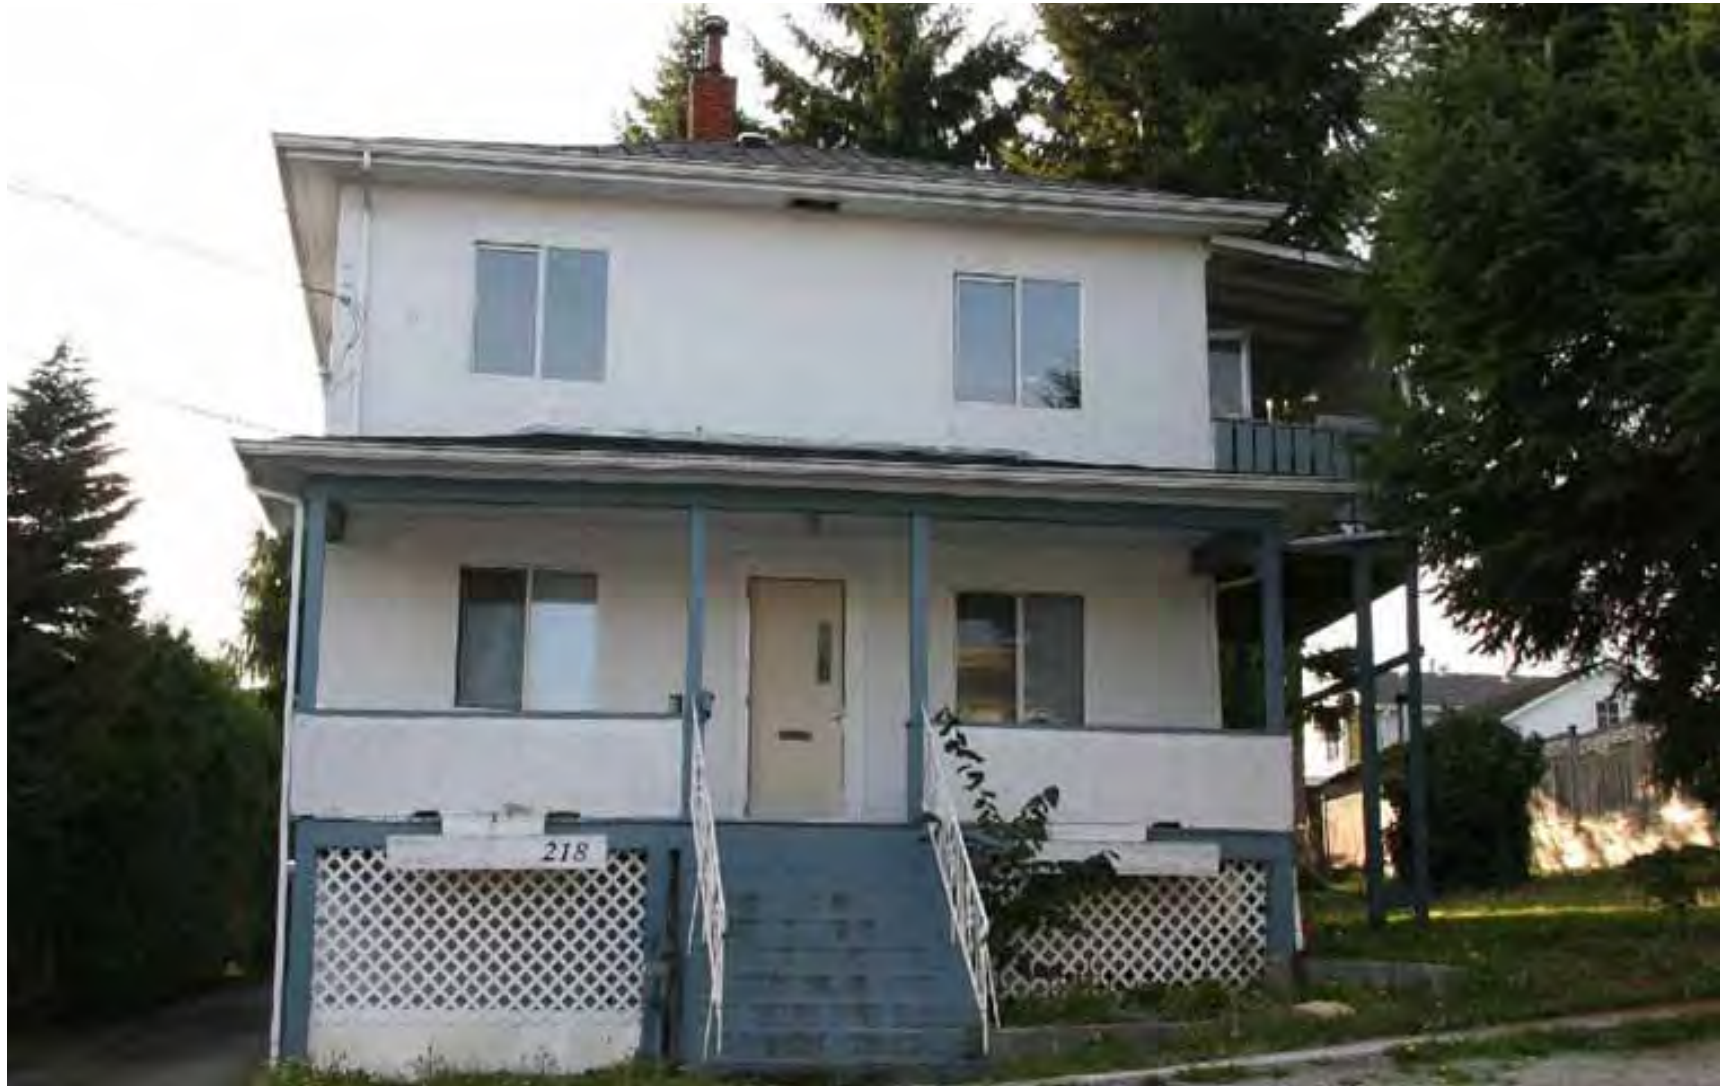
218 BEGIN STREET

Two storey Edwardian house with pyramidal roof; original windows intact. Has been stuccoed; two storey deck added at north side. In fair condition. Date of construction circa 1913.

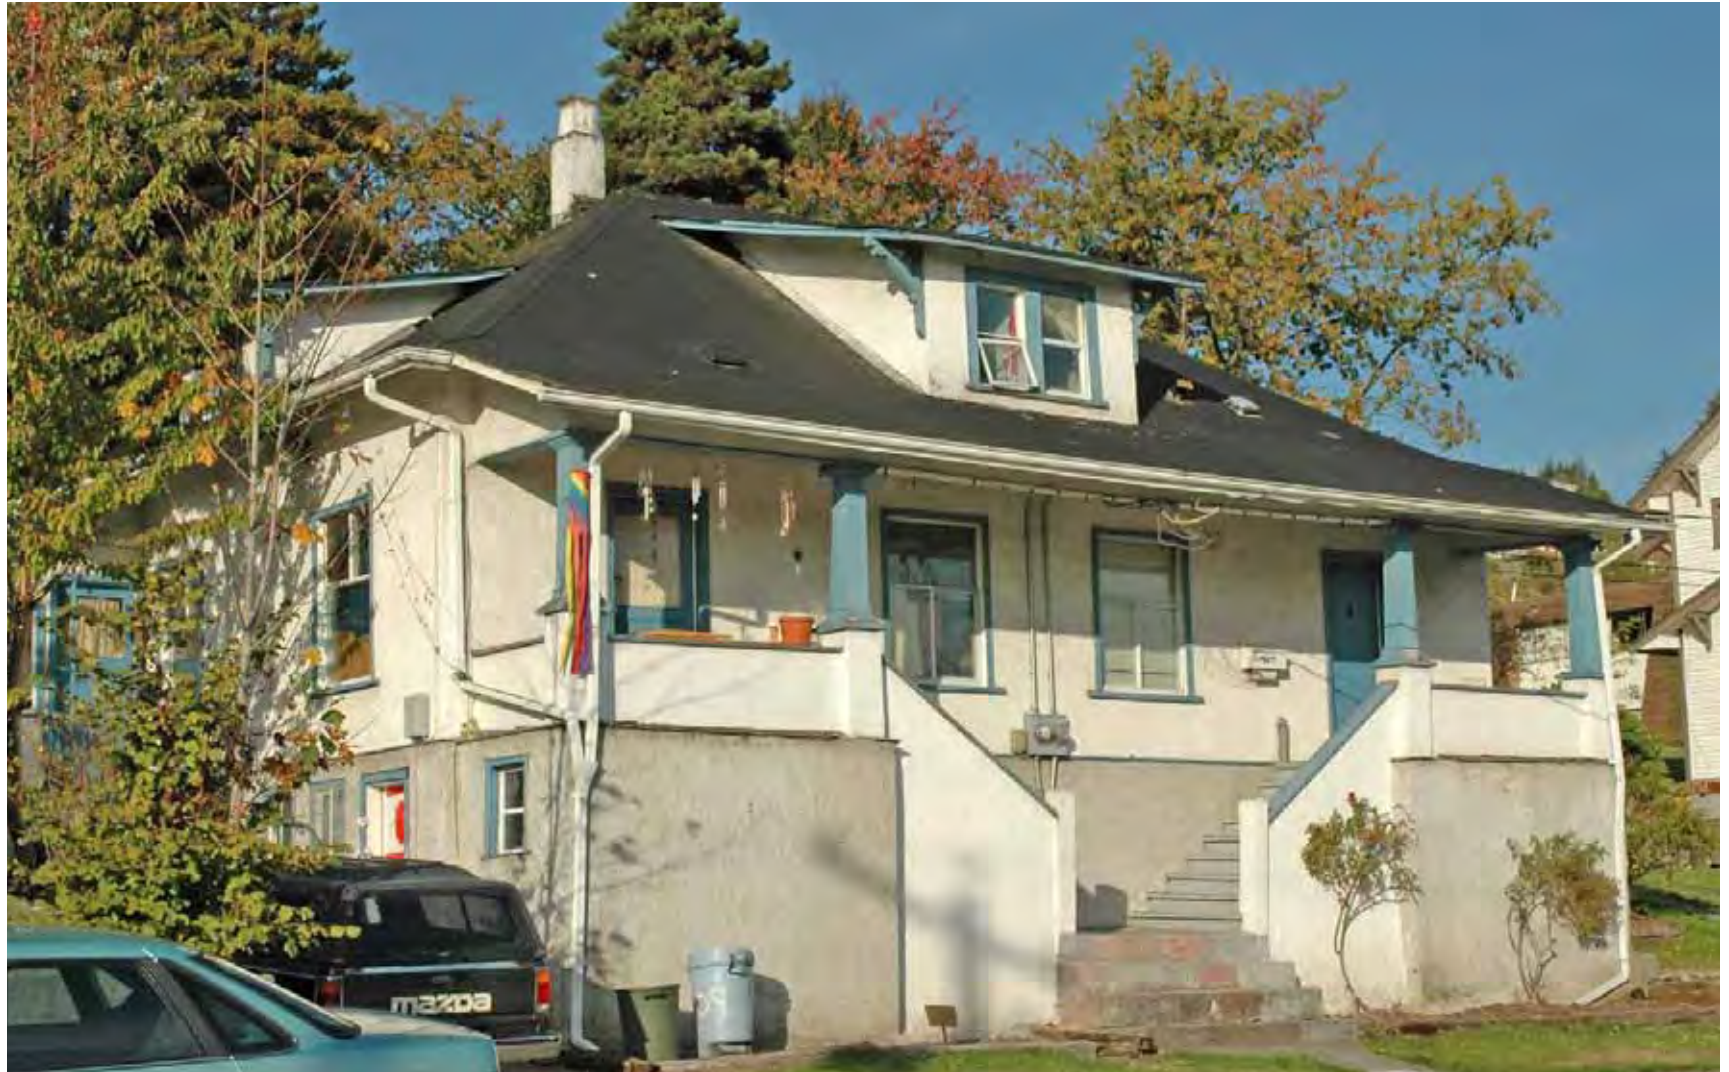
1409-1411 CARTIER AVENUE

An interesting and early example of a duplex structure. Has received an overall later coat of stucco; the windows have also been altered with new aluminum sash replacements.

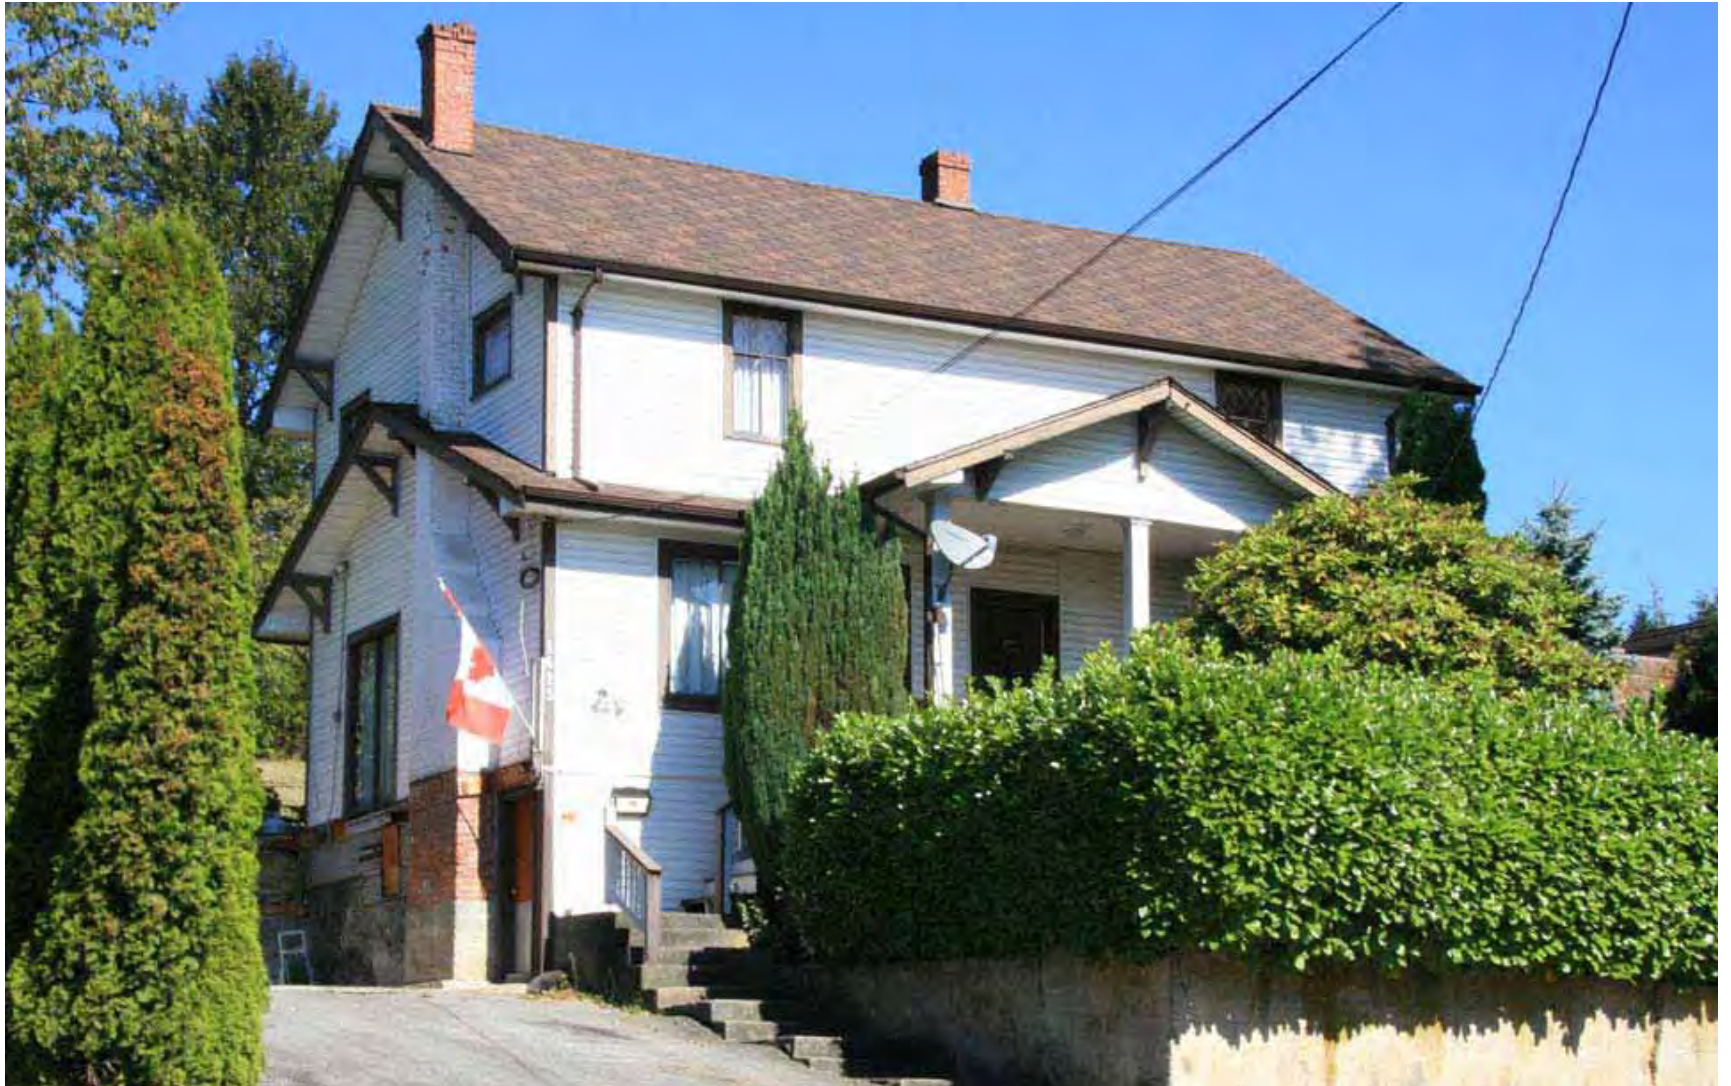
1415 CARTIER AVENUE

House has been somewhat altered: some windows have been replaced, a deck added at the side, and the front stairs replaced.

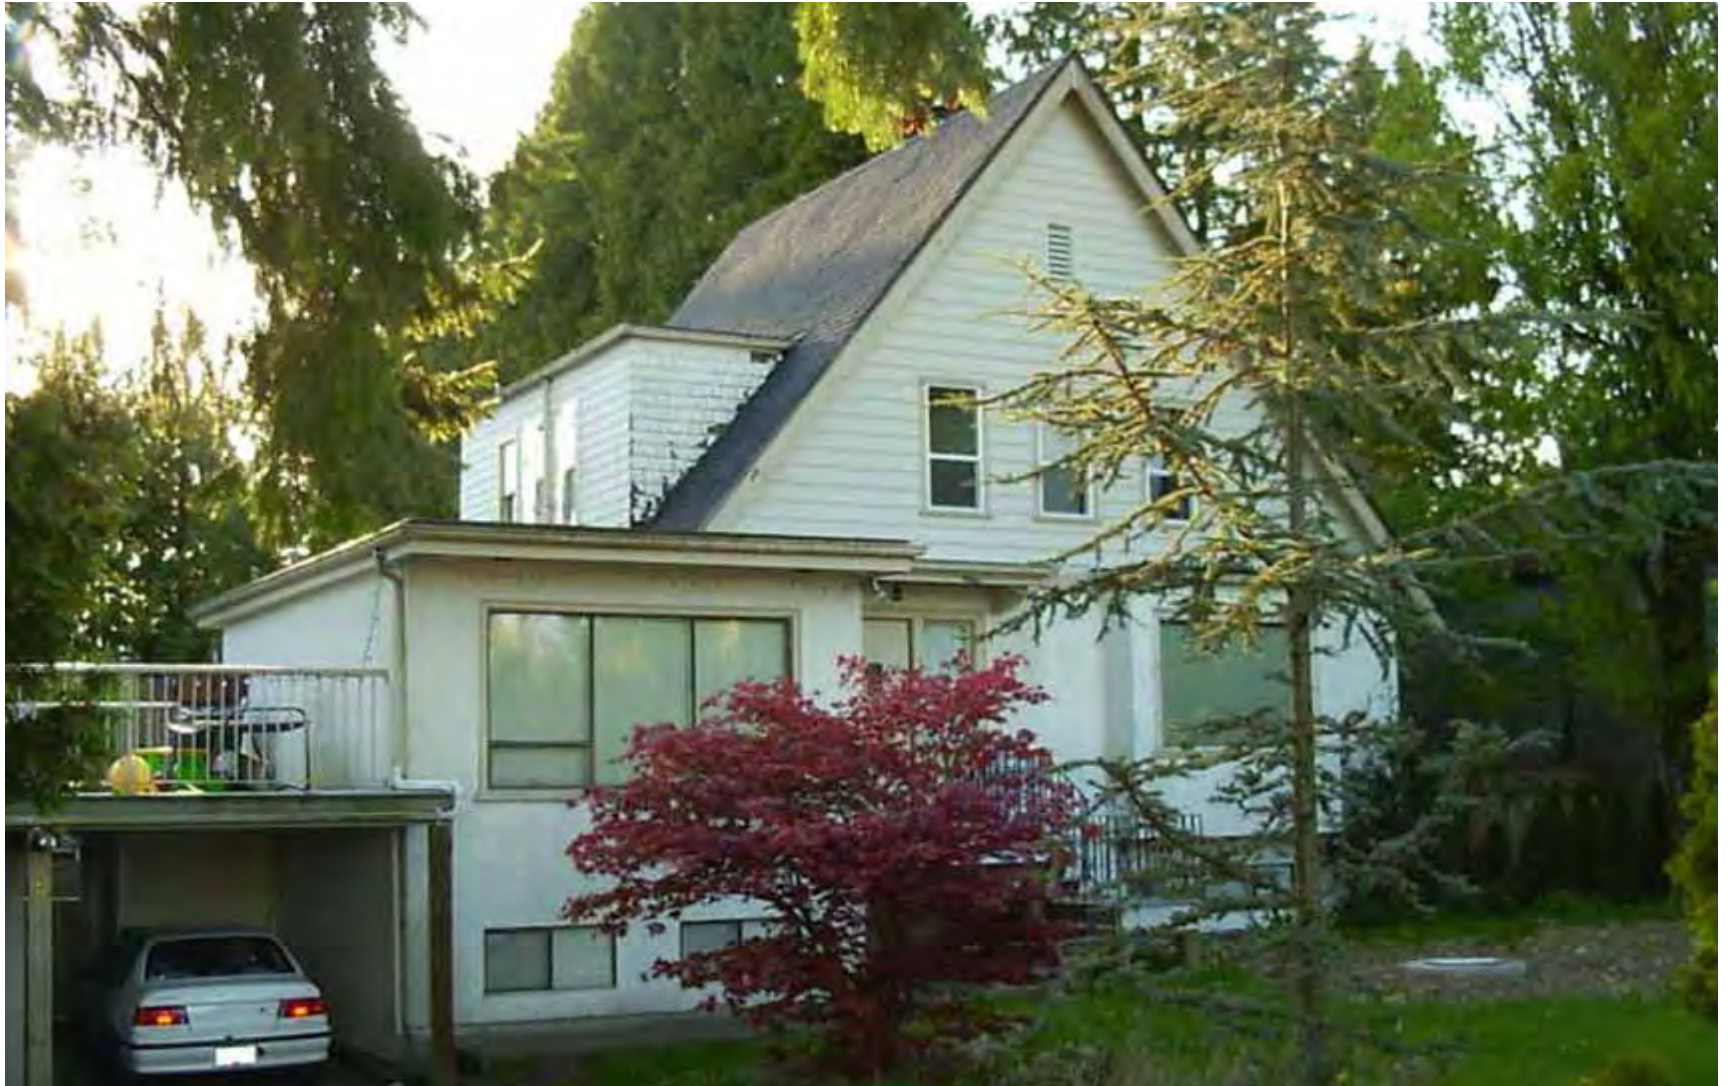
440 FAIRWAY STREET

Only remaining older house in this immediate area. Interesting for its steeply pitched front gable roof. The ground floor materials and windows have been altered, and a new deck and carport added to the south side. In very good repair and condition.

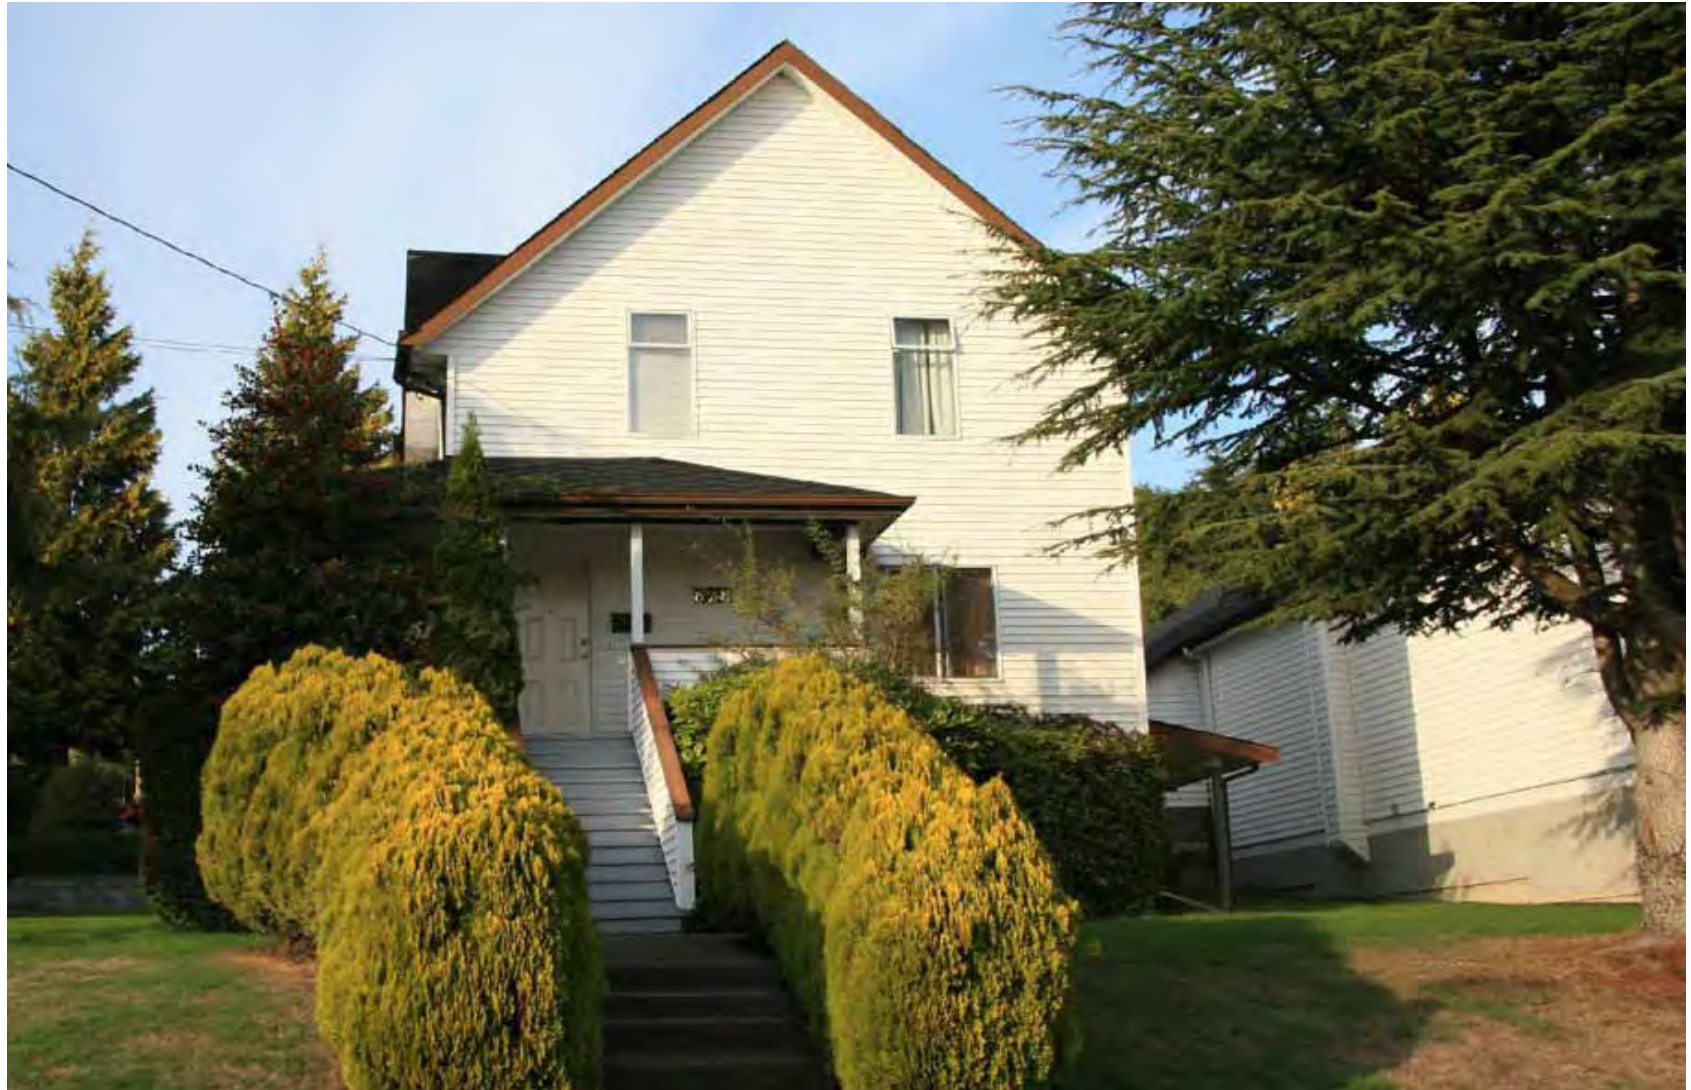
828 LAVAL SQUARE

The character of the Priest's House has been severely compromised; new vinyl siding has been applied over the stucco finish, which was previously applied over the original wood siding. All the windows have been replaced with aluminum sash windows. The front steps, porch skirting, and foundation have been altered. The basement level appears to have been changed. These alterations were made in 1976 as part of a total rebuilding of this structure, which had previously been stuccoed over its original lapped siding. Photographs of the renovation process are available in the Parish Archives, and show the original appearance of the house.

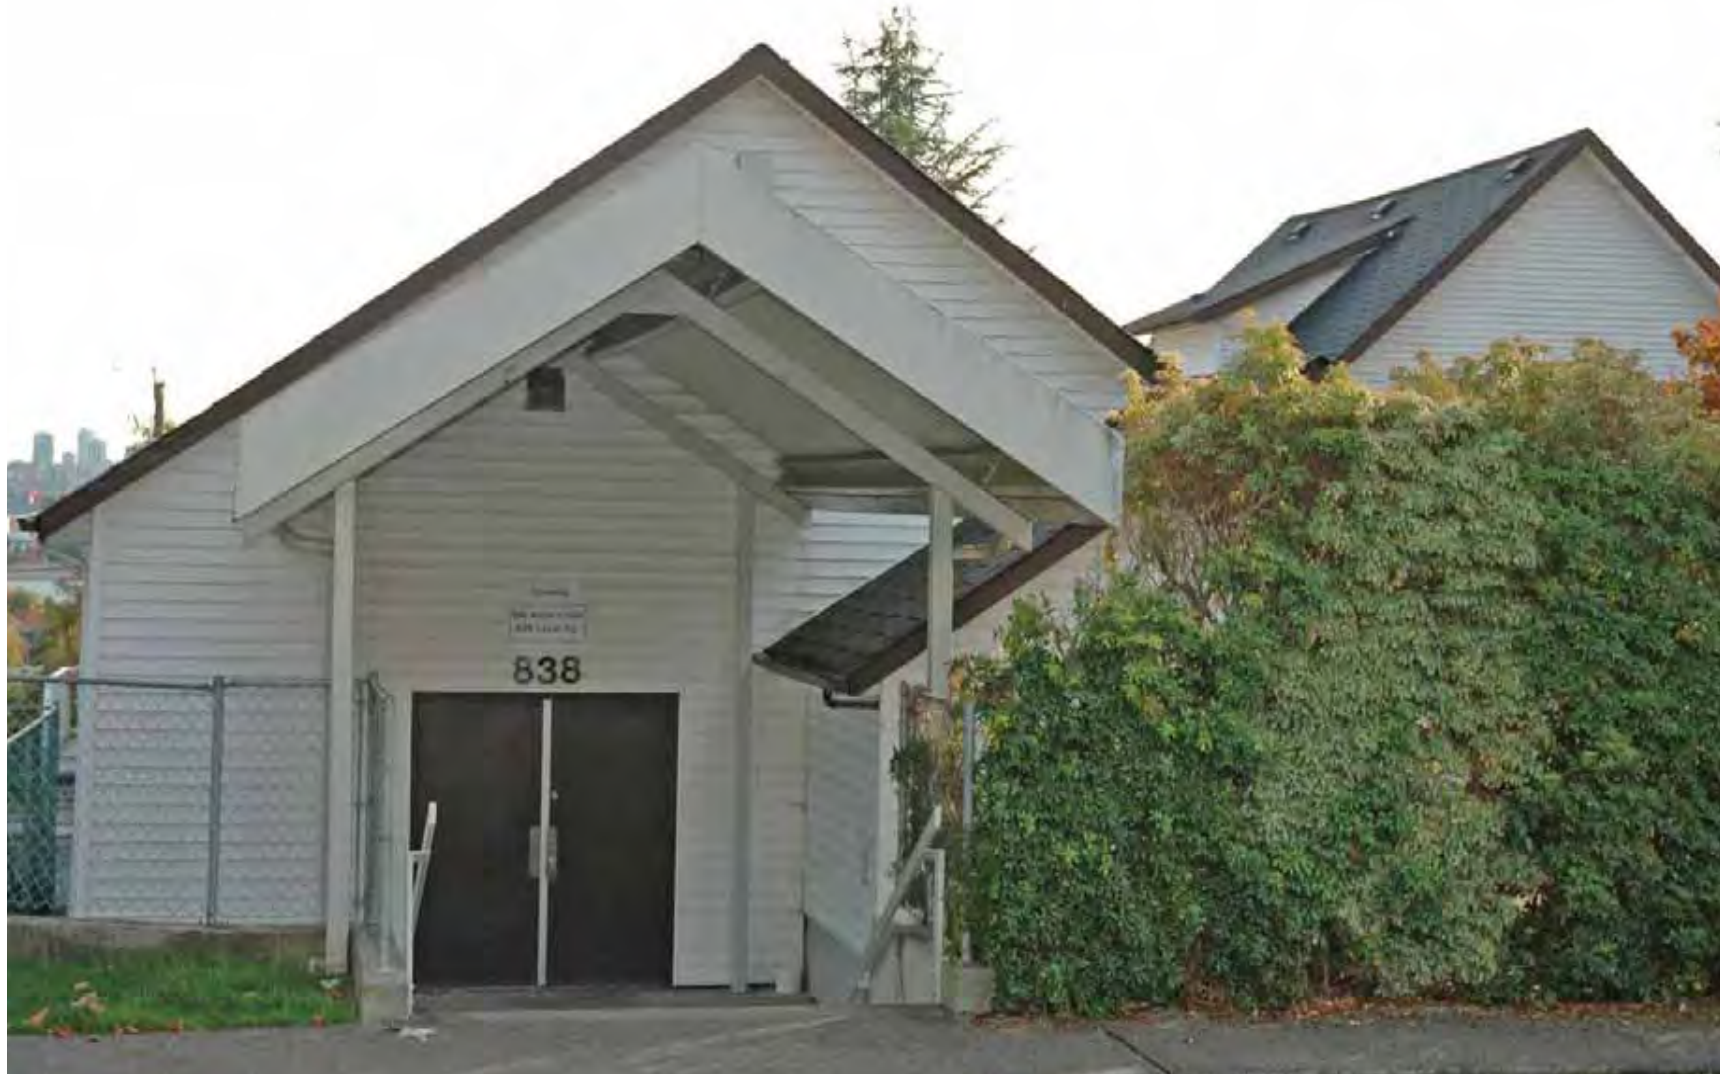
838 LAVAL SQUARE

In mostly original condition; in good repair. Unusual for a lack of windows to the outside. Provides support to the church grouping.

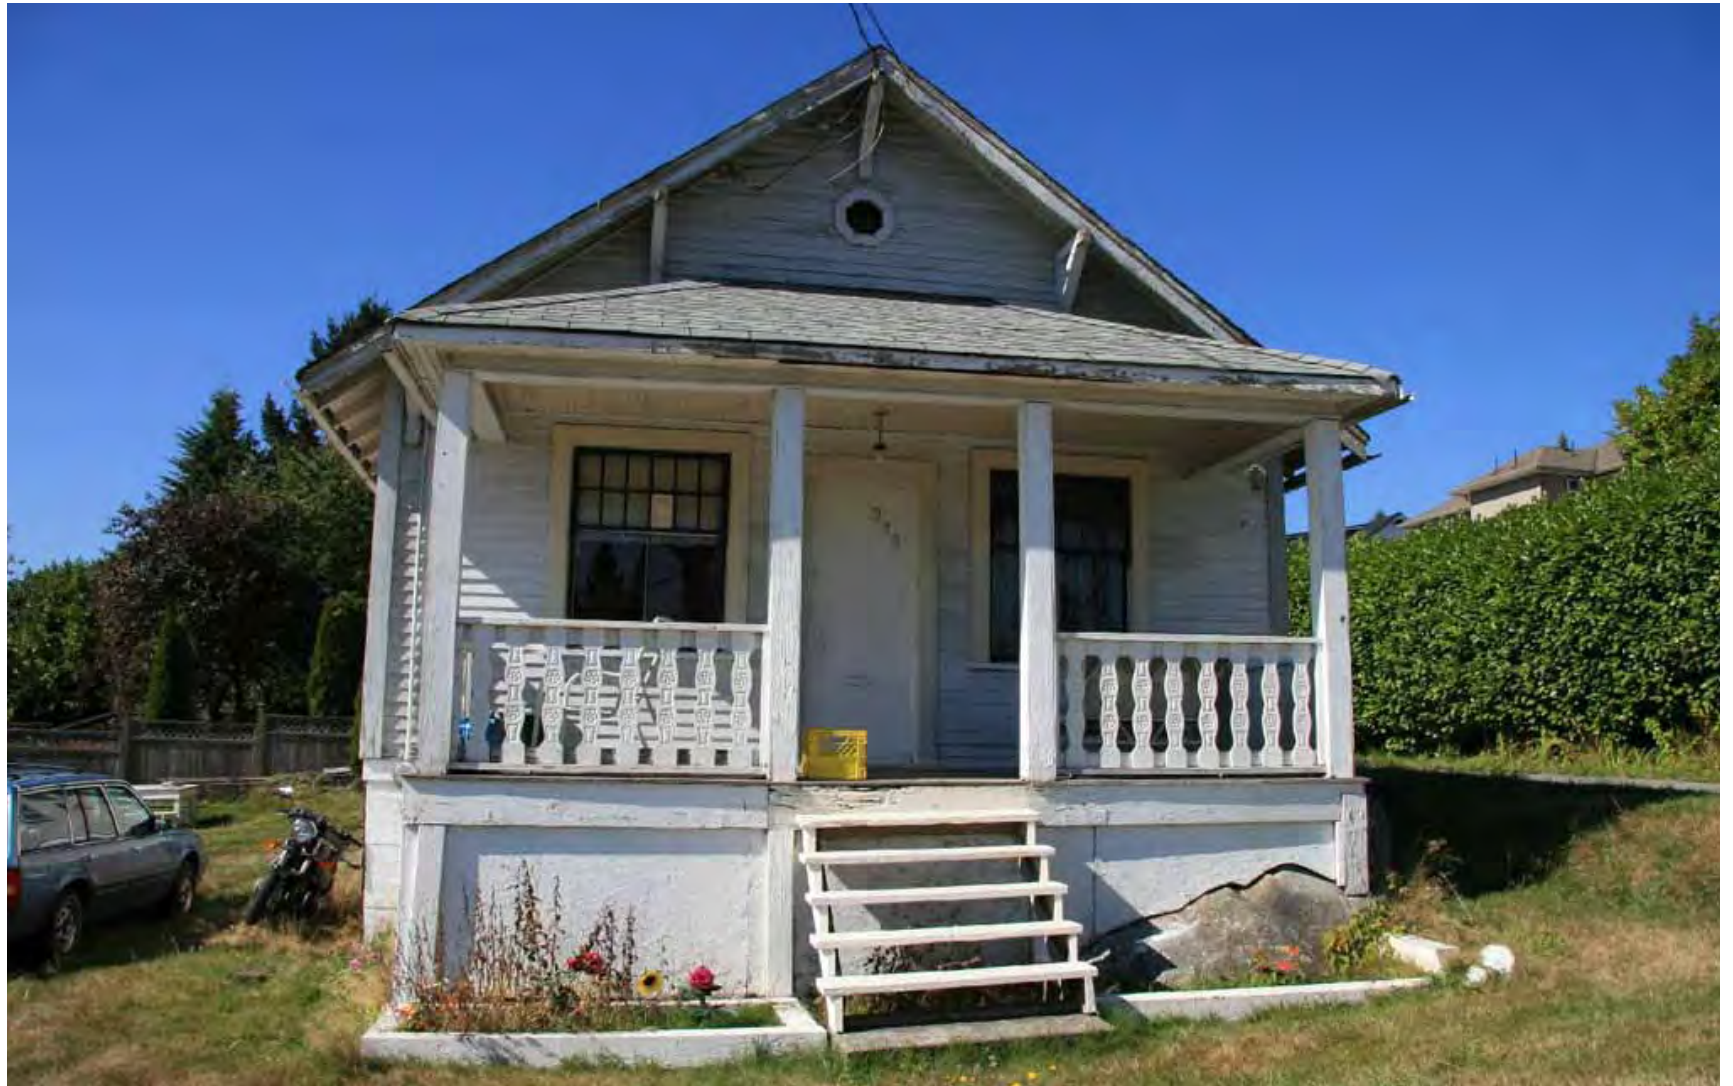
218 MARMONT AVENUE

In fair condition.
