HERITAGE INVENTORY | Maillardville

Originally developed in 1986 by Foundation Group Design Ltd.

Revised in 2007 by City of Coquitlam Community Planning Division

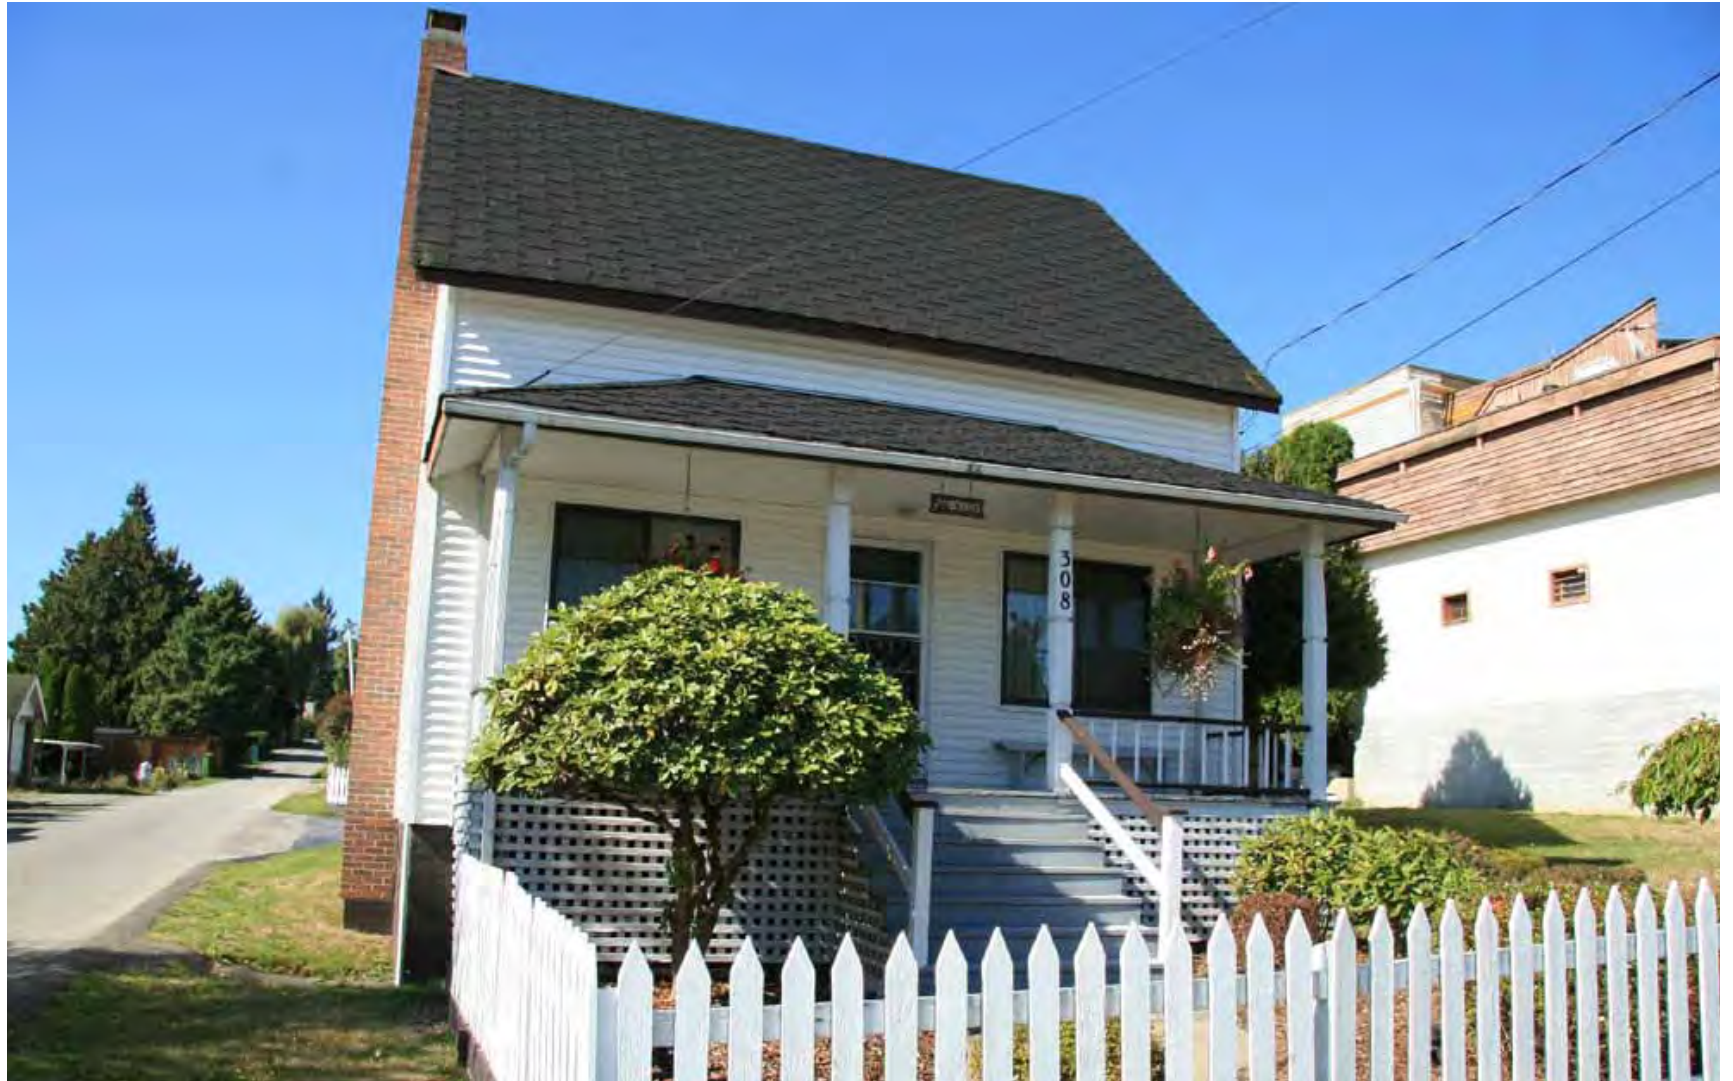
308 MARMONT AVENUE

House has suffered some alterations to original character; vinyl siding has been added over the original wooden siding, and the front windows have been replaced. The house is noteworthy for its unusual porch columns, and for its two outbuildings at rear. Has been maintained in very good condition.

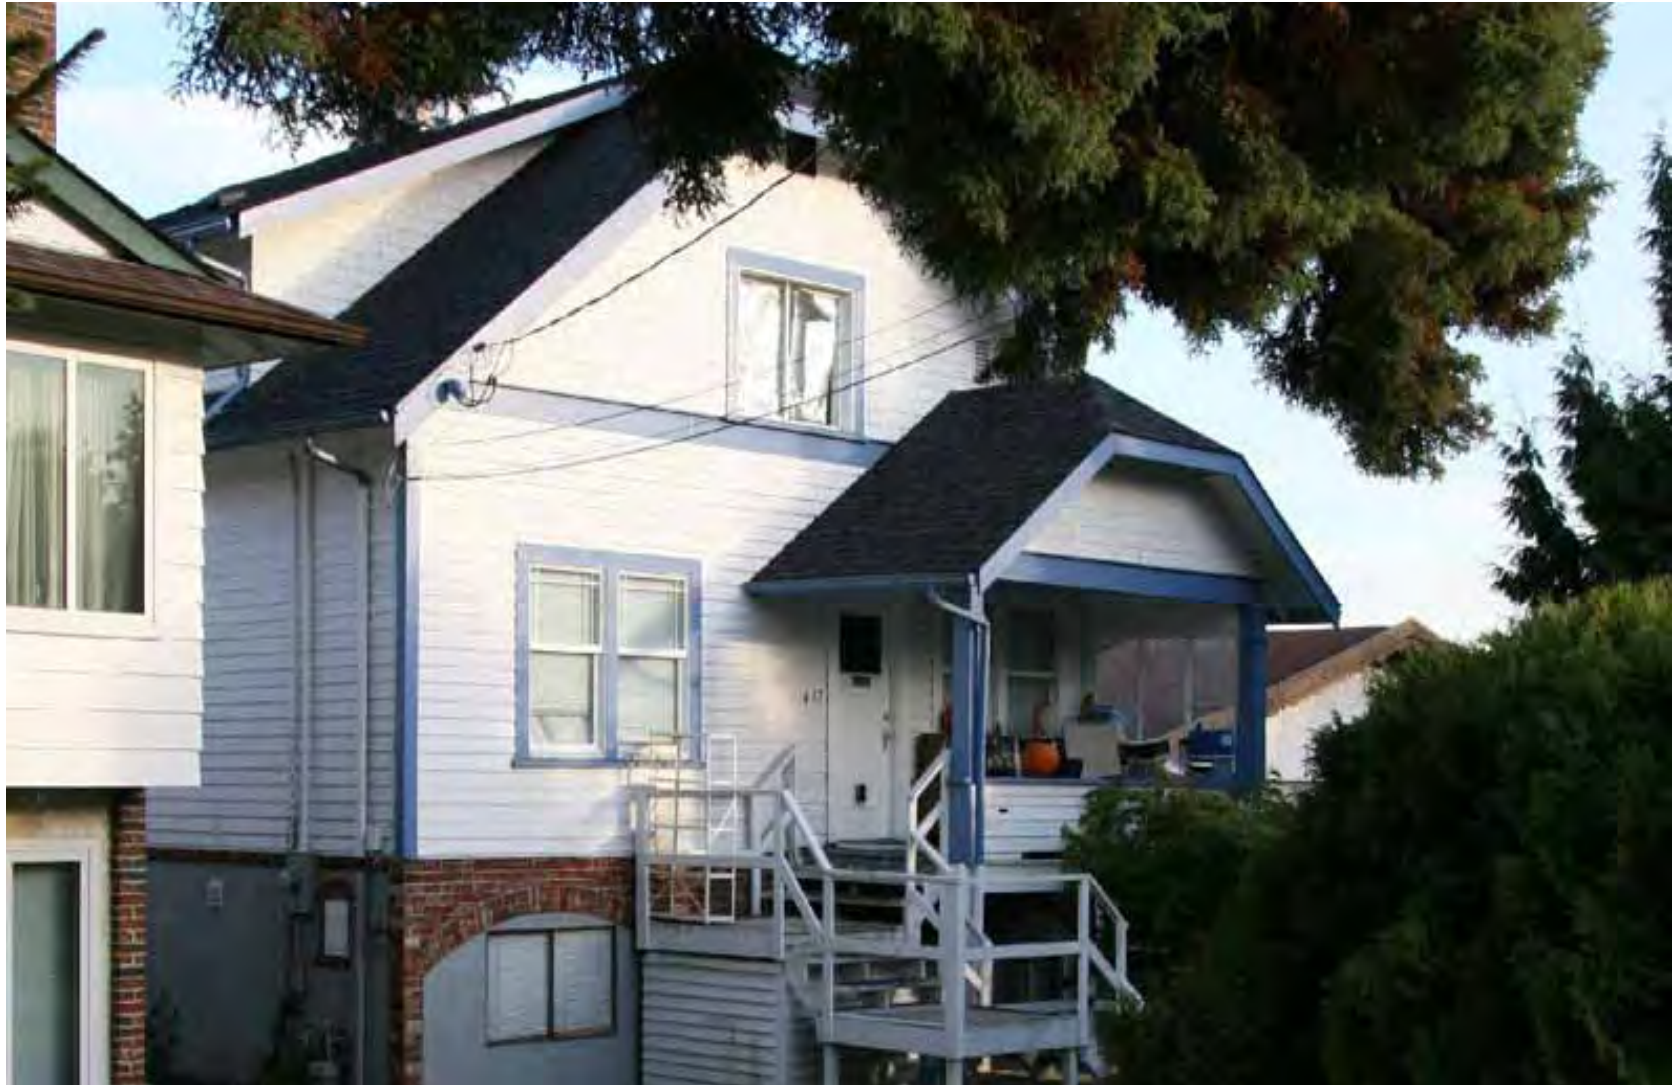
437 MARMONT AVENUE

Bottom level of house has been altered, and the front steps changed; otherwise original materials intact. Craftsman-style bungalow, has been maintained in good condition.

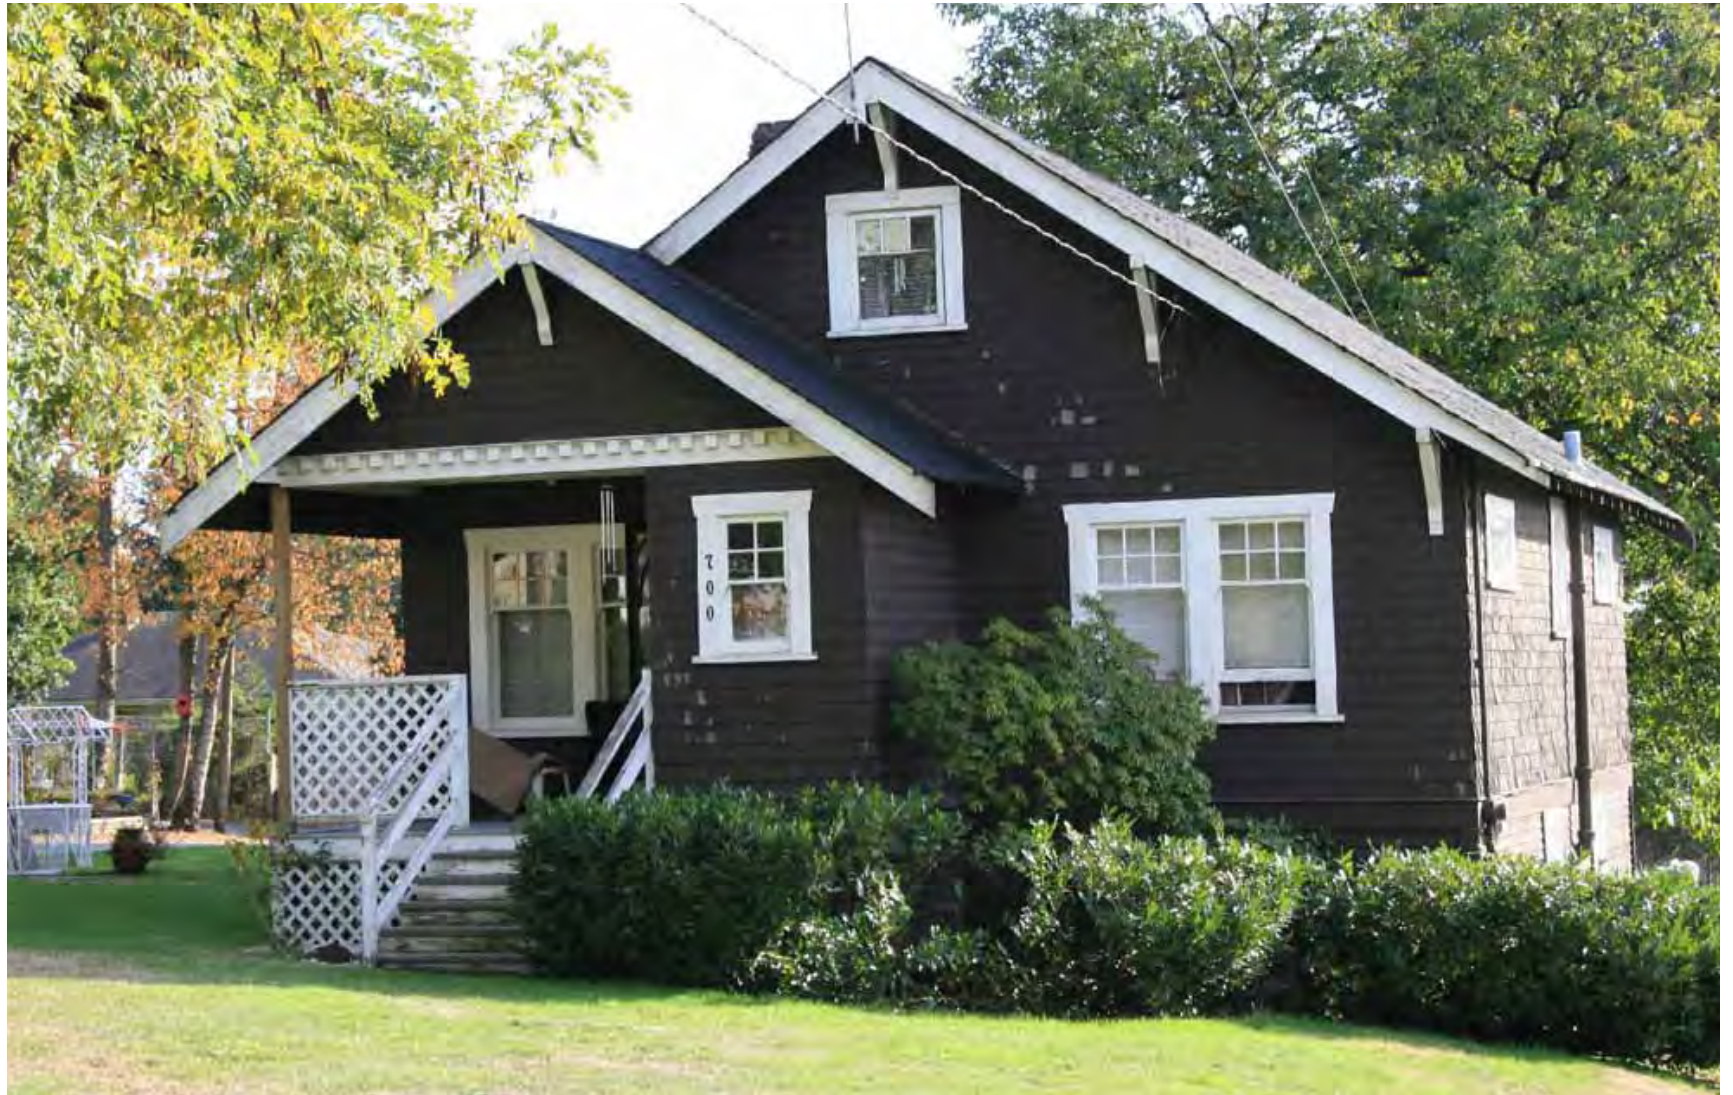
700 ROCHESTER AVENUE

Plain and modest Craftsman-styled bungalow; simple detailing. Typical of the period. Well maintained; in good repair.

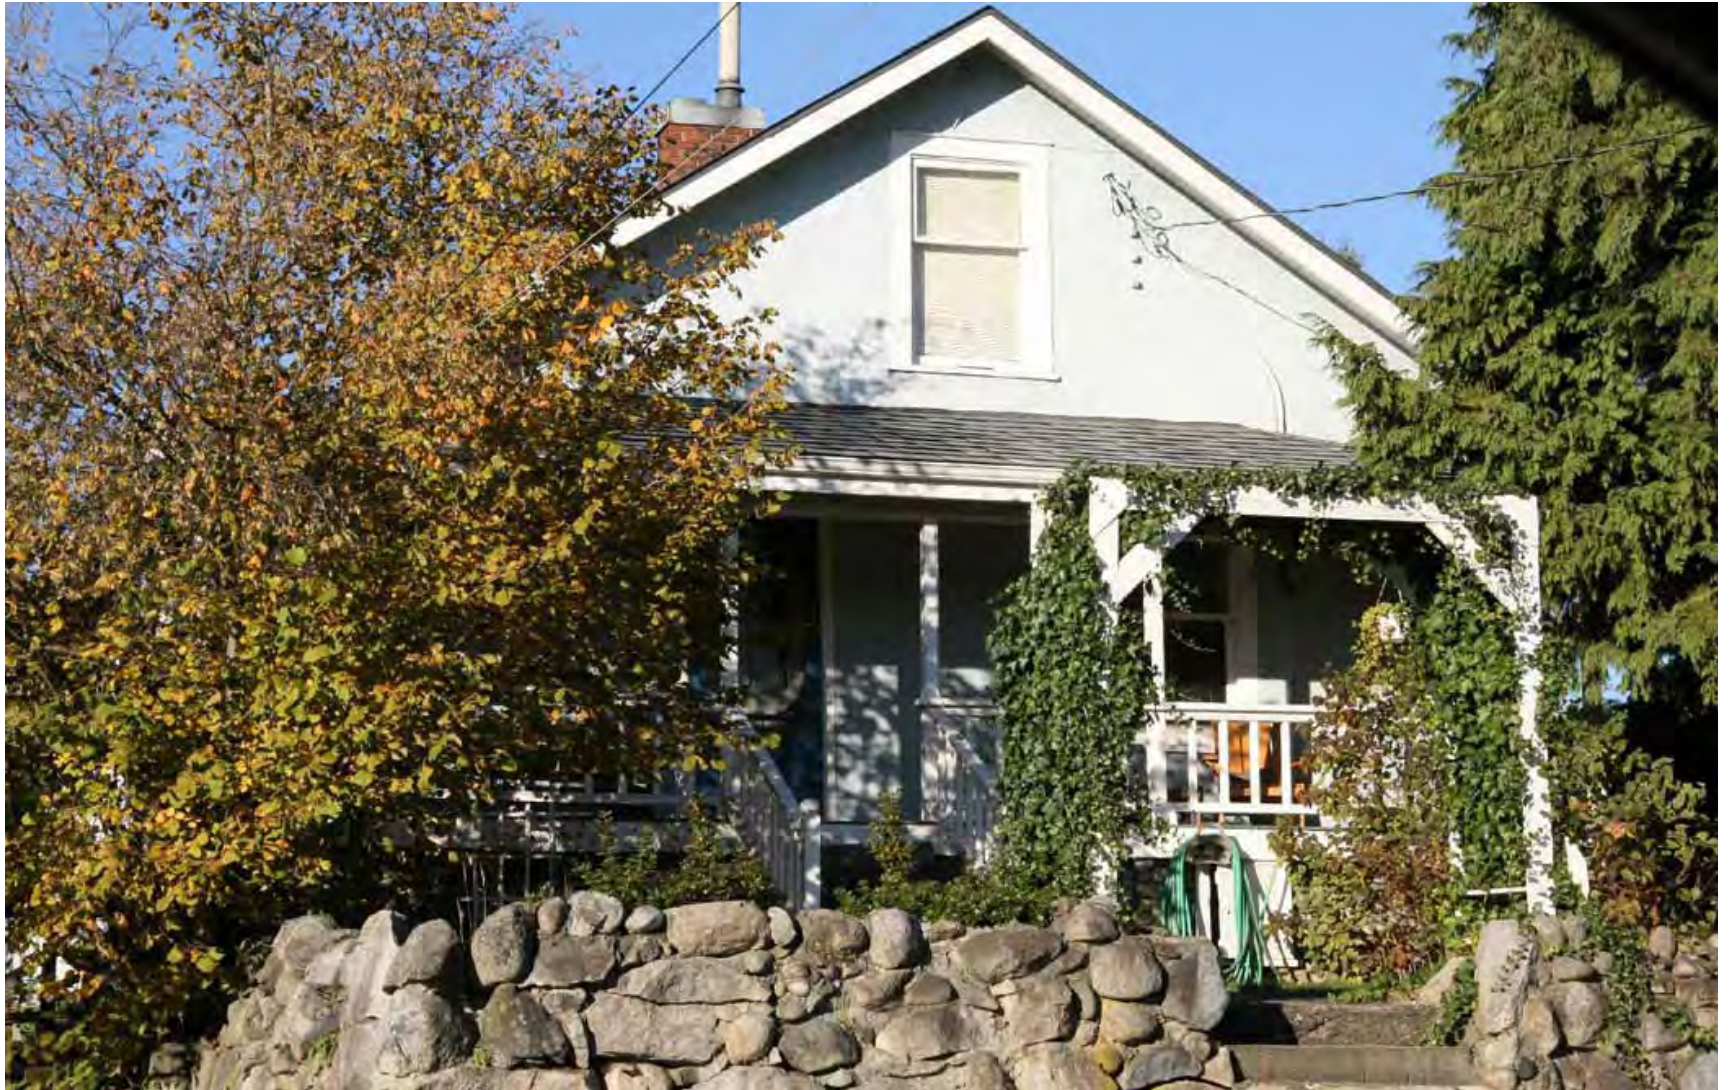
825 RODERICK AVENUE

Interesting variation on the Craftsman Bungalow type, with a wrap-around verandah and tapered porch piers built of graded river-rock. Has received a later overall coat of stucco. In fair condition; shows obvious signs of neglect and settling. Requires maintenance and repair.
