**F I N A L   R E P O R T**

**CITY OF COQUITLAM  
CITY OF PORT COQUITLAM**

**Hyde Creek Integrated  
Watershed Management Plan**

**Re: HYDE CREEK IWMP FINAL REPORT**

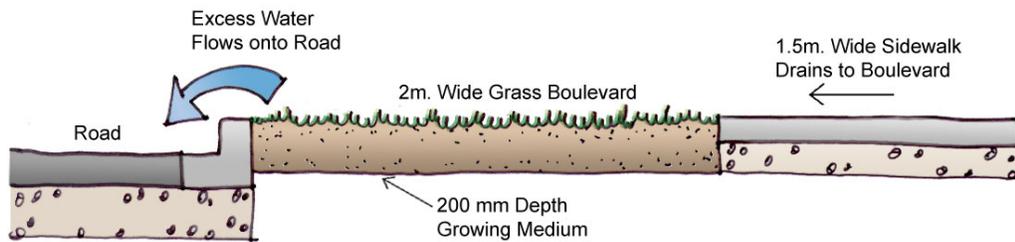
The following sketches illustrate a range of options with estimates of perviousness and effective impervious area. The estimates of EIA are based on a relatively impermeable underlying material.

**Option 1:** Increase growing medium to 200 mm – Perviousness 75% of stated amount - Estimated EIA 66% (approx.)

**Option 2:** Increase growing medium to 300 mm – Perviousness at stated amount

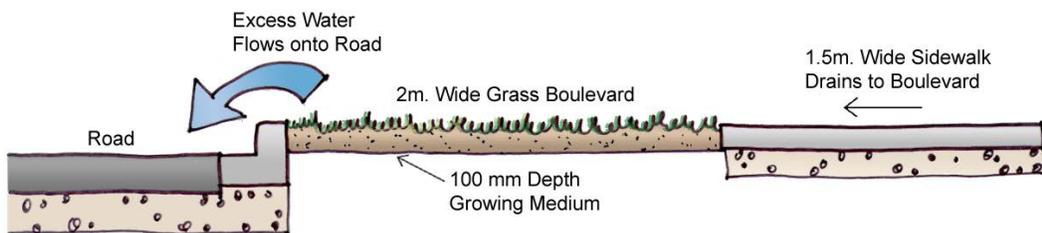
**Existing Proposal** – Perviousness 50% of stated amount due to shallow soil depth - Estimated EIA 77% (approx.)

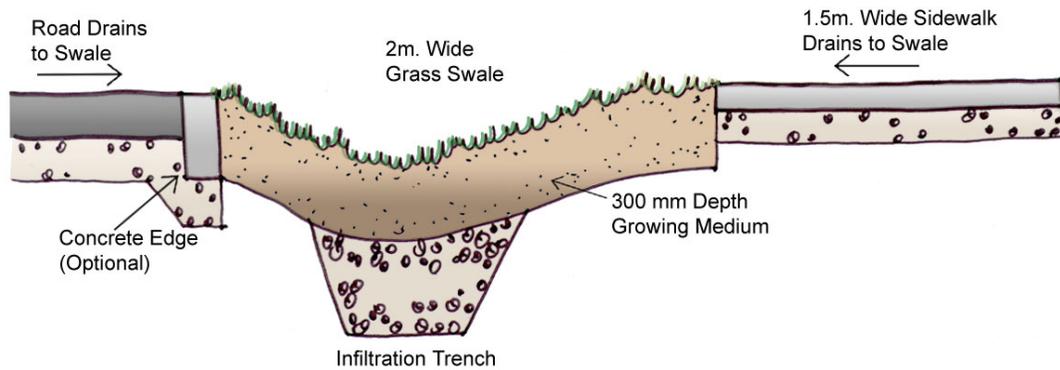
The next option for reducing EIA within the road rights-of-way would be to infiltrate the water from local roads. Local roads occupy the largest land area of any of the road types, and since they are the smallest roads, they are typically the ones on which a less urban standard is more acceptable. There are two primary methods by which the water from these roads could be infiltrated: using roadside swales, or with curb cuts enabling the water to flow into an infiltration trench, as shown below.

**Option 3:** Increase growing medium to 300 mm and infiltrate water from local roads with a swale and no curb. - *Estimated EIA 32% (approx.)*

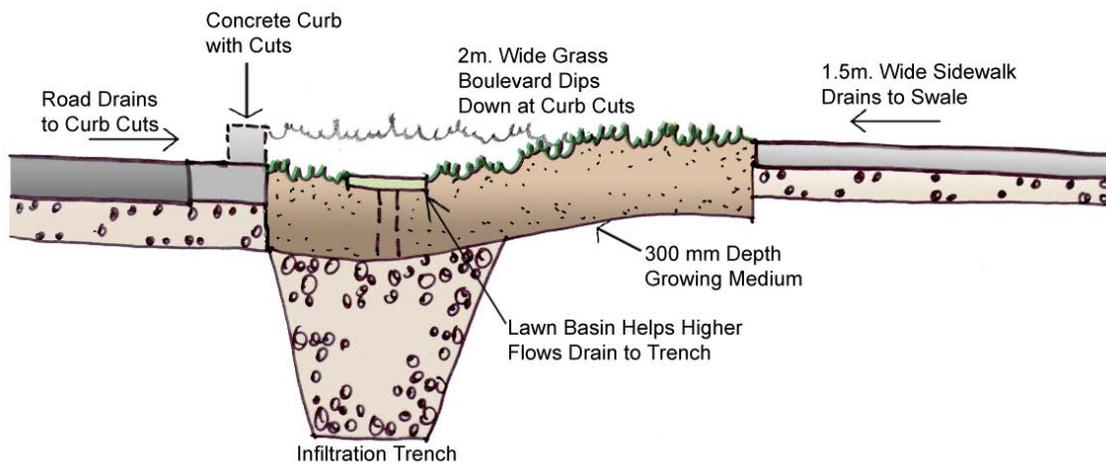
**Option 4:** Increase growing medium to 300 mm and infiltrate water from local roads with a trench and curb cuts - *Estimated EIA 32% (approx.)*

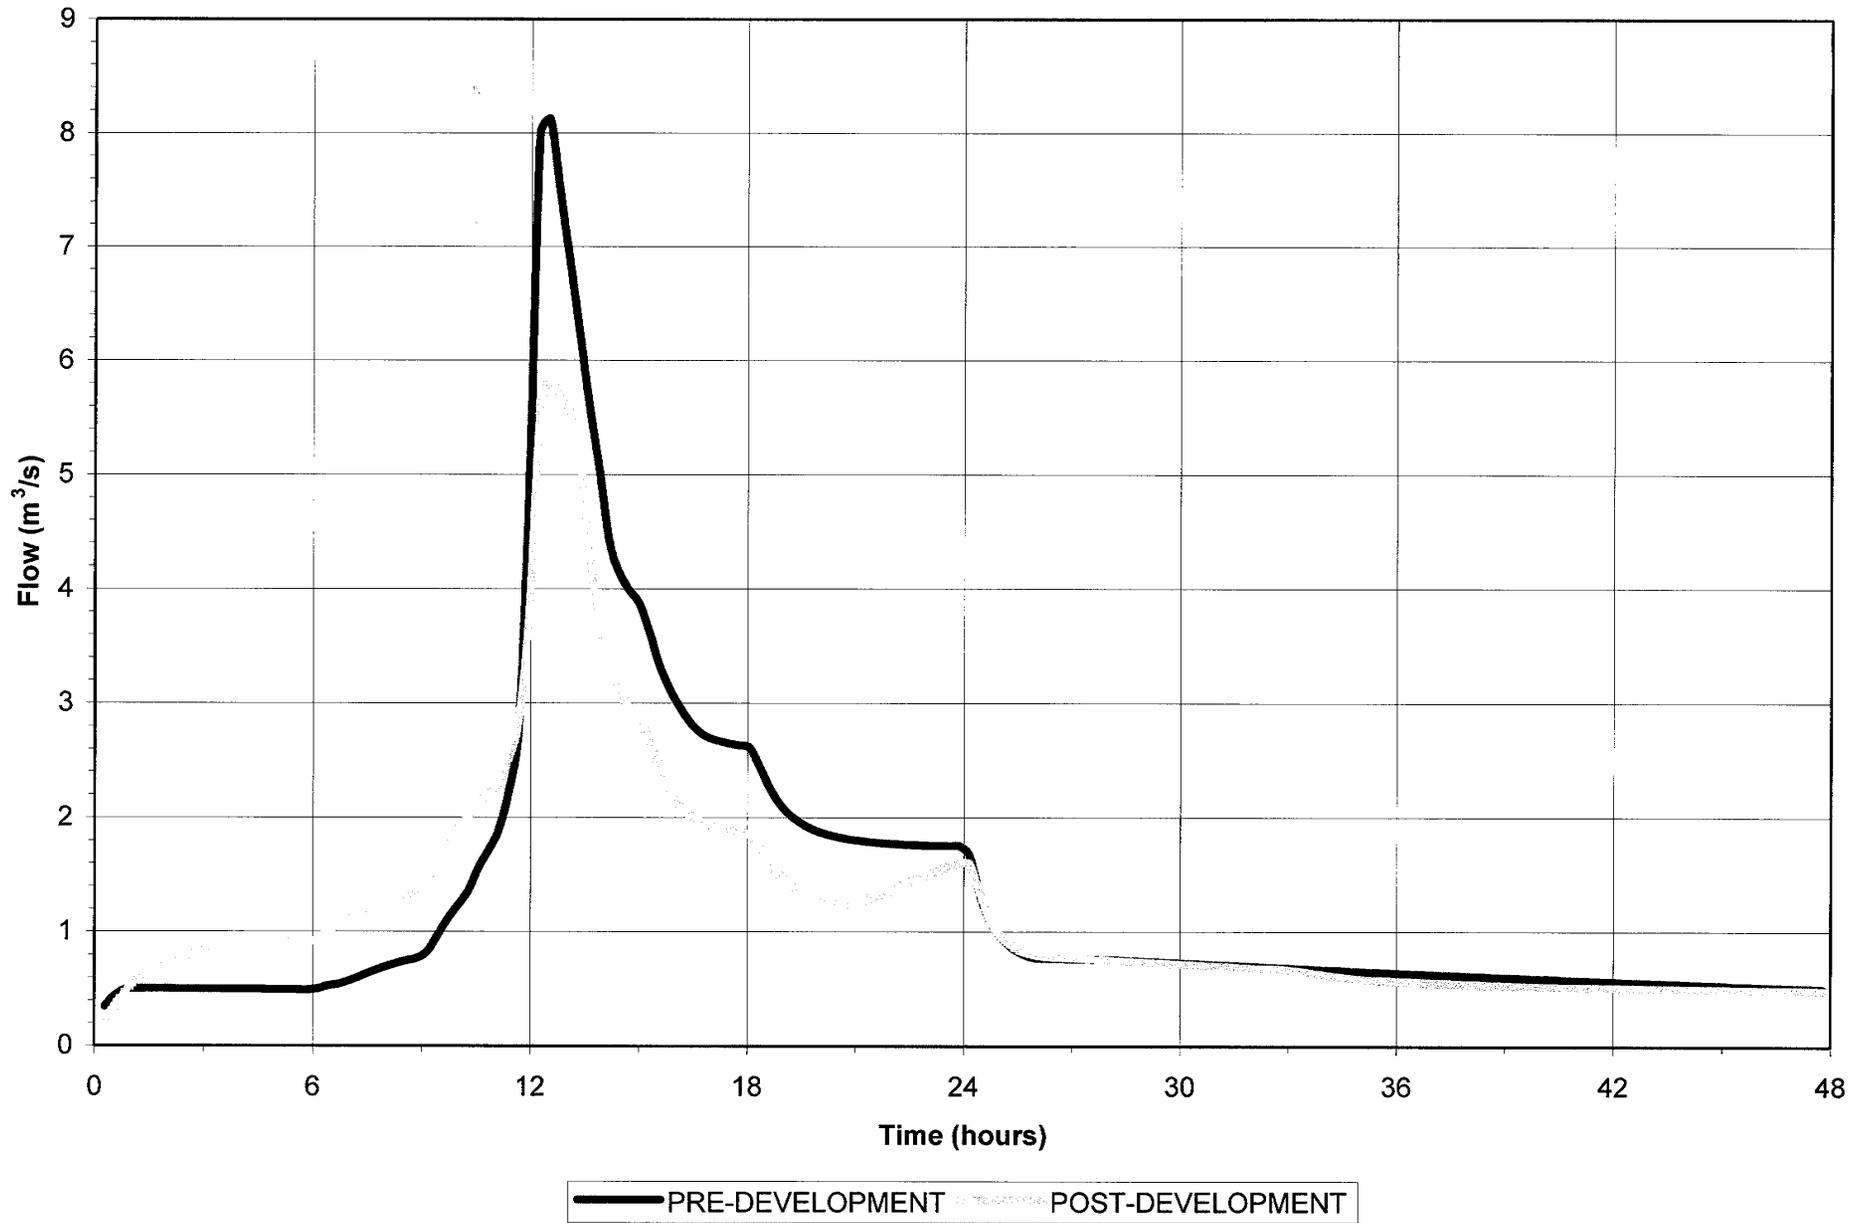
Figure 5.3A

# Hyde Creek @ Victoria Drive: Half-Year Hydrograph Comparison

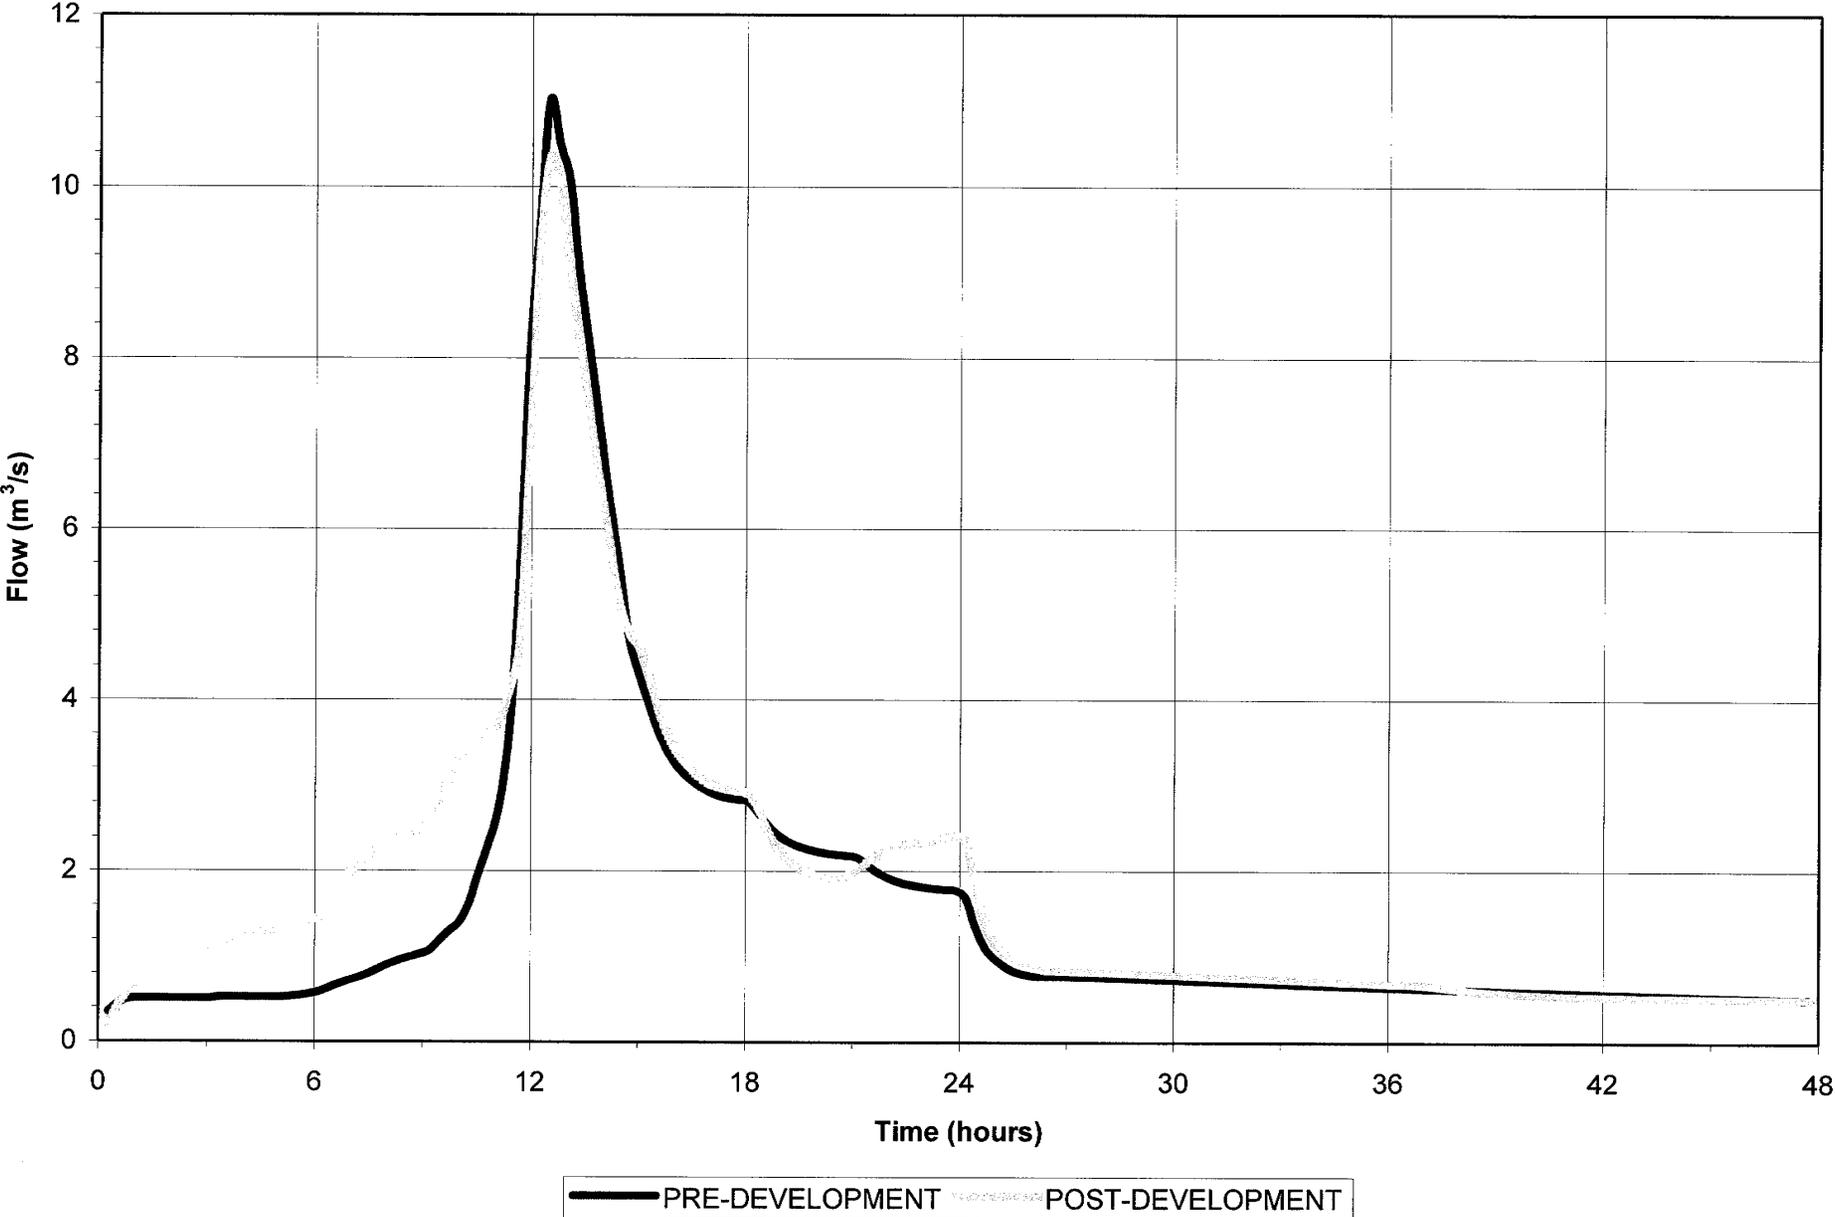
Figure 5.3B

# Hyde Creek @ Victoria Drive: 5-Year Hydrograph Comparison

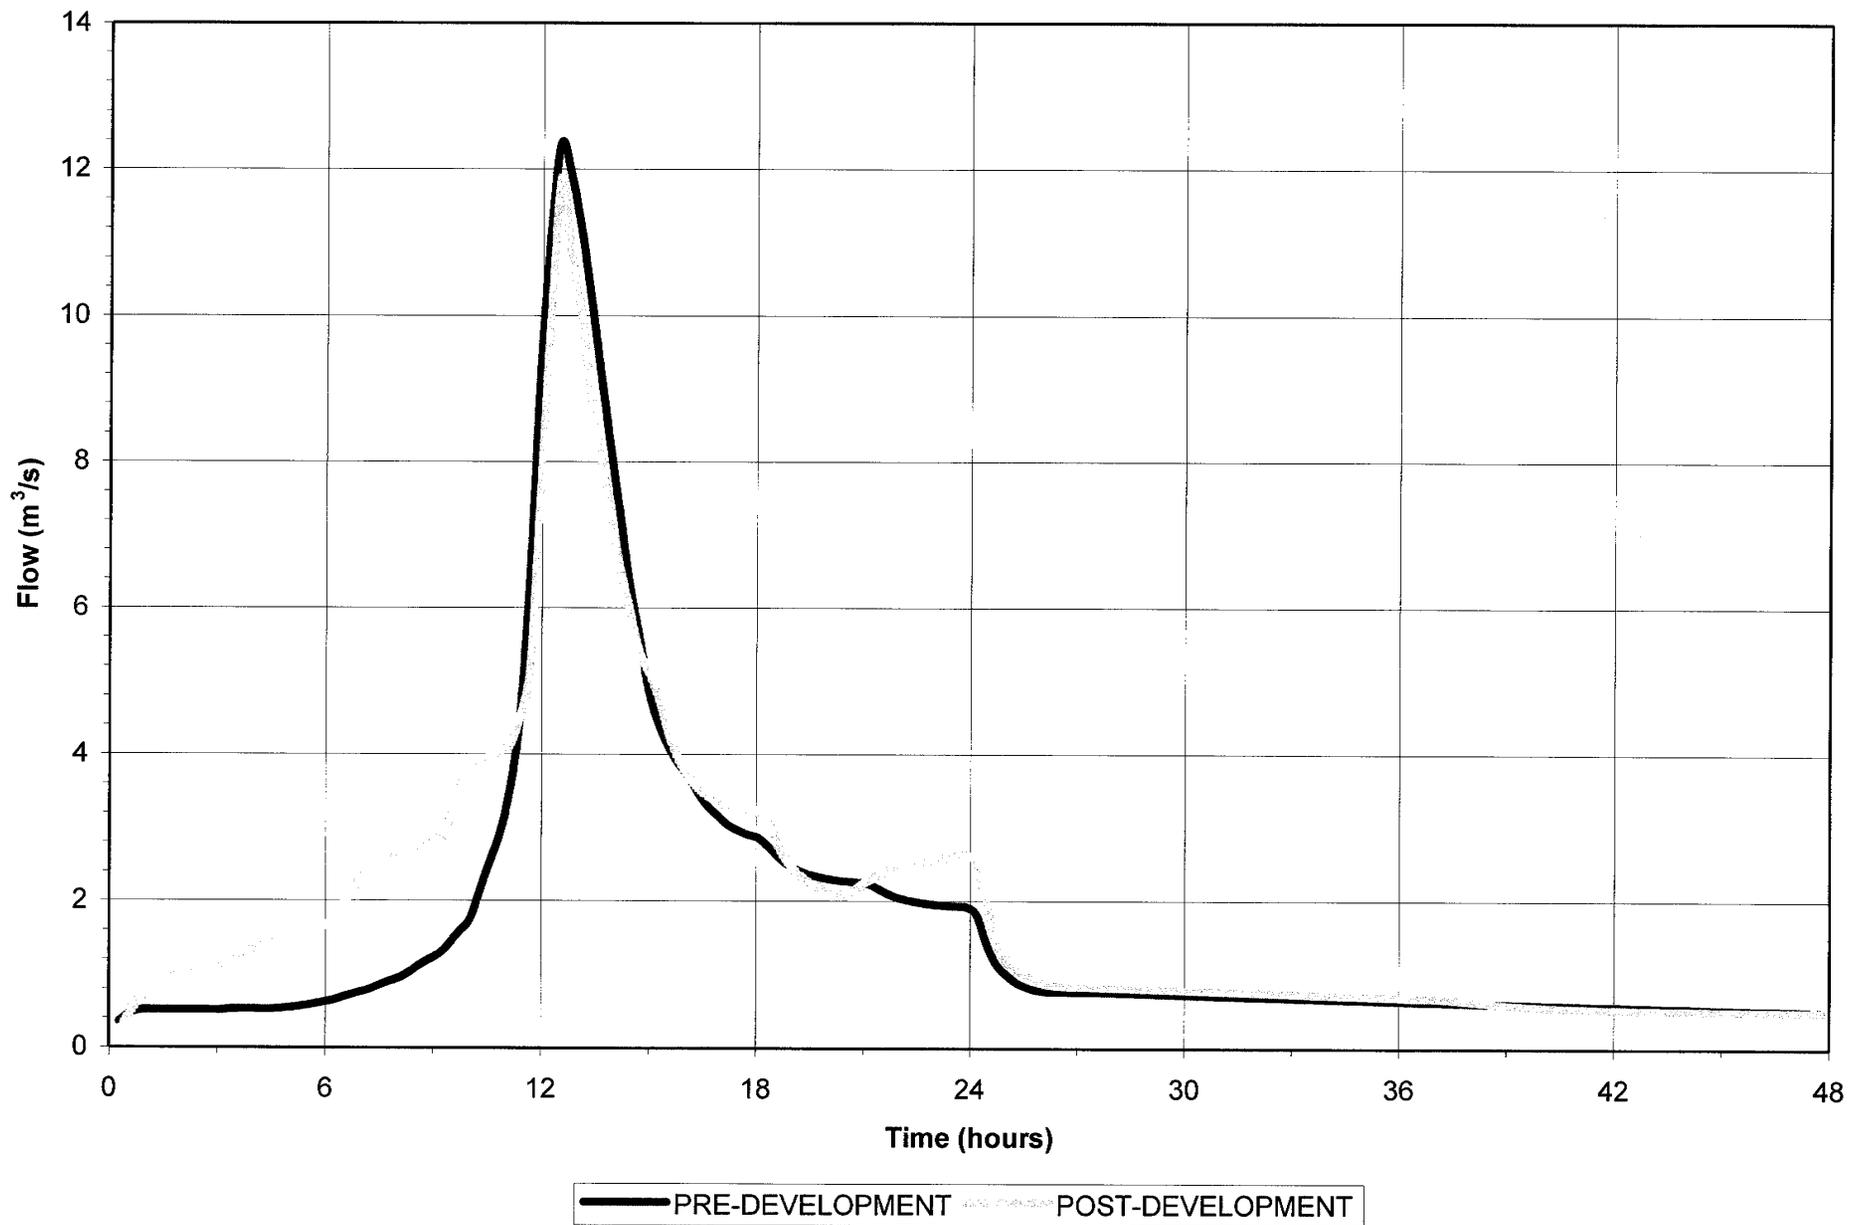
Figure 5.3C

### Hyde Creek @ Victoria Drive: 10-Year Hydrograph Comparison

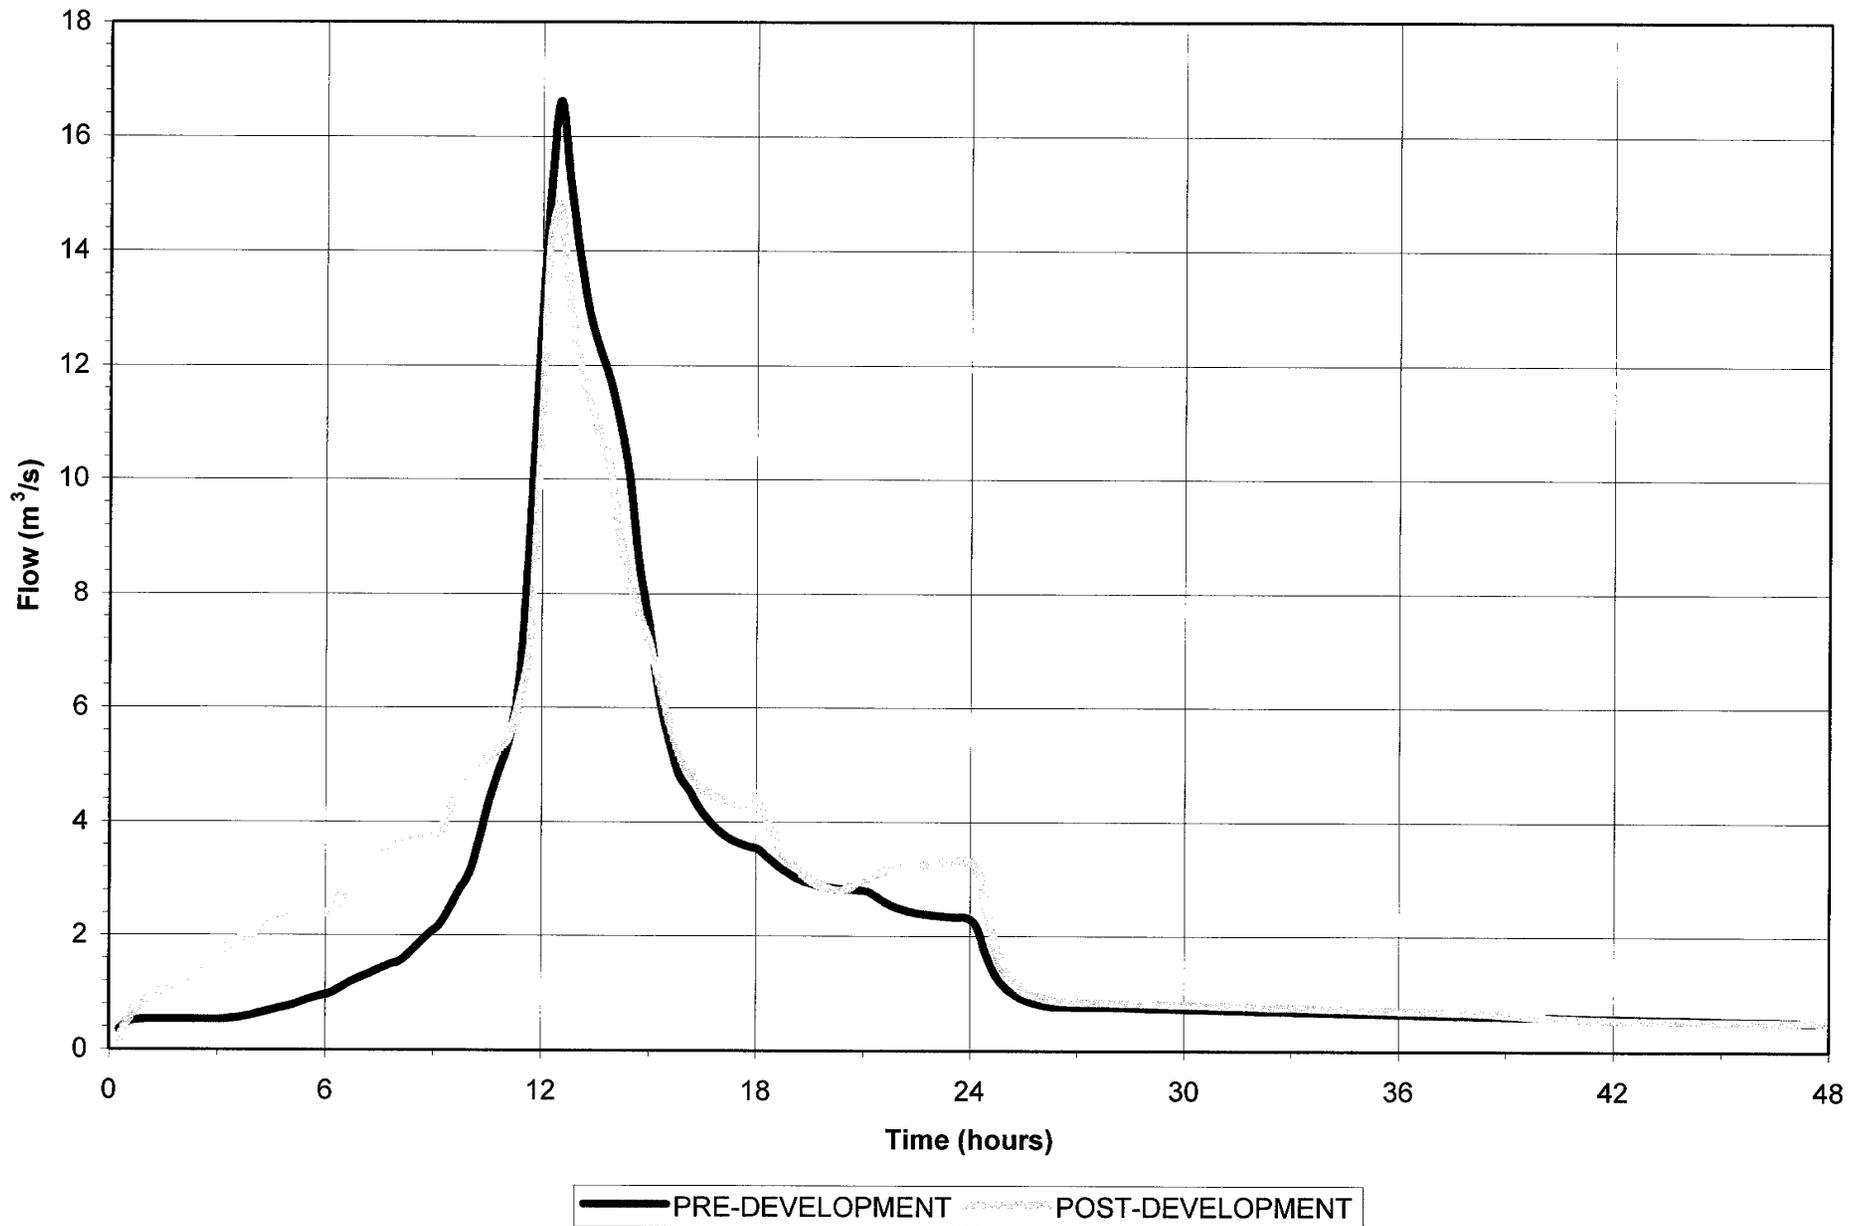
Figure 5.3D

# Hyde Creek @ Victoria Drive: 100-Year Hydrograph Comparison

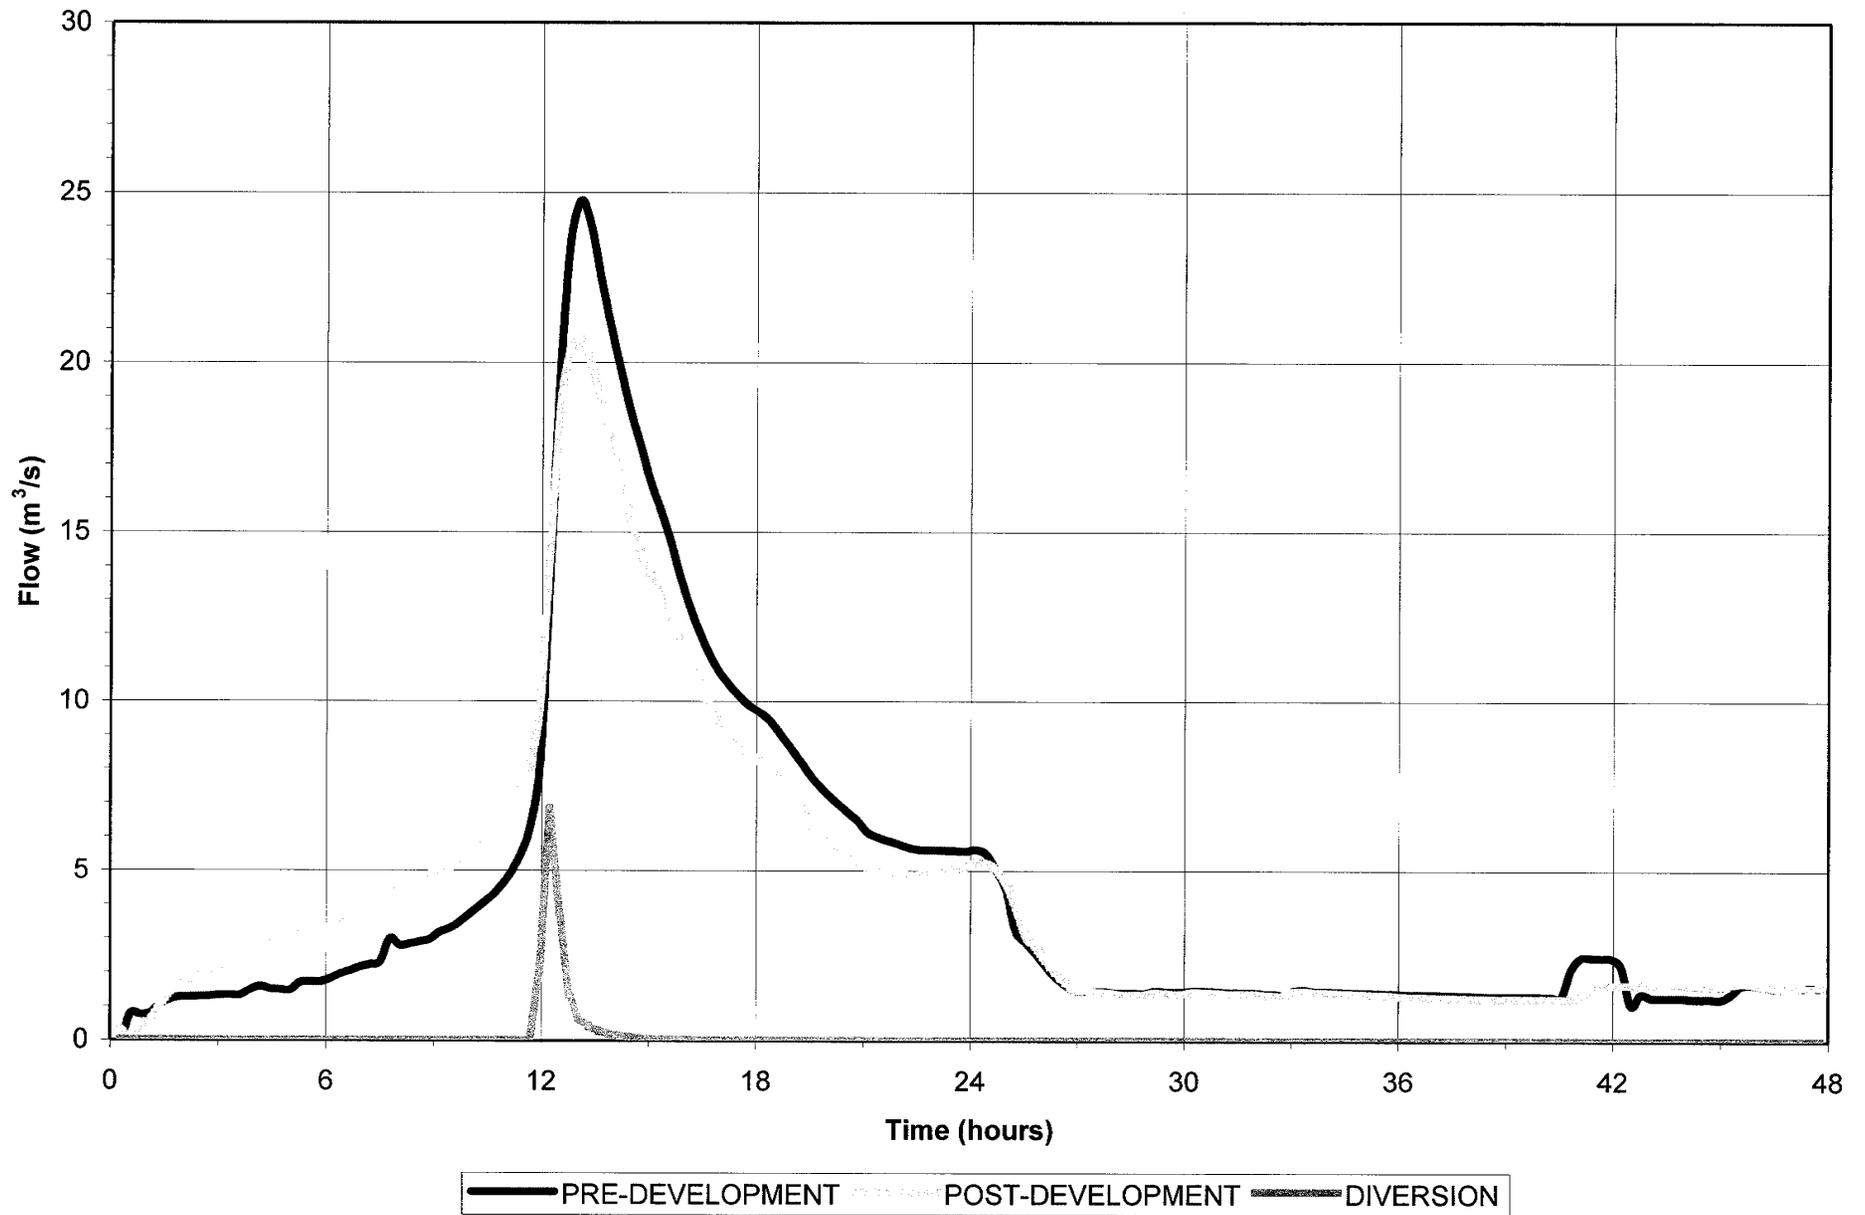
Figure 5.4A

### Cedar Ditch above DeBoville Slough: Half-Year Hydrograph Comparison

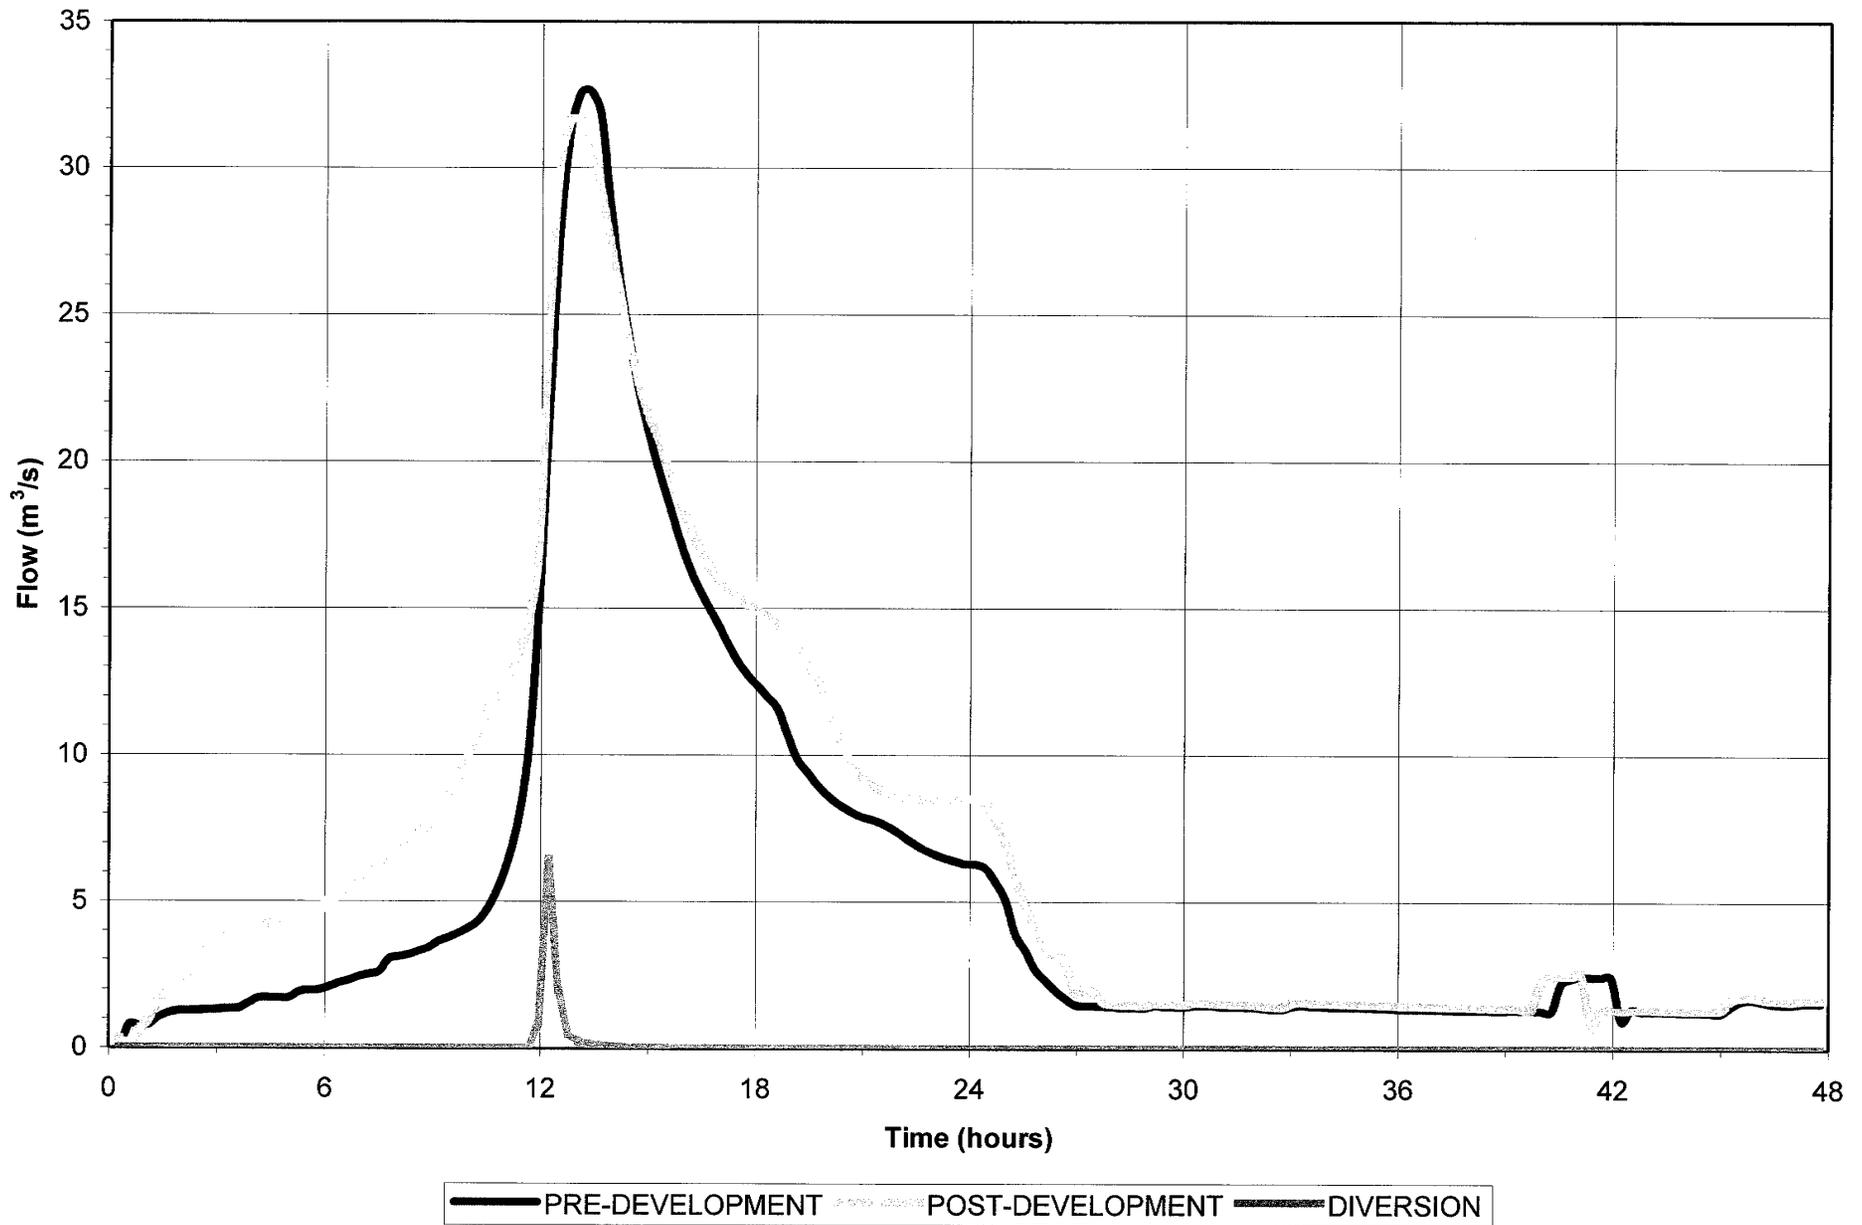
Figure 5.4B

### Cedar Ditch above DeBoville Slough: 5-Year Hydrograph Comparison

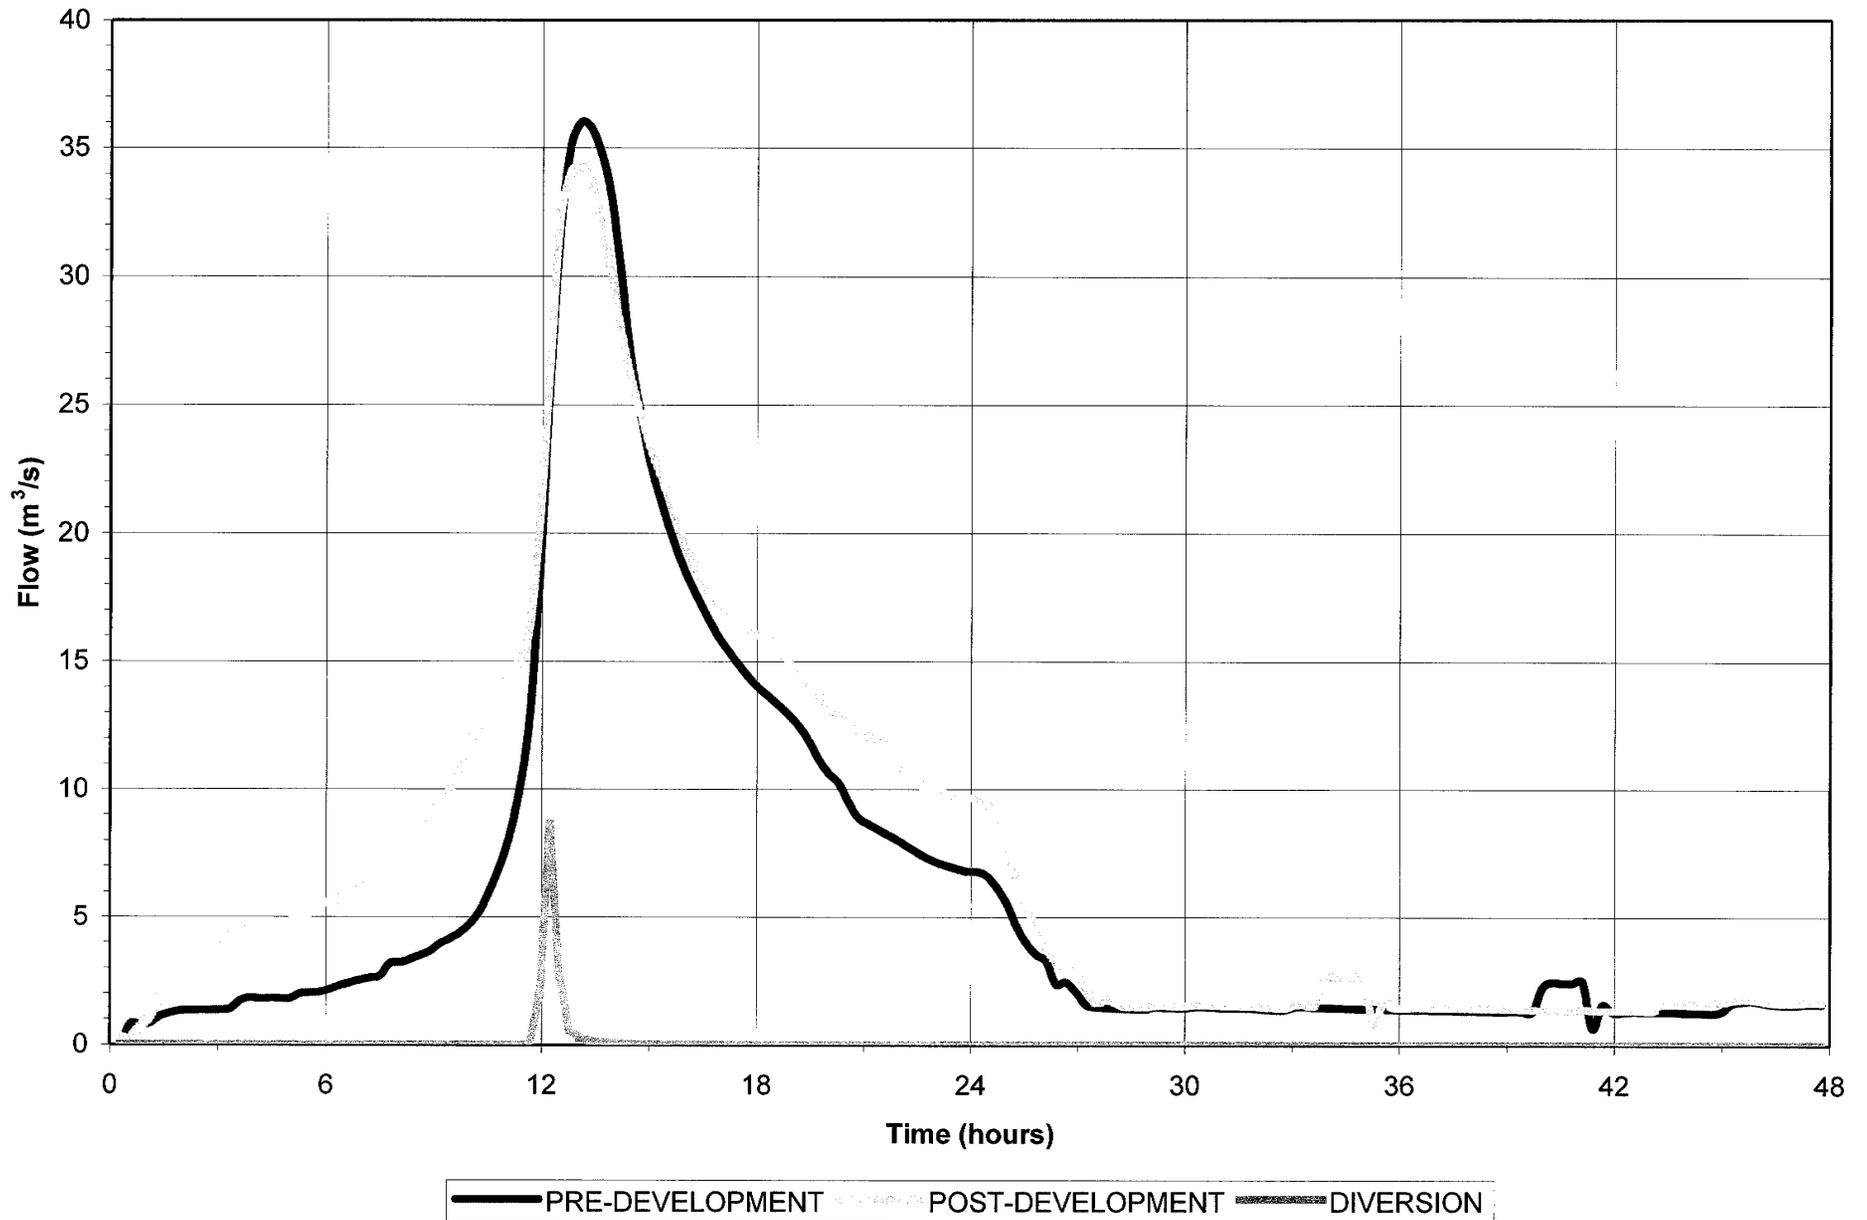
Figure 5.4C

### Cedar Ditch above DeBoville Slough: 10-Year Hydrograph Comparison

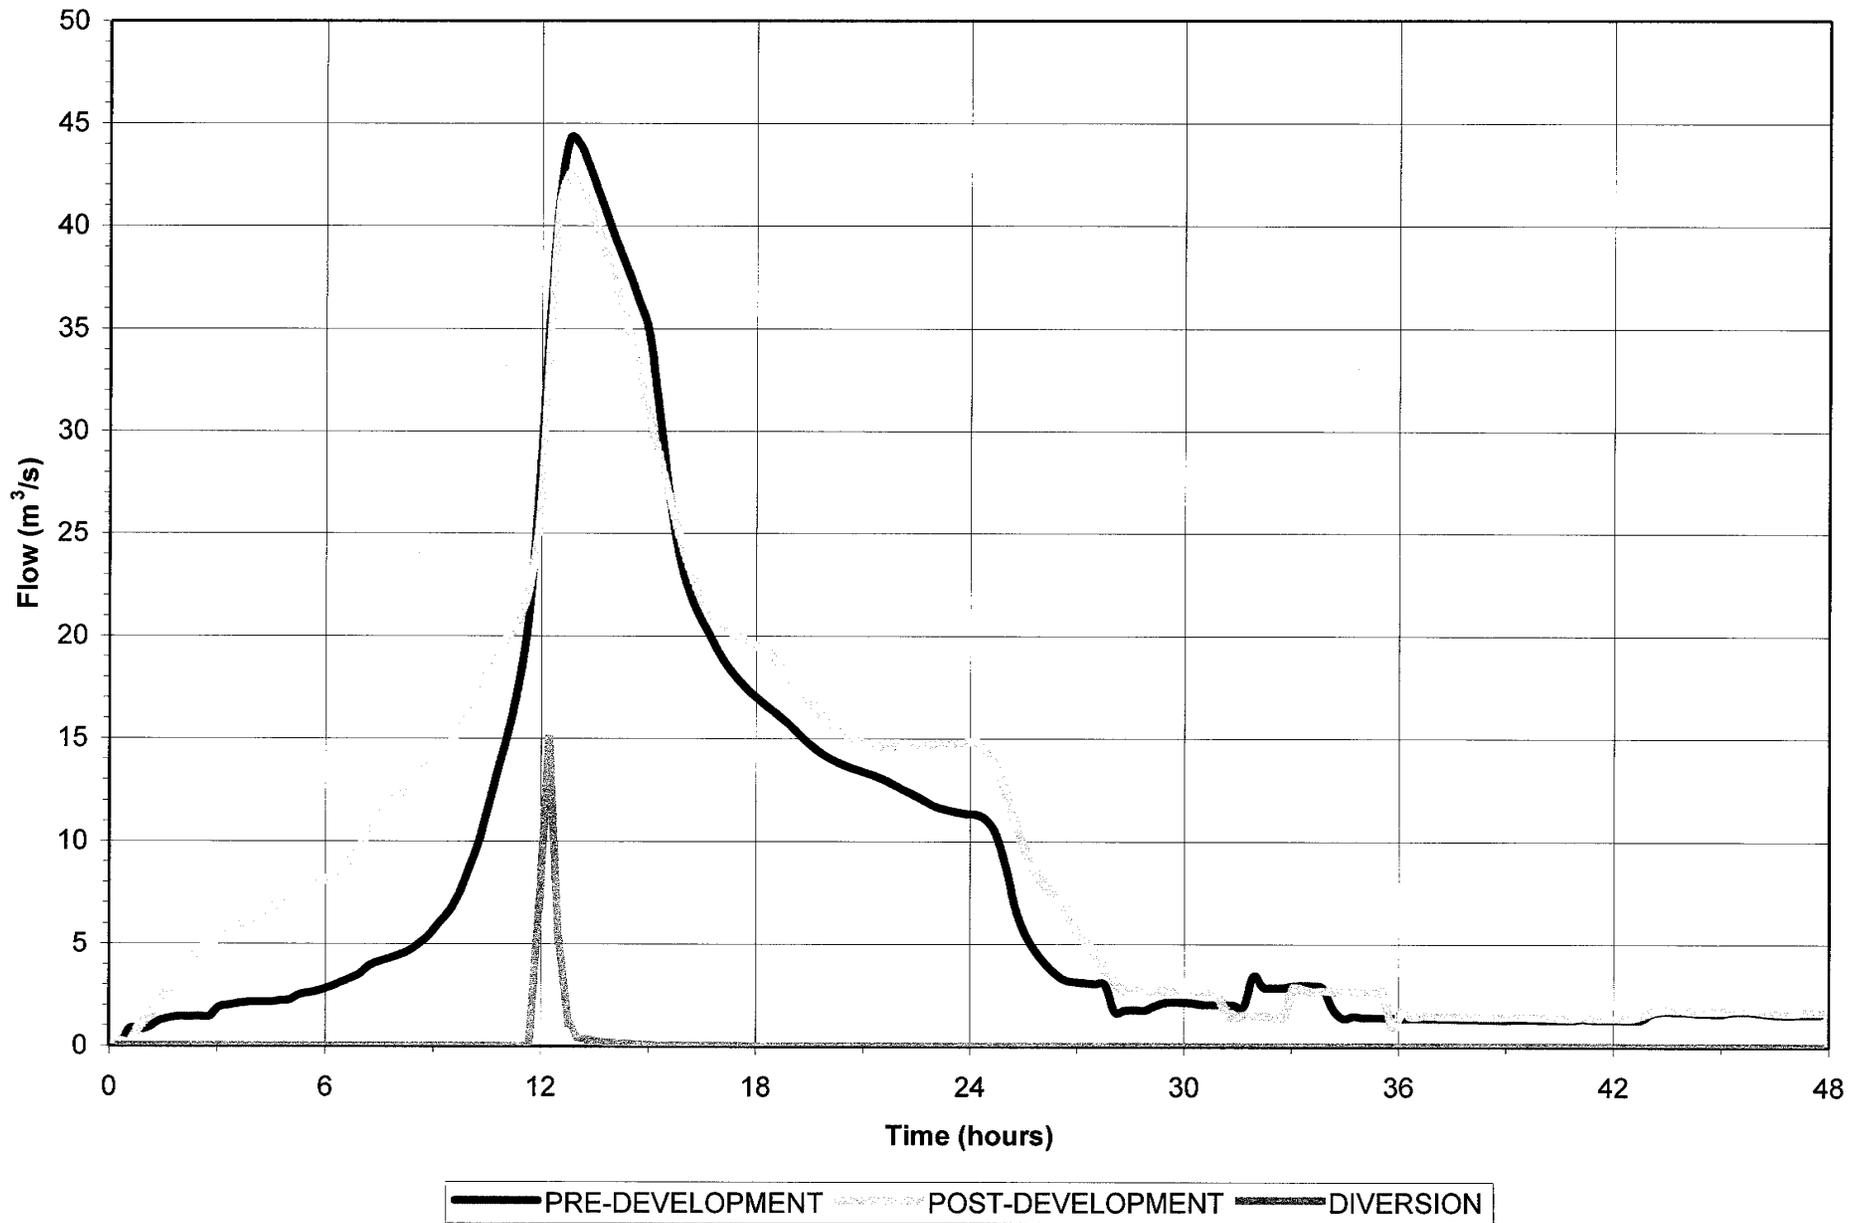
Figure 5.4D

### Cedar Ditch above DeBoville Slough: 100-Year Hydrograph Comparison

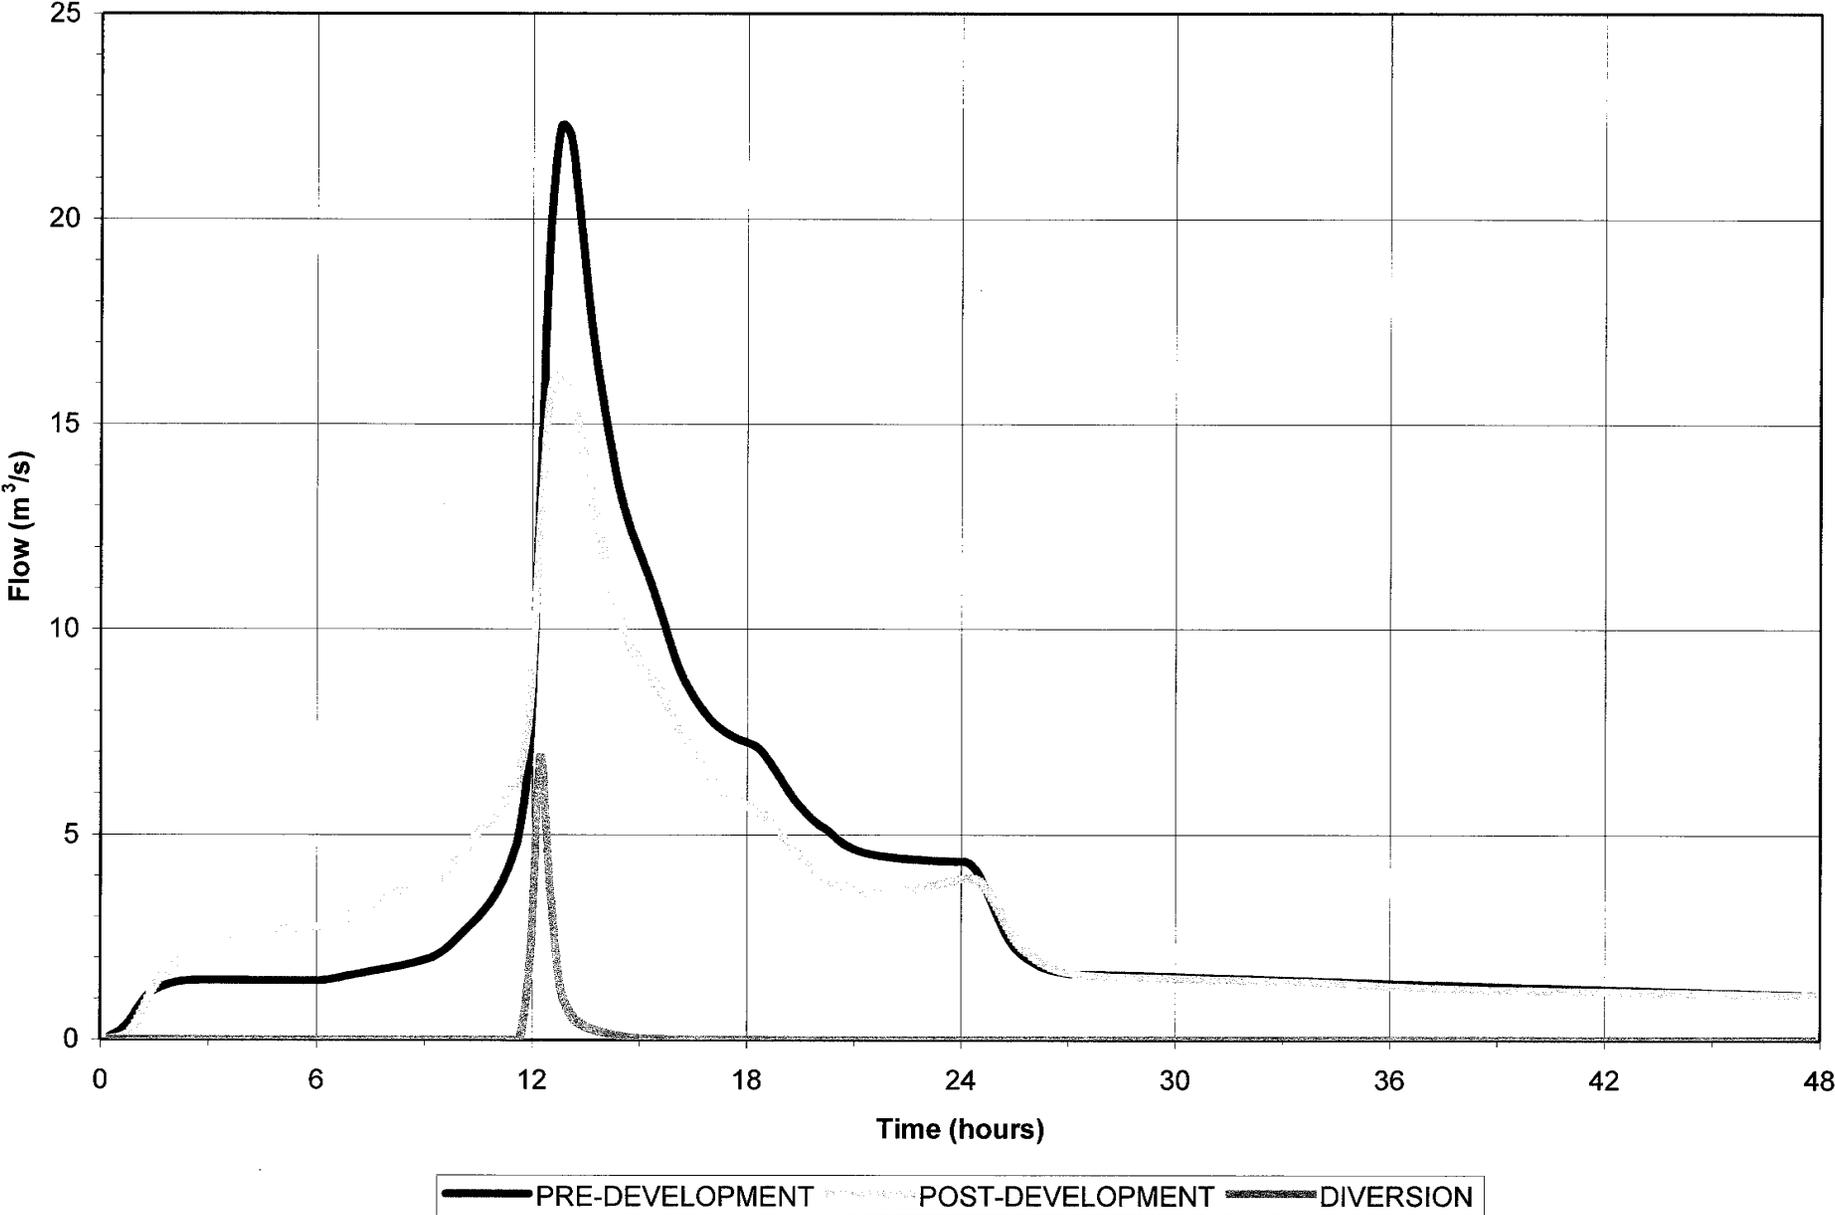
Figure 5.5A

# Hyde Creek above Cedar Ditch: Half-Year Hydrograph Comparison
