**F I N A L   R E P O R T**

**CITY OF COQUITLAM  
CITY OF PORT COQUITLAM**

**Hyde Creek Integrated  
Watershed Management Plan**

**Re: HYDE CREEK IWMP FINAL REPORT**

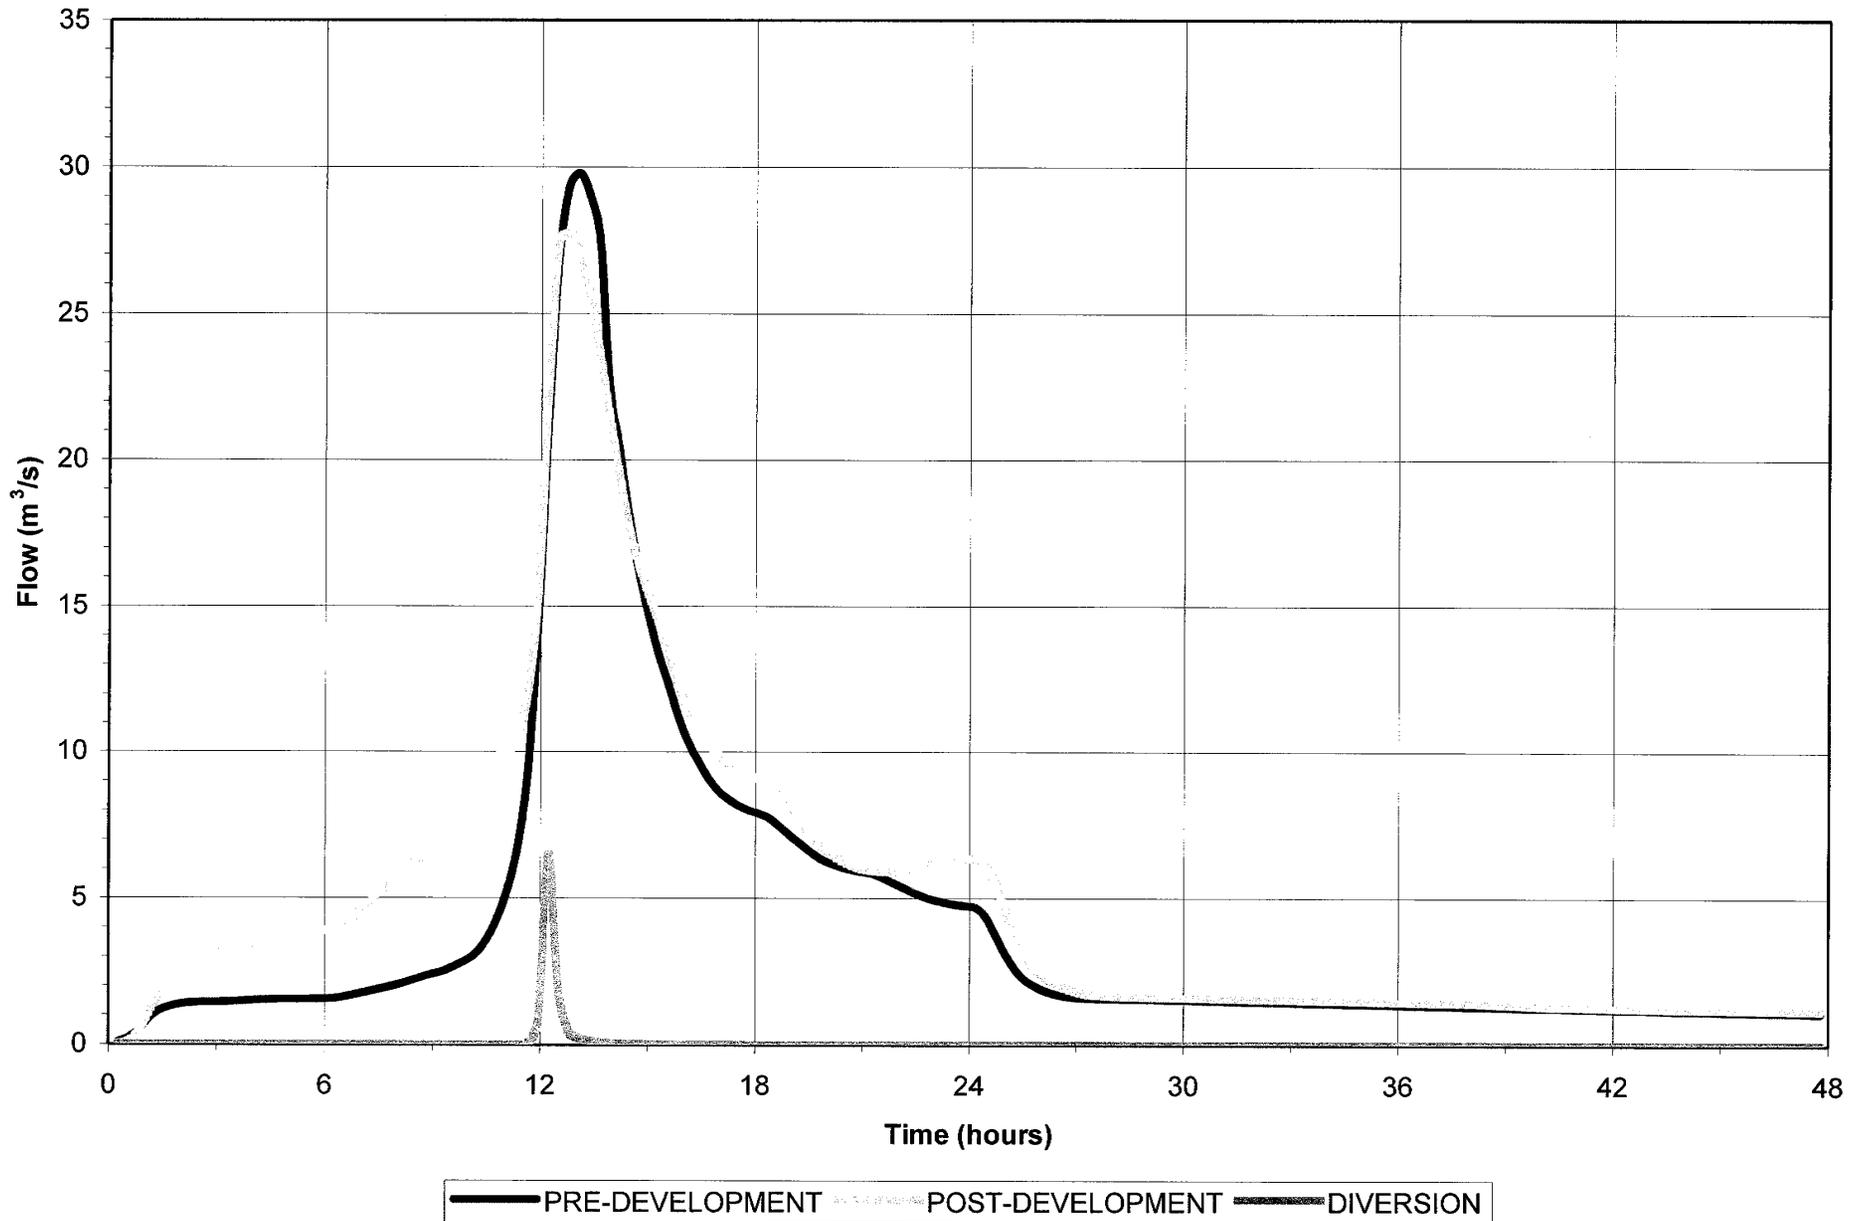
Figure 5.5B

# Hyde Creek above Cedar Ditch: 5-Year Hydrograph Comparison

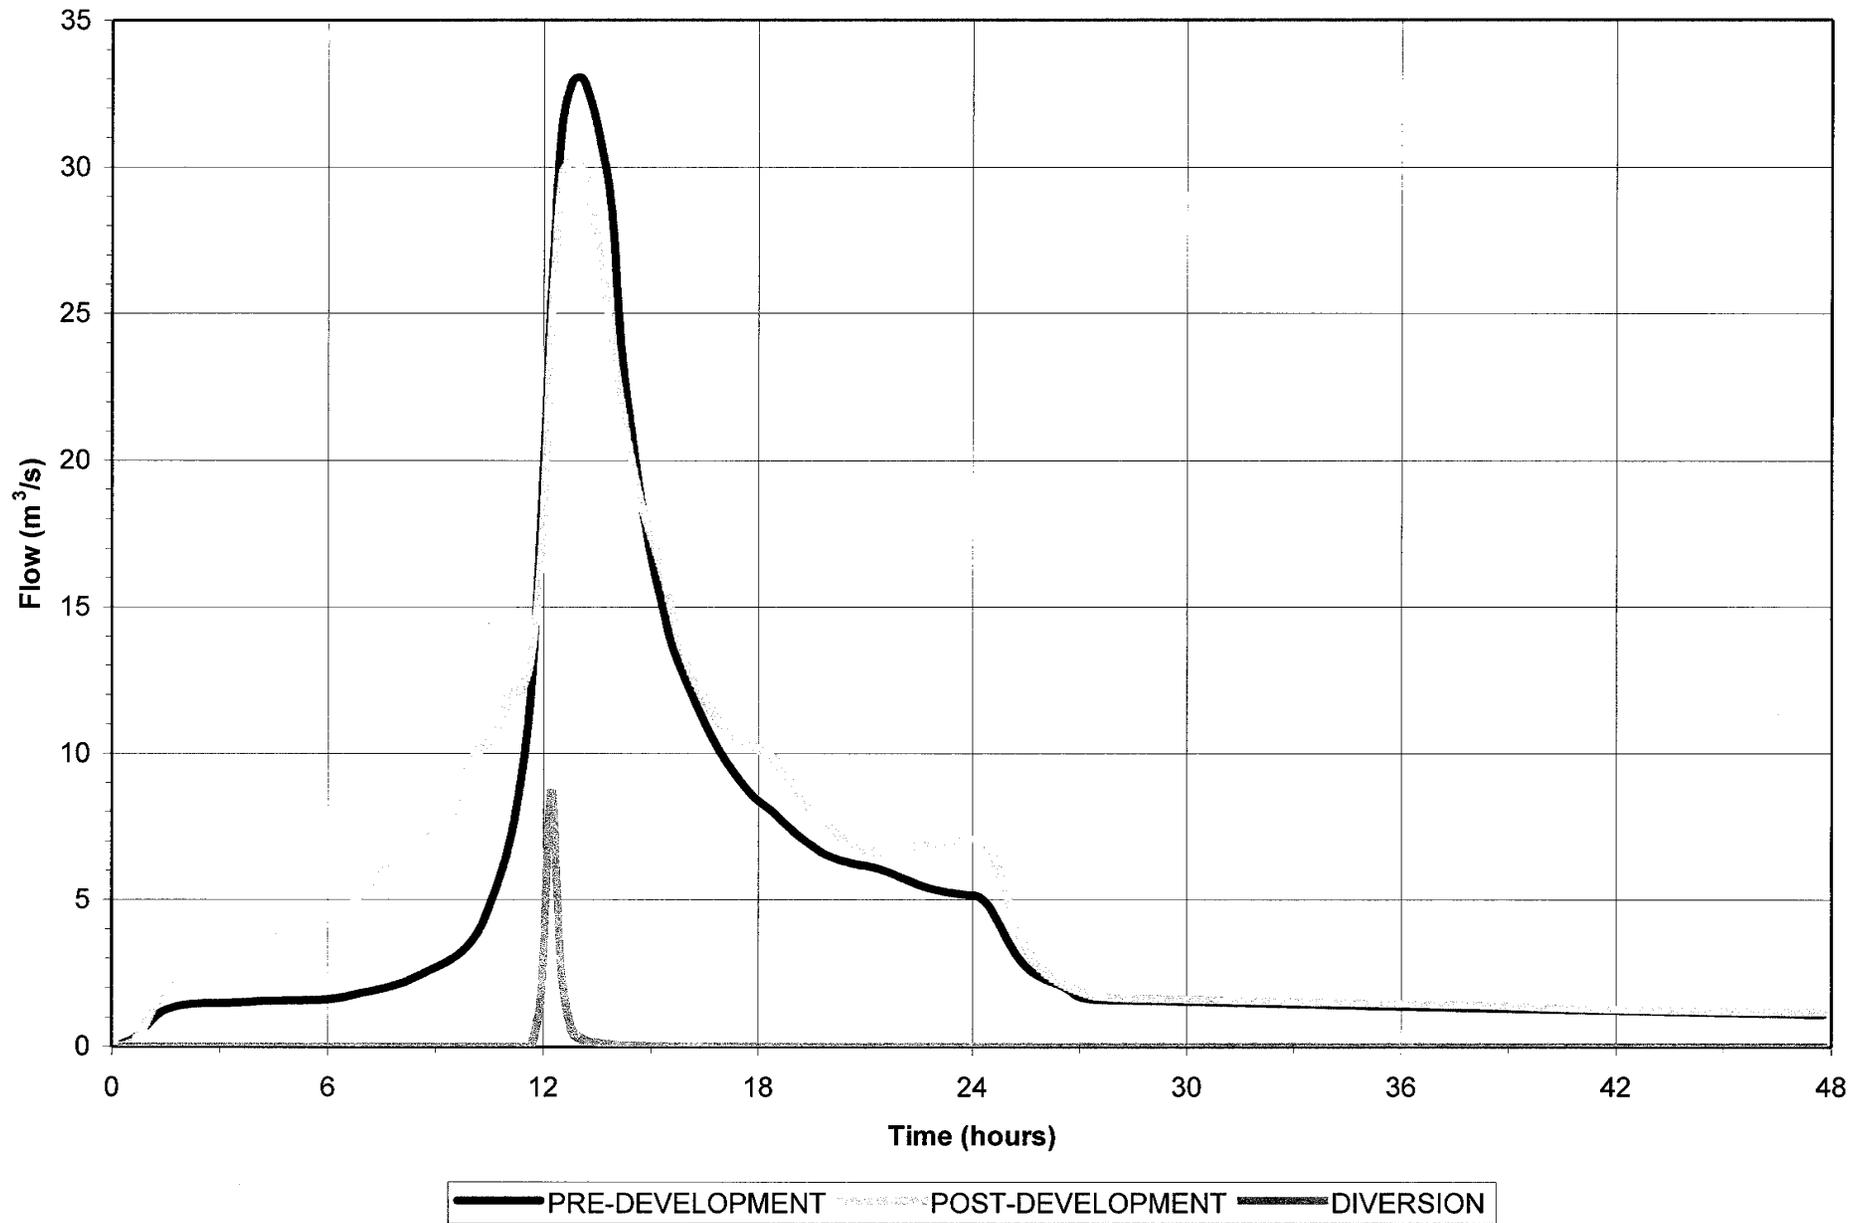
Figure 5.5C

### Hyde Creek above Cedar Ditch: 10-Year Hydrograph Comparison

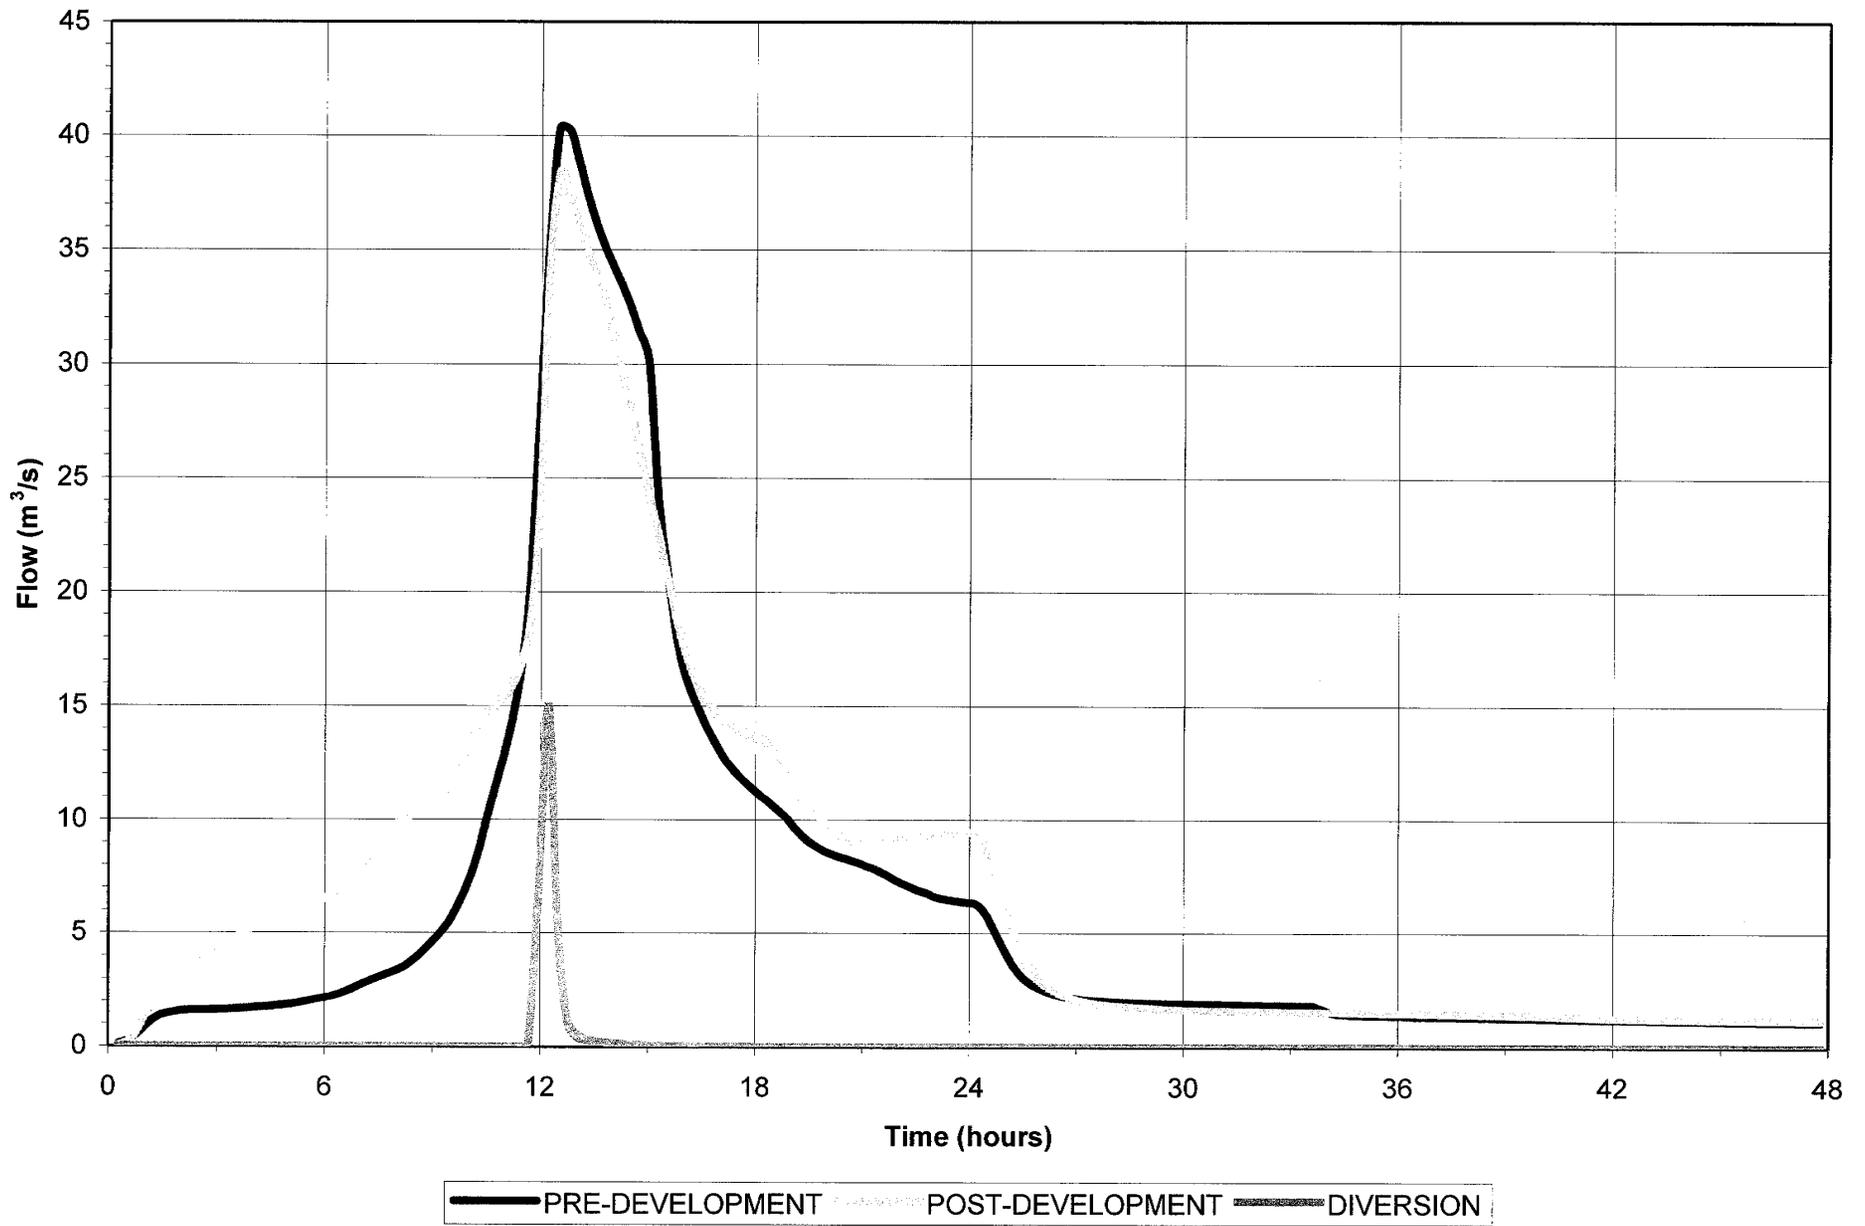
Figure 5.5D

### Hyde Creek above Cedar Ditch: 100-Year Hydrograph Comparison

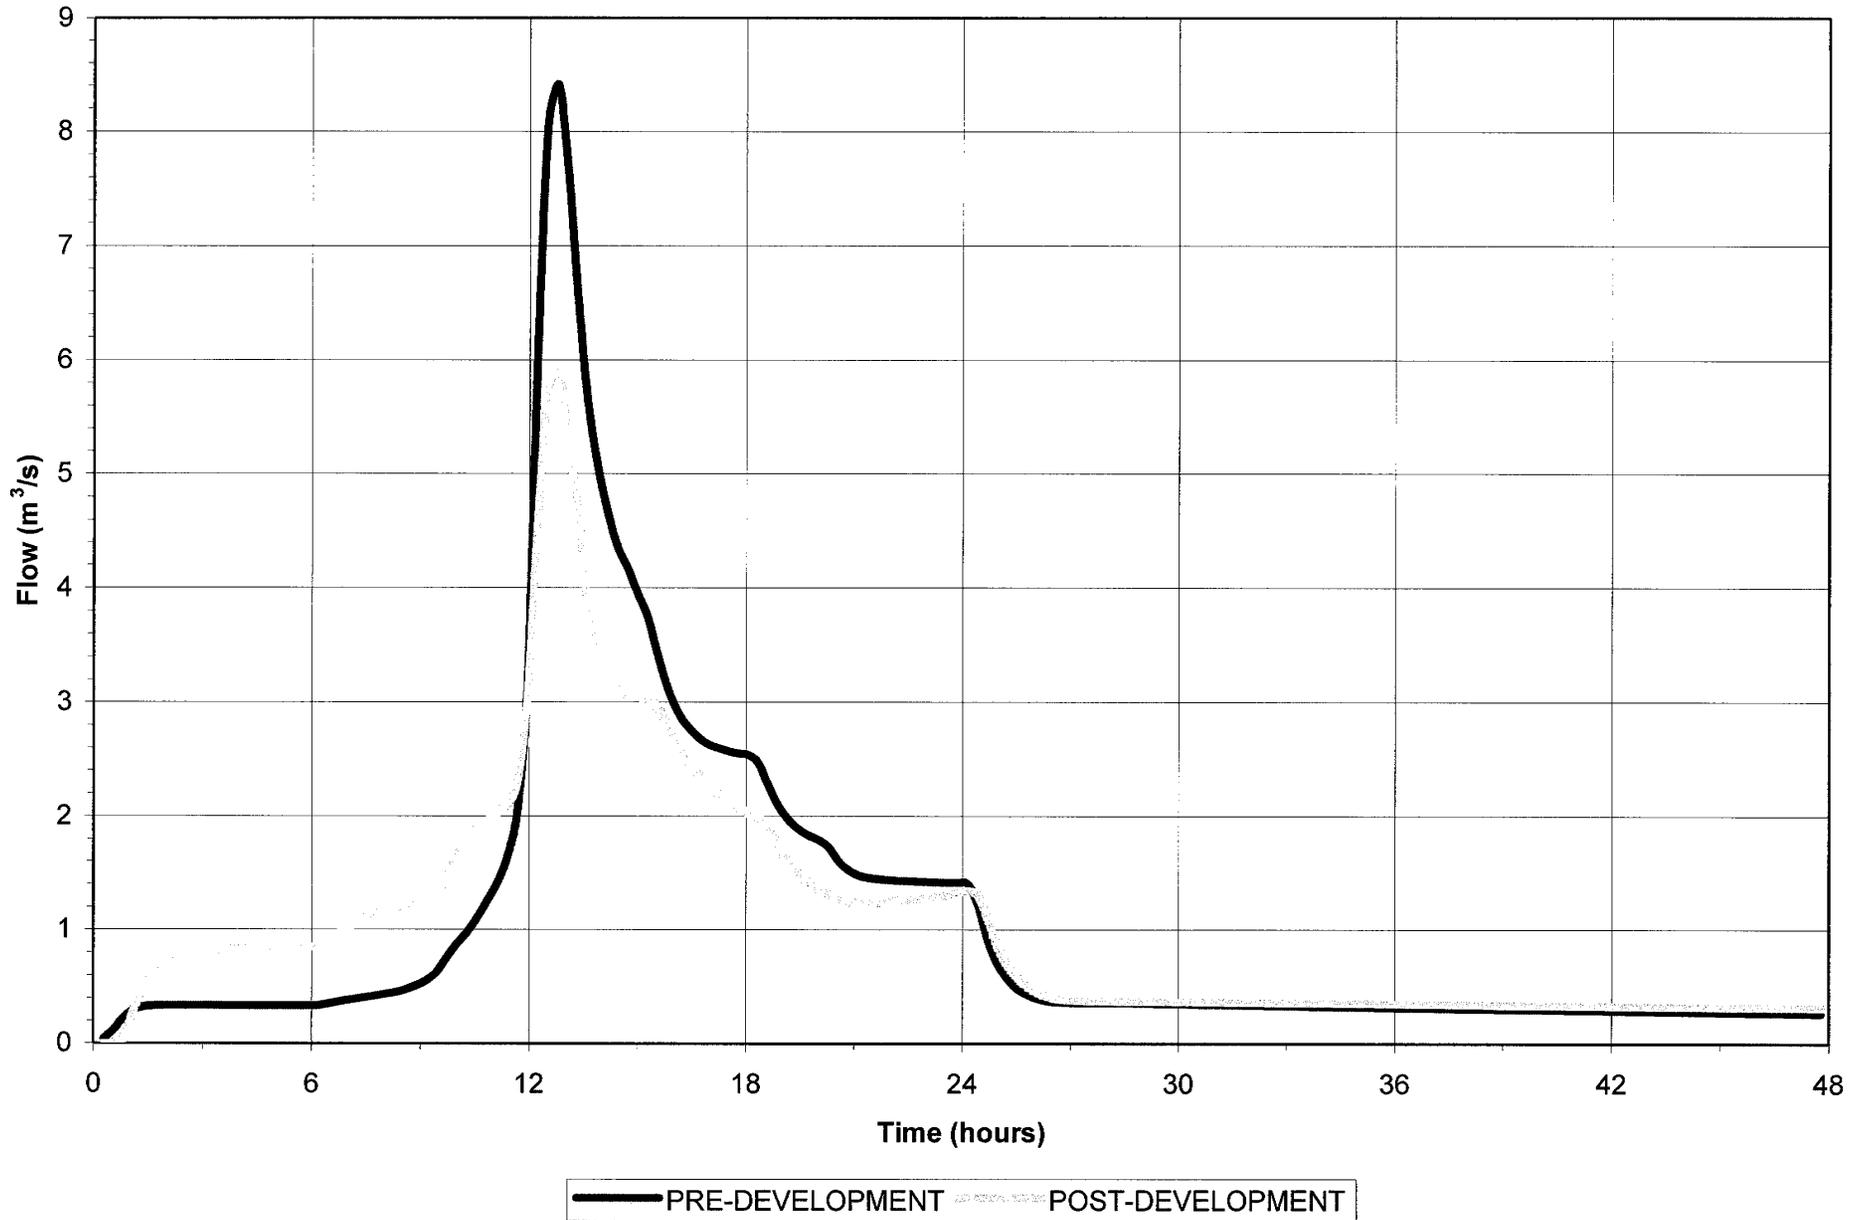
Figure 5.6A

### Smiling Creek above Hyde Creek: Half-Year Hydrograph Comparison

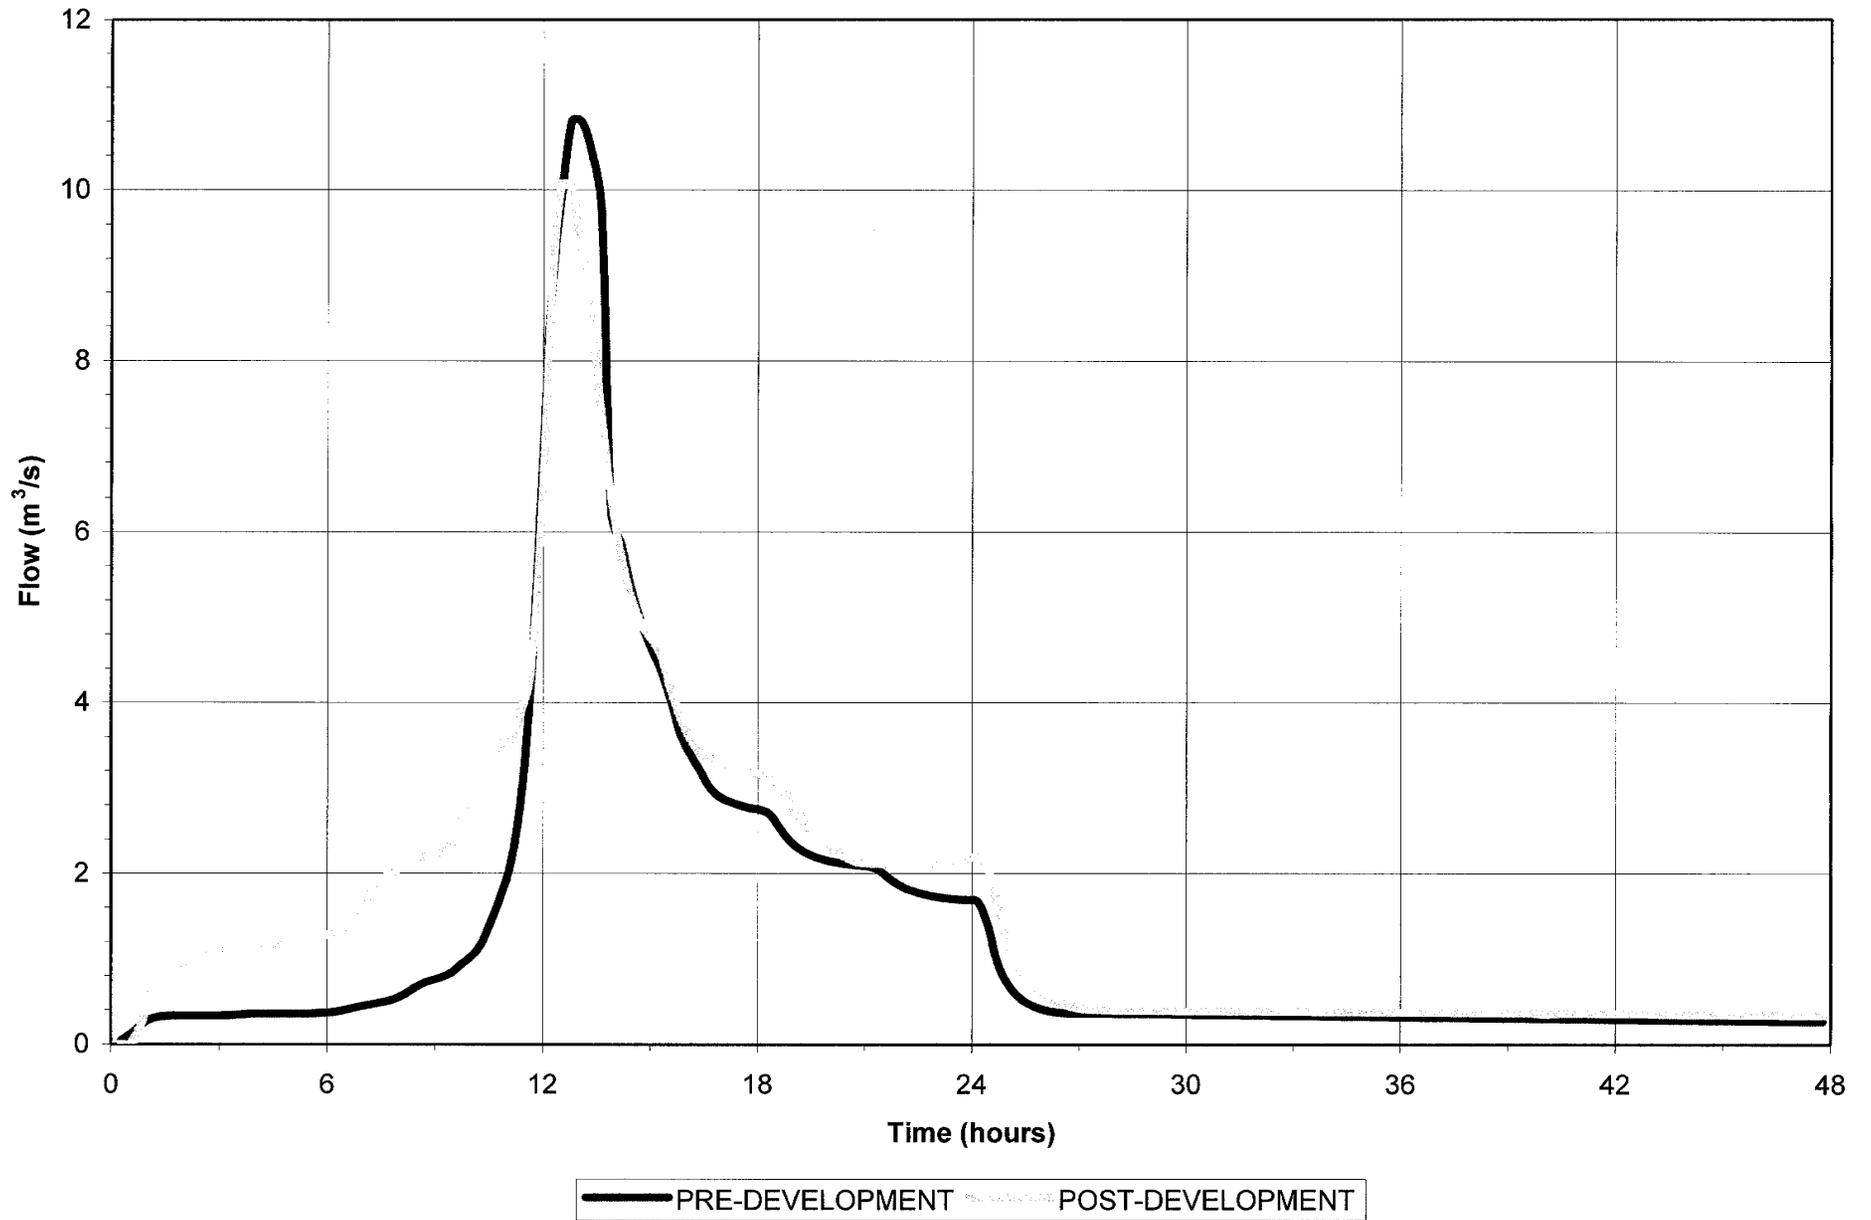
Figure 5.6B

### Smiling Creek above Hyde Creek: 5-Year Hydrograph Comparison

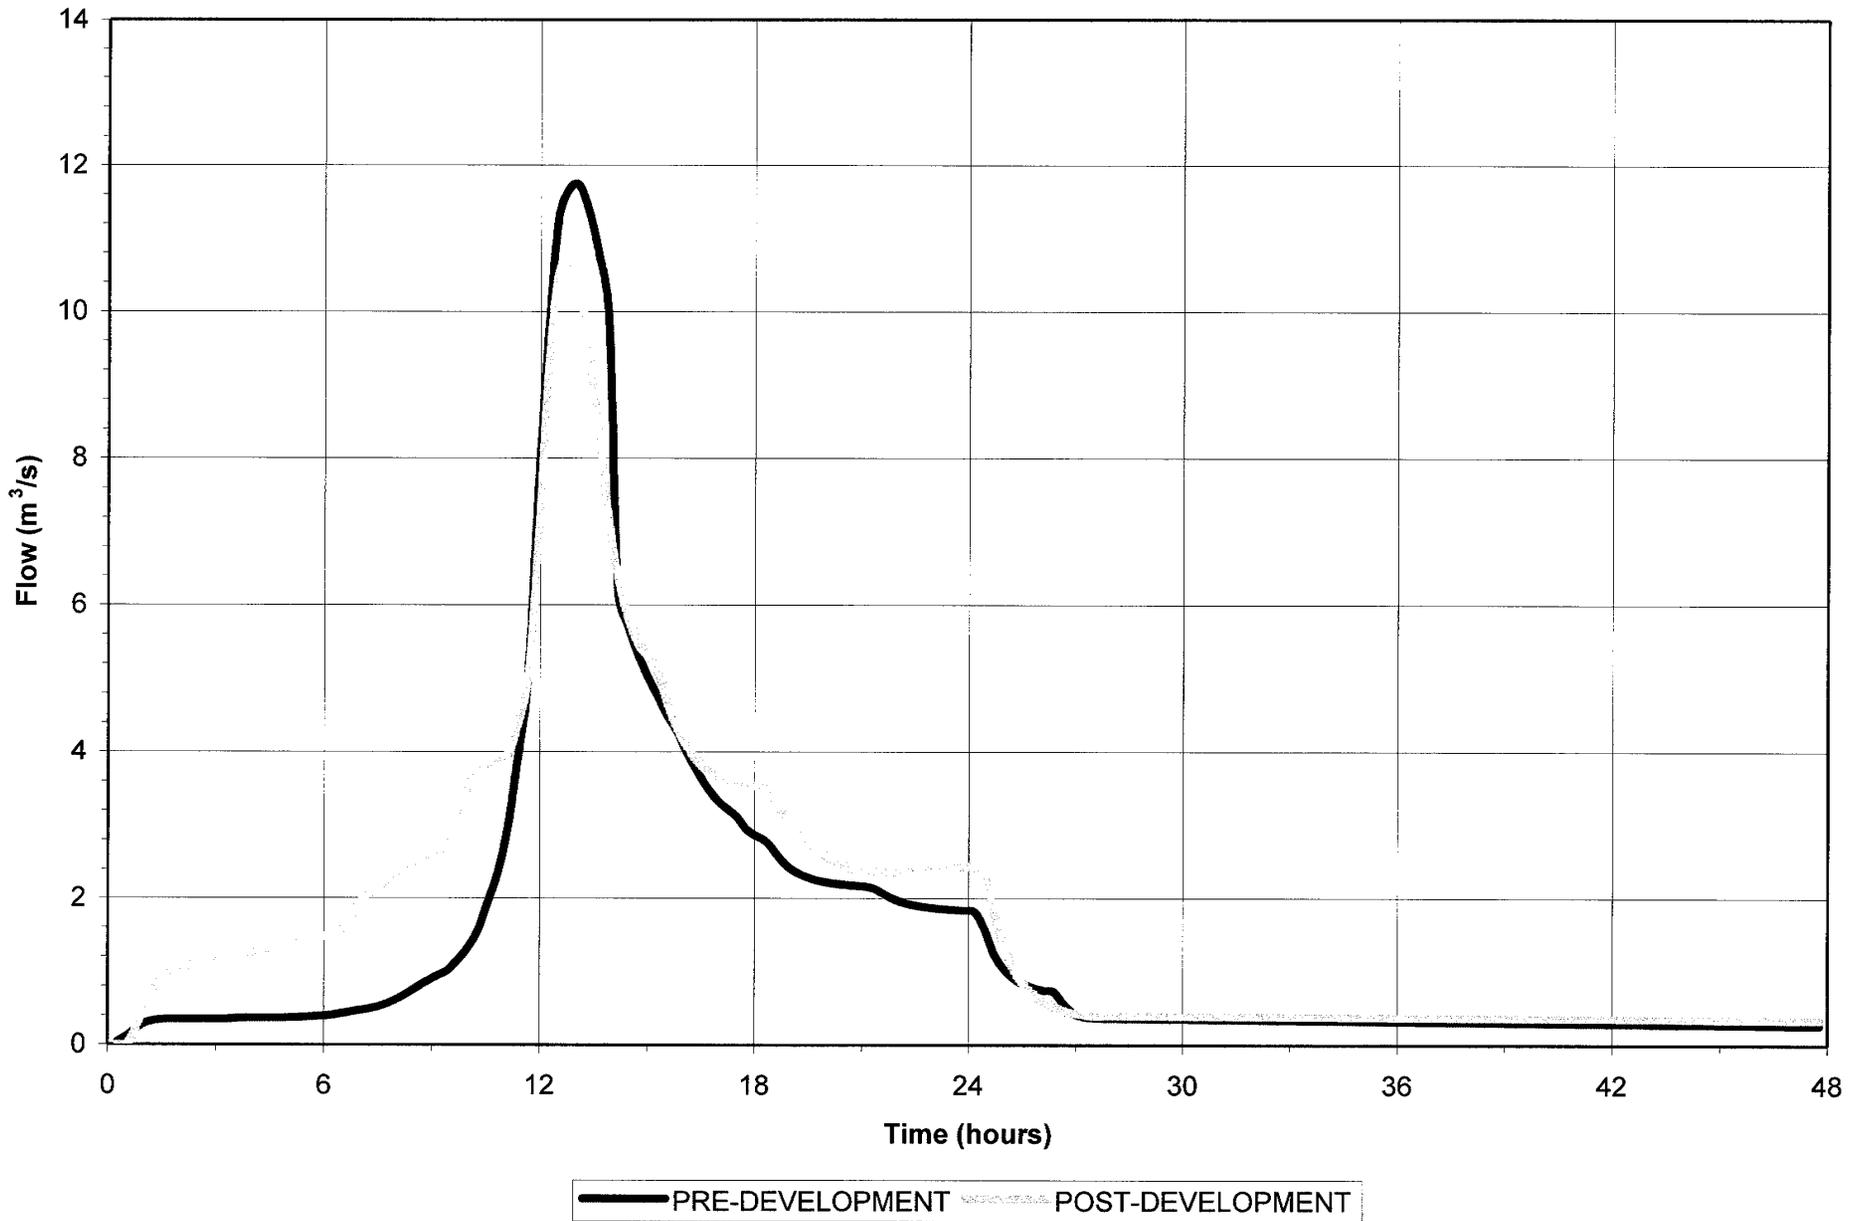
Figure 5.6C

### Smiling Creek above Hyde Creek: 10-Year Hydrograph Comparison

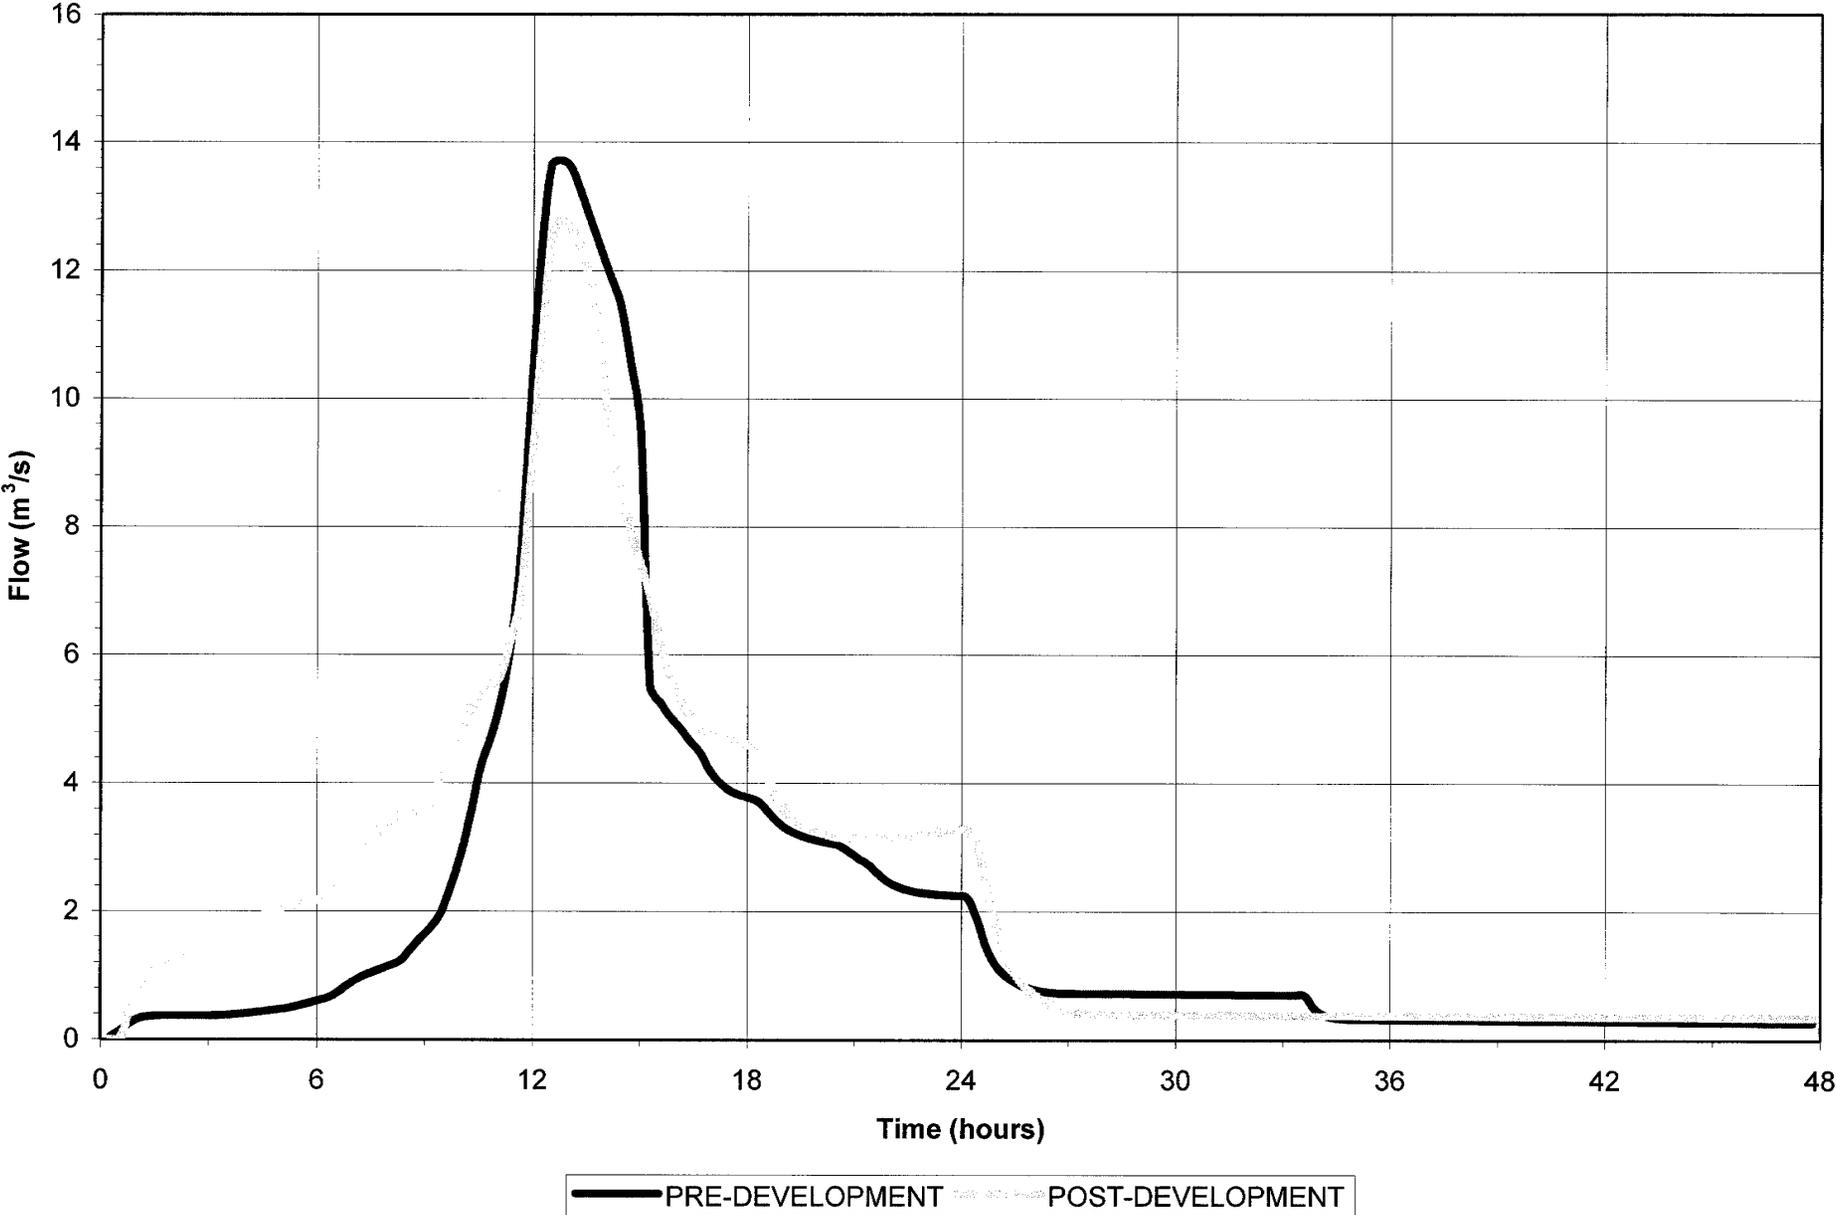
Figure 5.6D

### Smiling Creek above Hyde Creek: 100-Year Hydrograph Comparison

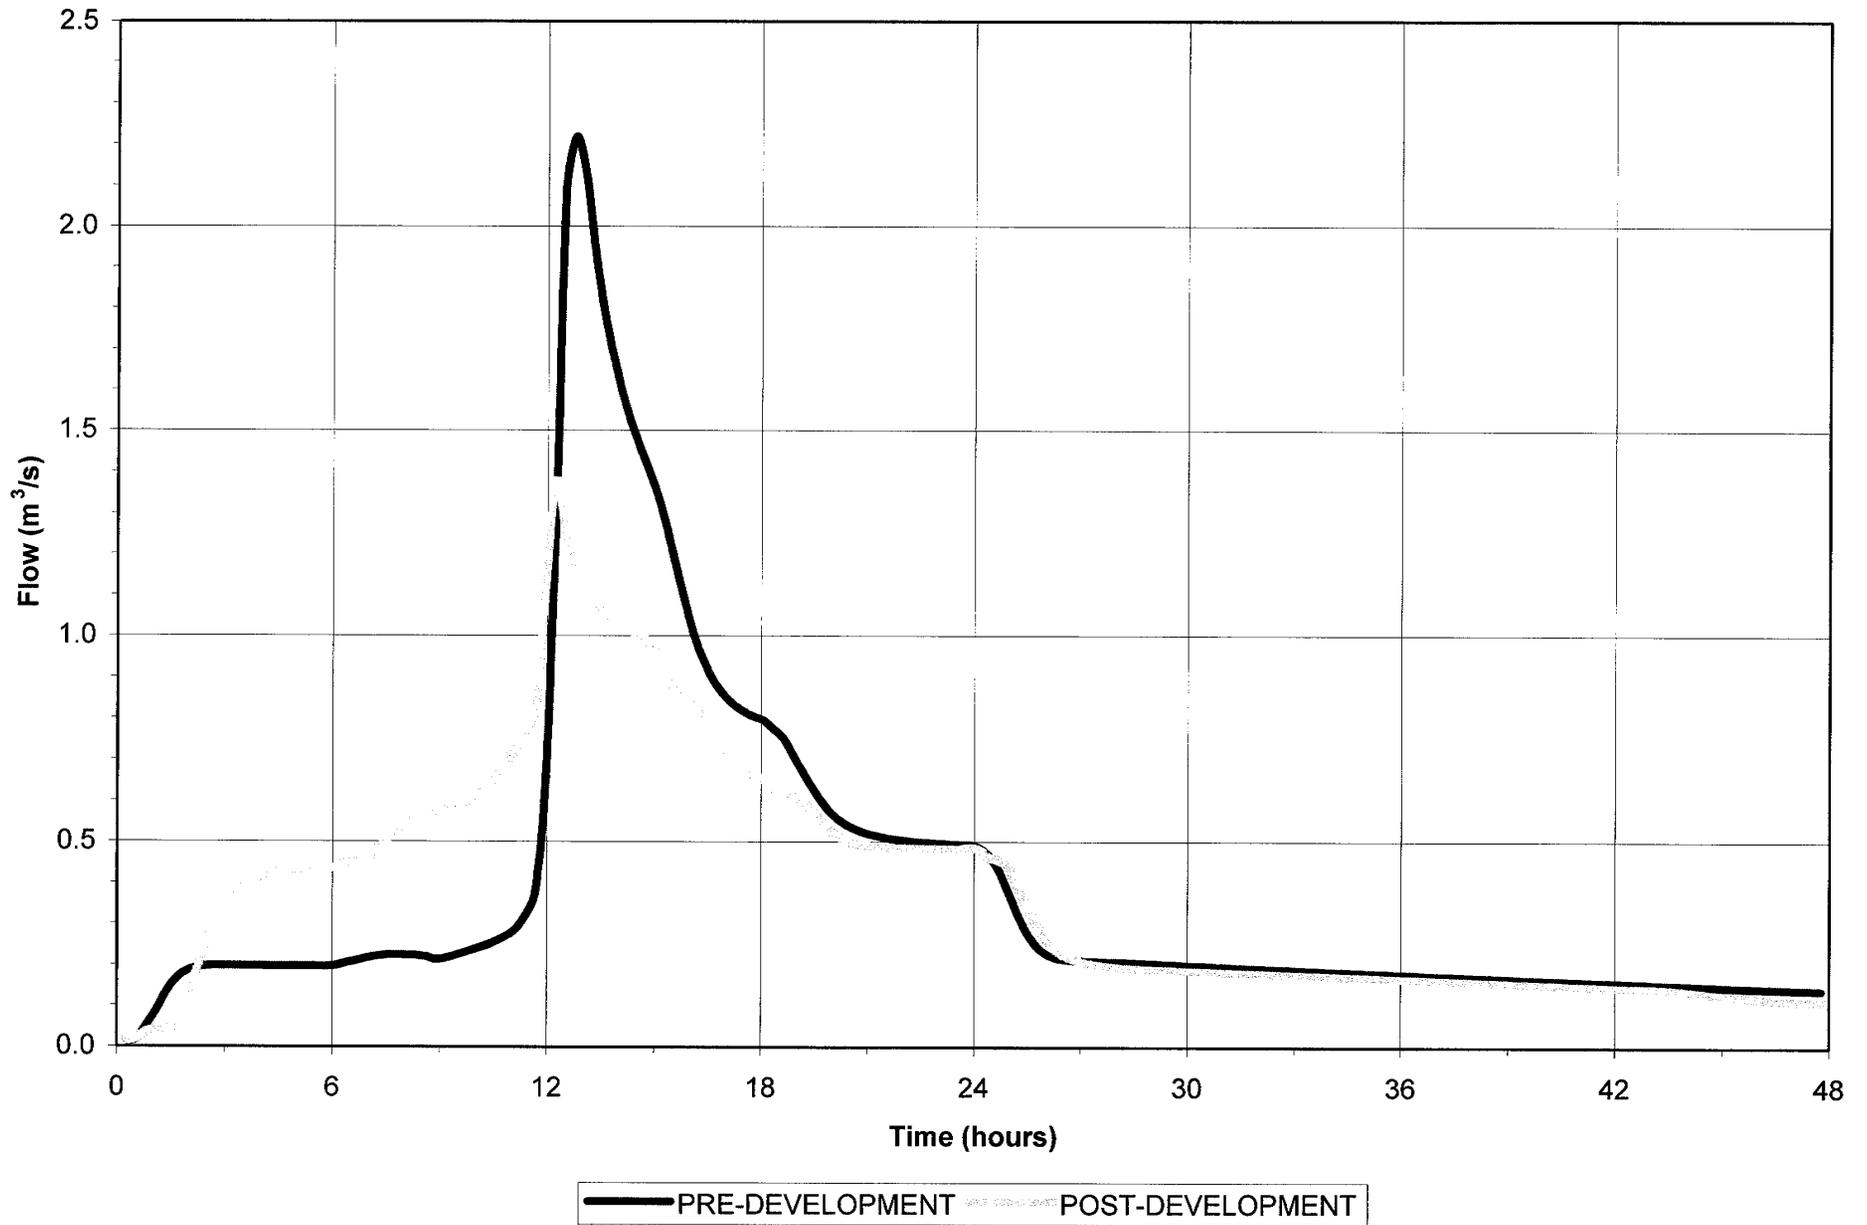
Figure 5.7A

### Watkins Creek above Hyde Creek: Half-Year Hydrograph Comparison

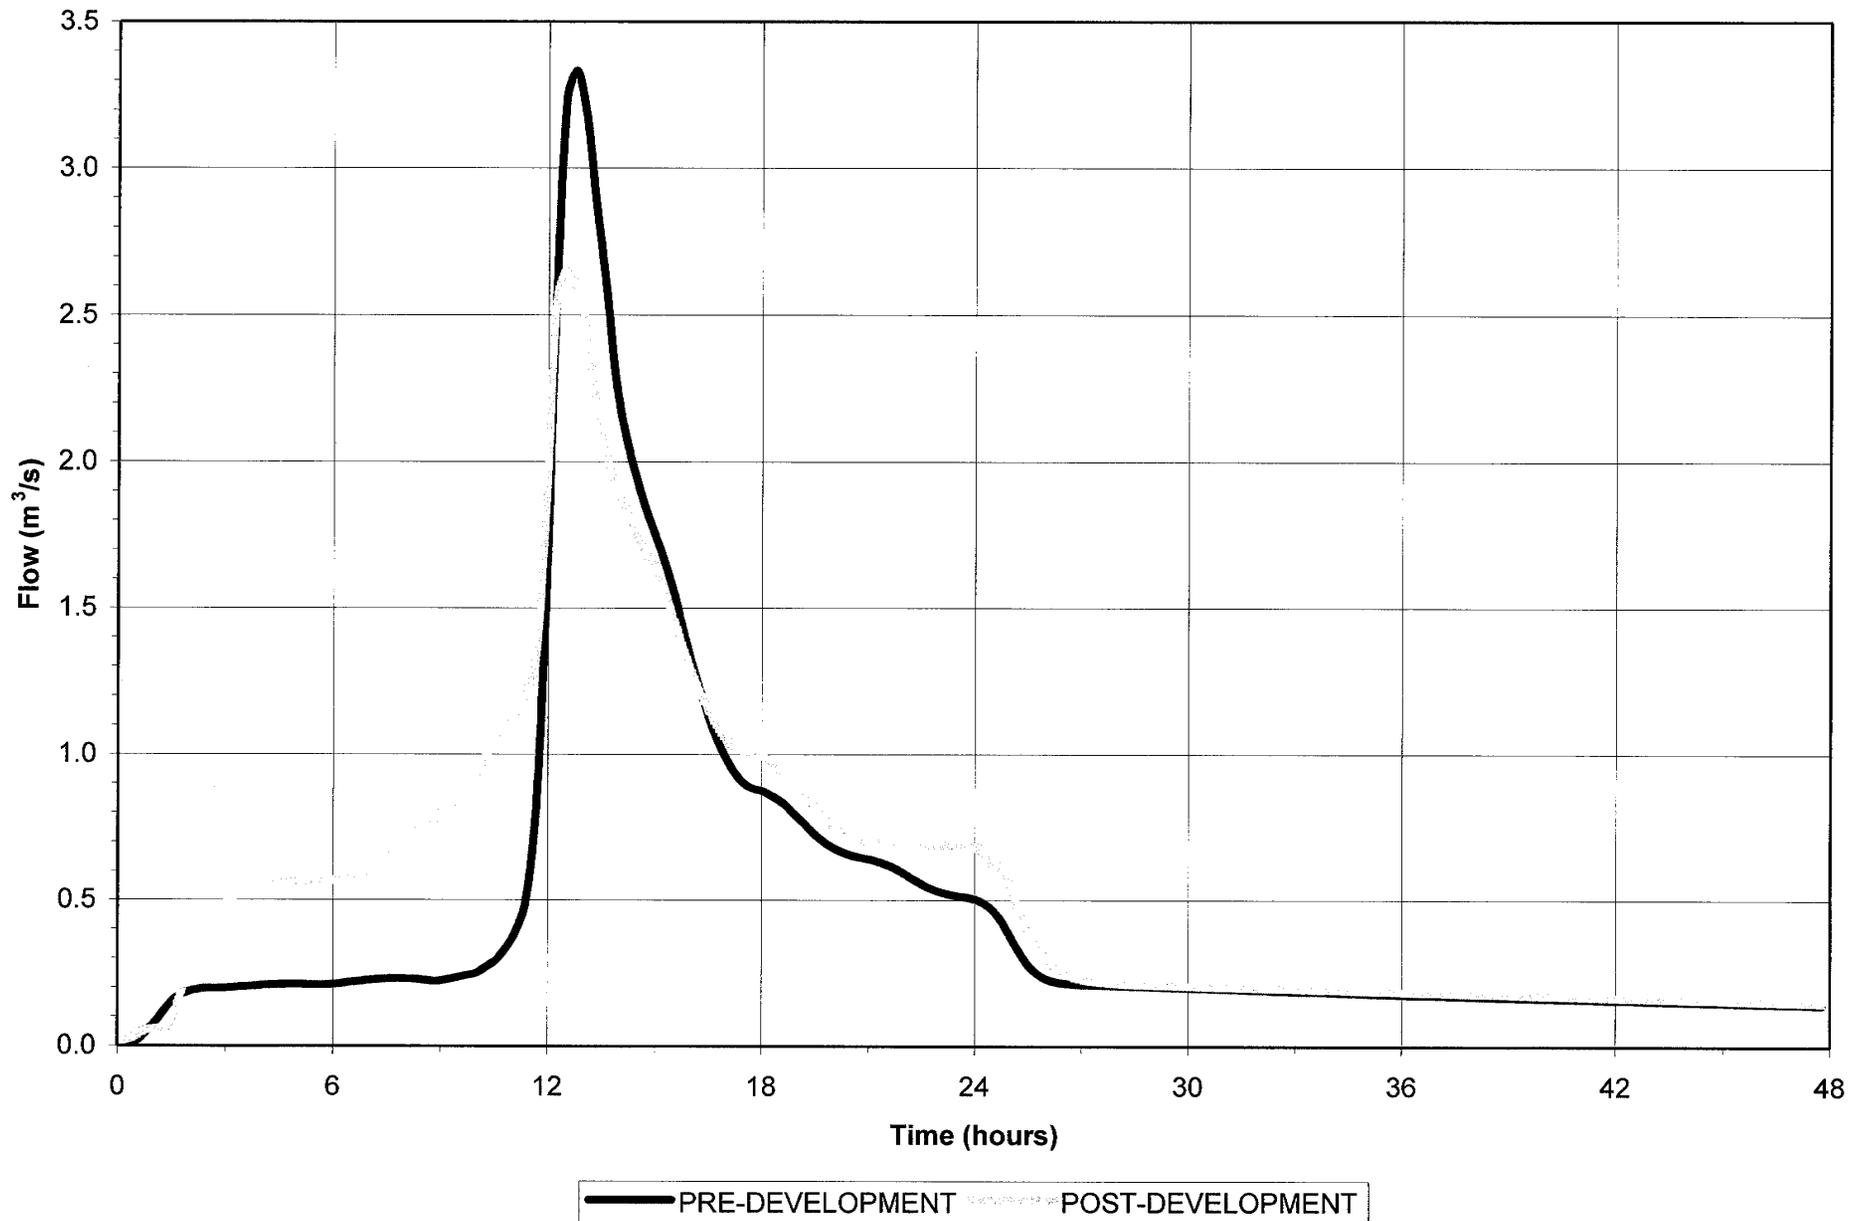
Figure 5.7B

### Watkins Creek above Hyde Creek: 5-Year Hydrograph Comparison

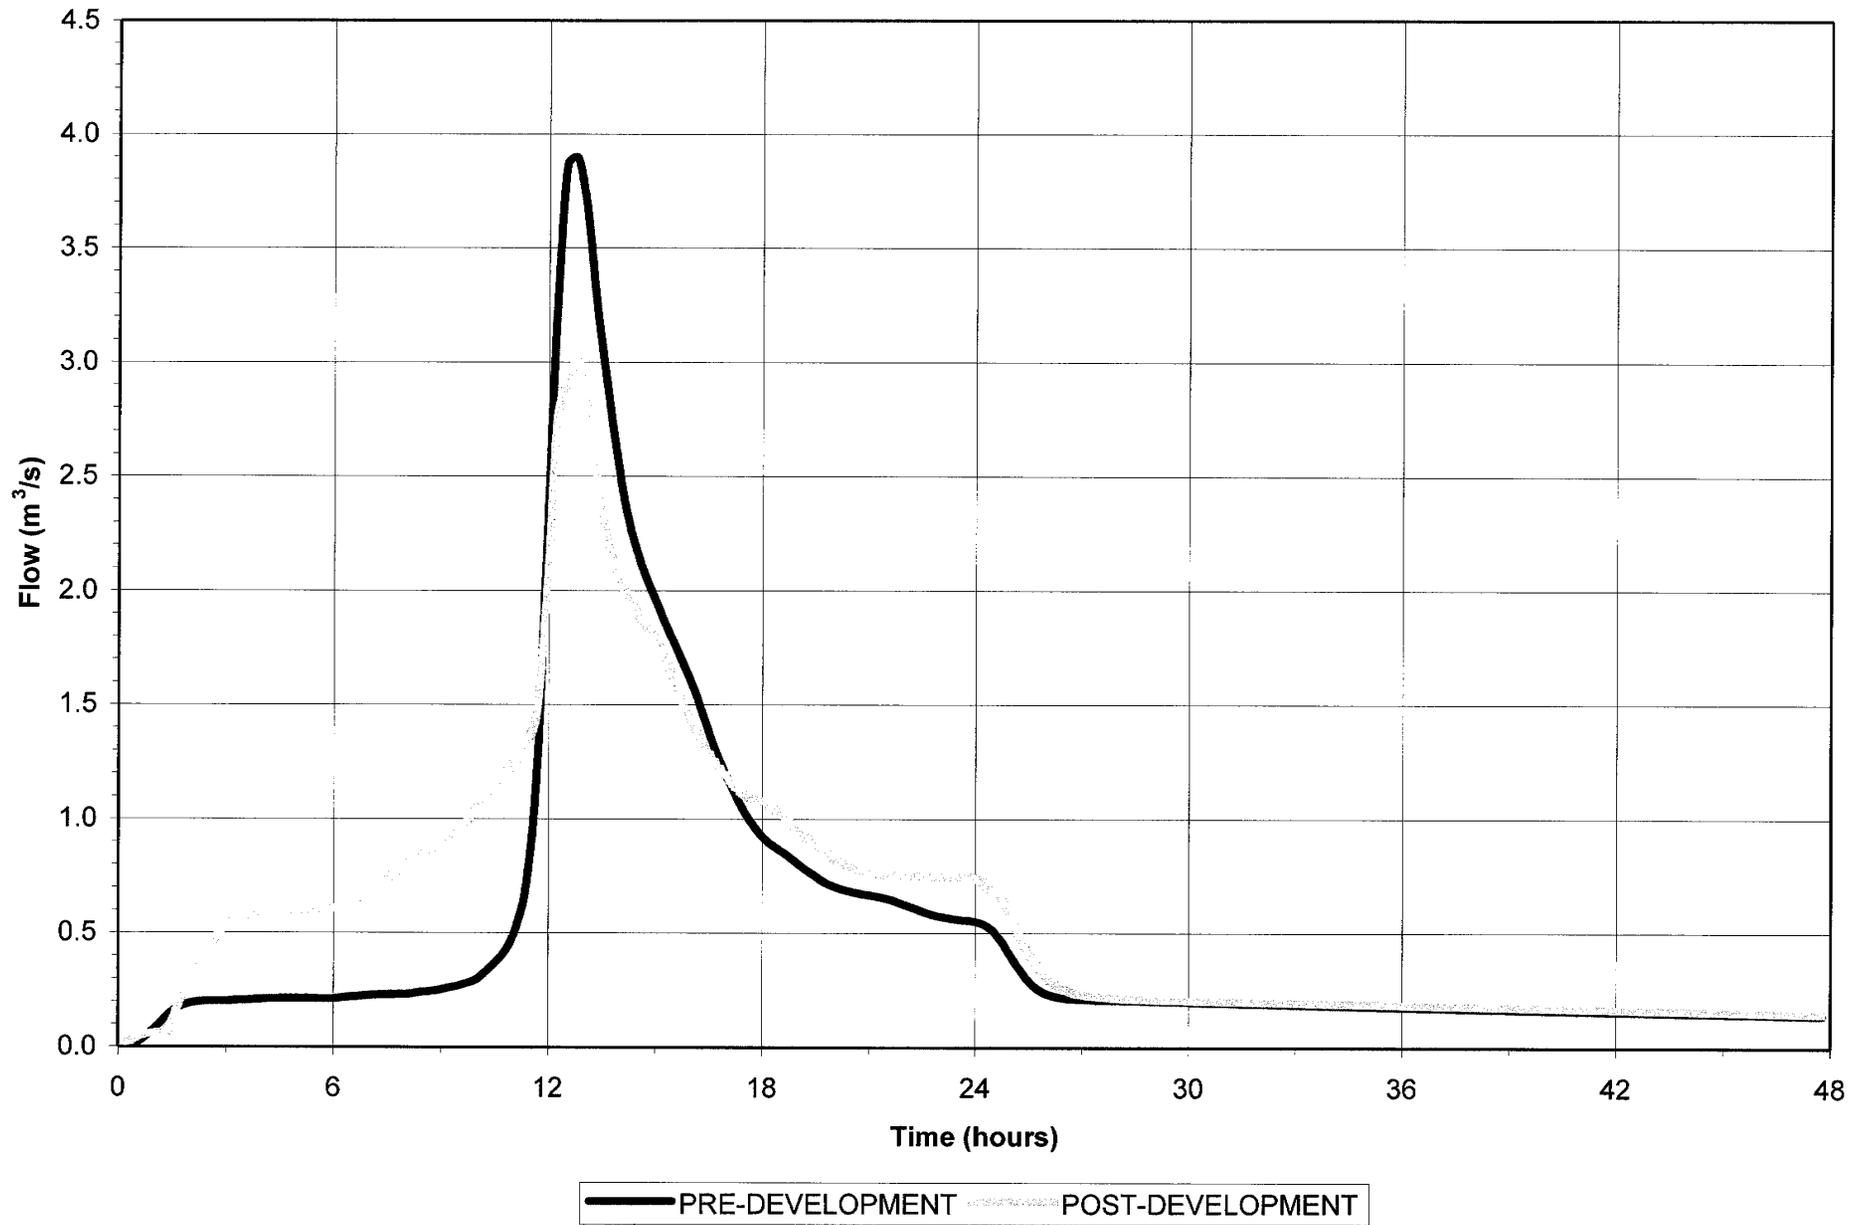
Figure 5.7C

# Watkins Creek above Hyde Creek: 10-Year Hydrograph Comparison
