**F I N A L   R E P O R T**

**CITY OF COQUITLAM  
CITY OF PORT COQUITLAM**

**Hyde Creek Integrated  
Watershed Management Plan**

**Re: HYDE CREEK IWMP FINAL REPORT**

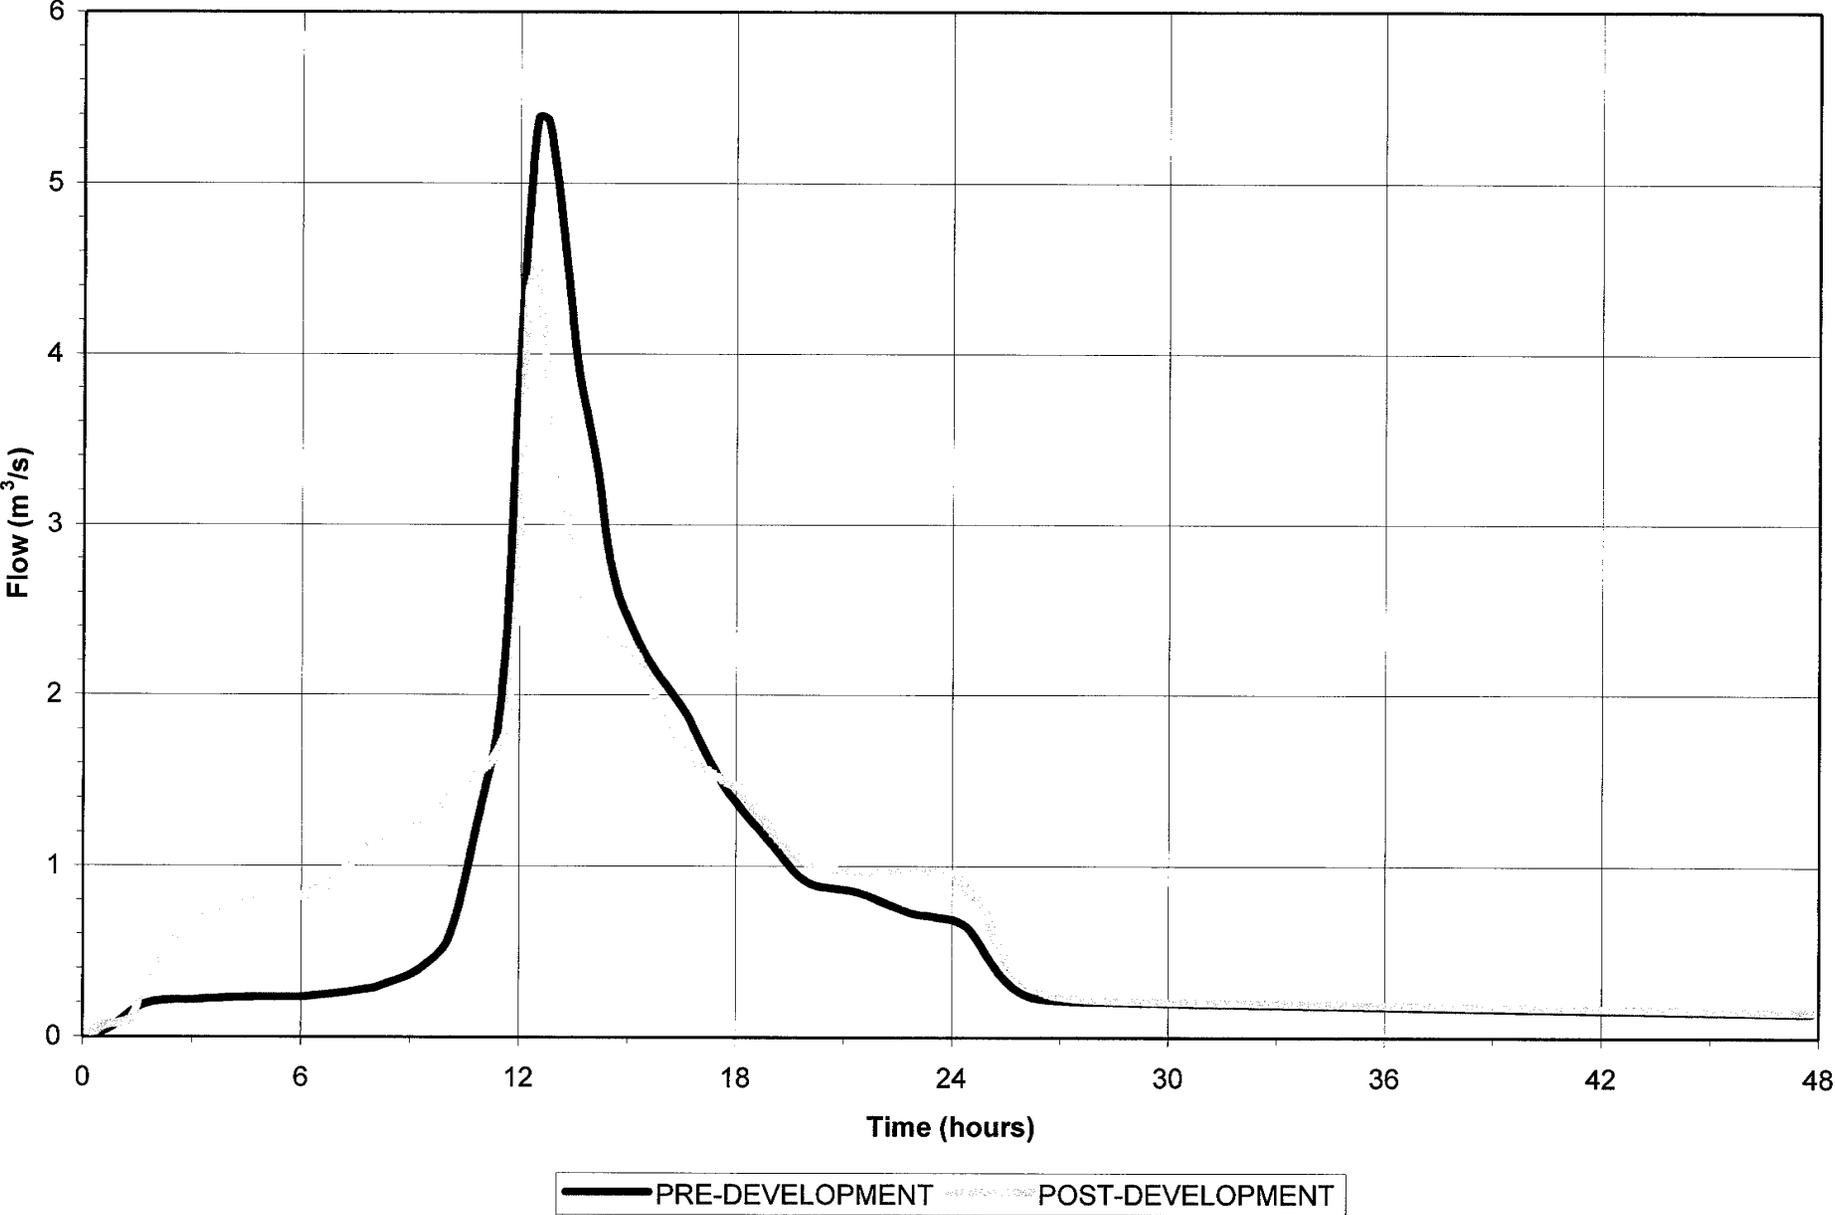
Figure 5.7D

### Watkins Creek above Hyde Creek: 100-Year Hydrograph Comparison

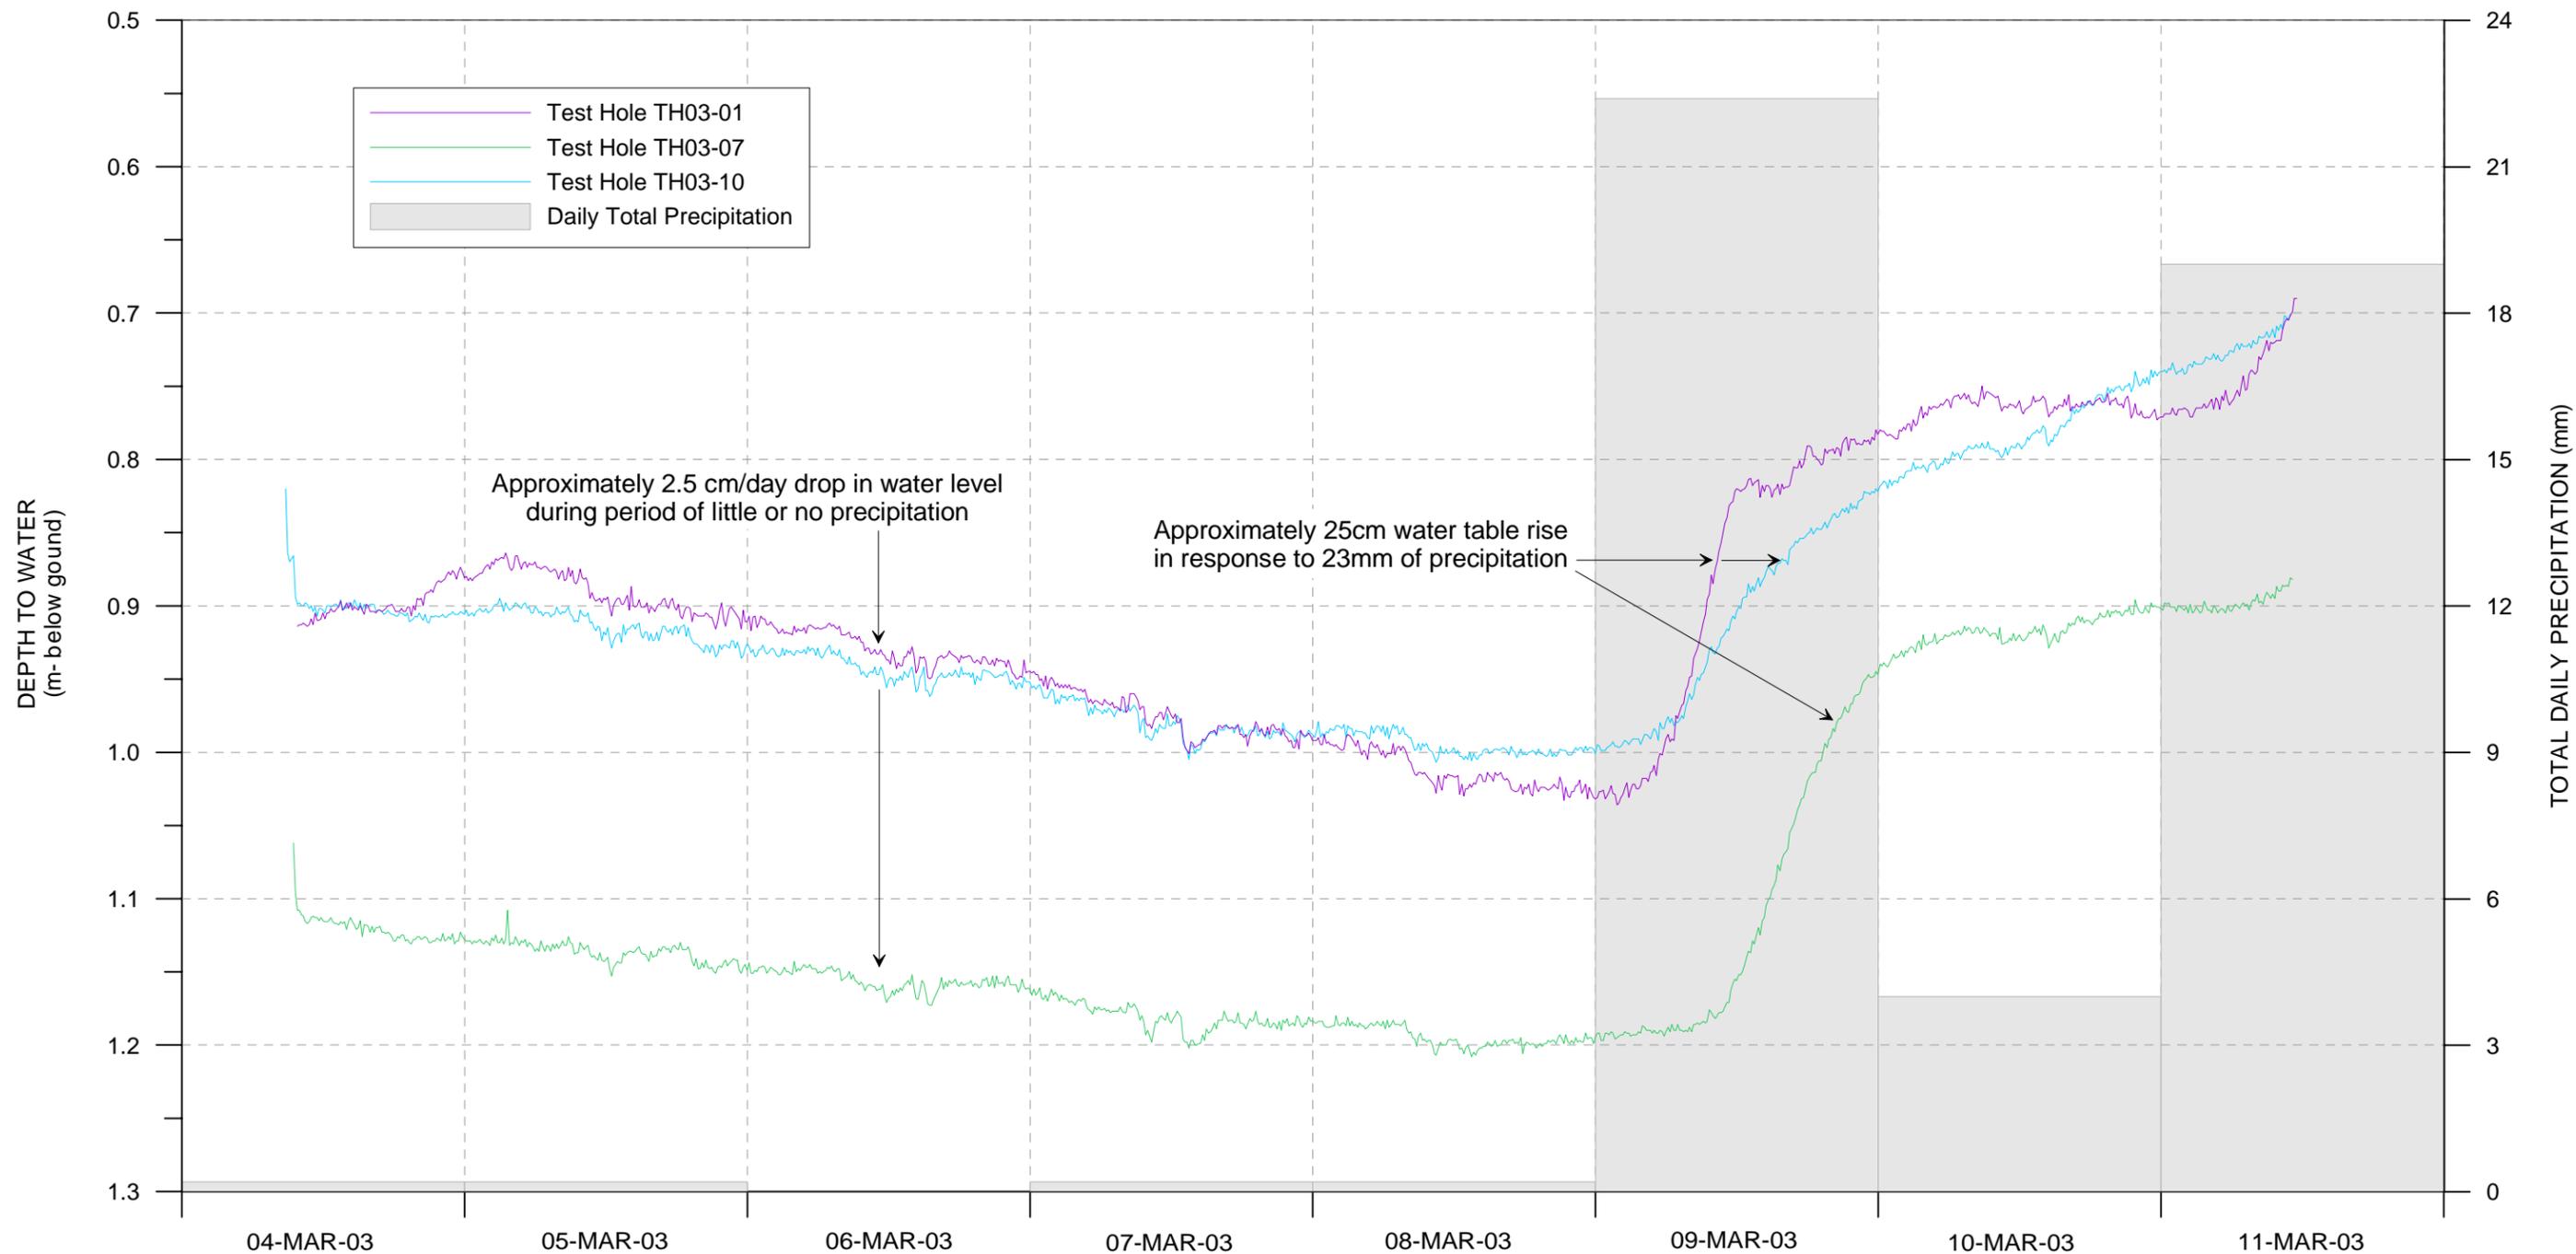
BY: MDM	DATE: MAR 03
APPROVED:	FIG: 3

NOTE: 1) Climate data from Environment Canada's Pitt Meadows automated weather station  
 2) Water level data obtained with automated pressure transducers installed in standpipe piezometers

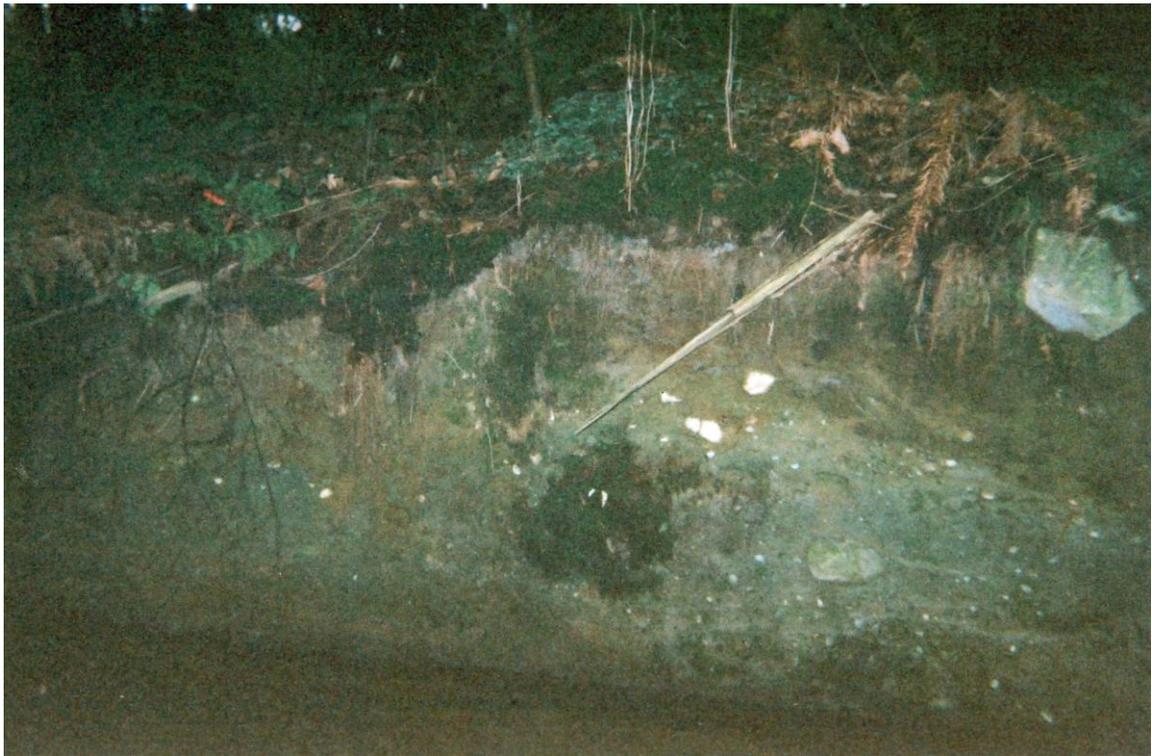
**Photo7.**  
1.8m exposure of silty sand/gravel over dense till (south side of Victoria Avenue).
