Site Observation Form

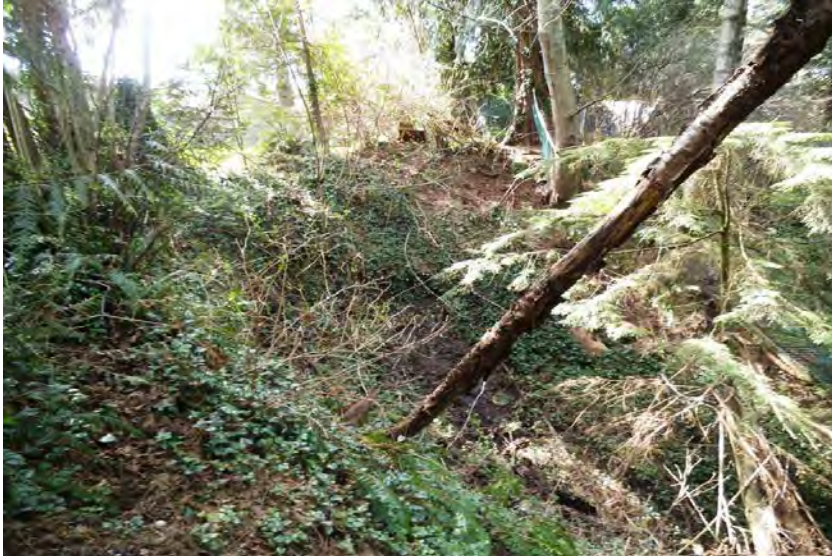
View Across North Part of Slope Below Crest

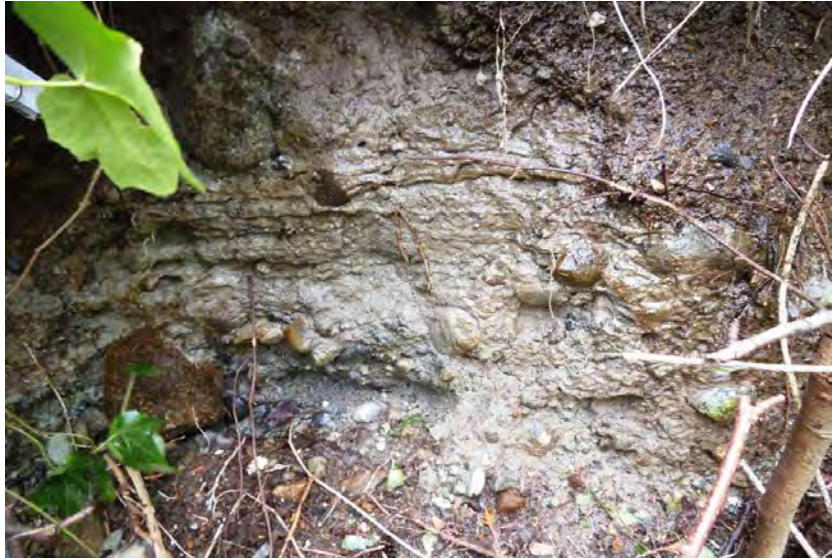
Seepage Occurring Over Dense Till in Headscarp of Ravine Below Yard

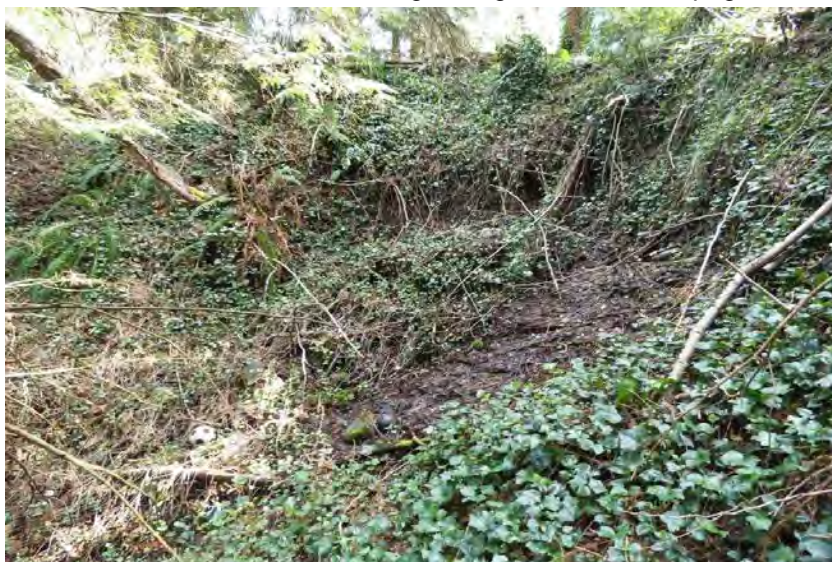
View Across Bowl to North Showing Revegetation and Seepage Area

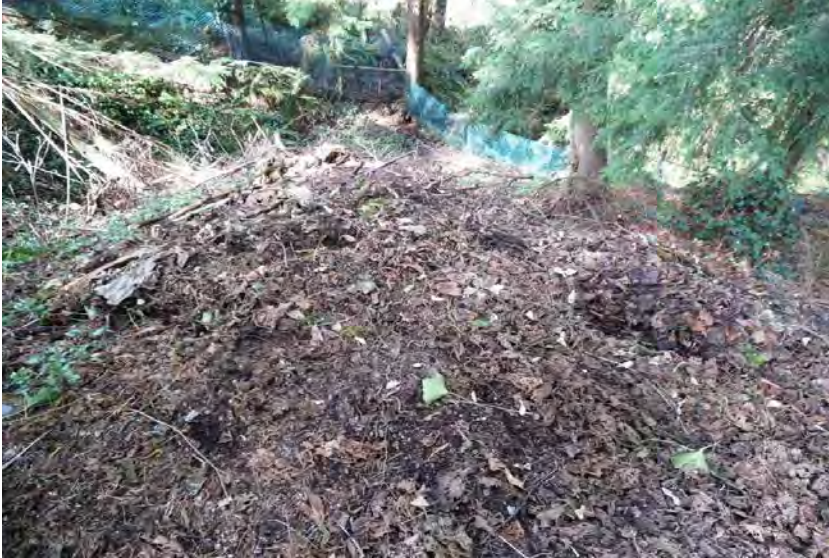
Pile of Compost and Yard Clippings at North Edge of Crest

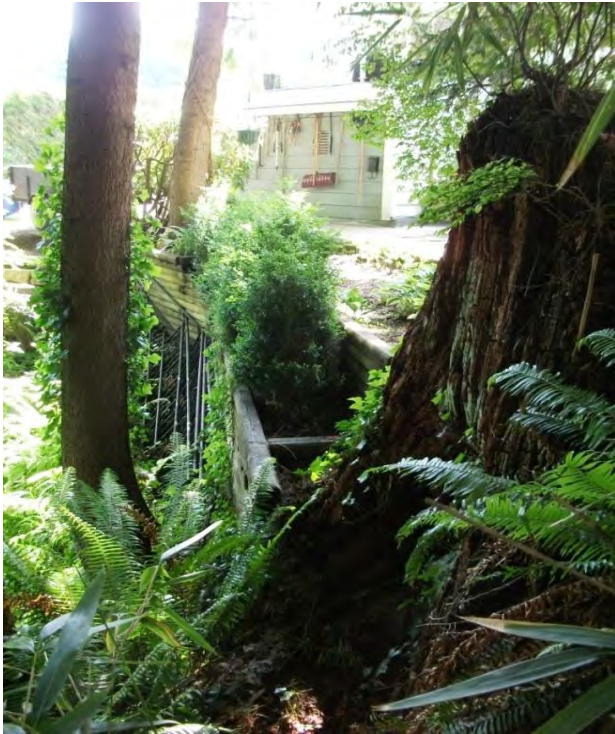
Main Crest With Wood Tie Retaining Walls

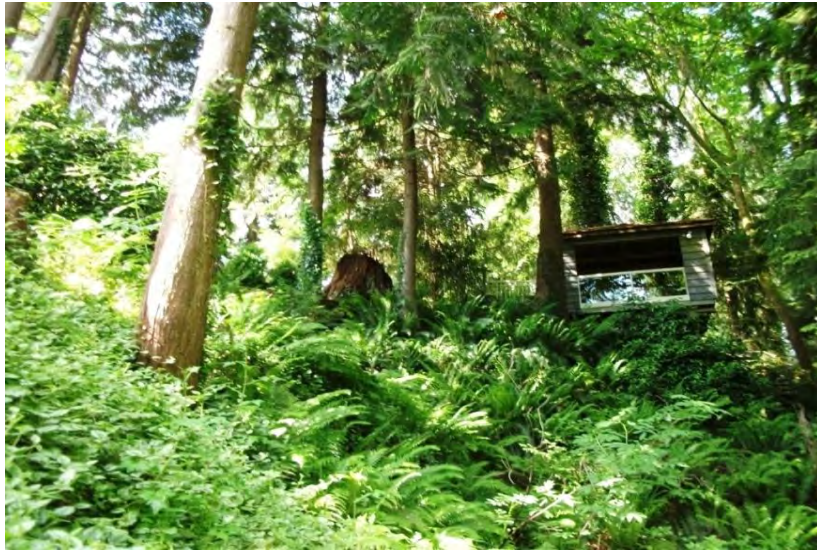
Patio Building On Escarpment Promontory

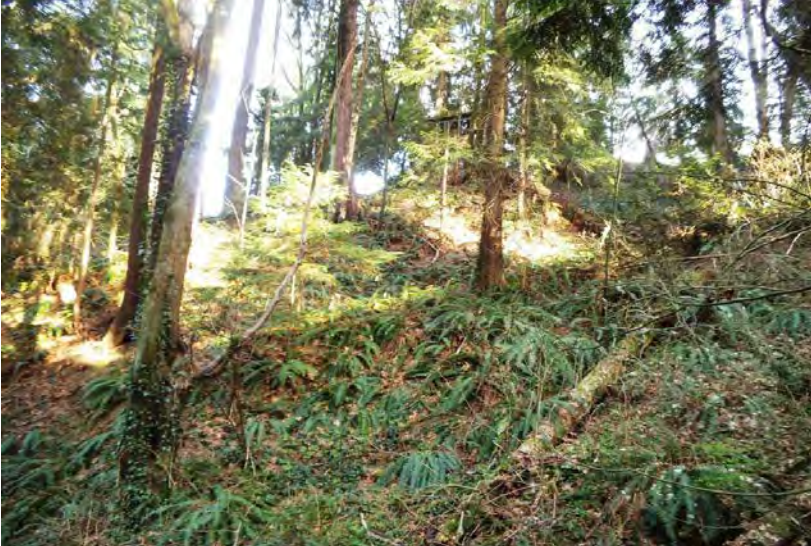
2013 View From Northwest of Lower Slopes and Patio Building

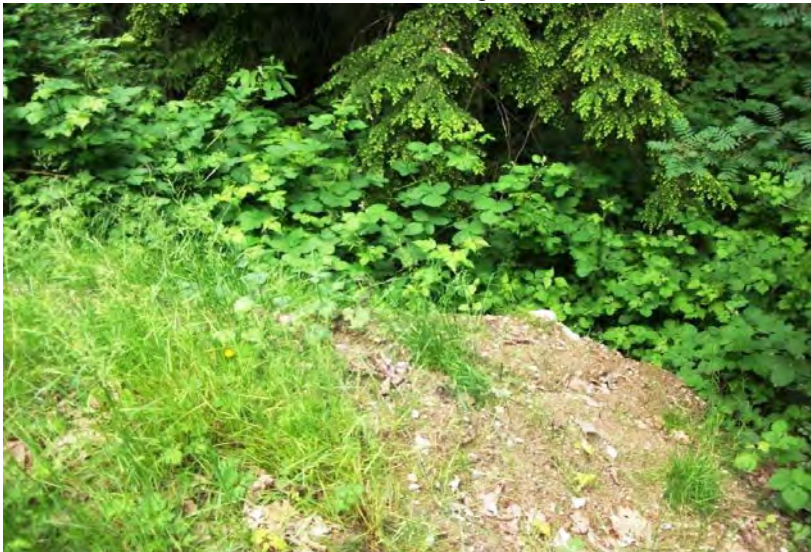
Small Lobe New Fill At Crest From Garage Excavation

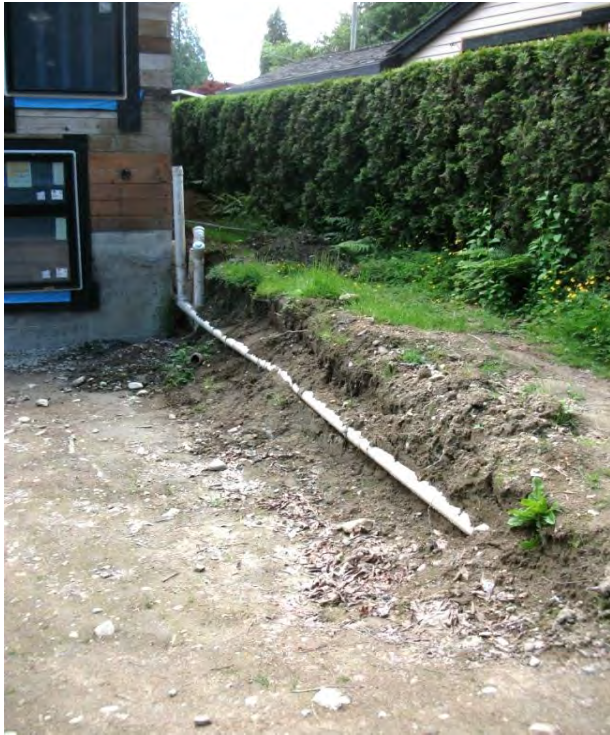
New Roof And Foundation Pipes Drain
Towards Storm Sewer And Crest

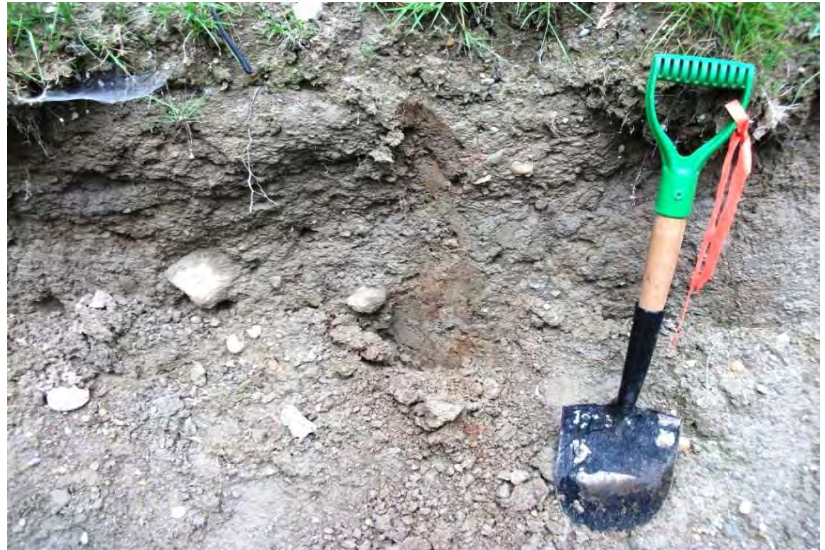
Garage Excavation Into Till

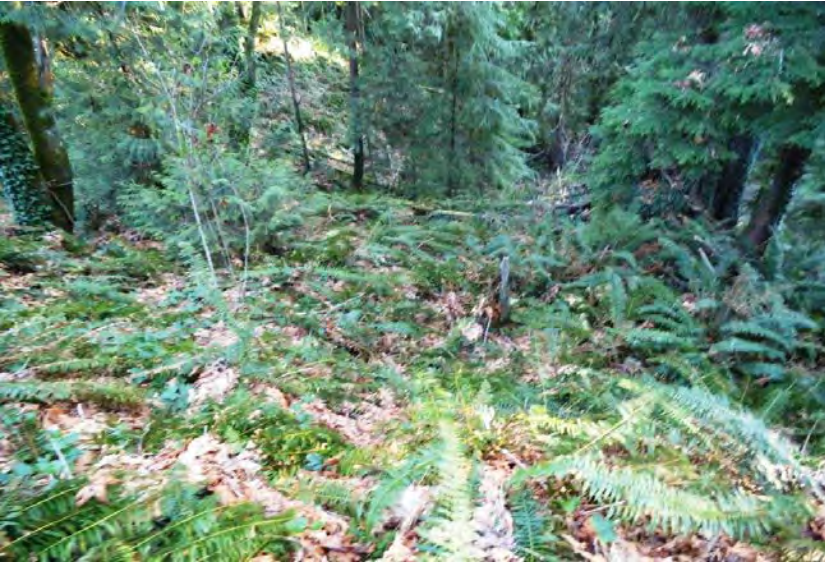
Below Crest, Possible Nose of Fill, No Directed Water

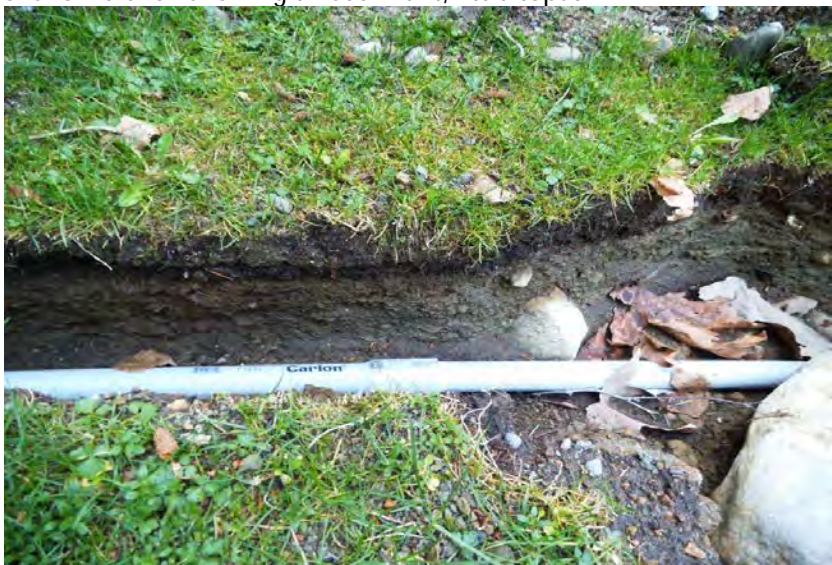
Shallow trench showing till sediment, little topsoil

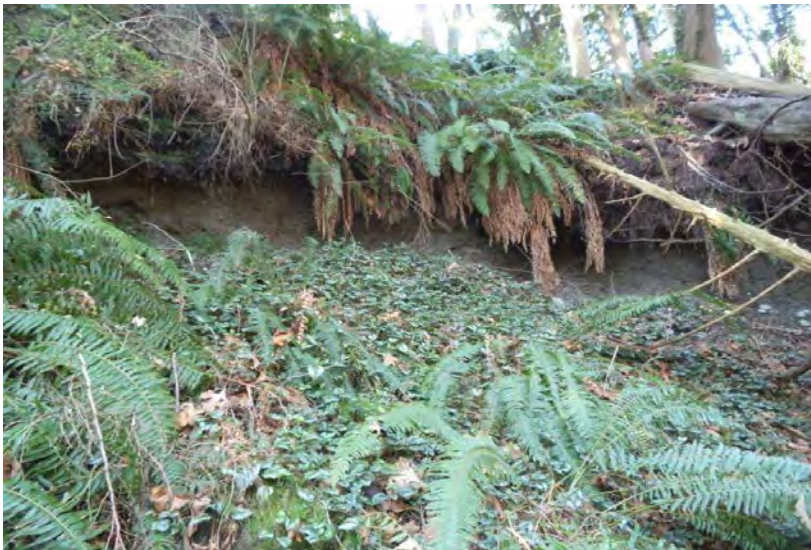
Comments Slope failure below. Outer edge lawn subsided.

Headscarp of Failure Below Property Along Sundial Creek Tributary

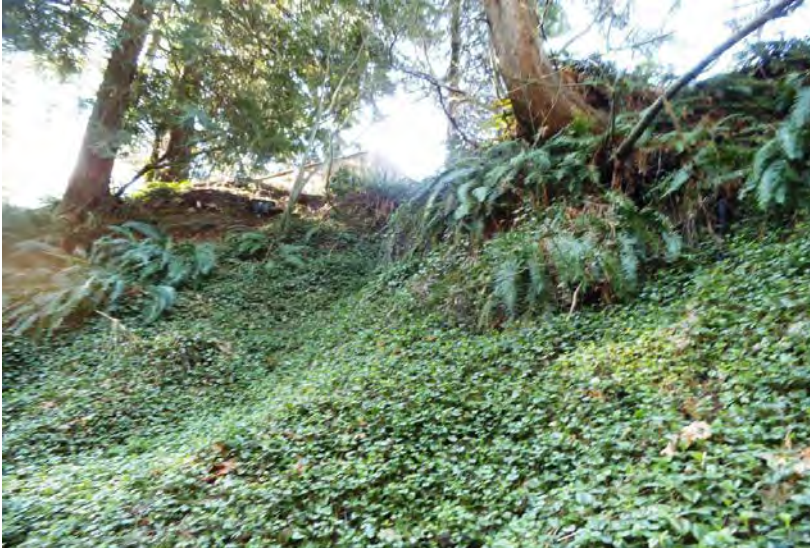
Top of Slope Below Back Yard With Old Failure Evidence

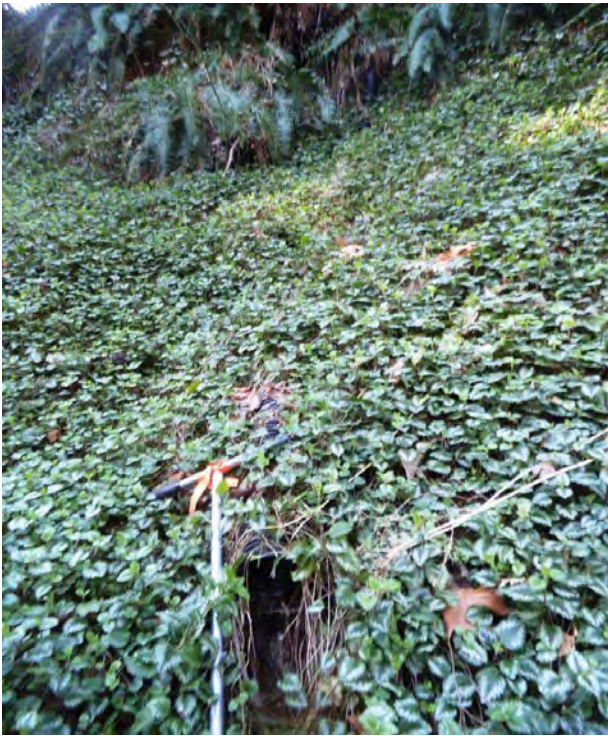
Below property, near creek, 6 in black corrugated plastic pipe with strong flow evidence. No slope stability issues apparently caused by this pipe.

Pipe Outlet Near Base of Slope Showing Evidence Recent Strong Outflow

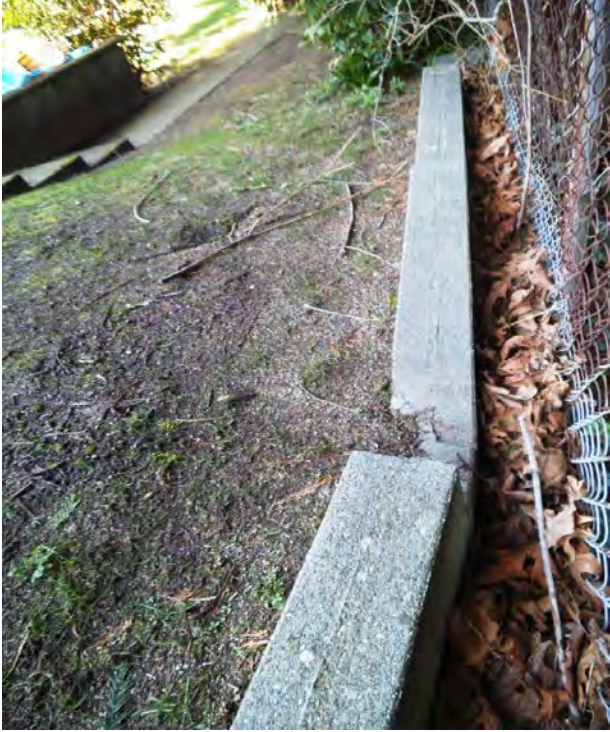
Size	Condition
Timber crib	N	
Stacked blocks	N	
Concrete	1 m H	Cracked, Leans
Rock / mortar	N	
Engineered	N

Concrete Wall Along Crest

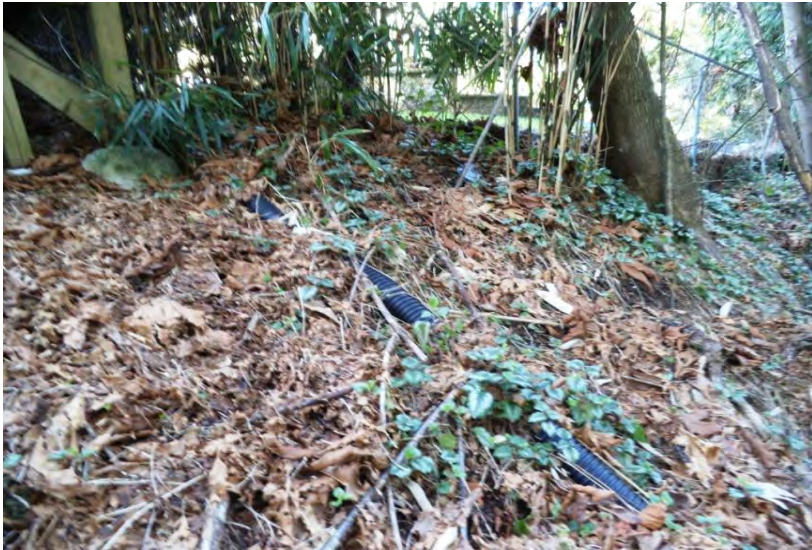
Slope Below With Drainage Pipe

The City and the Property Owner should work to resolve roof/foundation/driveway drainage problems.

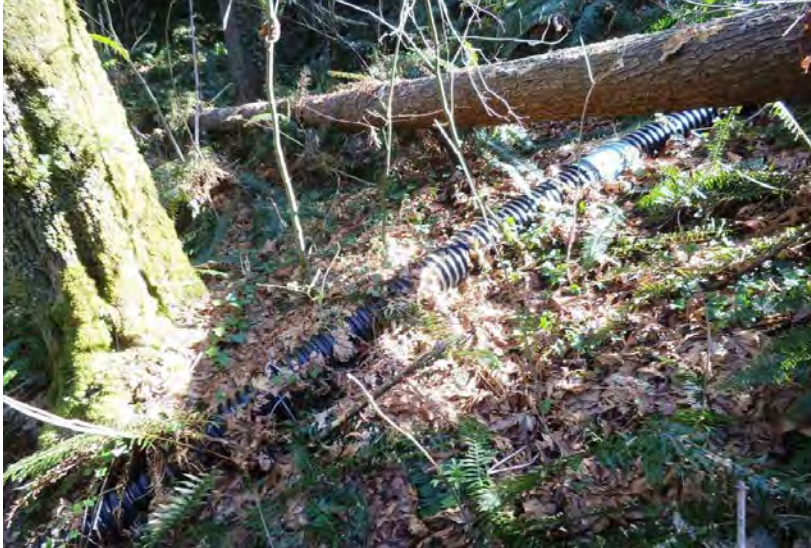
City Stormwater Pipe Down East Side Slope

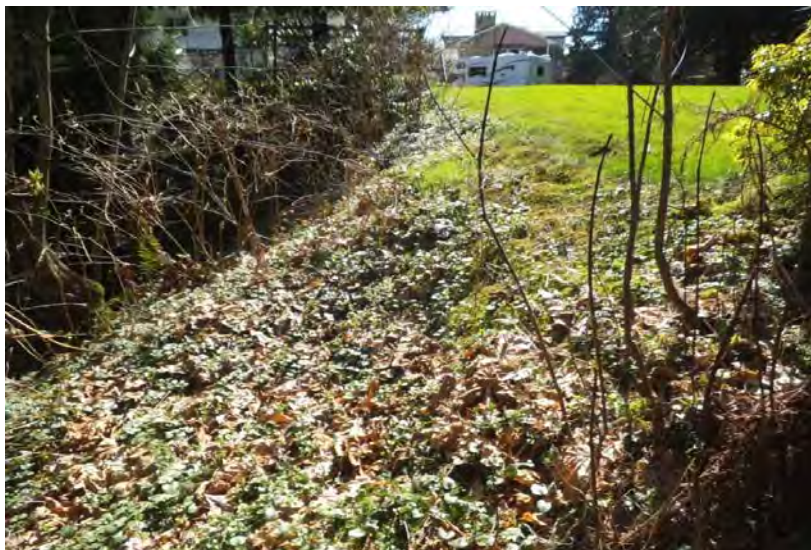
Possible old failure northeast corner, re: shallow swale with moist soil (weathered till)

Possible Subsidence North End of Yard

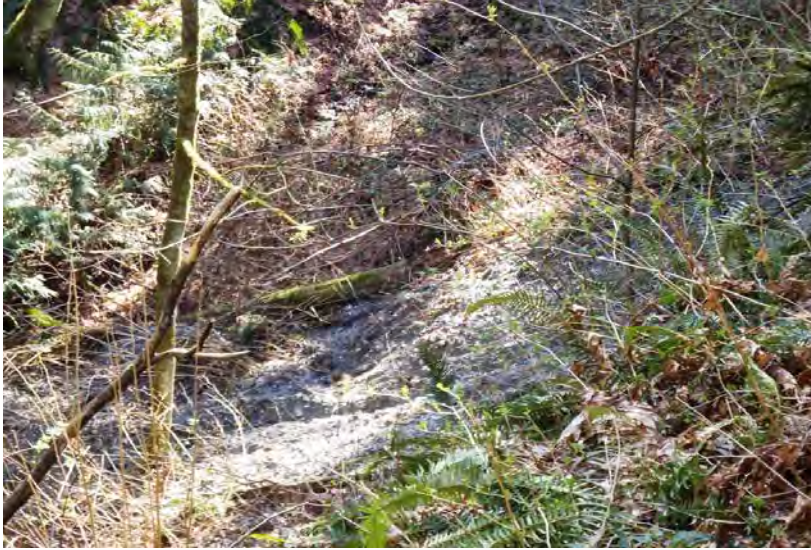
View of East Sundial Creek Gully Erosion Below Property

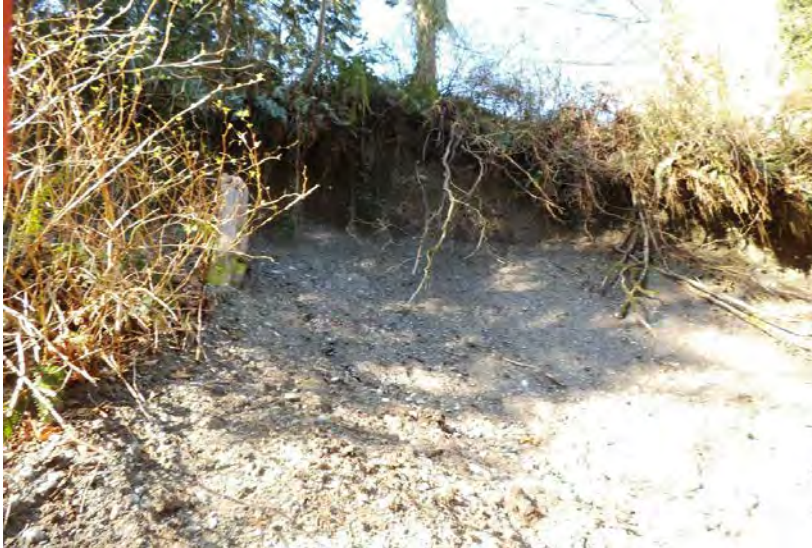
Central Part Headscarp Below Crest

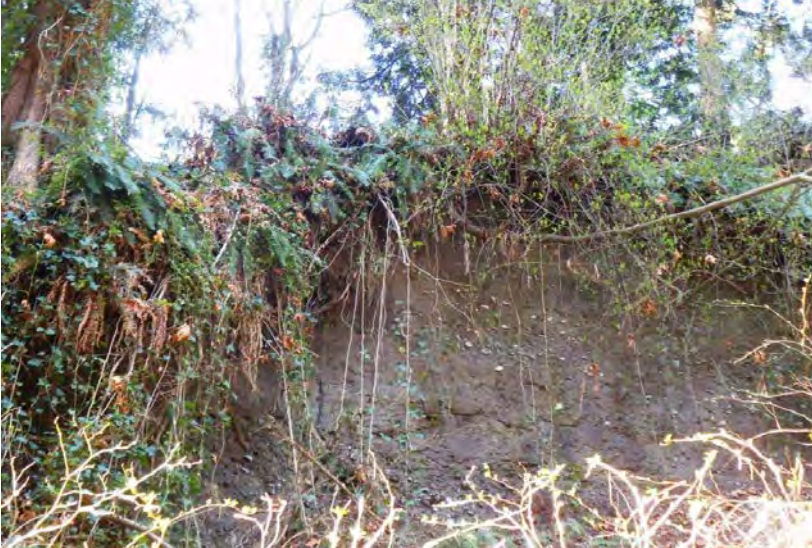
South Part of Headscarp Below Crest

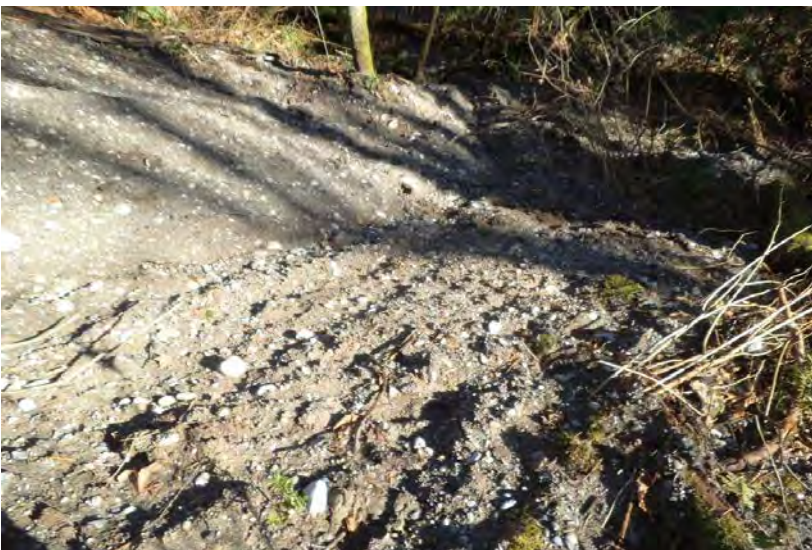
Eroding Slope Below Crest, Sediment Into Creek At Base

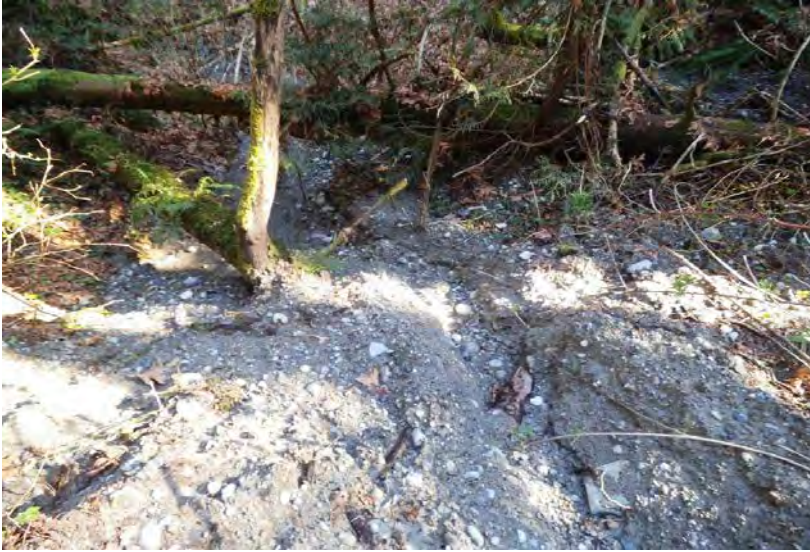
Sediment Into East Sundial Creek At Base of Gully

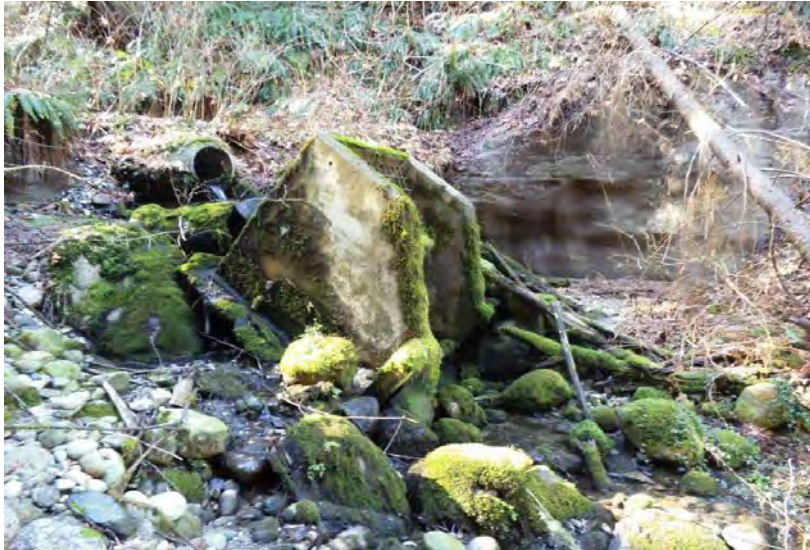
Downstream of Property, Stormsewer Outlet Damaged and Water Erosion

The City and the Property Owner should work to resolve roof/foundation/driveway drainage problems.

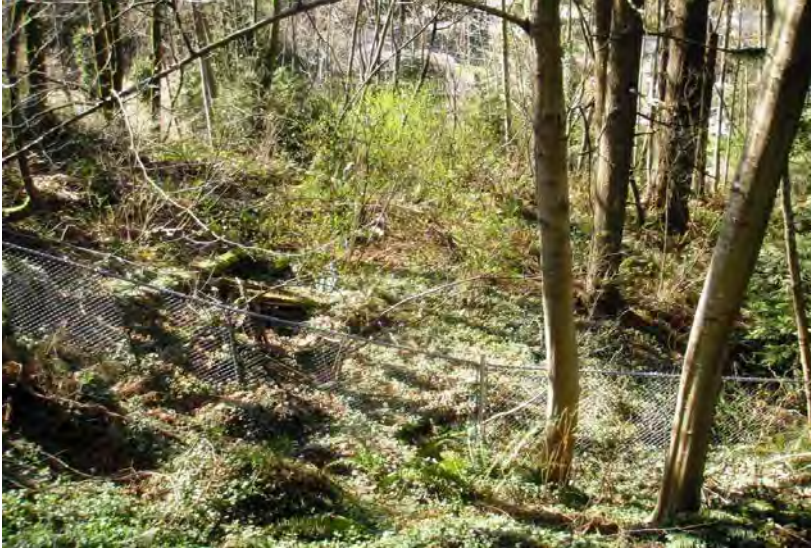
View North From South West Part of Back Yard

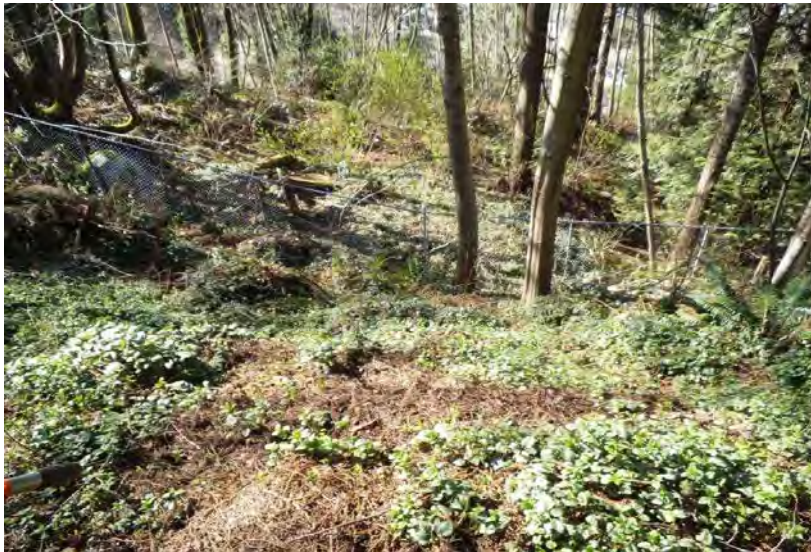
View North Across Area With Shallow Fill

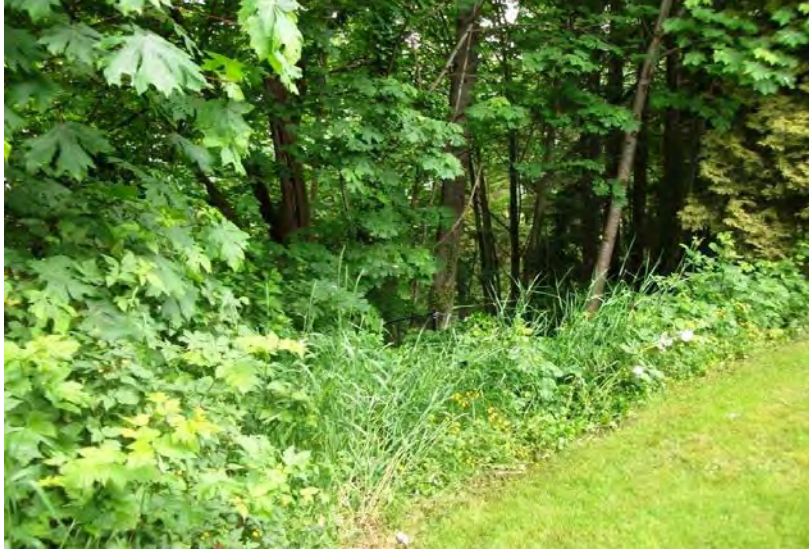
1012 Corona Drive

Back Yard Crest

Interval (m)	
0-0.15	Brown, moist, topsoil, lots of roots
0.15-1.0	Dark brown, moist, loose pebbly silty sand
1.0	Silty sand, occ. silty layers

Soil pit at crest

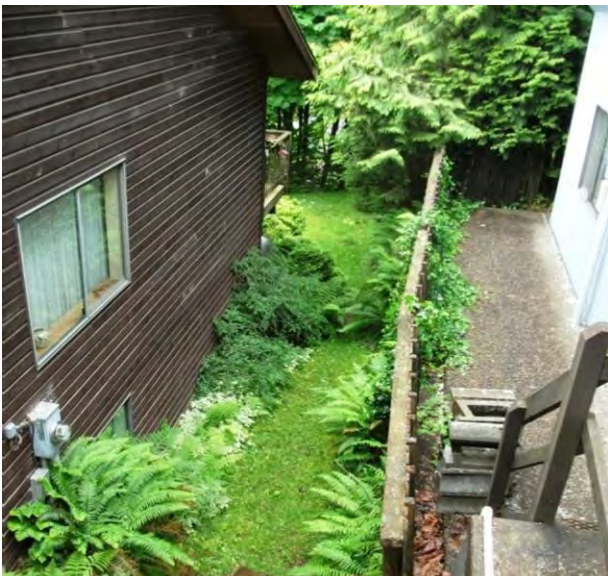
Concrete Wall along Side Yard Showing Poor Foundation

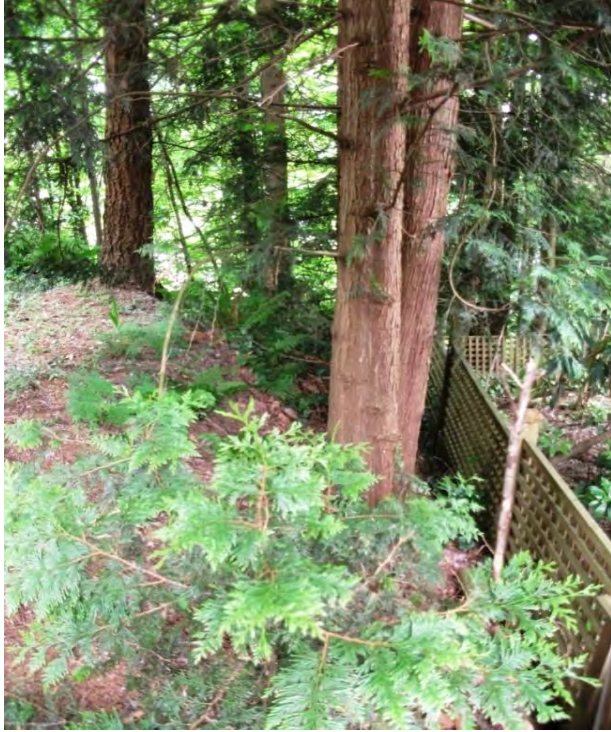
1016 Corona Drive

Slope Below Yard

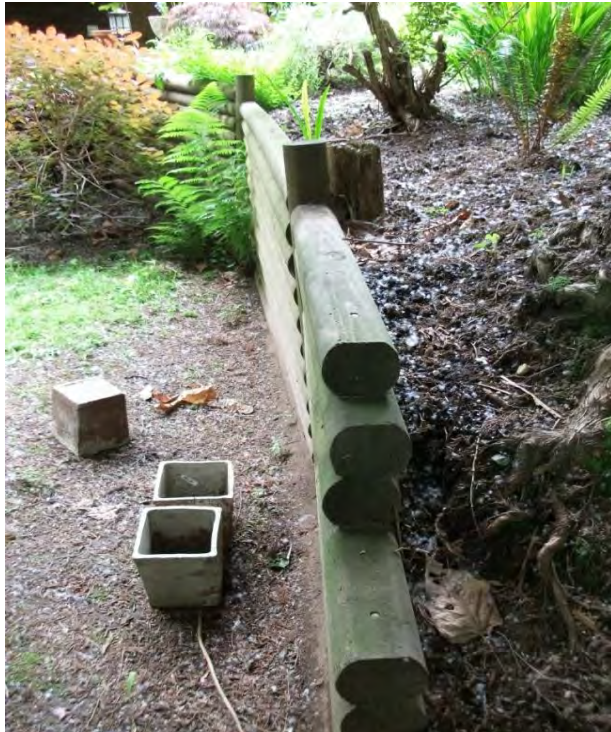
Timber Wall Side Garden

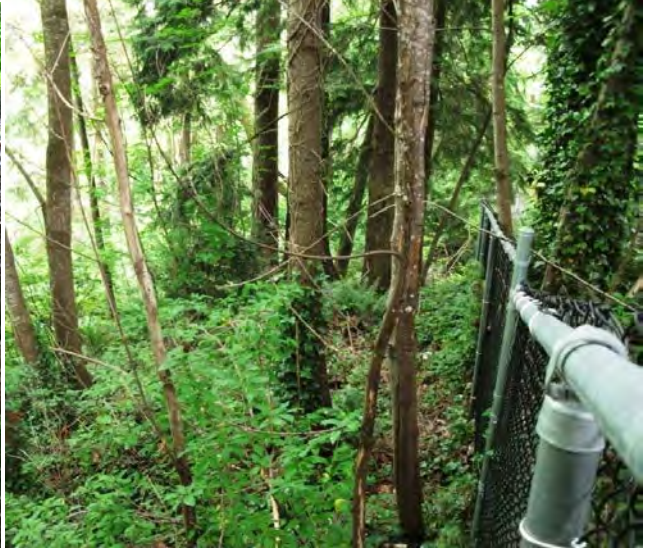
Fence At Edge Of City Park

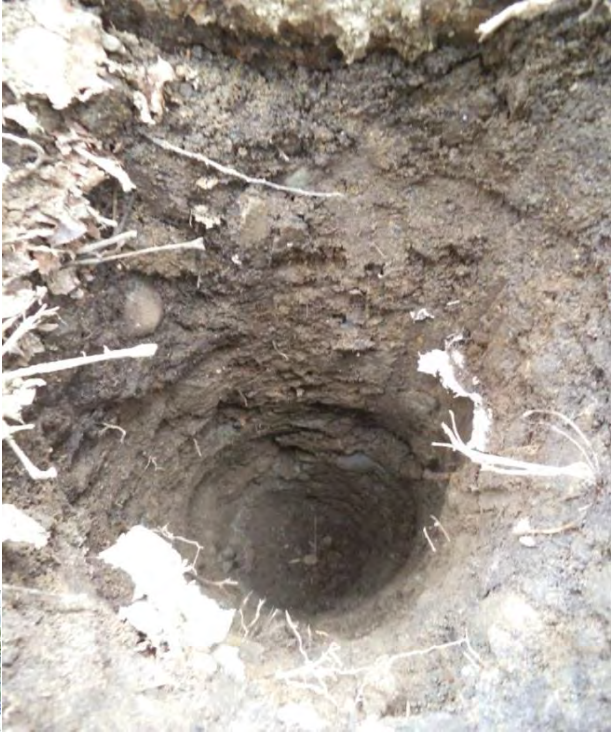
Post Hole With Silty Sand With Tr. Cobbles

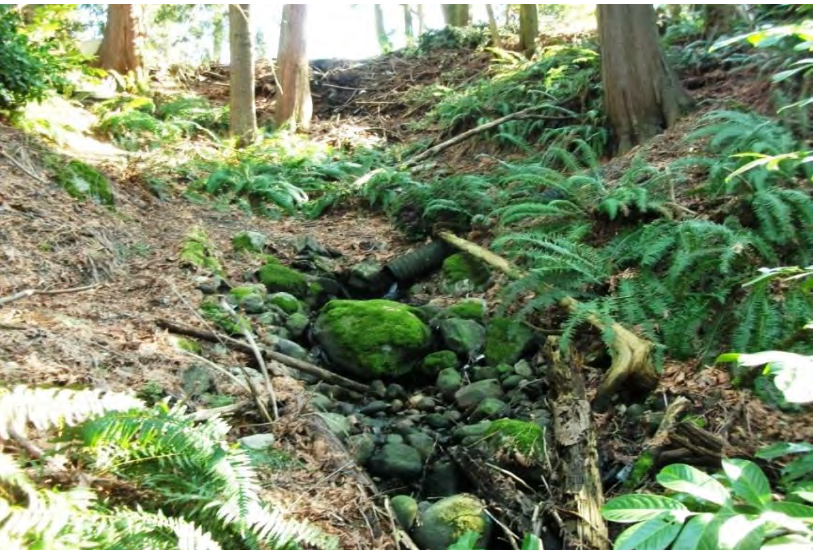
Head End of Suter Brook Upstream of Site, Fed By Stormwater Pipes

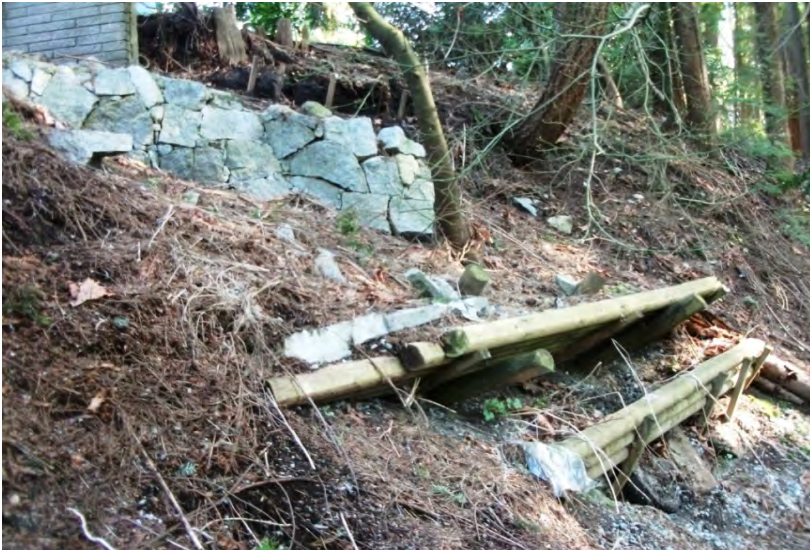
Below Crest - Small Sections Old Wall

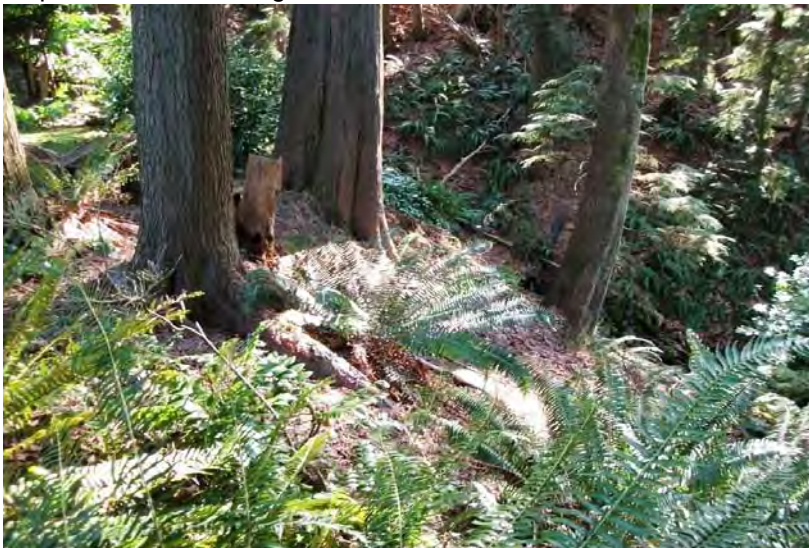
Slope Below With Straight Conifers

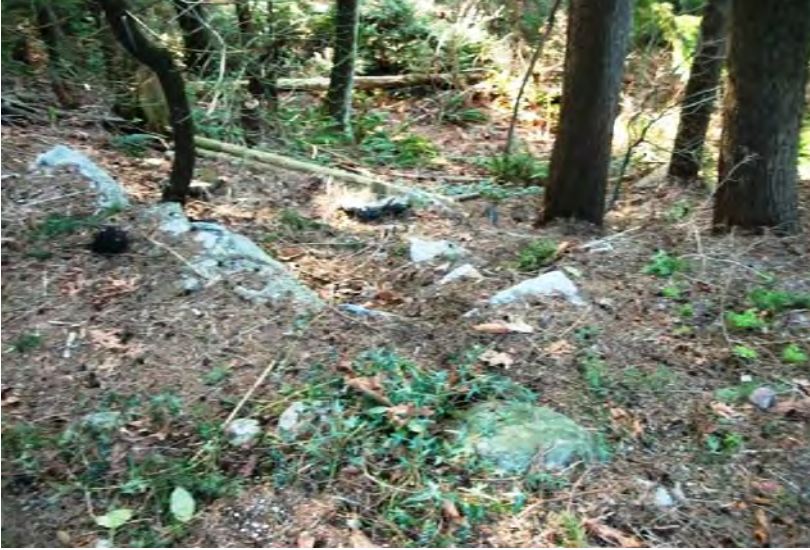
972 Corona Drive

Possible Nose of Fill At Crest, Centre of Yard

**Probability of a specific hazardous landslide starting from this property affecting downslope properties:
Moderate.**

A fill failure or rupture of storm/sanitary sewers could potentially cause a landslide or debris flow and affect 2242 Park Crescent below.

The Property Owner must be pro-active and review the slopes and ravine crest area during and after times of heavy rainfall or snowmelt to monitor slope stability and check for erosion. If there is any evidence of slope movement, water erosion or drainage problems on the property or nearby, we recommend that the Property Owner immediately contact the City and also immediately engage a geotechnical engineer to conduct an assessment.

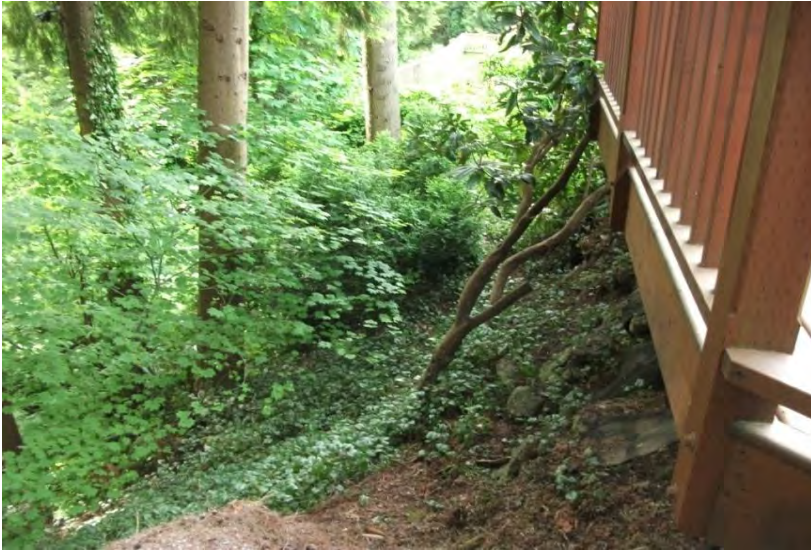
Backyard And Crest

Probability of a specific hazardous landslide starting from this property affecting downslope properties: High.

A fill failure or rupture of storm/sanitary sewers could potentially cause a landslide or debris flow and affect 2242 Park Crescent below.

In the Phase 3 geotechnical assessments, investigations of subsurface soil composition, distribution and strength, and water conditions may be required.

The Property Owner must be pro-active and review the slopes and ravine crest area during and after times of heavy rainfall or snowmelt to monitor slope stability and check for erosion. If there is any evidence of slope movement, water erosion or drainage problems on the property or nearby, we recommend that the Property Owner immediately contact the City and also immediately engage a geotechnical engineer to conduct an assessment.

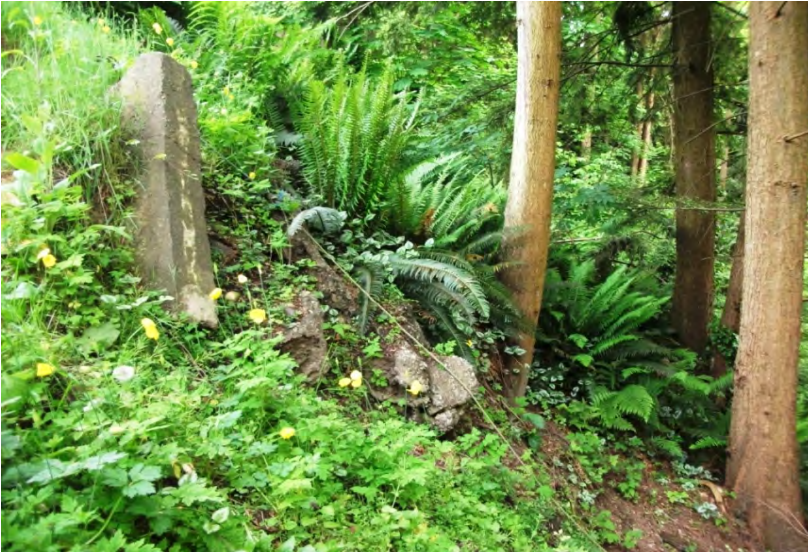
View Across Main Slope With Lobe of Concrete Debris

**Probability of a specific hazardous landslide starting from this property affecting downslope properties:
Very High.
See Table 5-9.**

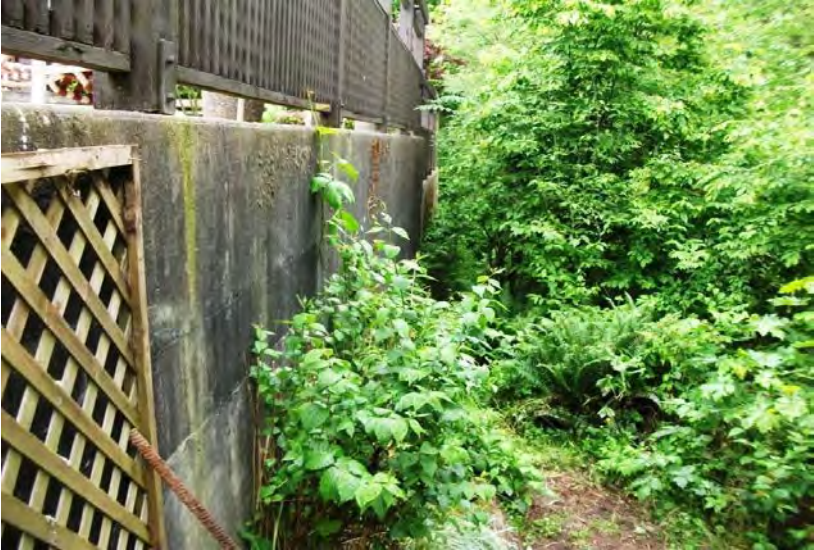
South End of Outer Concrete Wall

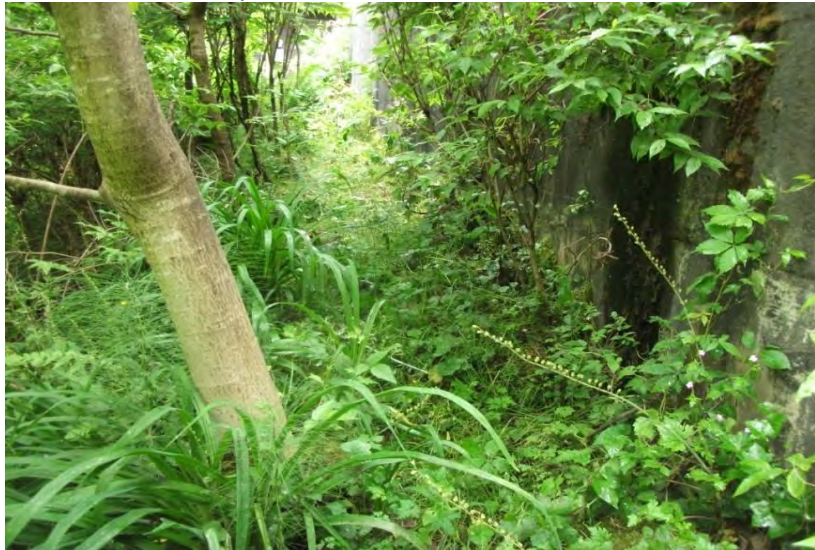
Patio Beside Pool With Subsidence Indicators

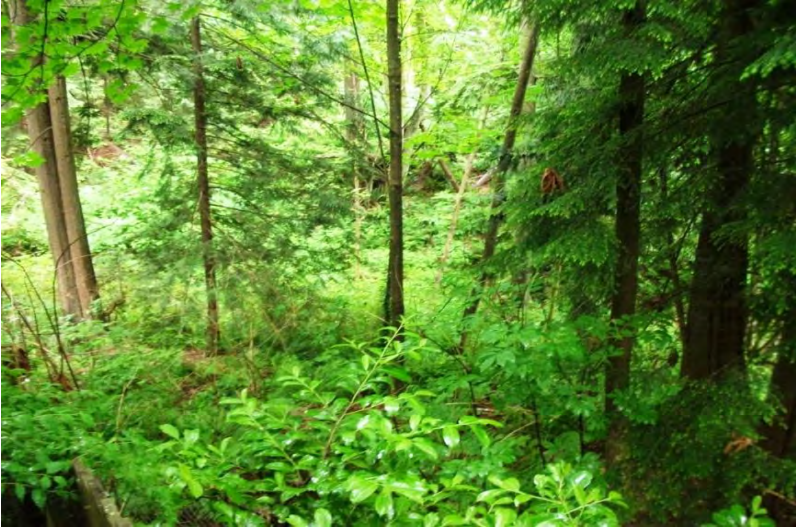
Southwest Part of Property, Wet Patch

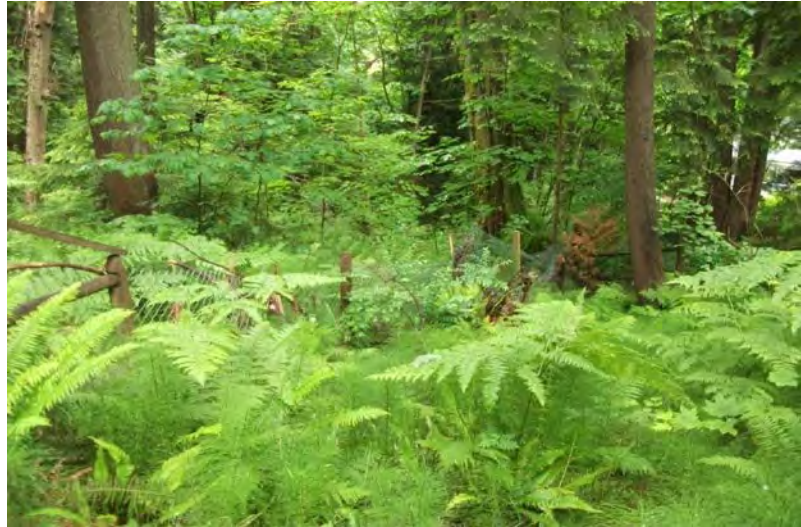
Southwest Part of Property, Water-loving Vegetation

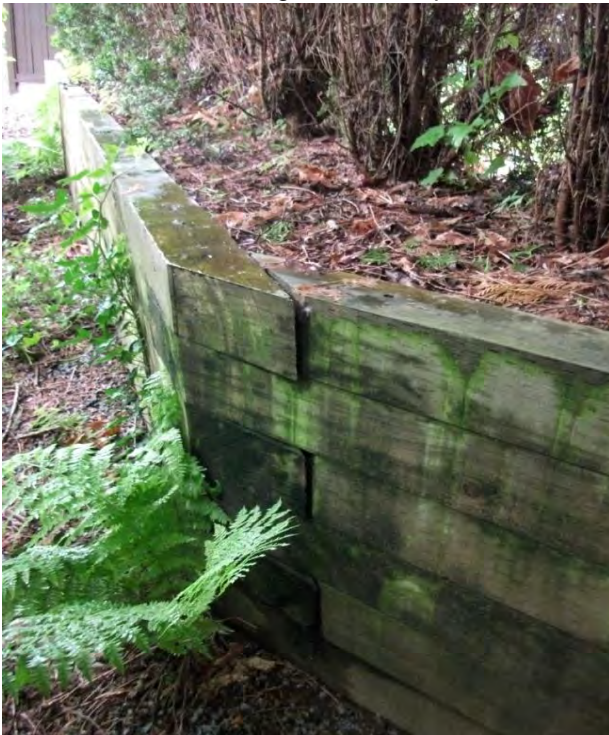
Timber Wall Along Crest, Creep Indicators

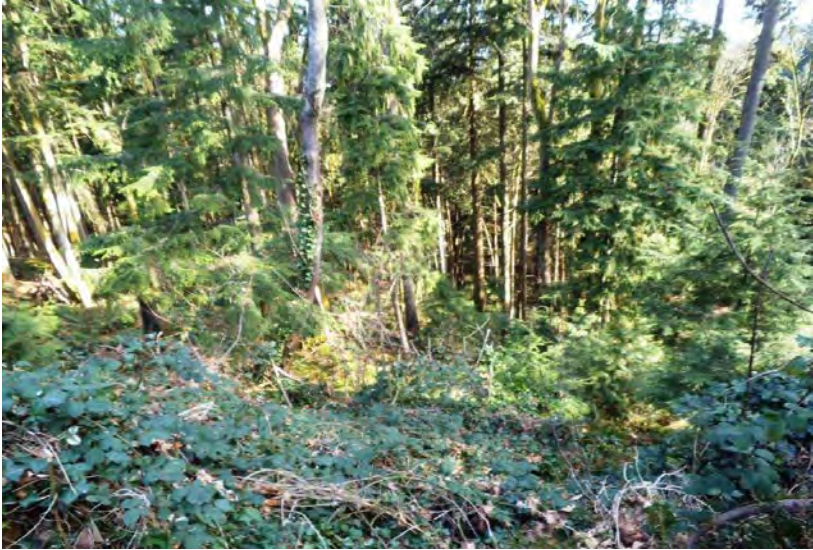
Slope Below East Section of Wall

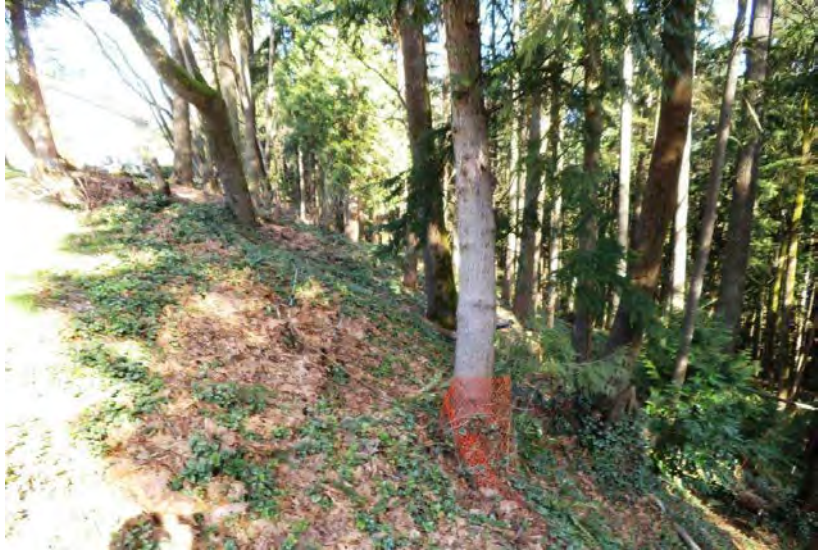
Slope Below West Part of Lot

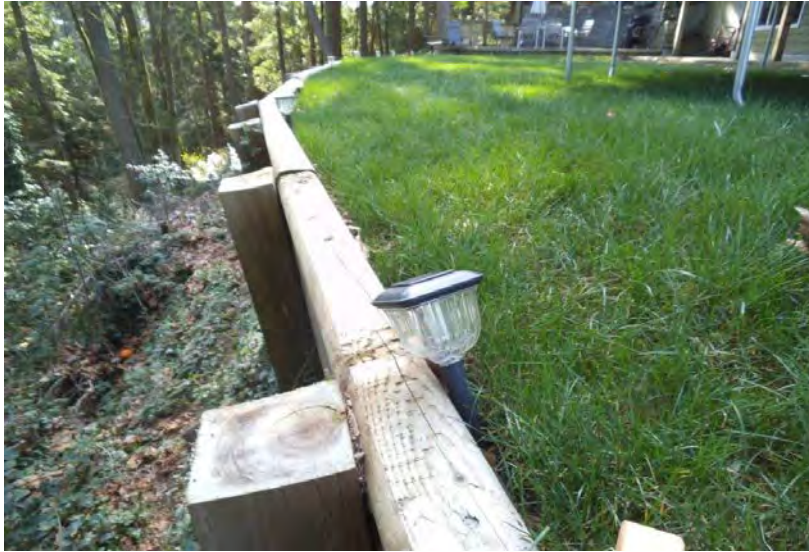
Crest Along Back Yard

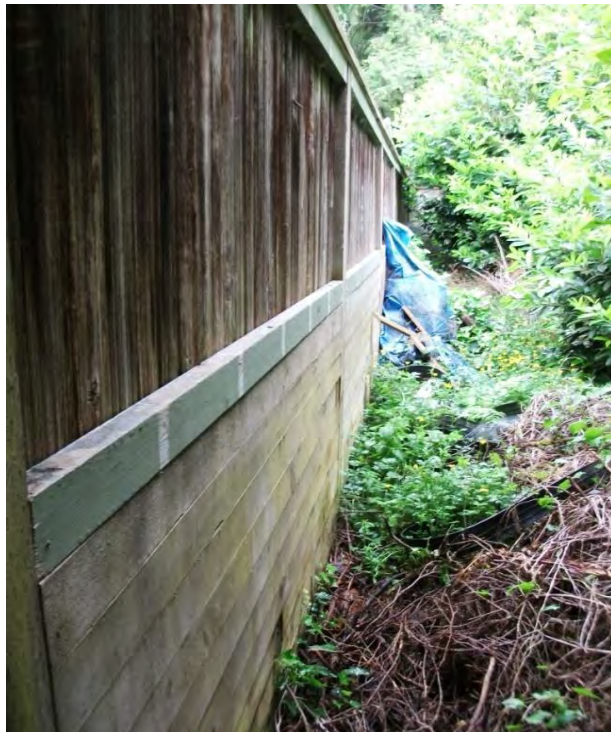
Size	Condition
Timber crib	1.2 m H	Newer, slight bulge
Stacked blocks	N	
Concrete	N	
Rock / mortar	N	
Engineered	N

Below Wood Timber Retaining Wall

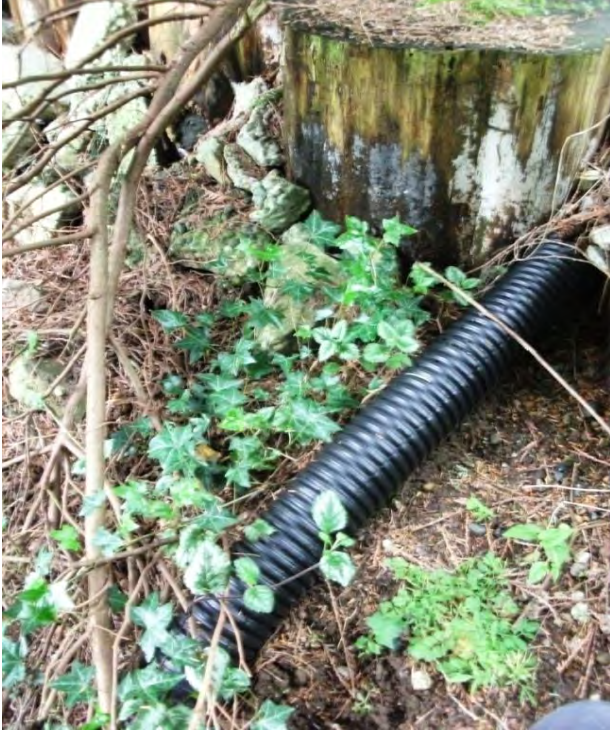
Roof and Yard Drain
