Site Observation Form

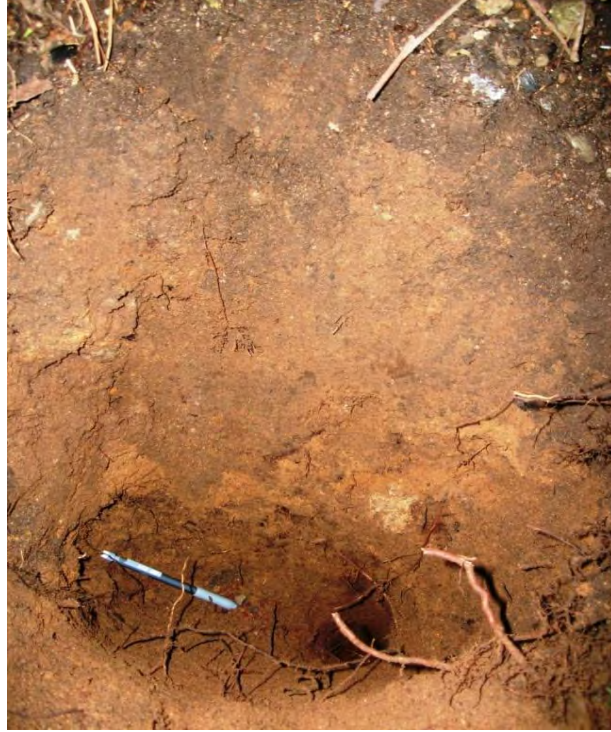
Soil Pit Below Crest

Interval (m)	Downslope
0-1.1 Fill?	Red brown, low compaction, mix fine to coarse sand rotted cedar
1.1	Black, organic rich sandy silt - old soil?
	4 m below fence and wall

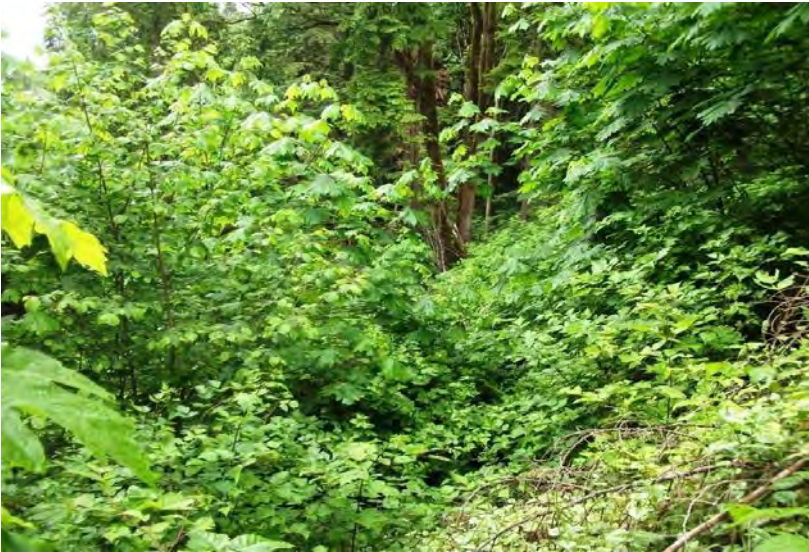
Backyd	Crest	Below
Creep	Y	Y	Y
Tension Cracks	N	N	N
Leaning trees	N	Y	Y
Pistol-butt trees	N	N	N
Shallow failures	N	Y	Y
Deep failures	N	N	N
% conifer cover at crest			
Prev. slide magnitude/runout		Small, shallow

Below Crest, Old Slope Failure Scar

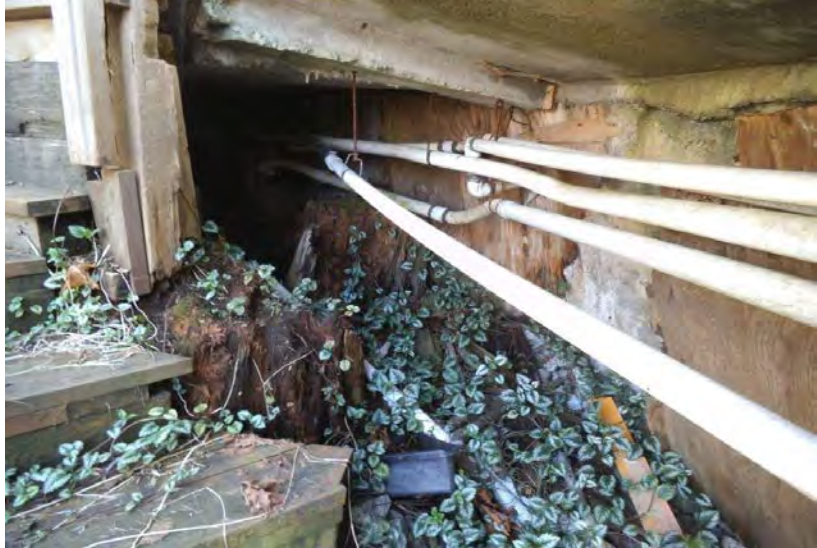
West Edge of Crest

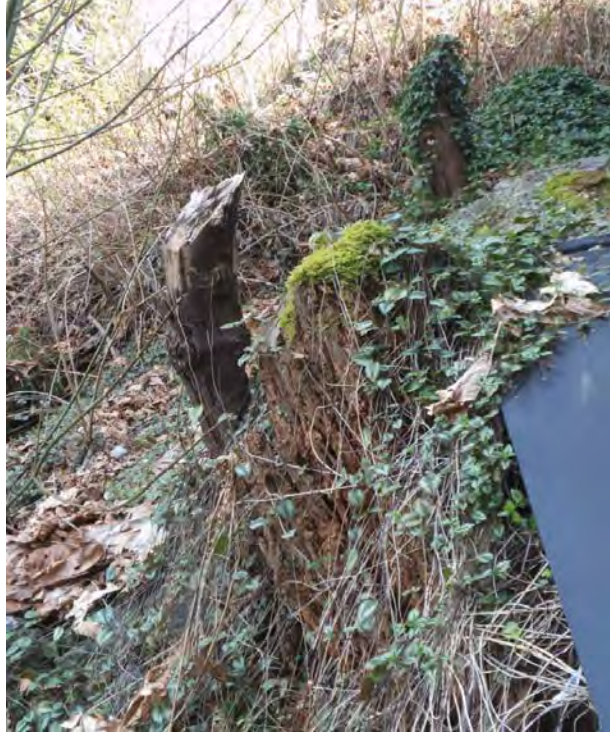
Slope Below West Edge of Property, Trees Removed

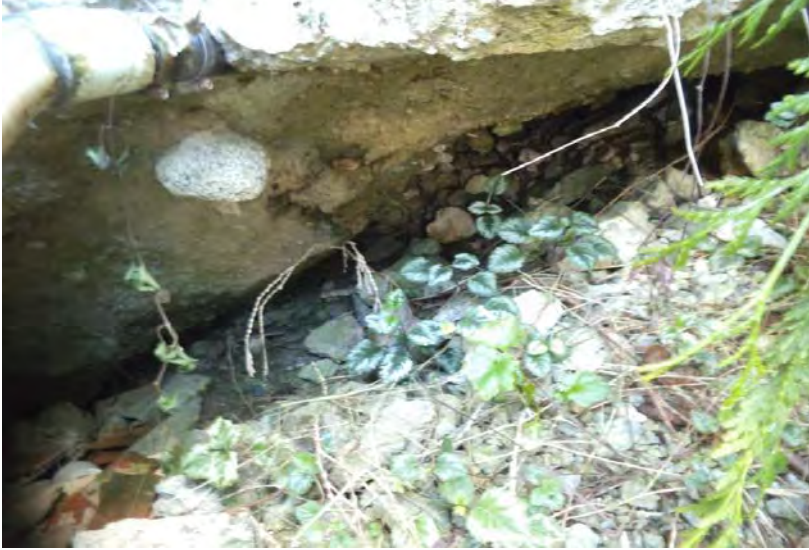
Gap In Fill Below Concrete Surface Layer

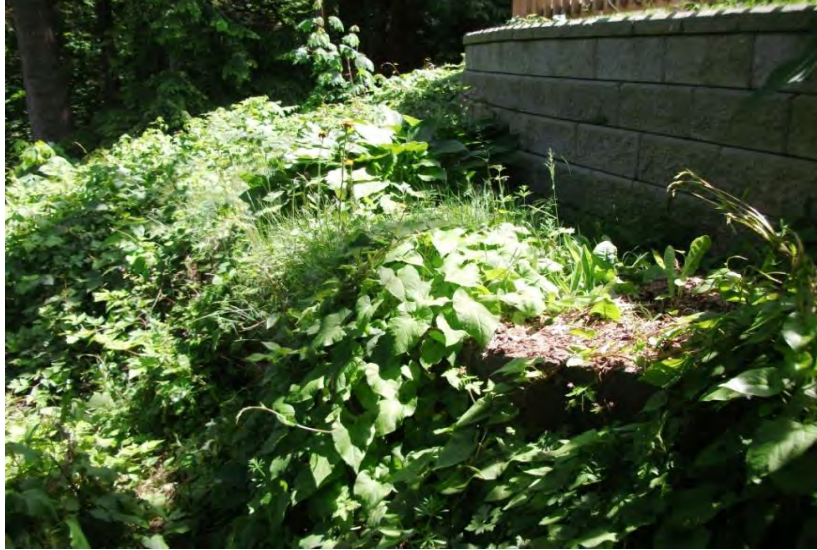
Size	Condition
Timber crib	N	
Stacked blocks	Allen, 0.8 m H	New, straight
Concrete	0.5 m H	Old, settled
Rock / mortar	N	
Engineered	N

Old Small Walls

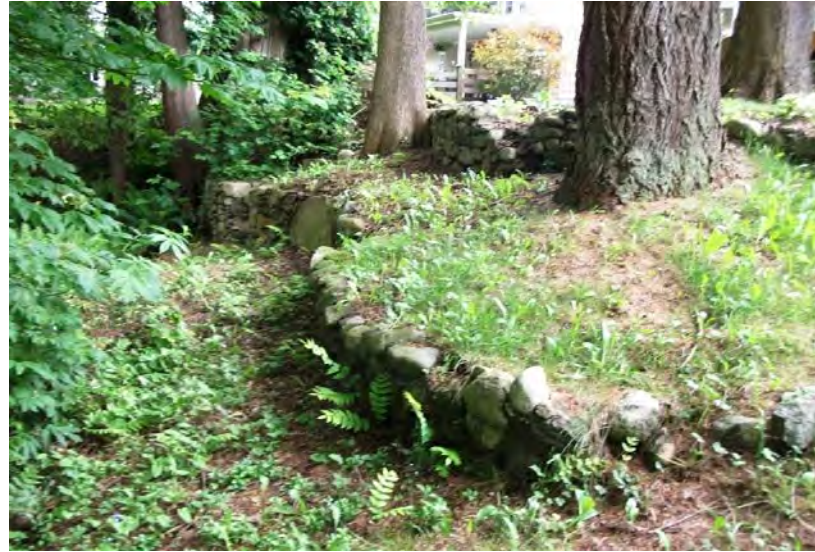
Size	Condition
Timber crib	N	
Stacked blocks	Y < 1 m H	Old, no movement
Concrete	Y < 1 m H	Old, buried
Rock / mortar	N	
Engineered	N

Old Small Walls

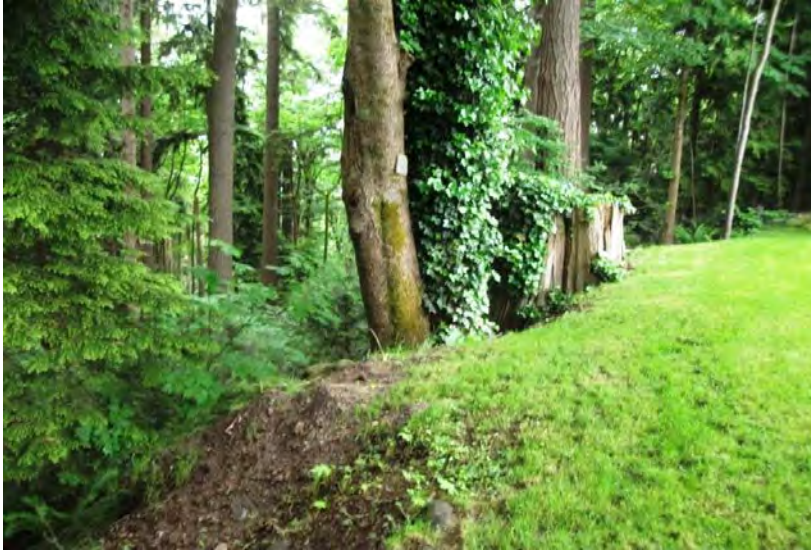
Fill at Crest

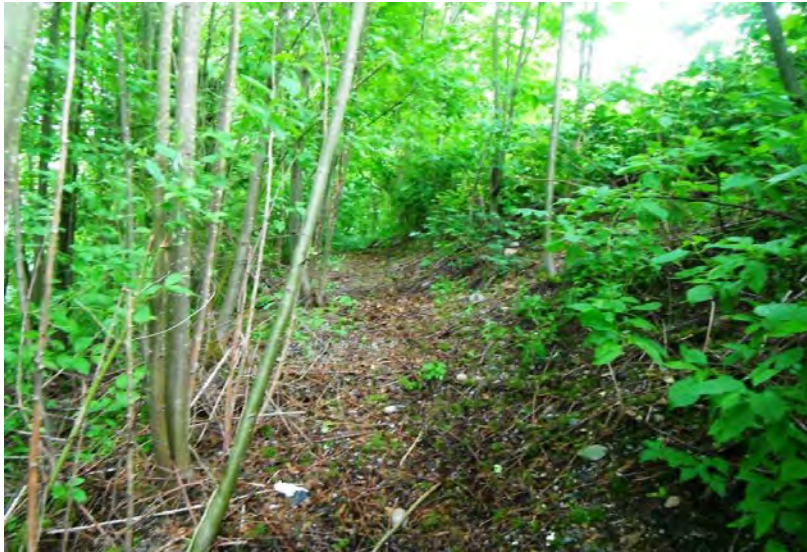
Trail On Slope Below

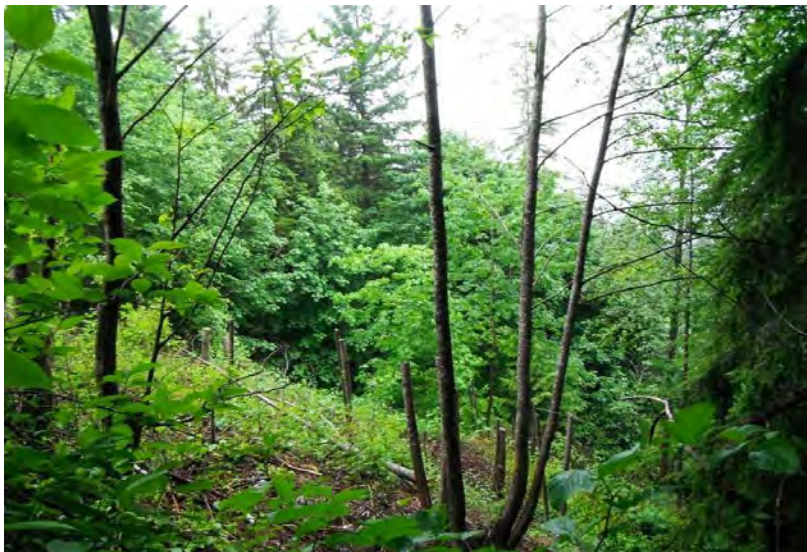
North Part of Large Fill Area

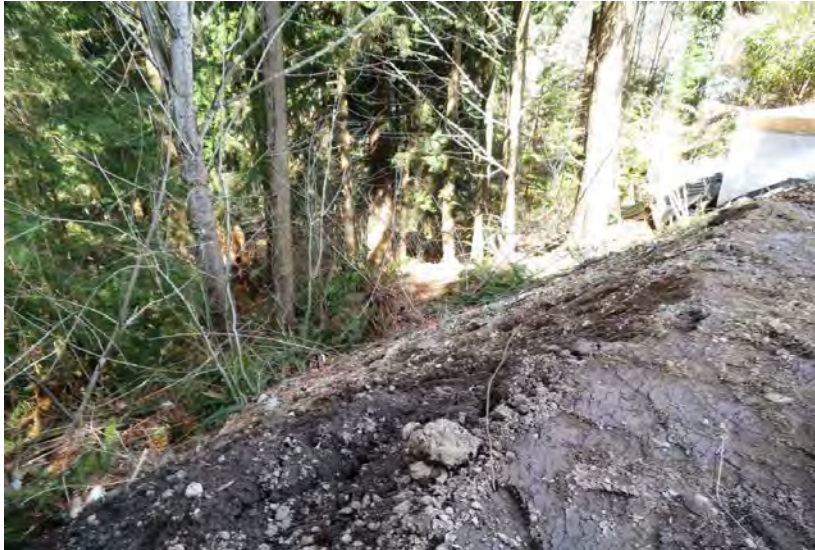
Fill Near New Pool Building

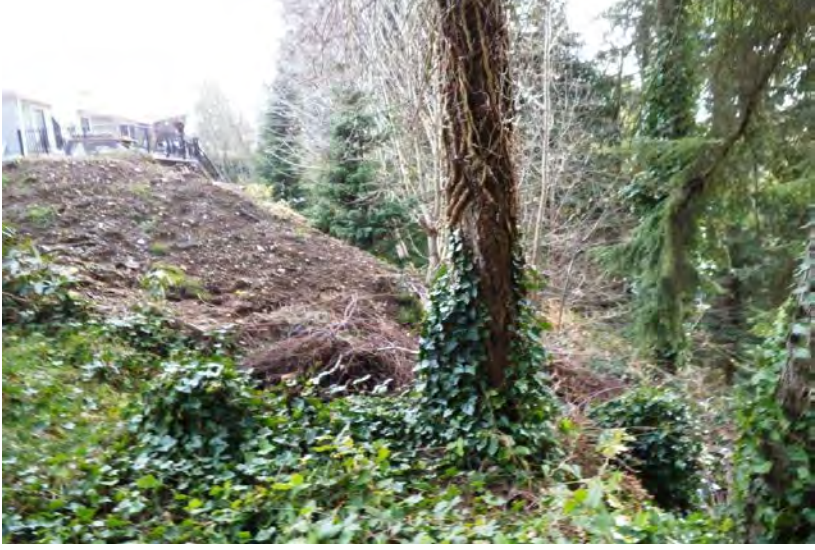
Fill At North End Property, Below End of Driveway

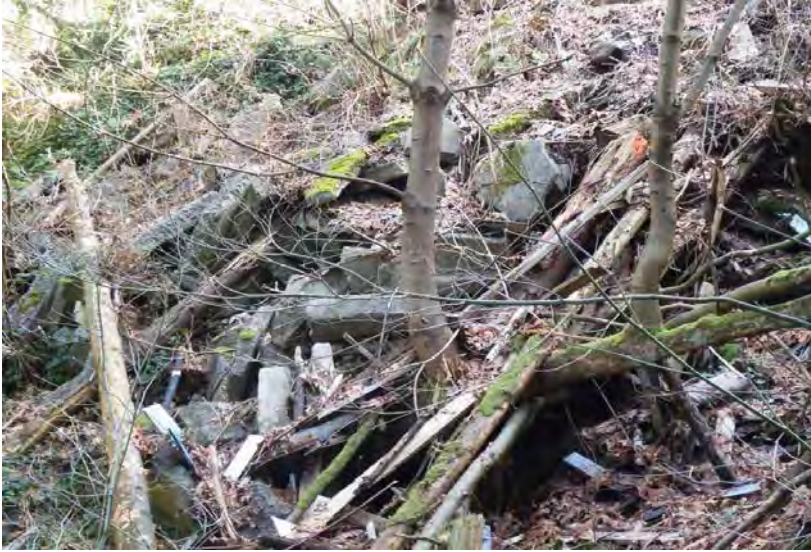
Large Wet Swale With Old Concrete Debris, Northwest Corner

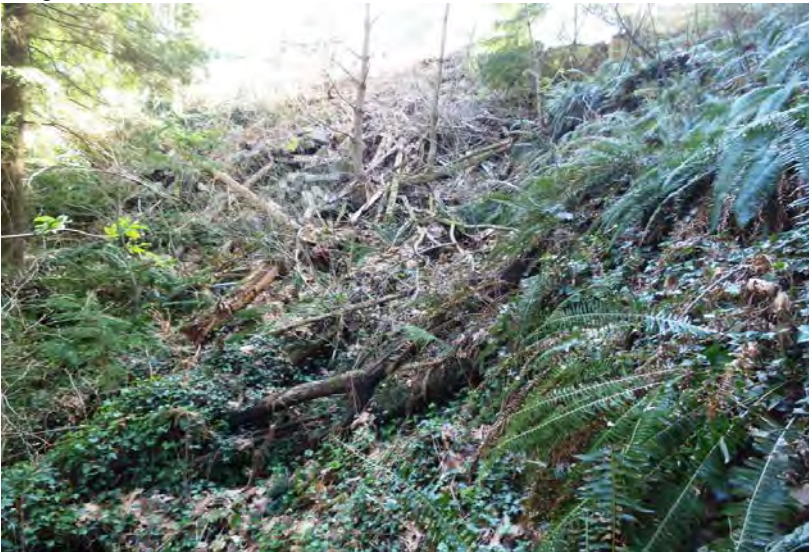
Large Wet Swale From Distance, Northwest Corner

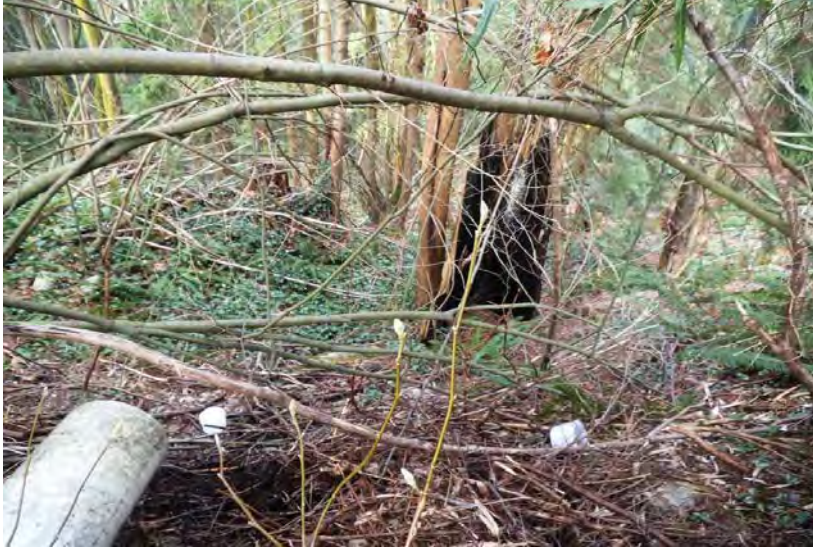
City Stormsewer Outlet At Top Of Slope, West Boundary

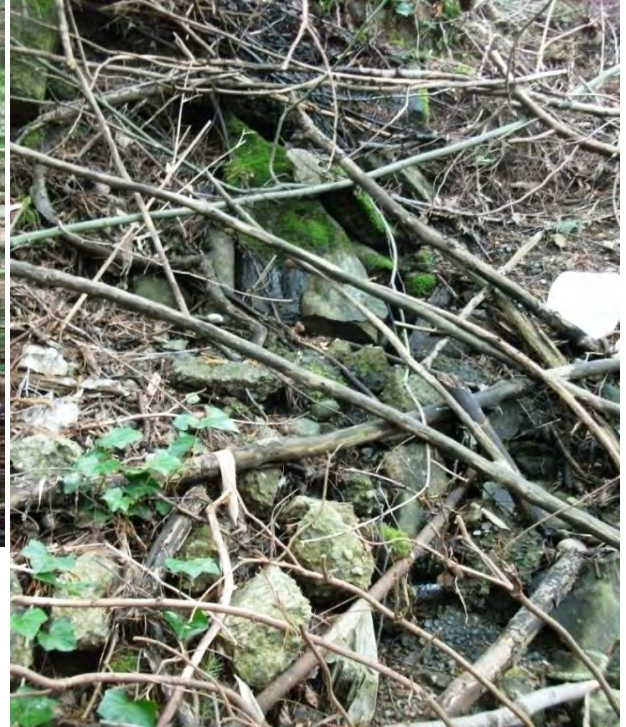
Armour Along Water Track Below Storm Outlet

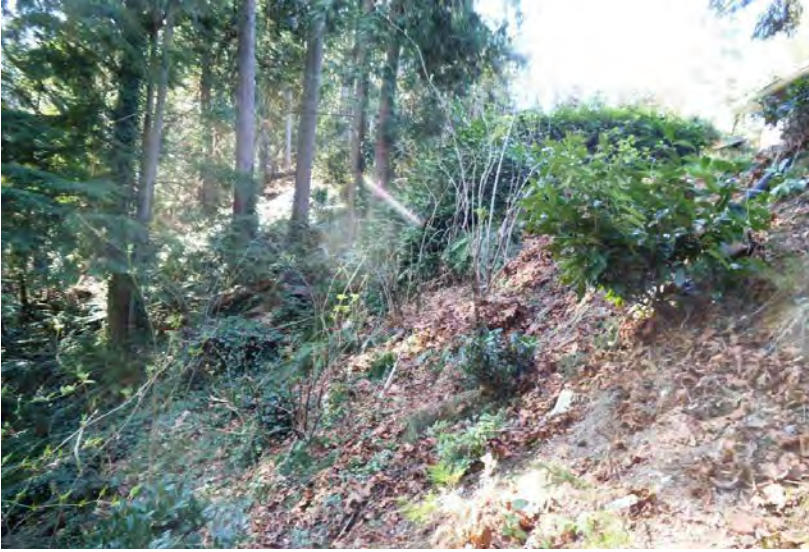
View Across Slope Below Crest with Possible Fill

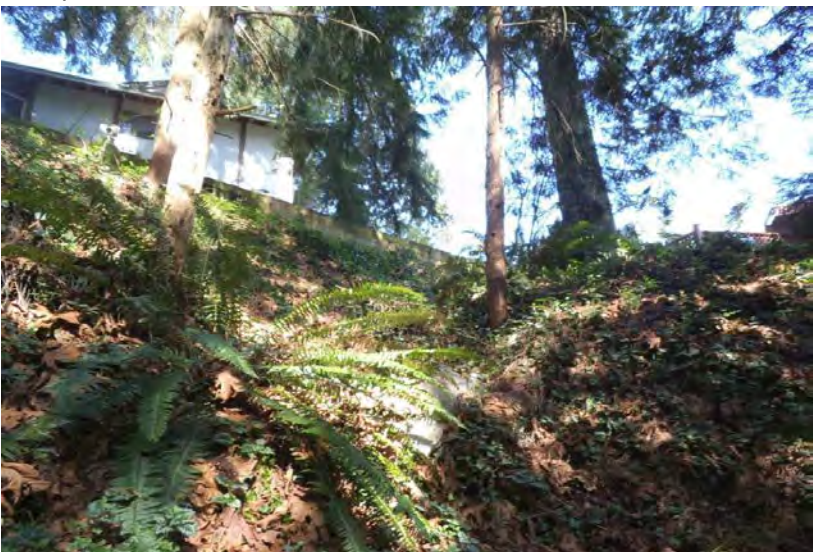
Fill Apron North Part of Crest

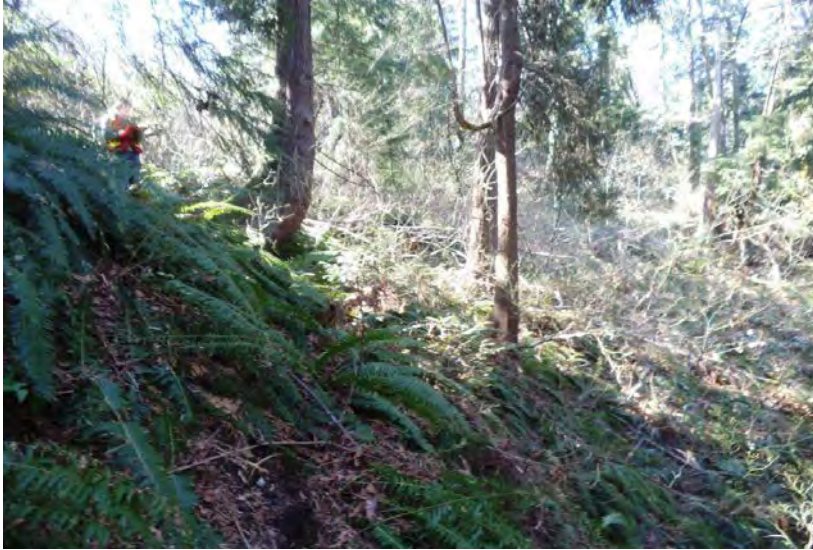
Across Slope Below Edge of Fill

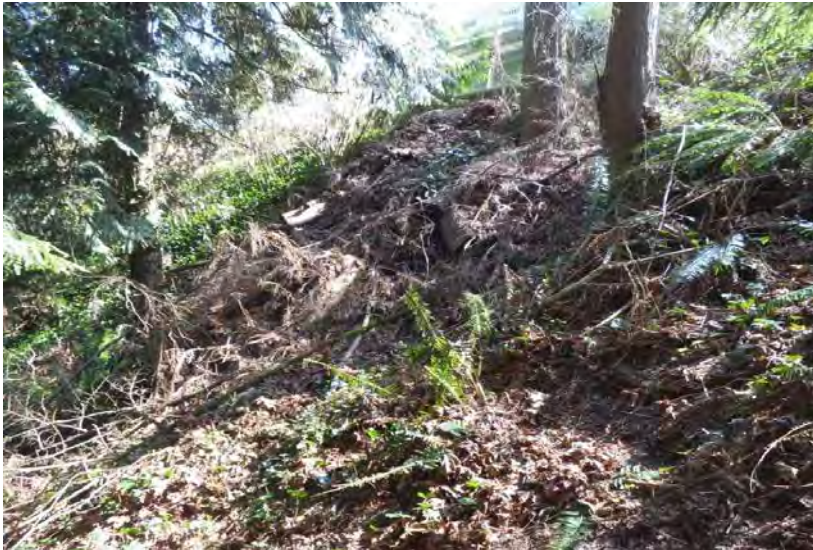
Slope Below Fill Apron, North Side

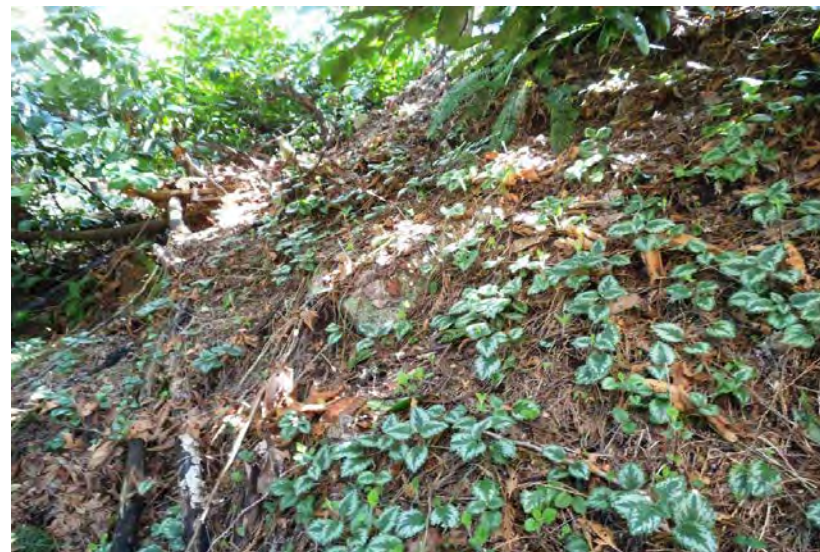
Fill Back Edge Of Yard.

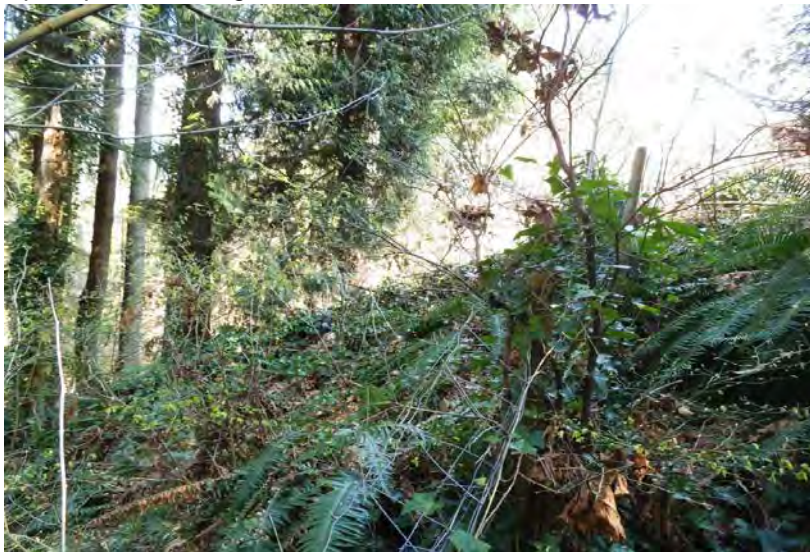
Up Slope Below Edge of Fill

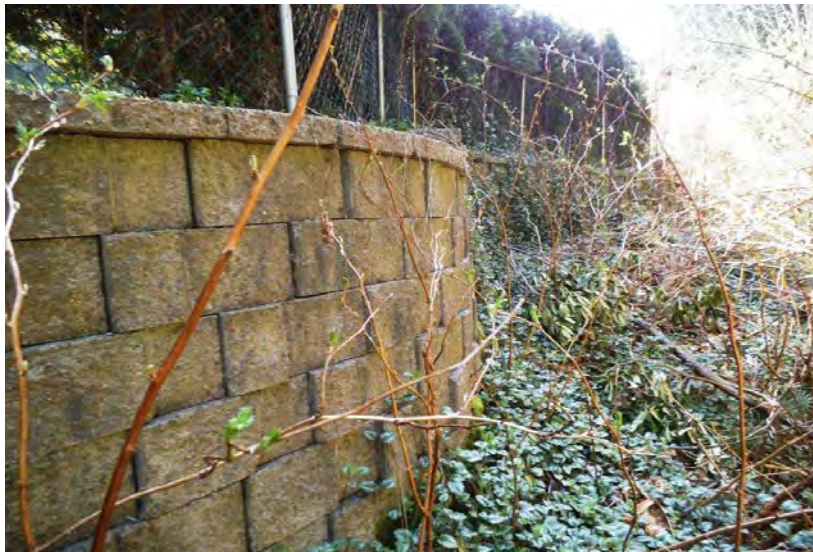
Slope Below North Side

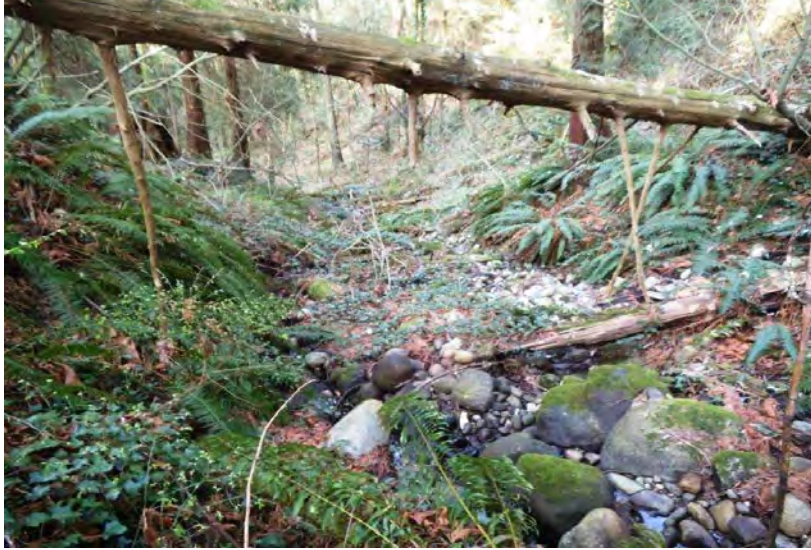
Roof and/or Foundation Drainage East Side of Slope Below Crest

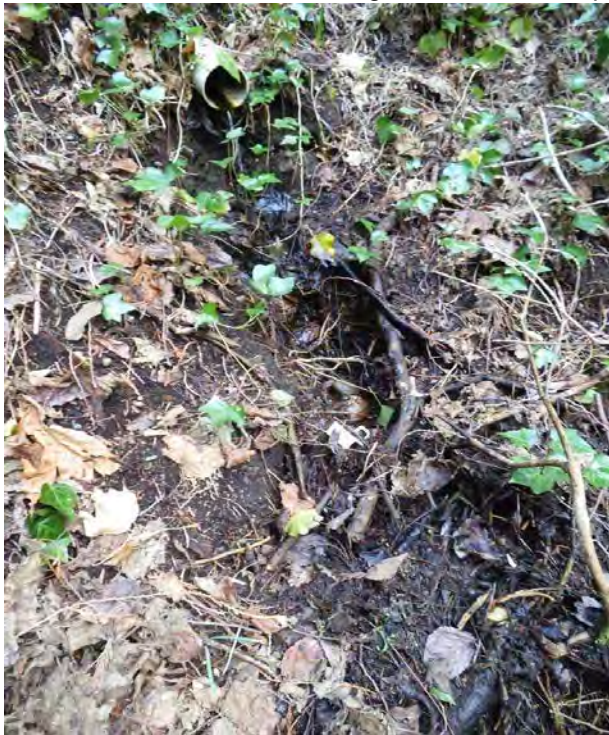
Wet Zone Below Pipe, East Side

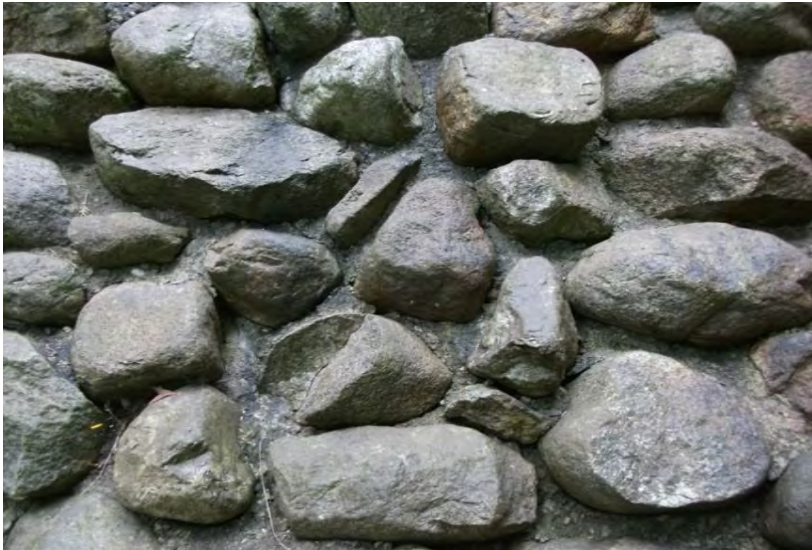
2 cm crack in 2.5 m H upper wall - bowing outwards
 Cracks in concrete trough - subsided 10 cm
 Small cracks in 3.2 m H lower wall - photo
 Terrace with grass between outstepped walls

Concrete and boulder lower retaining wall with small cracks

A geotechnical assessment of the concrete retaining wall at the storm sewer outlet is recommended.

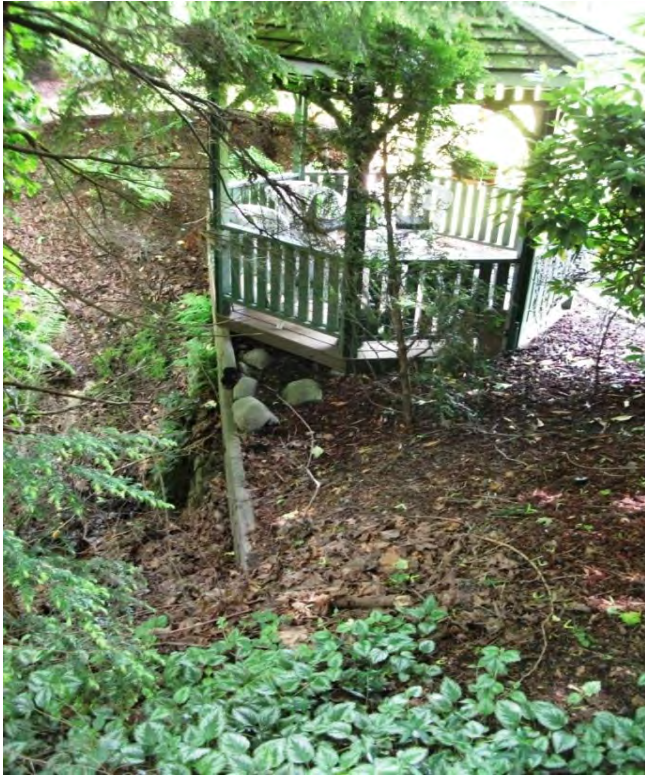
Plunge Pool from Stormwater Outflow

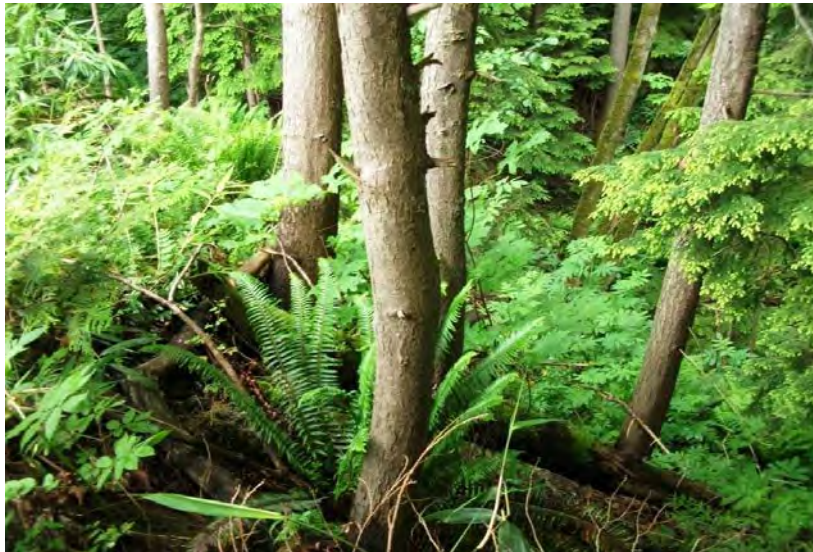
Slopes Below Crest

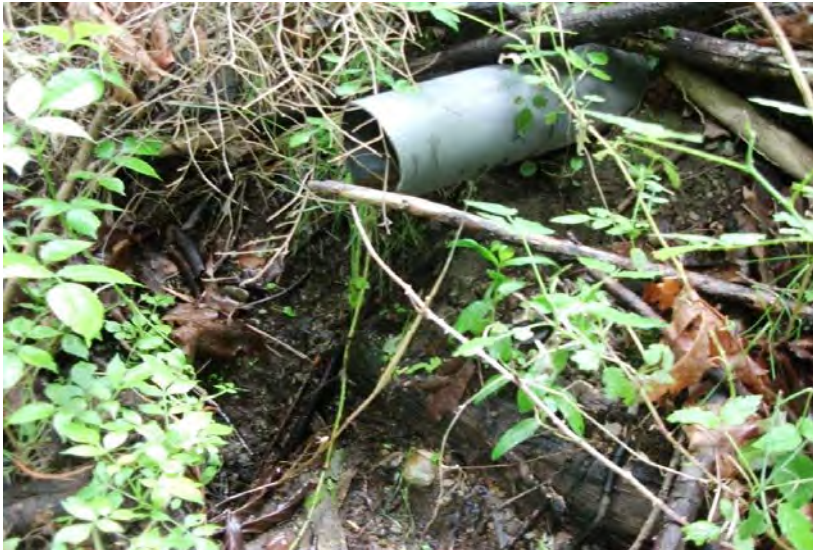
Small Drain Pipe on Slope

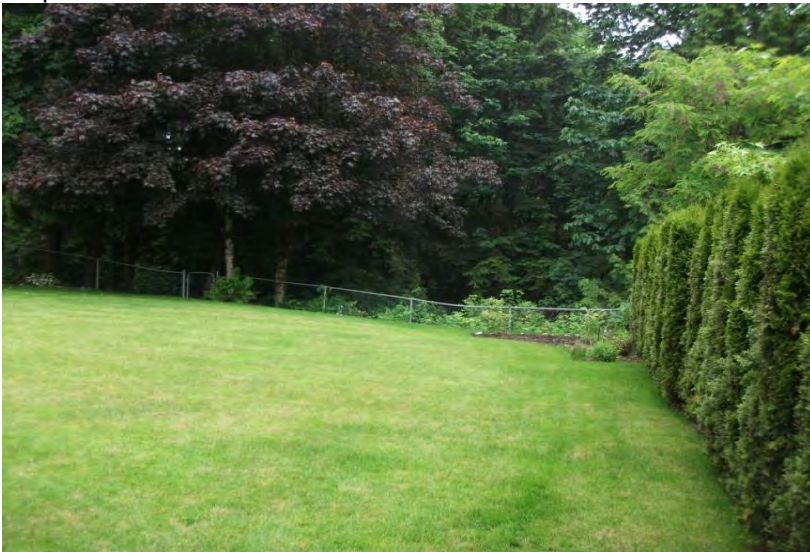
Slopes Below Crest

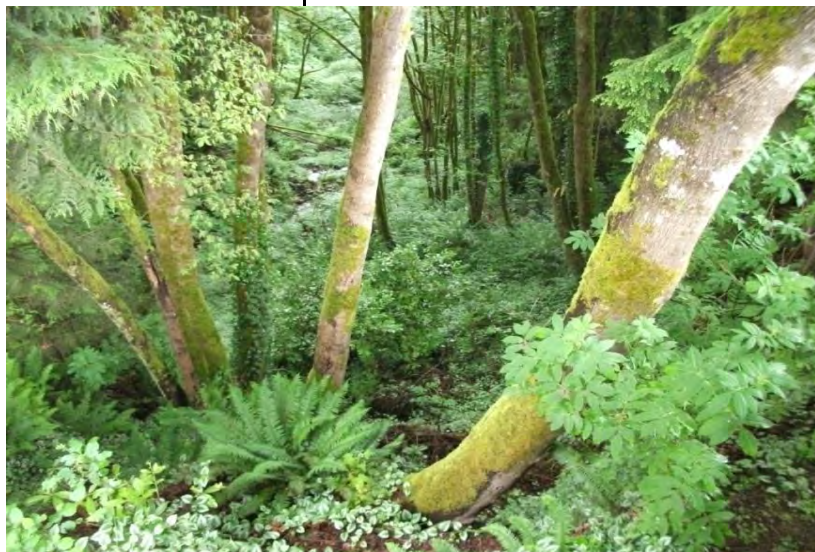
Down Slope With Maple to Creek in Distance

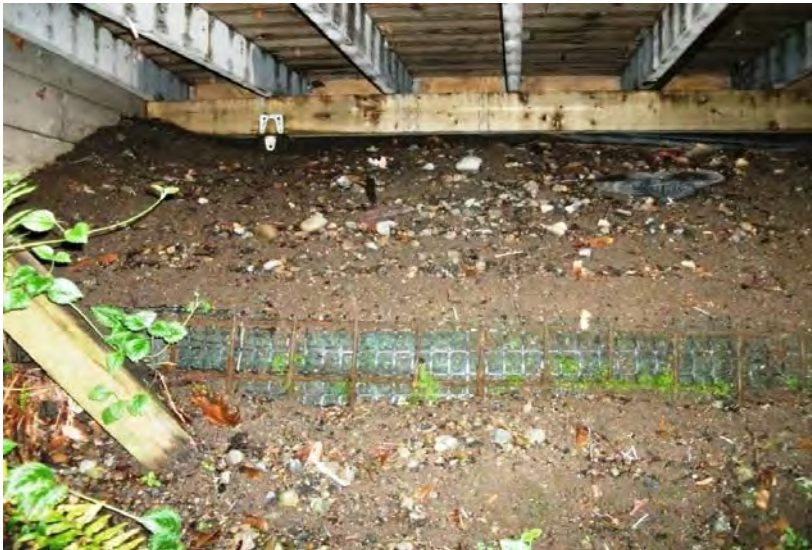
Crest Under Wooden Patio

A review of the patio footings in the ravine slope area is recommended.

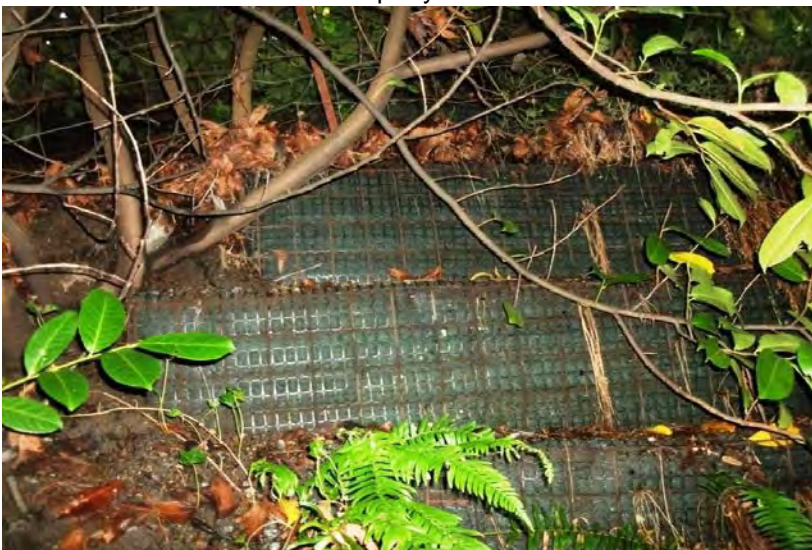
Size	Condition
Timber crib	N	
Stacked blocks	N	
Concrete	N	
Rock / mortar	N	
Engineered	Y Gabion plus geogrid	Appears intact.

Gabion Under North Side of Property

A geotechnical assessment of the gabion retaining wall at back yard edge is recommended.

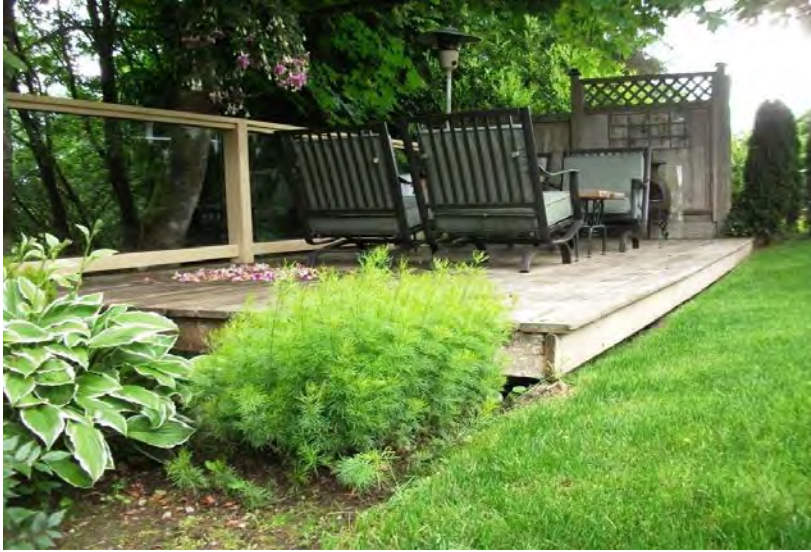
Patio At Centre Of Yard At Crest

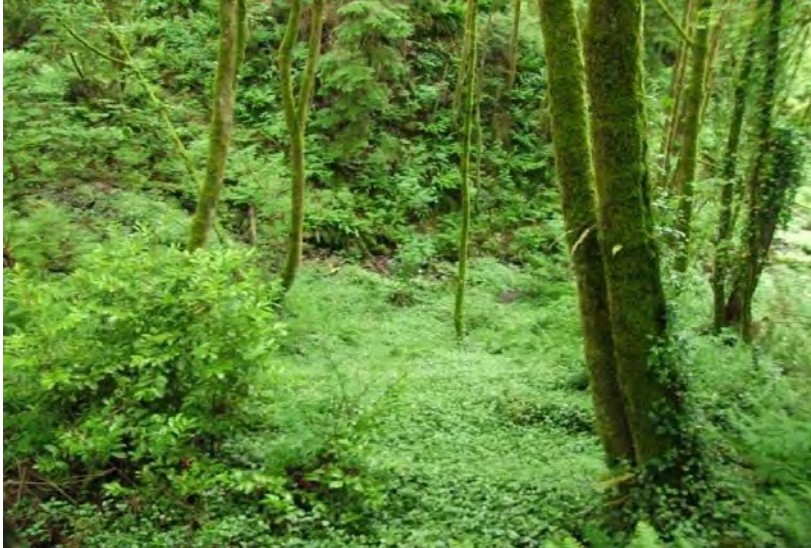
Ravine Slope Below South Side Of Property, Leads Down To Creek

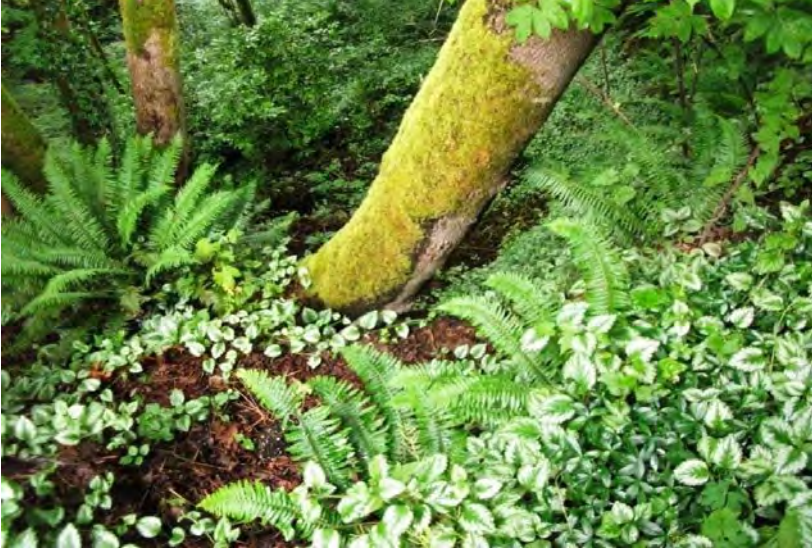
Below Crest

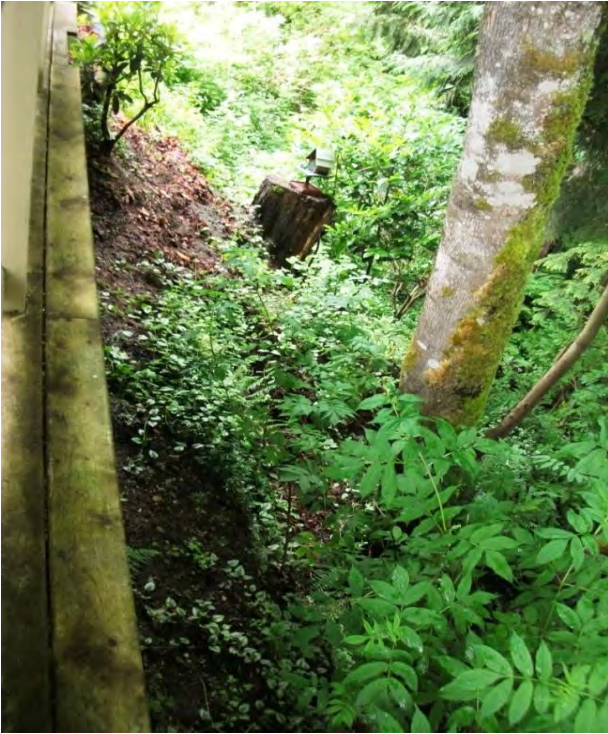
1785 Harbour Drive

Along Crest

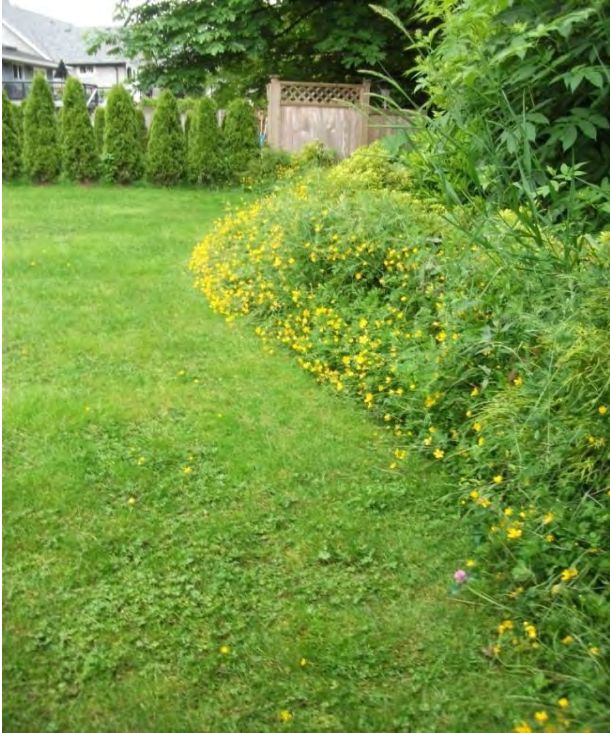
1789 Harbour Drive

Back Yard

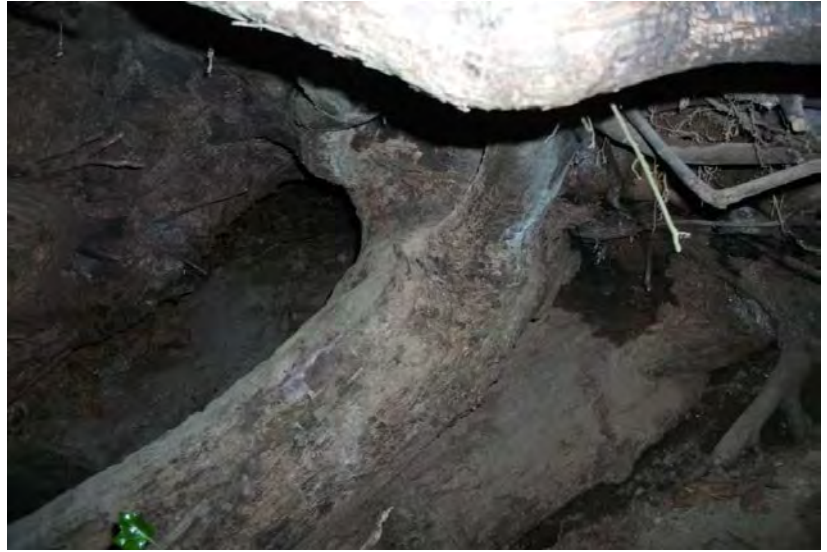
Old Stump Below Crest From Land Clearing

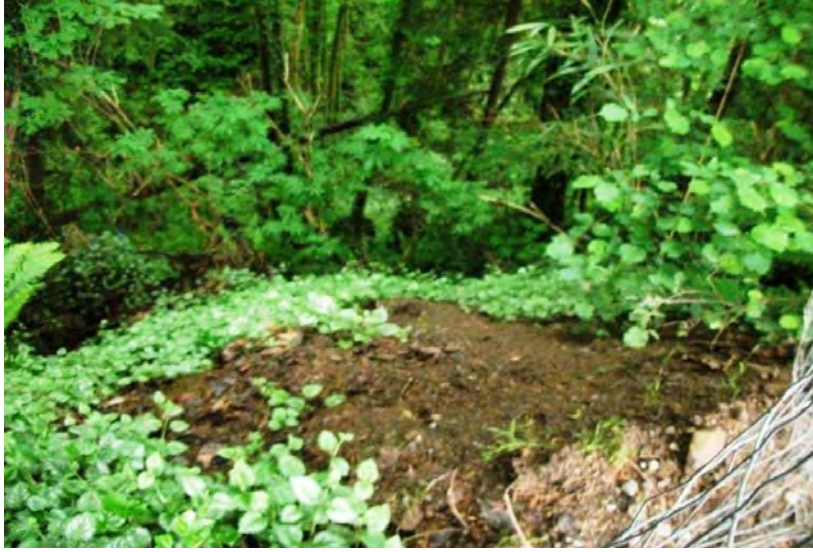
Slope Below Crest

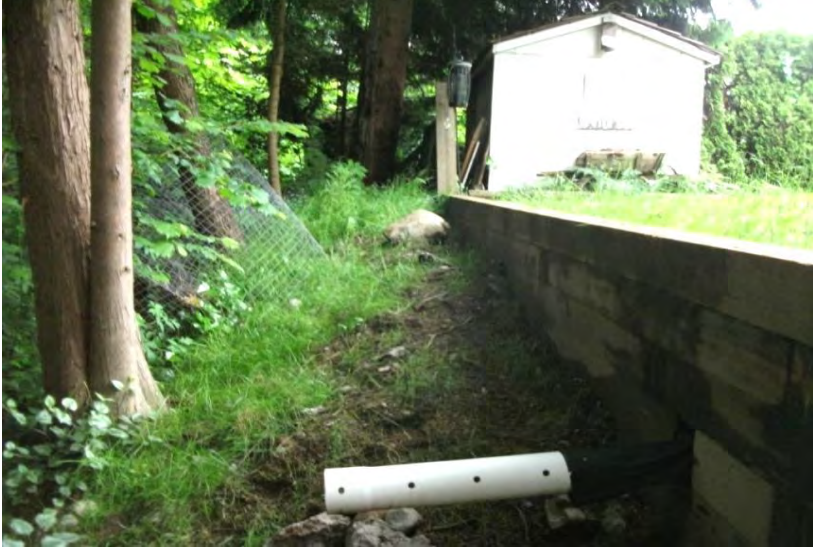
Small Drain Pipe On Slope

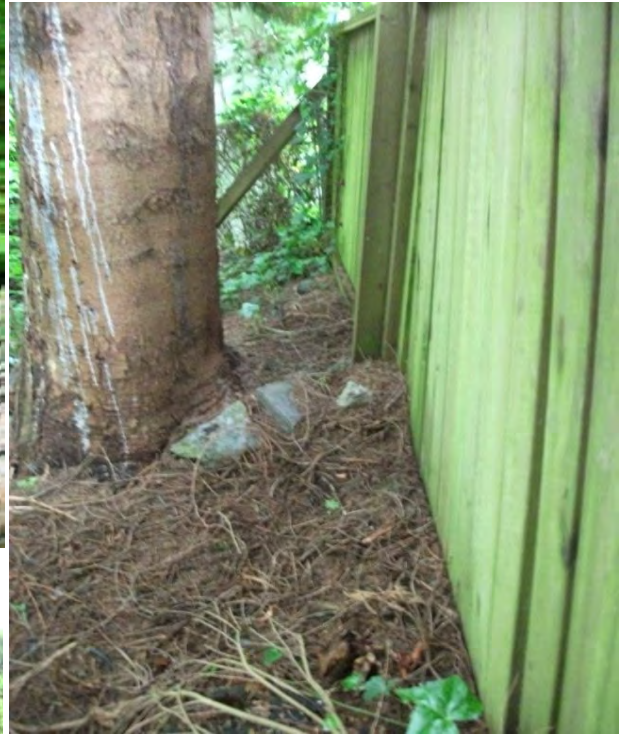
1791 Harbour Drive

Back Fence Line

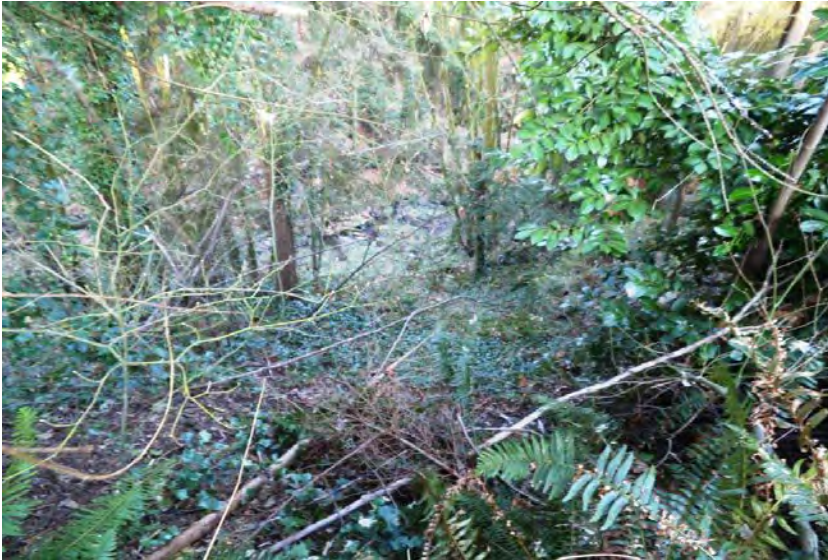
Slope Below Yard

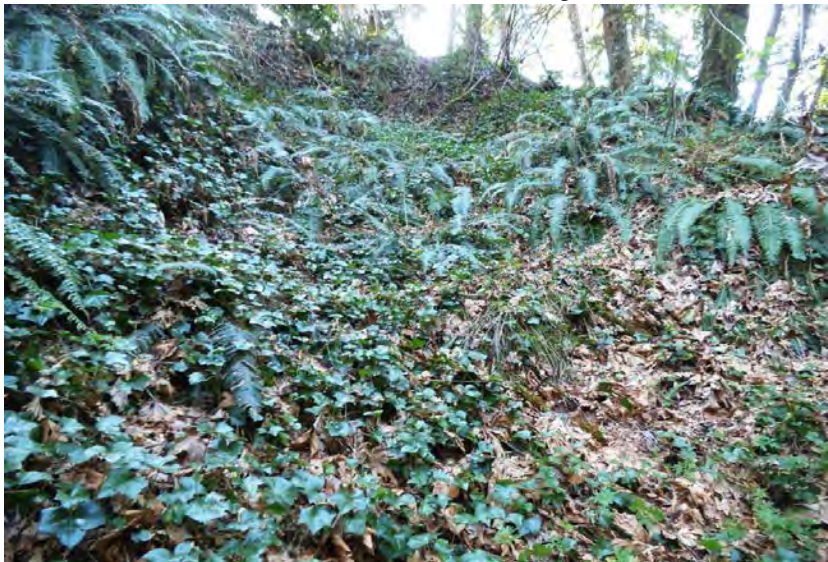
About 1990, drained pool onto slope behind, erosion, headscarp and track to creek. Replanted DFO recommended species. Trace seepage in old headscarp, likely till.

Head of Old Shallow Erosion Feature, Now Vegetated

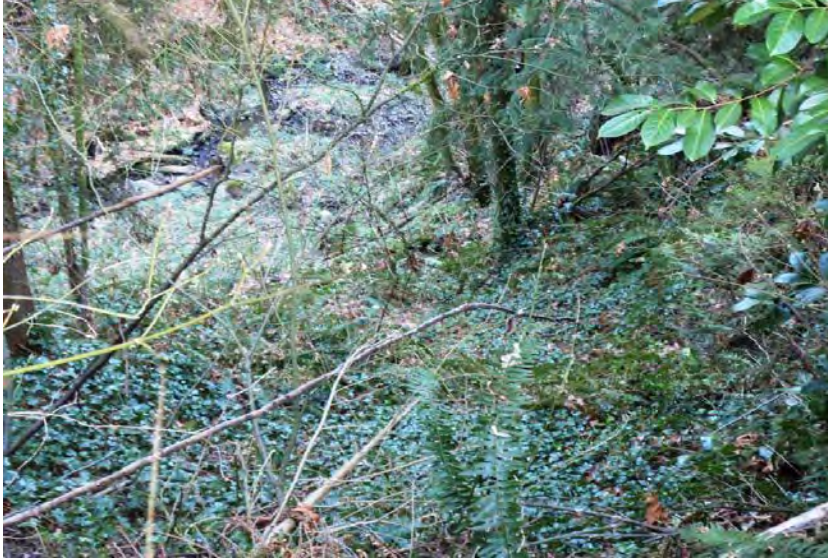
View Down Track of Old Erosion Feature

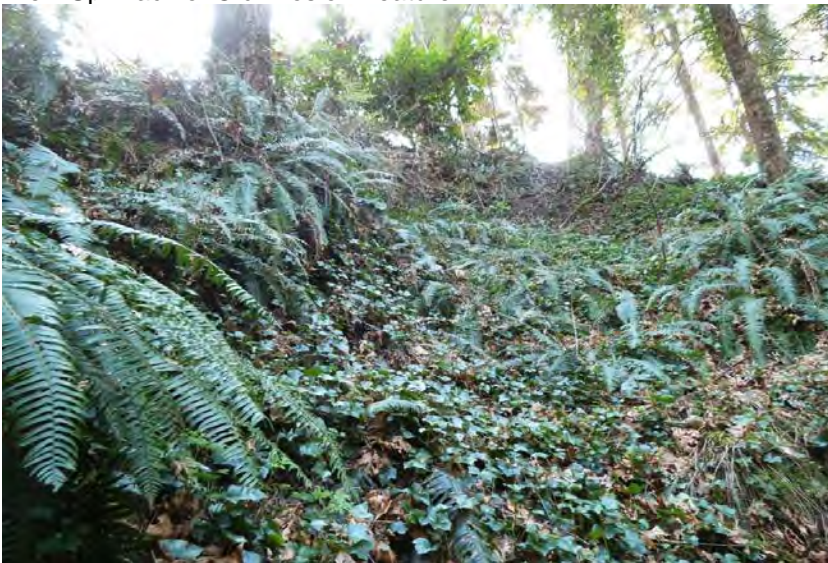
1793 Harbour Drive

View Up Track of Old Erosion Feature

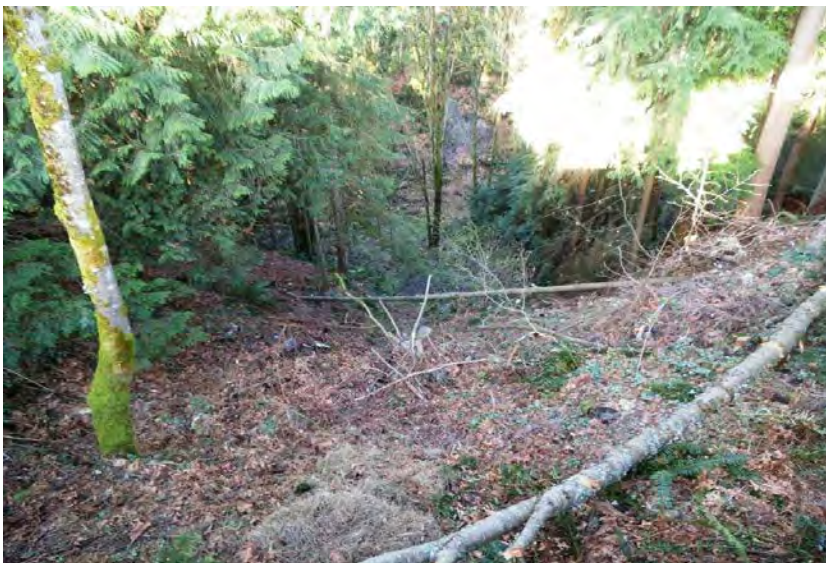
New mound soil fill NW corner from pool reconstruction, perched above old failure side ravine
Should relocate fill away from slope.
On far side of ravine is a 10 m H, near vertical headscarp in till and Quadra Sands

Apron of New Soil Fill from Pool/Patio Reconstruction

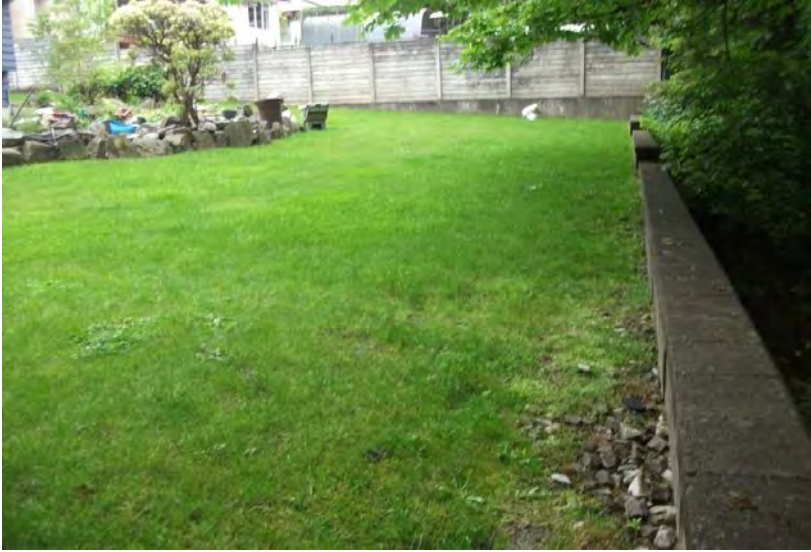
1801 Harbour Drive

Back Yard And Crest

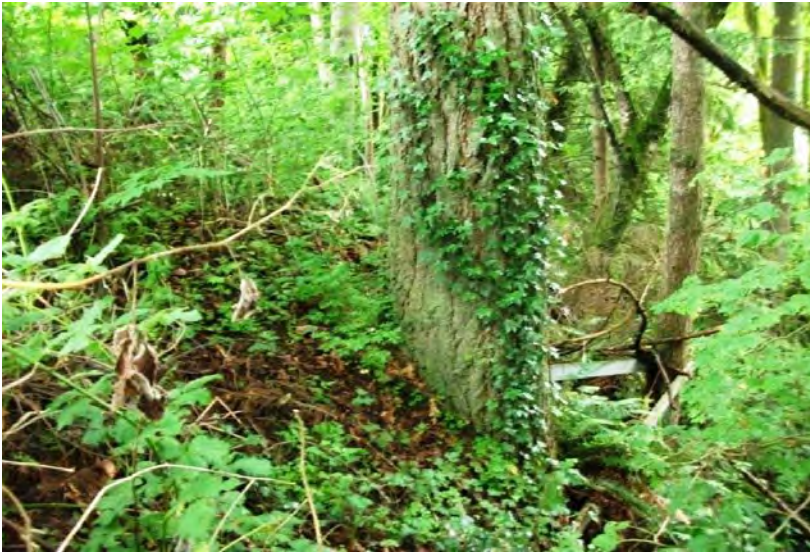
View Down Slope
