Site Observation Form

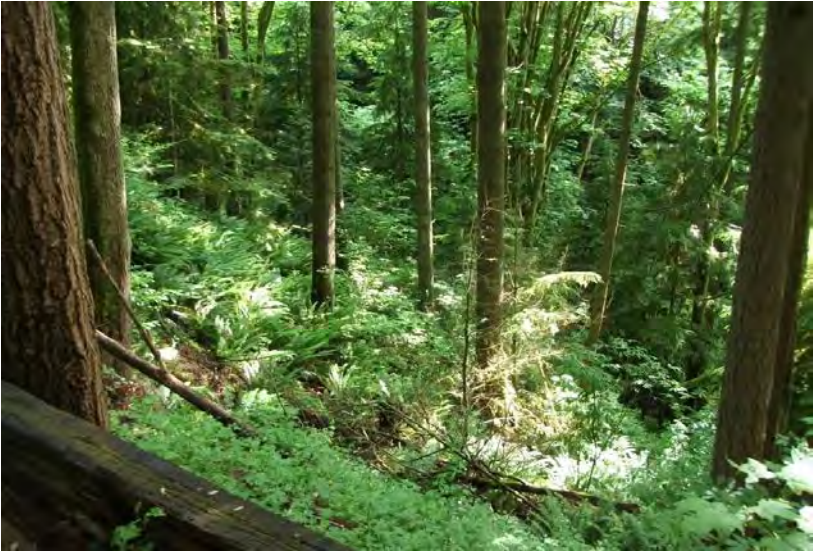
View Down Slope

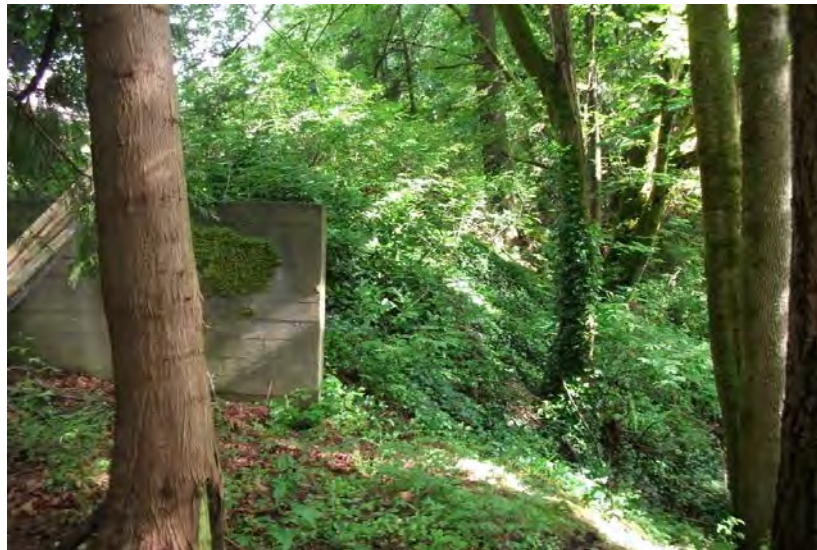
View Along Slope Crest Near End Of Side Wall

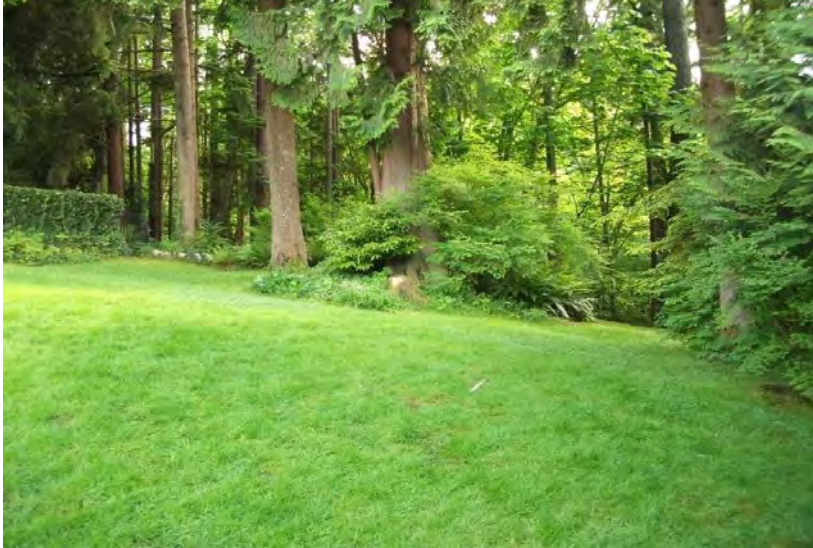
Back Yard And Crest

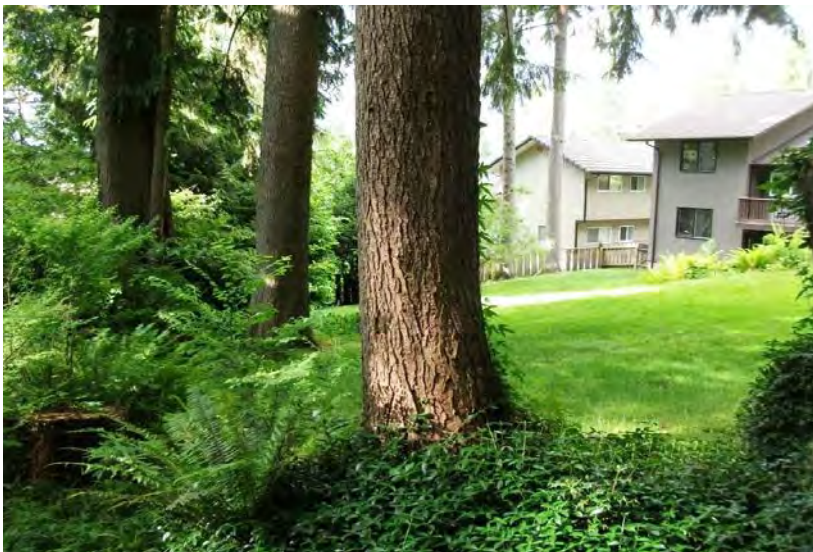
Crest

Probability of a specific hazardous landslide starting from this property affecting downslope properties:

Low.

No geotechnical assessment is recommended at this time. If there is any evidence of slope movement, water erosion or drainage problems on the property or nearby, we recommend that the property owner immediately contact the City and also immediately engage a geotechnical engineer to conduct an assessment.

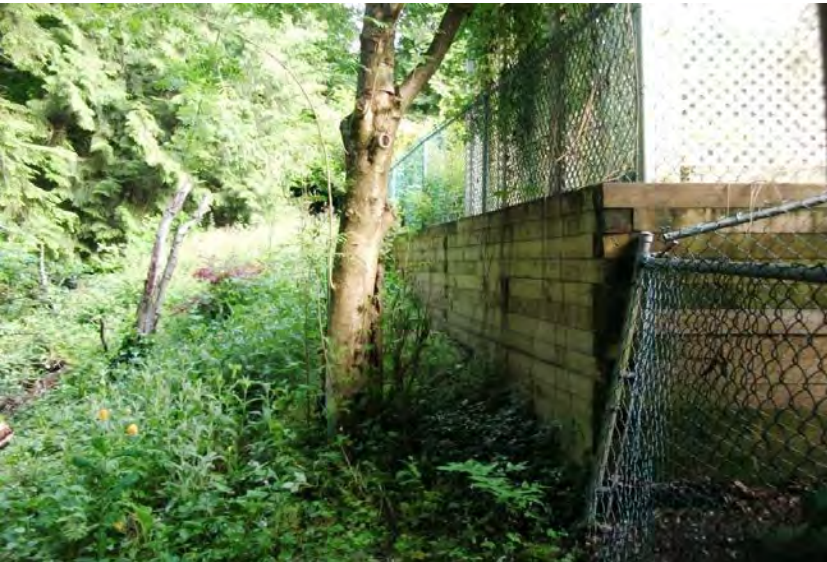
Northeast Corner Yard and Crest

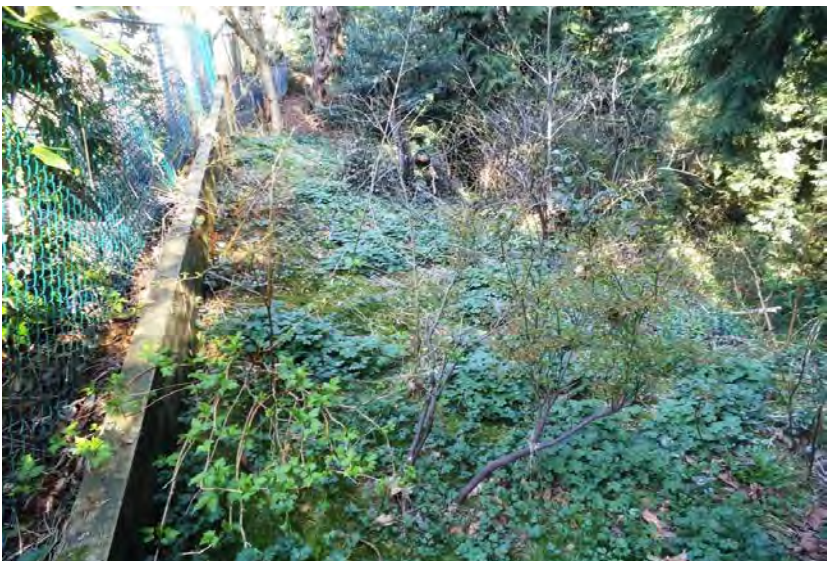
View Along Crest to North

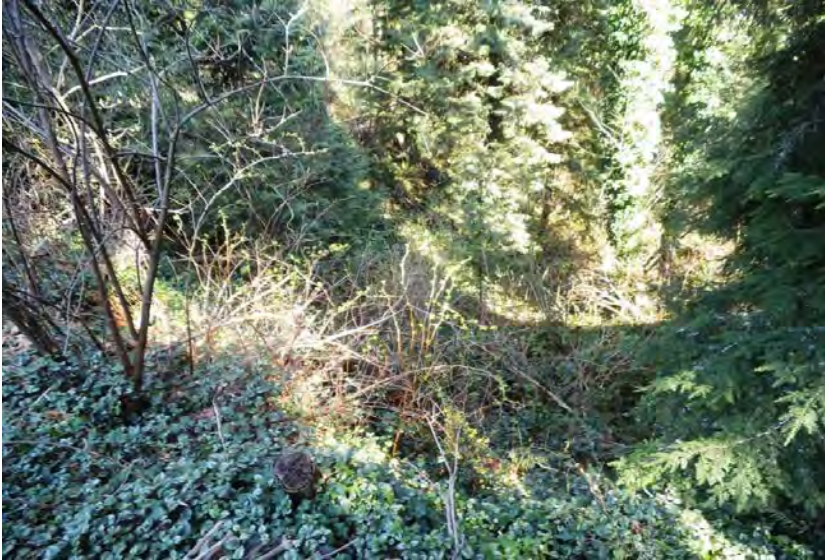
View Down Slope

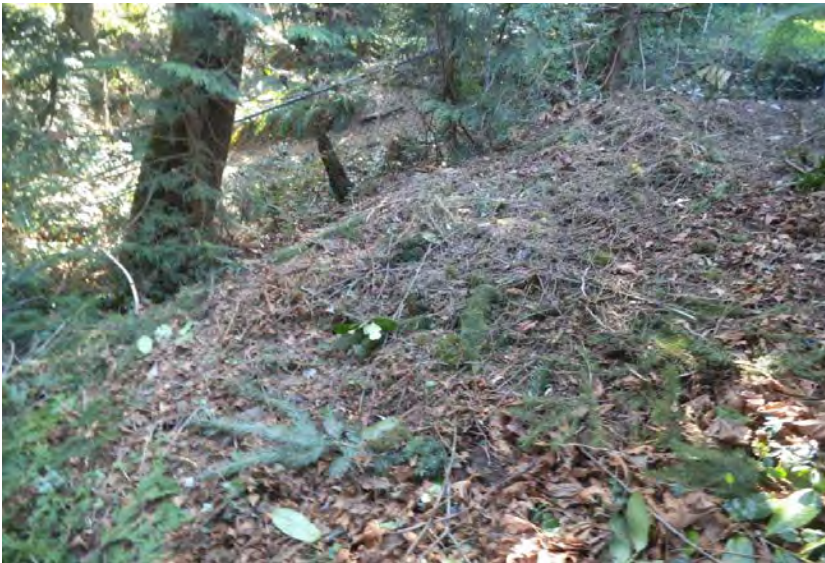
Compost Area

No geotechnical assessment is recommended at this time. If there is any evidence of further slope movement, water erosion or drainage problems on the property or nearby, we recommend that the property owner immediately contact the City and also immediately engage a geotechnical engineer to conduct an assessment.

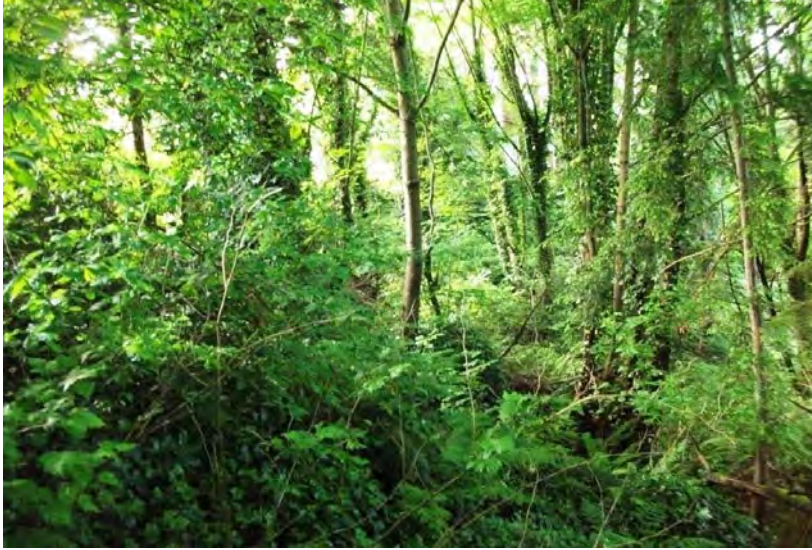
Slope Below

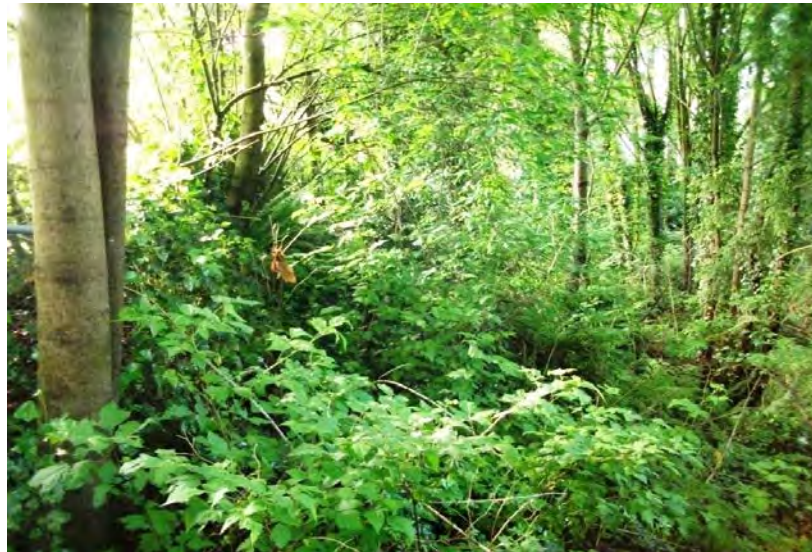
Slope Below Crest

**Probability of a specific hazardous landslide starting from this property affecting downslope properties:
Low.**

No geotechnical assessment is recommended at this time. If there is any evidence of slope movement, water erosion or drainage problems on the property or nearby, we recommend that the property owner immediately contact the City and also immediately engage a geotechnical engineer to conduct an assessment.

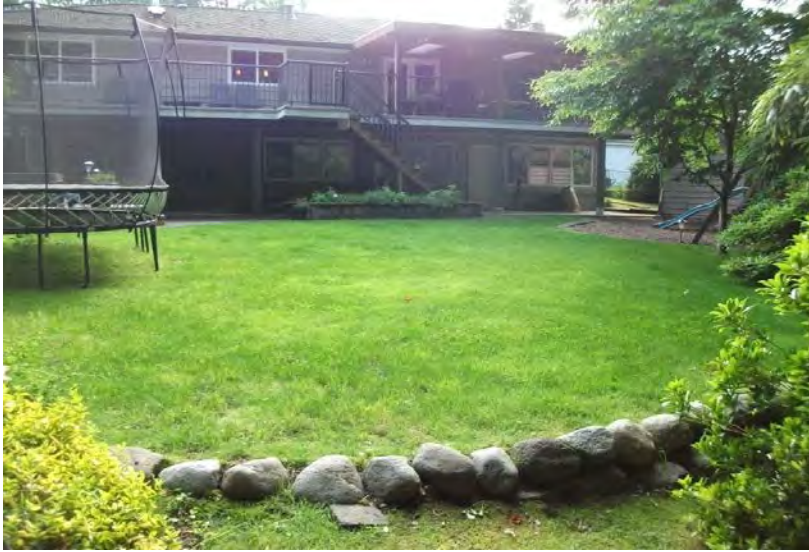
Back Yard

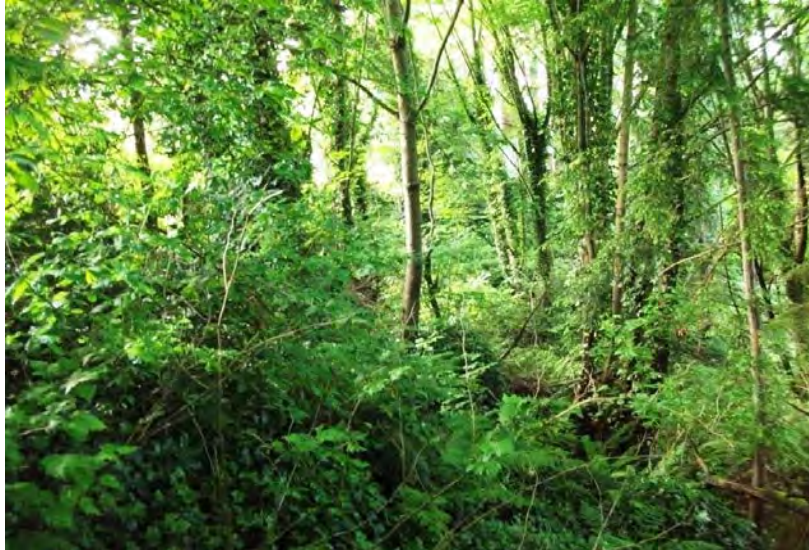
Slope Below Yard

No geotechnical assessment is recommended at this time. If there is any evidence of slope movement, water erosion or drainage problems on the property or nearby, we recommend that the property owner immediately contact the City and also immediately engage a geotechnical engineer to conduct an assessment.

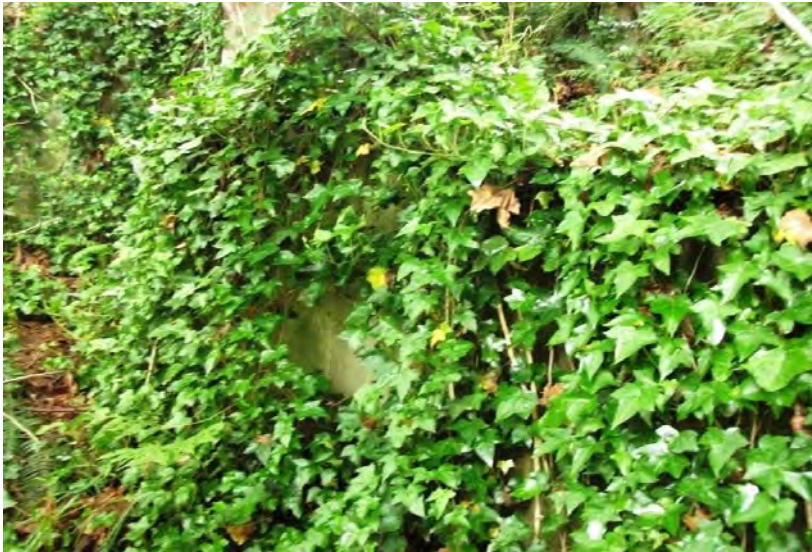
Shallow Scallop With Wet To Flowing Water, About 20 m Below Crest.

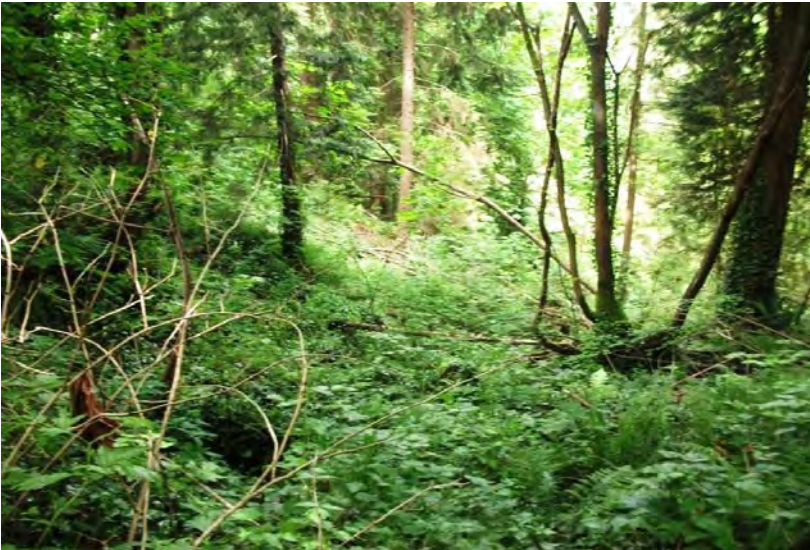
Slope Below To North

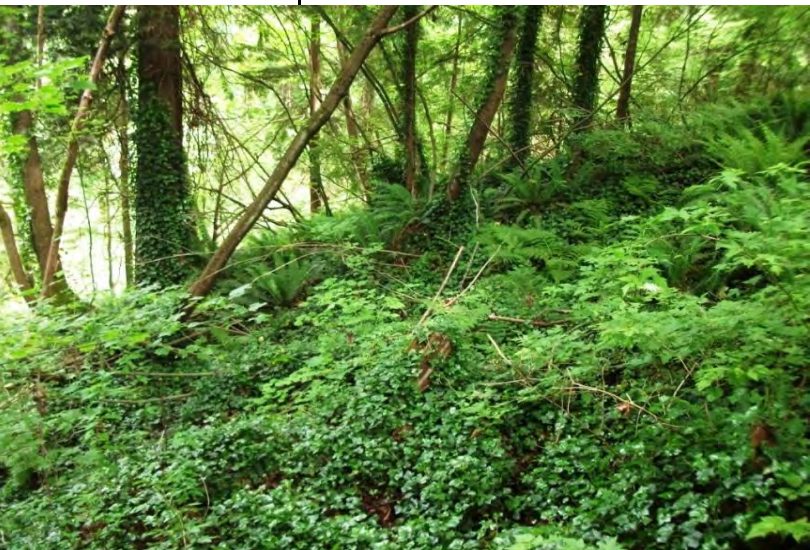
Slope Below To South

No geotechnical assessment is recommended at this time. If there is any evidence of slope movement, water erosion or drainage problems on the property or nearby, we recommend that the property owner immediately contact the City and also immediately engage a geotechnical engineer to conduct an assessment.

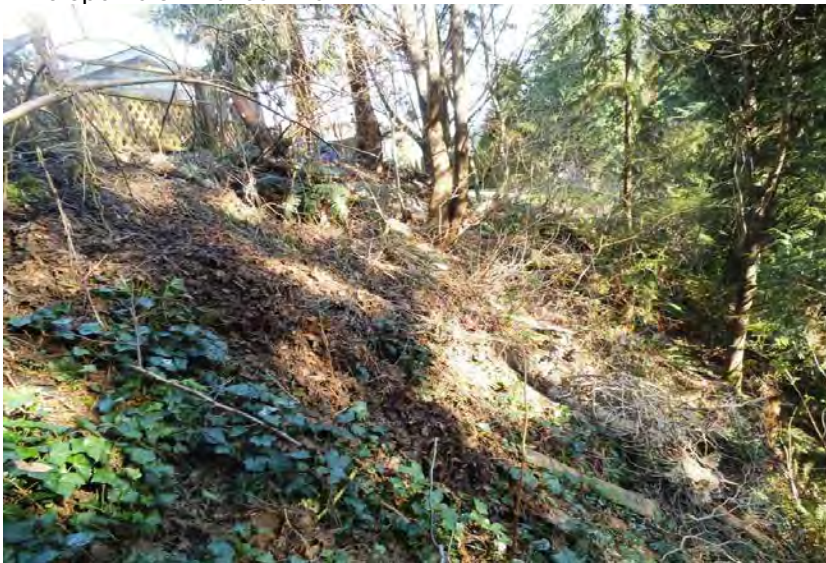
Fill Slope Below Fence Line

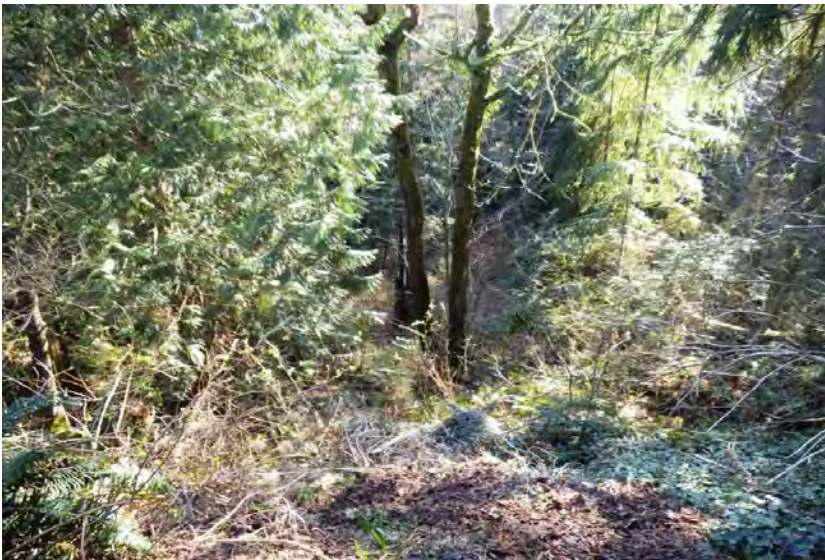
View Down Slope With Rolled Boulders Far Below

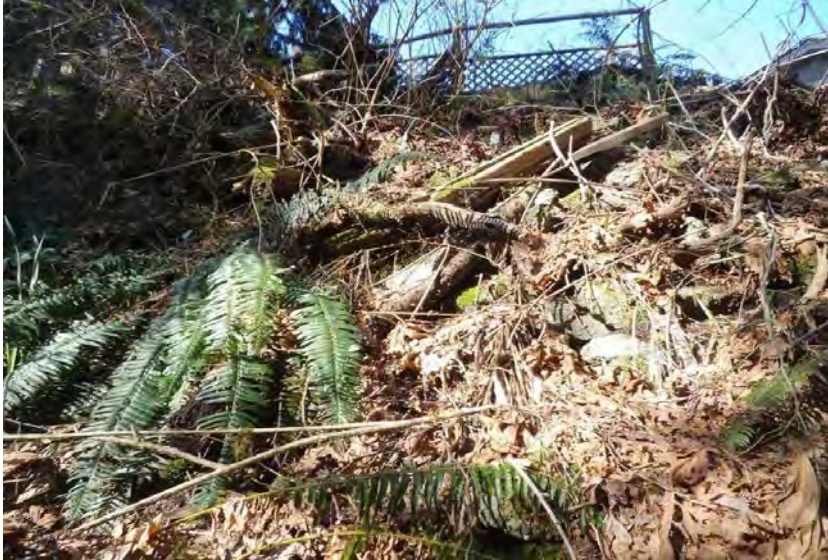
View of Old Concrete Debris Below Crest

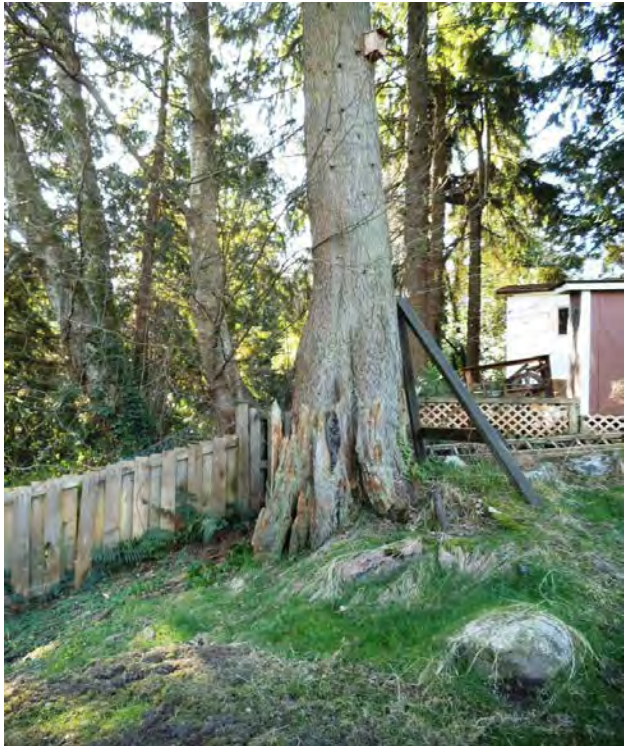
Tree Growing on Old Stump in Back Yard With Some Pushed Boulders

No geotechnical assessment is recommended at this time. If there is any evidence of further slope movement, water erosion or drainage problems on the property or nearby, we recommend that the property owner immediately contact the City and also immediately engage a geotechnical engineer to conduct an assessment.

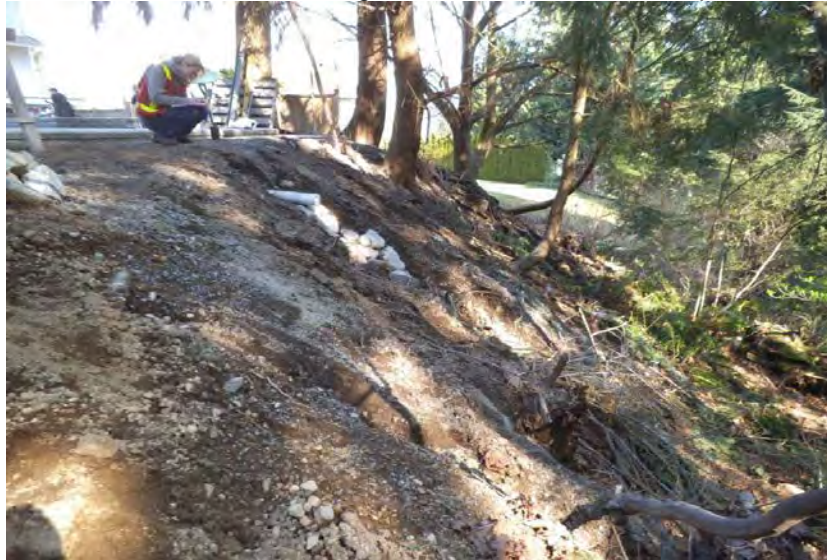
Crest Area During Construction

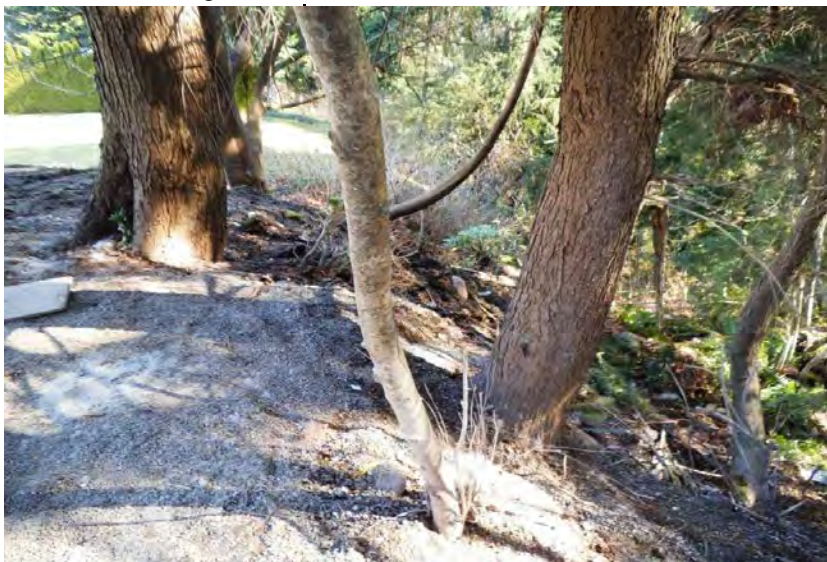
Fill Slope Northeast Corner of Lot. Owner Indicates This Will Be Pulled Back.

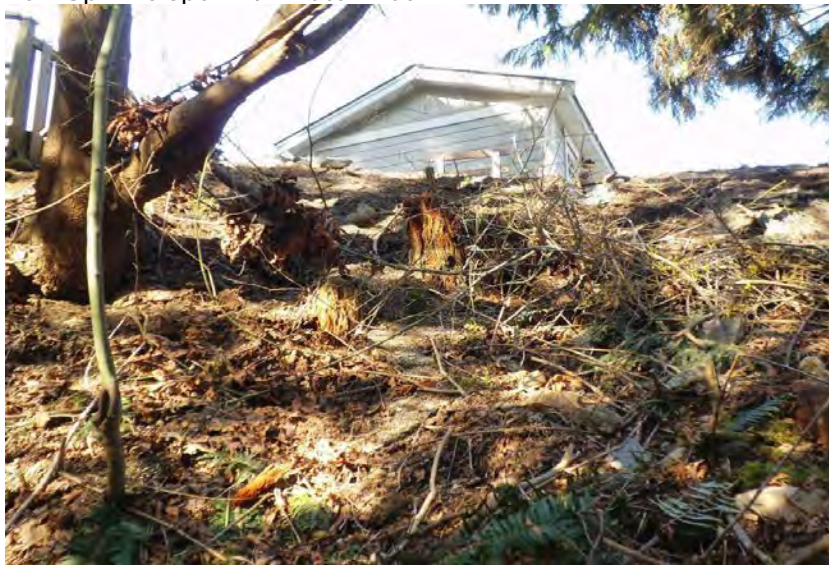
Evidence of Water Flow Downslope Carrying Gravel, Filling Plant Pot

No geotechnical assessment is recommended at this time. If there is any evidence of further slope movement, water erosion or drainage problems on the property or nearby, we recommend that the property owner immediately contact the City and also immediately engage a geotechnical engineer to conduct an assessment.

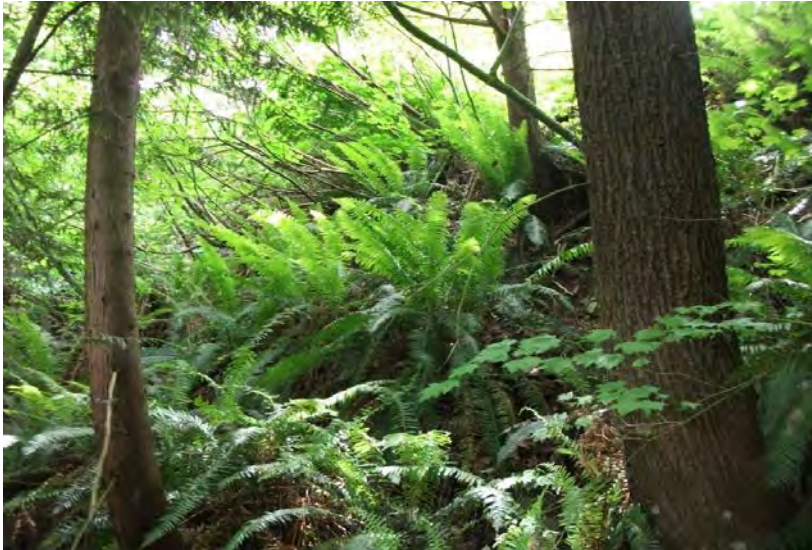
View Of Fill Apron At Crest Of Ravine With Subsidence

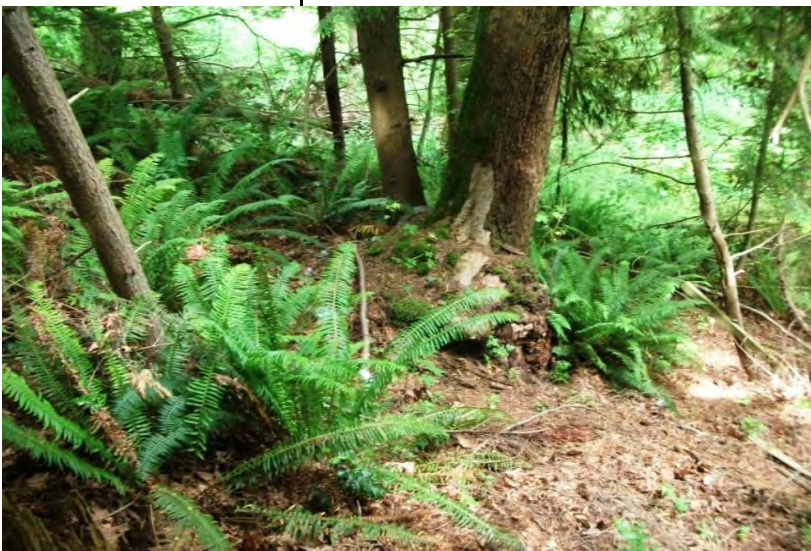
Approximate Outer Edge Of Fill With Damage To Trees

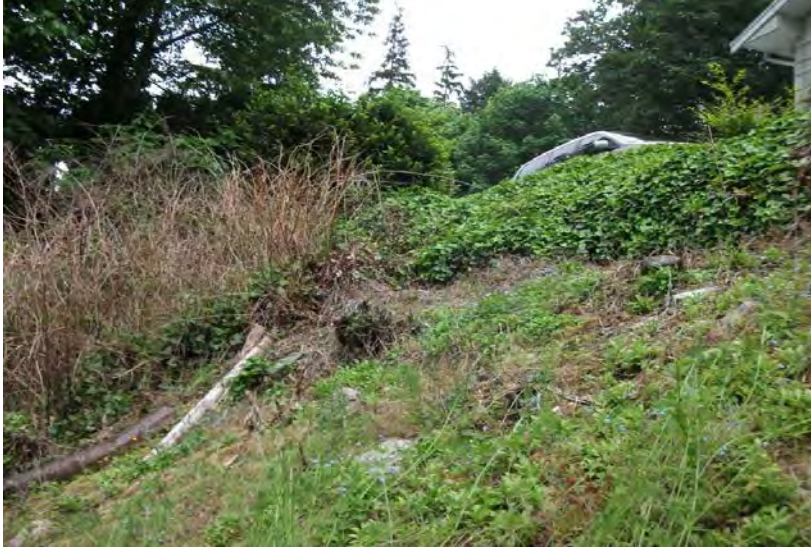
Crest And East Part Of Head Scarp

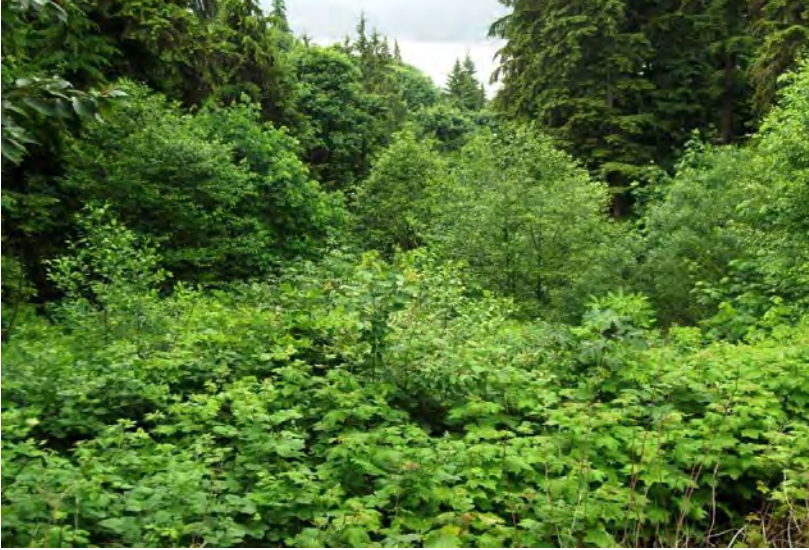
1861 Harbour Drive

Overgrown 1979 Landslide Track Below House and Headscarp

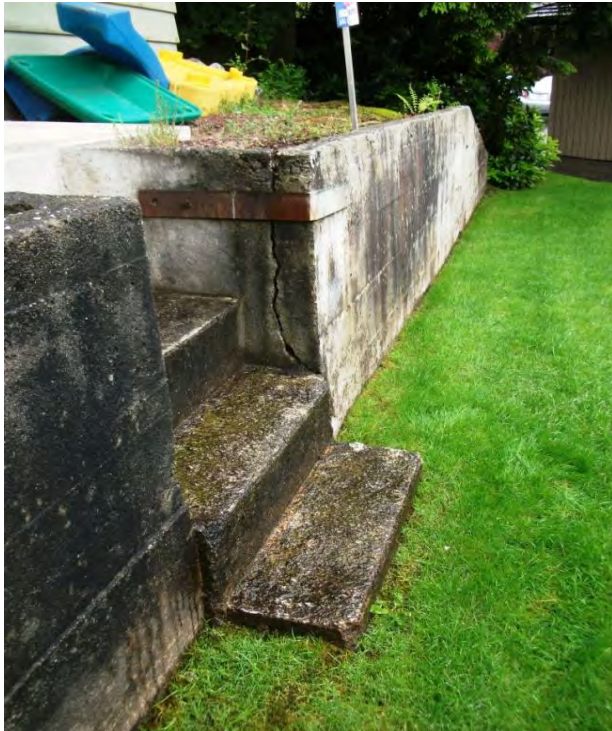
Comments Concrete wall near house with cracks

View Along Wall With Cracks

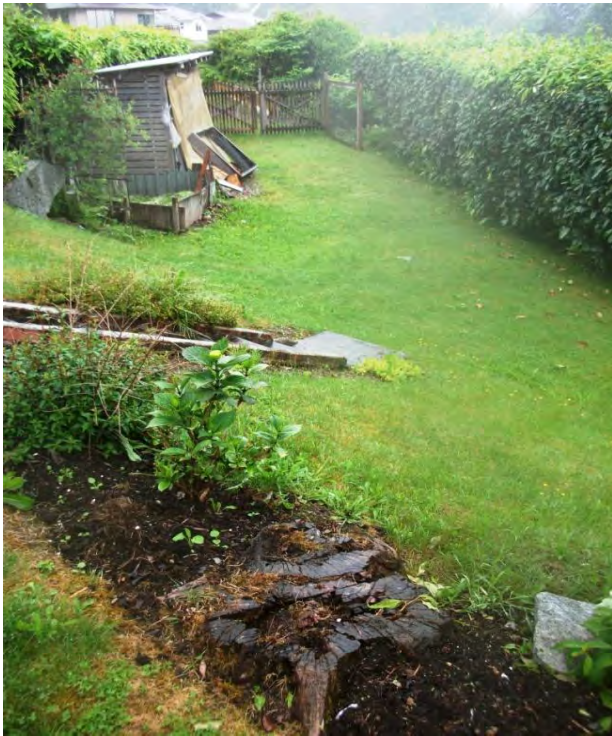
Roof Drain Outlet Pipe on Back Yard Slope

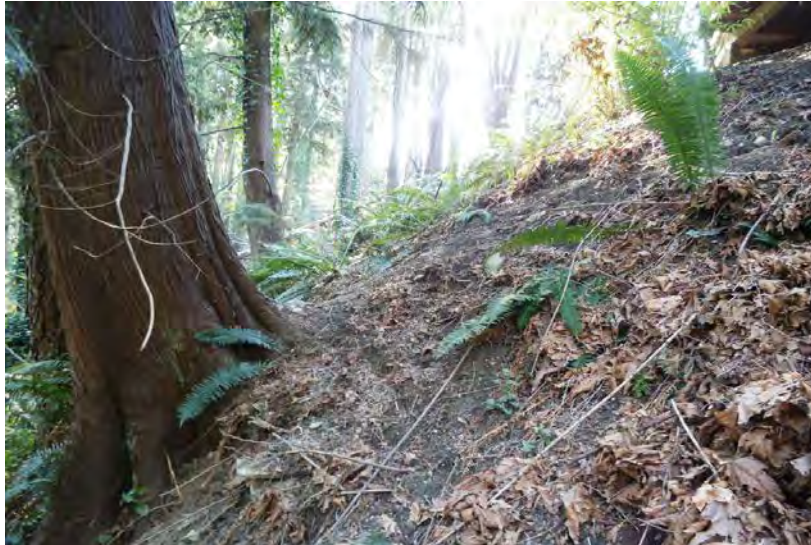
Fill Below Deck and Post-Development Cedar Tree Leaning

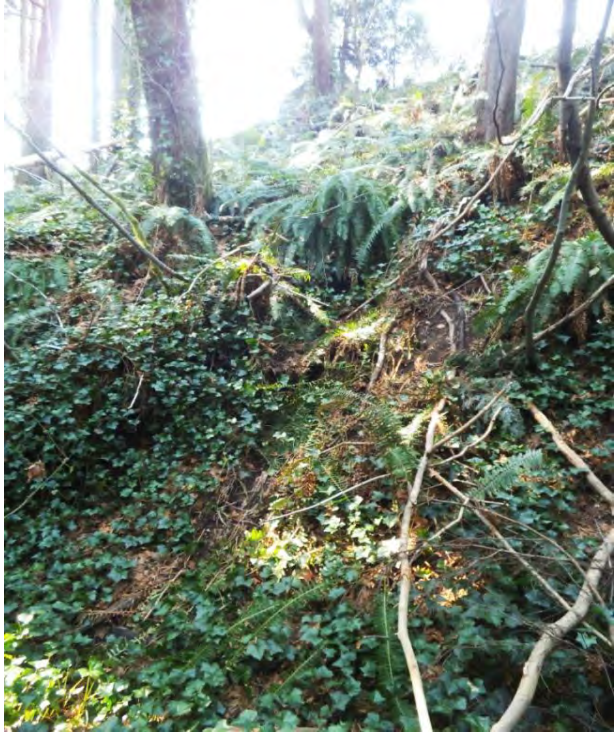
Possible Tree-Fall Hollow, Central Part Of Slope

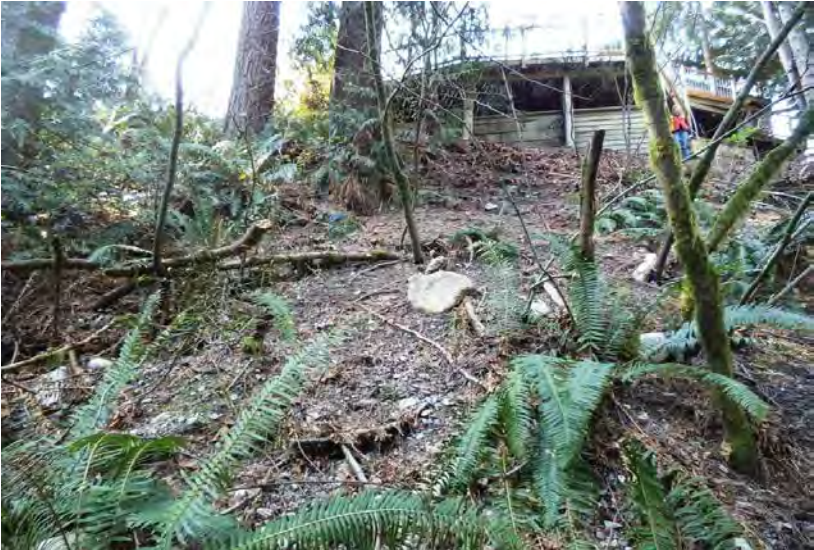
1037 Gatensbury Dr.

Gaps Below Garage Wall and Door, Suggest Some Subsidence or Jacking of Building Frame

Geotechnical evaluation recommended if not already completed.

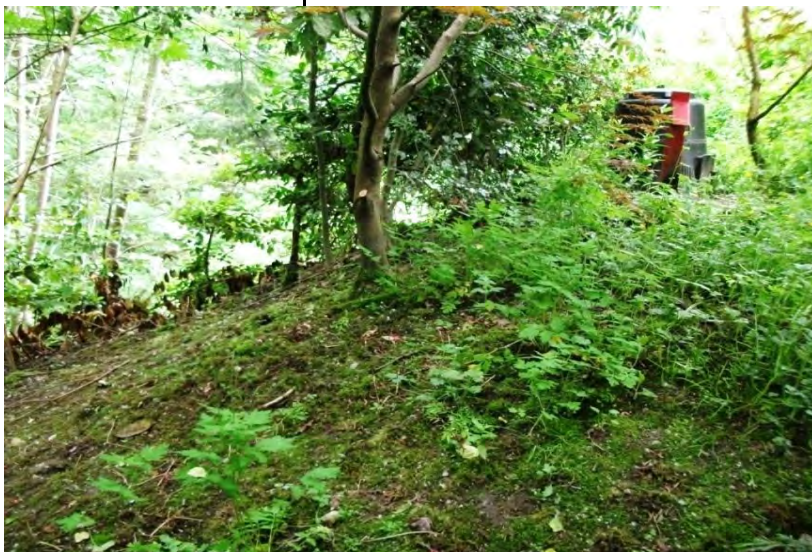
Edge of Large Fill Pile Behind Residence, With Red Geotechnical Wells

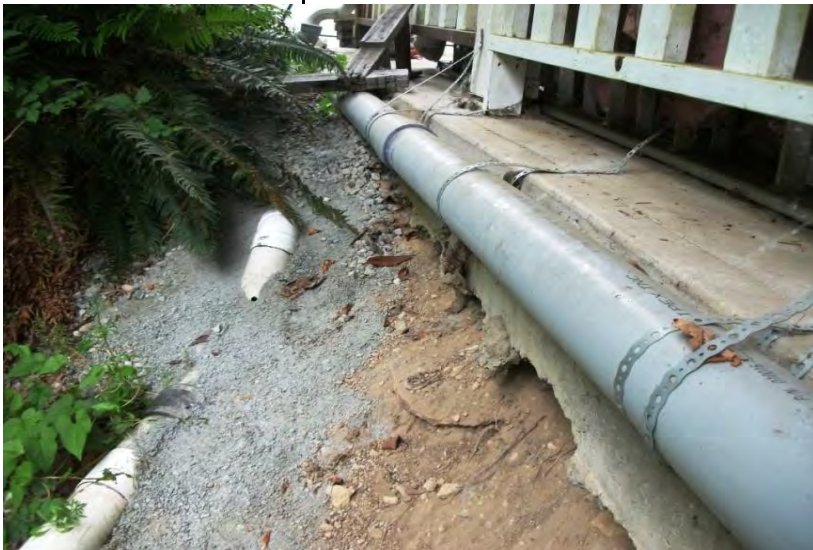
Exposed Roof Drain Pipes On East Side of House, View To Front

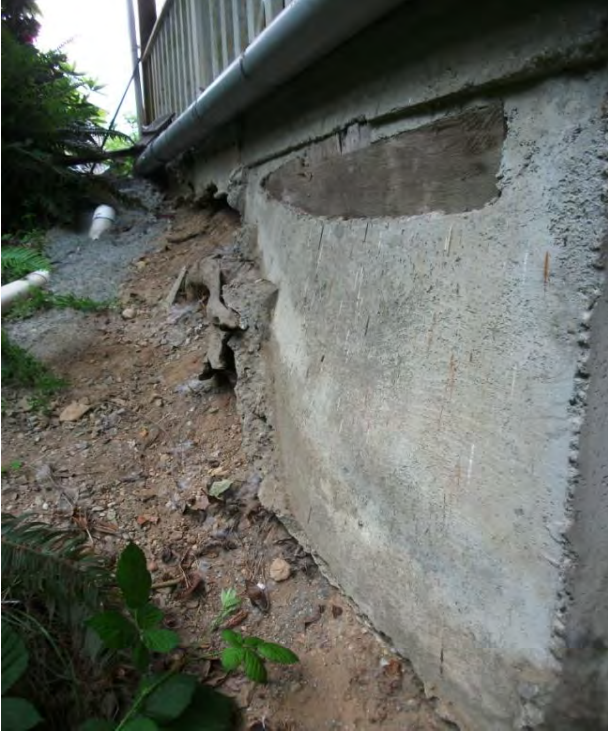
View of Exposed House Foundations, To South From Centre

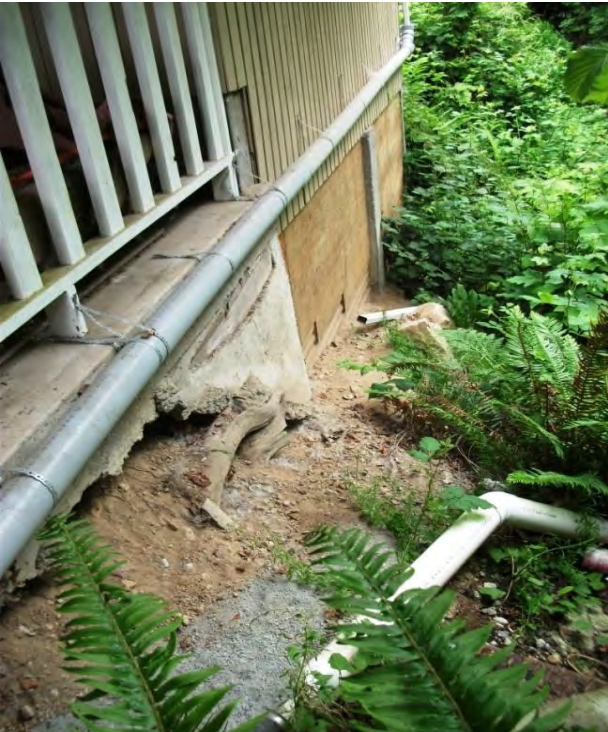
845 Catherine St.

View of Exposed House Foundations, To North From Centre

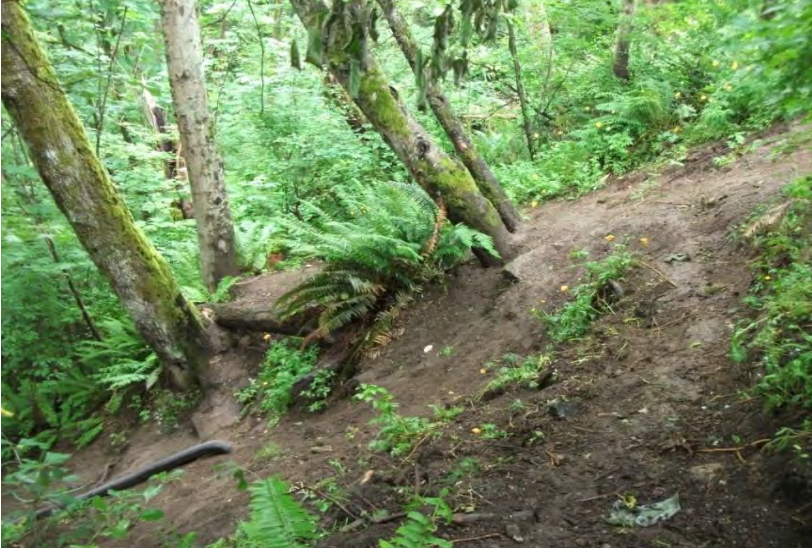
Spoils Pile Below Ingersoll With Concrete Pieces, Pipes, Leaning Trees

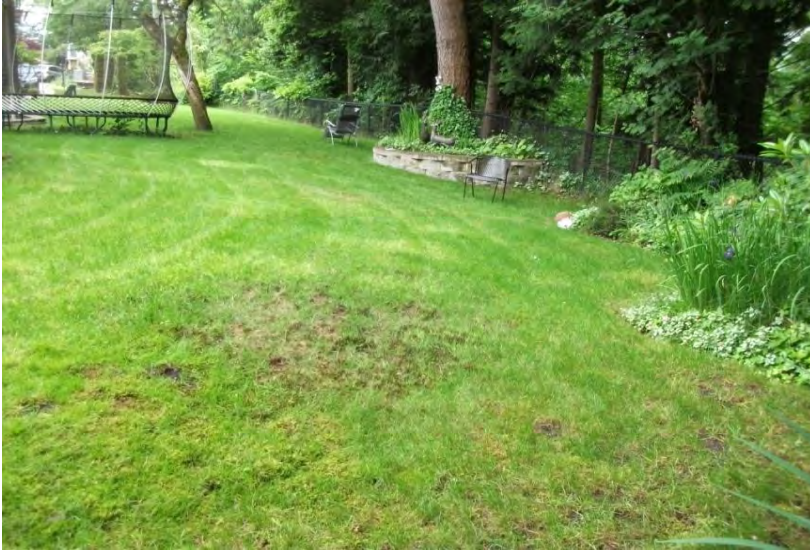
Along Slope, Below Crest, Straight Mature Trees

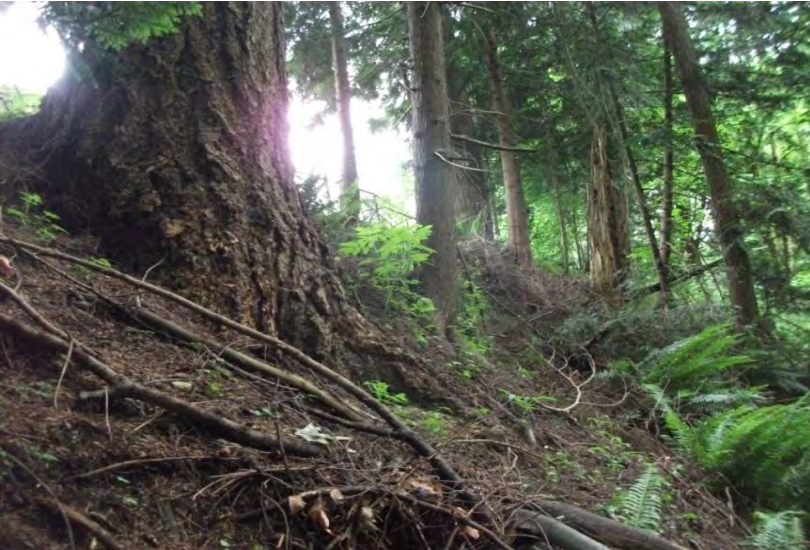
Shallow Soil Slough At Edge of Fill, Exposes Sands

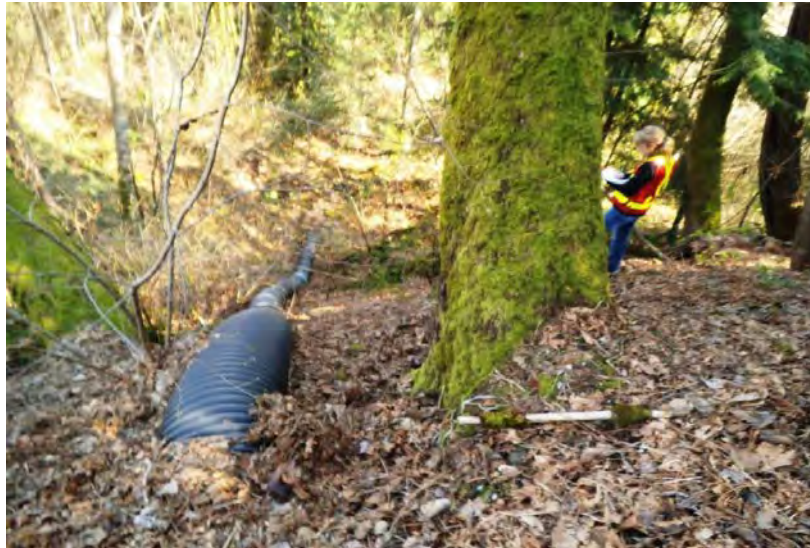
New Landslide From Tree Fall, August 2011

Parking lot drainage is likely to have caused previous landslide and slope erosion.

A drainage assessment of the parking lot and slope below is recommended.

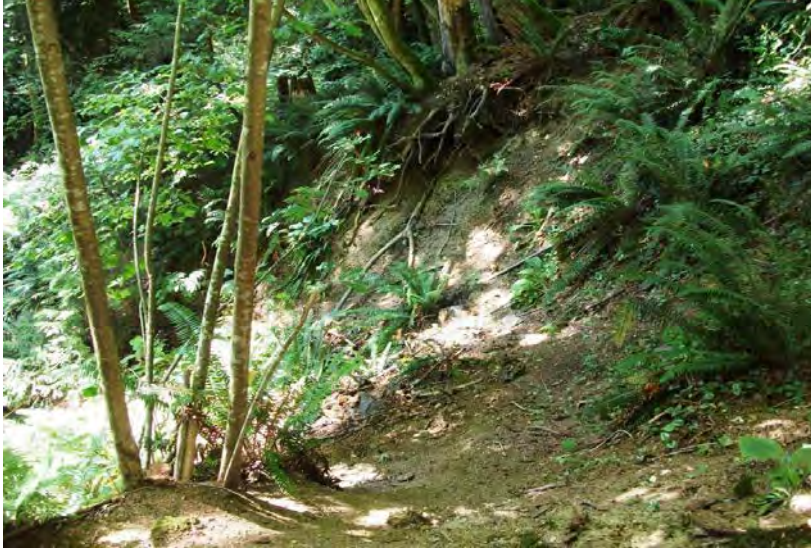
Landslide Track in Soil Fill and Native Soil, August 2011

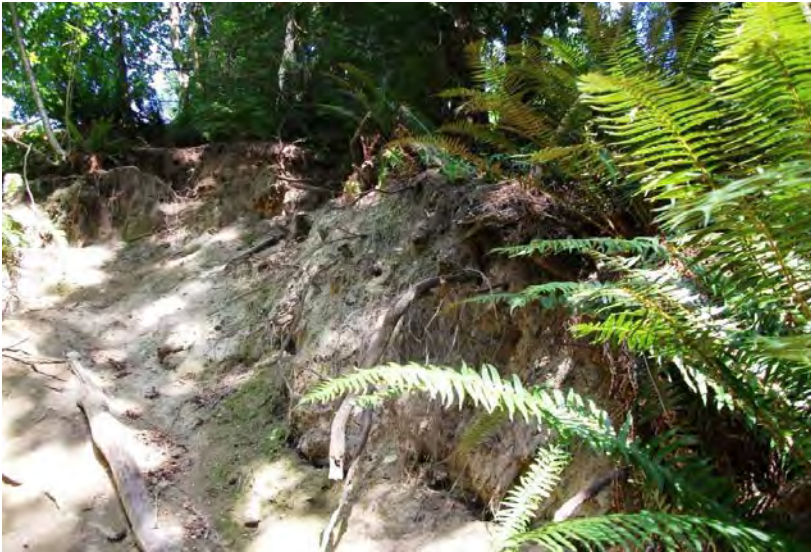
Headscarp of Landslide, August 2011

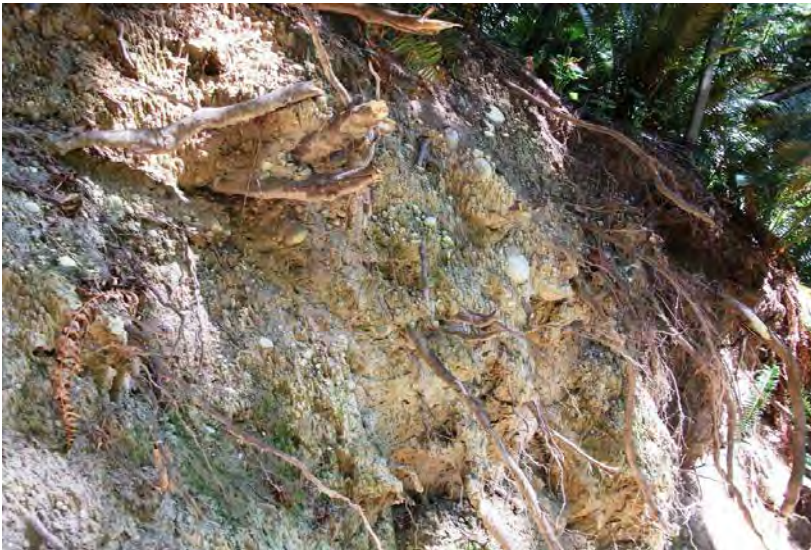
Landslide Scar, March 2013

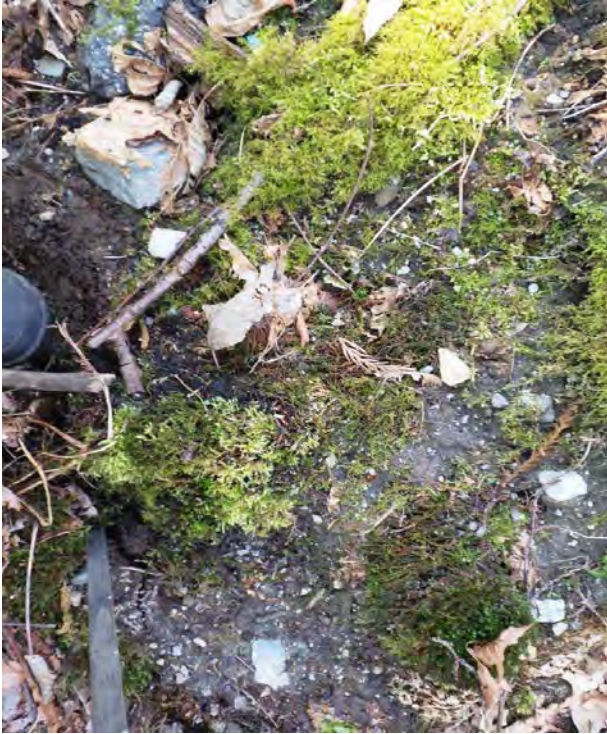
Sept. 2011 Parking Lot, Drainage Down To East End

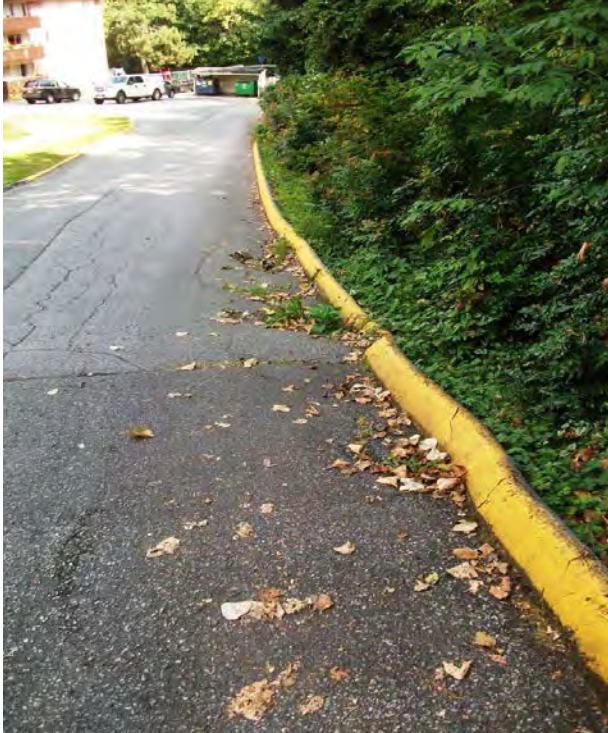
Sept. 2011 Parking Lot Drains Down Along Concrete "No Posts", Not All Surface Flow Directed to Catch Basin.

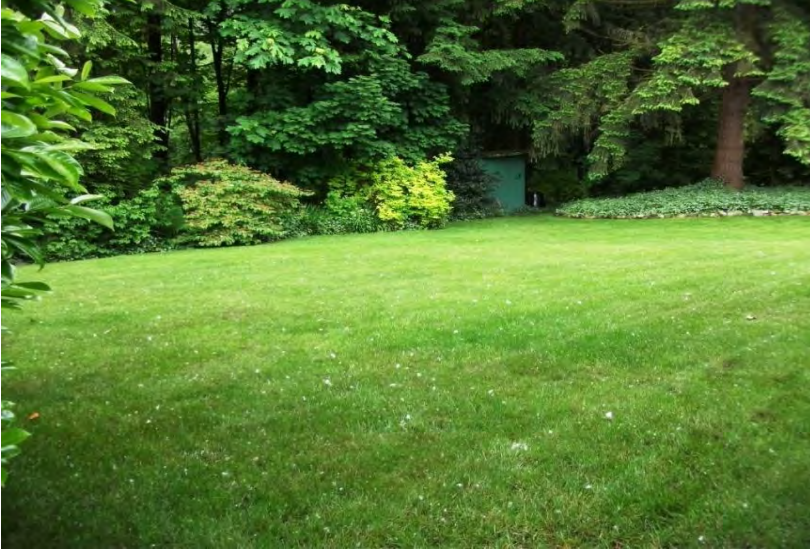
Slope Below Crest, Curved And Leaning Maples

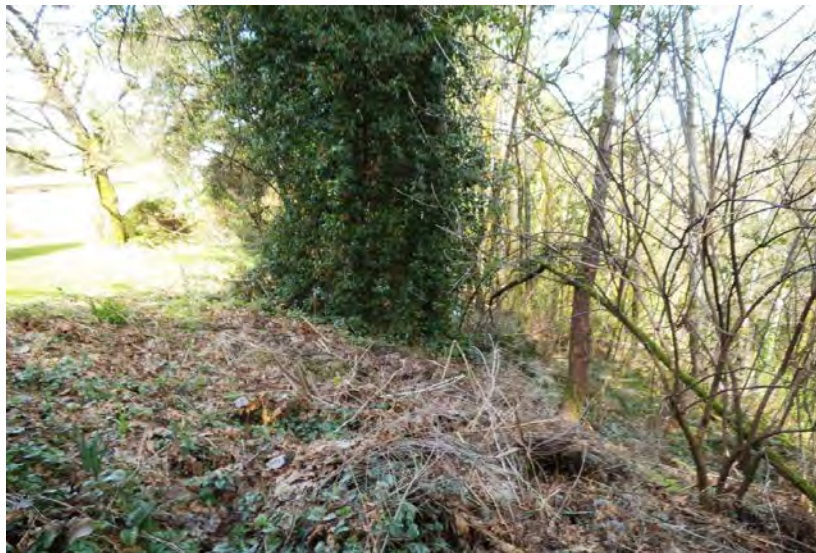
Swale Down Slope, North Side

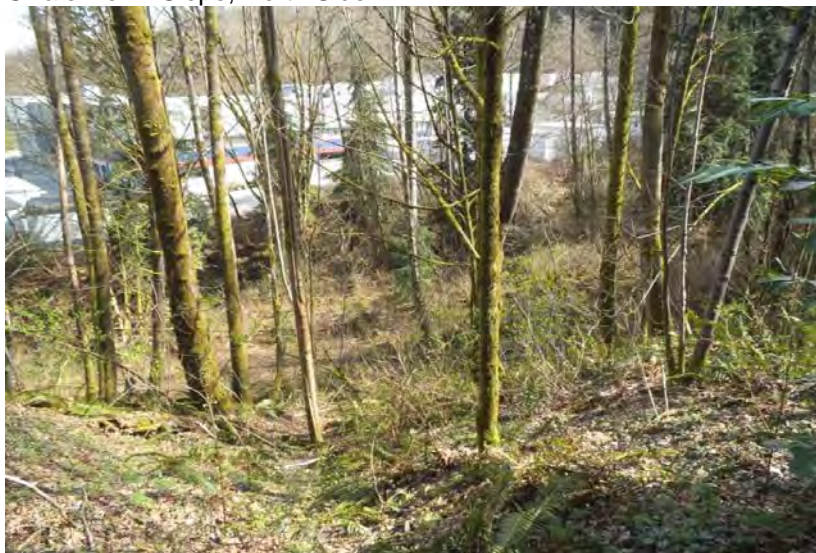
Swale Down Slope, South Side

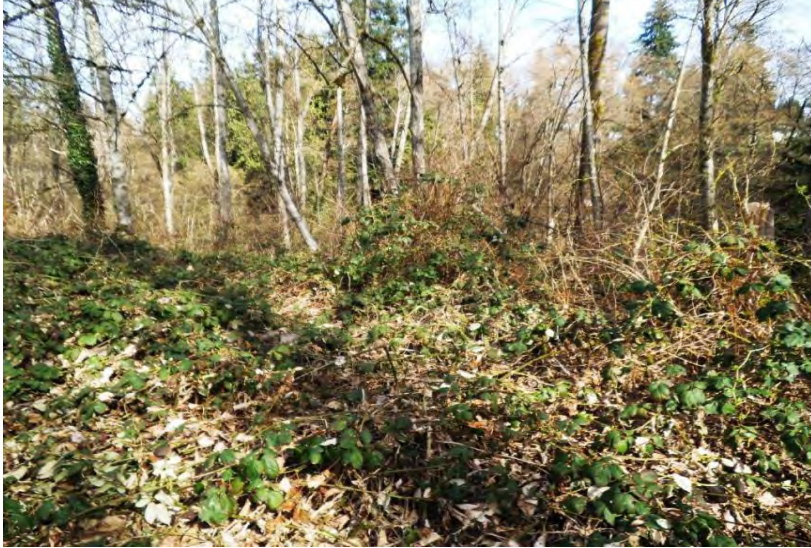
Subsidence Area Downslope In Park
