Site Observation Form

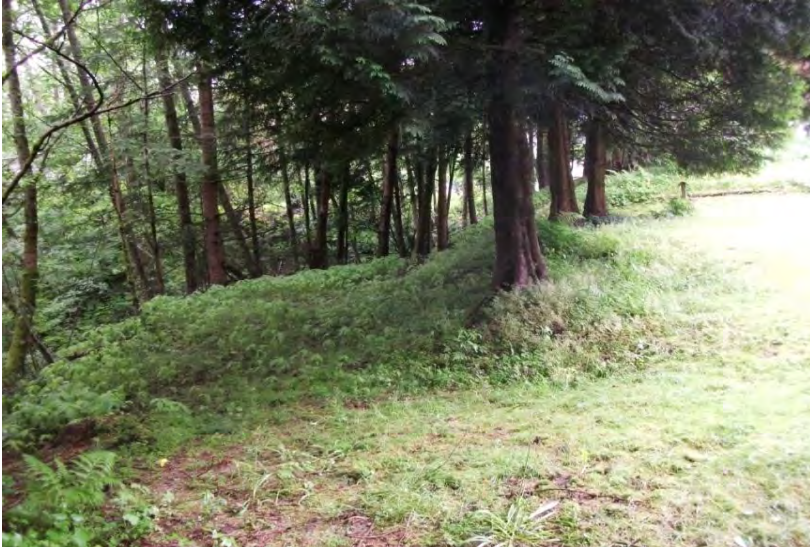
Fill Slope With Debris Below House, No Mature Conifers

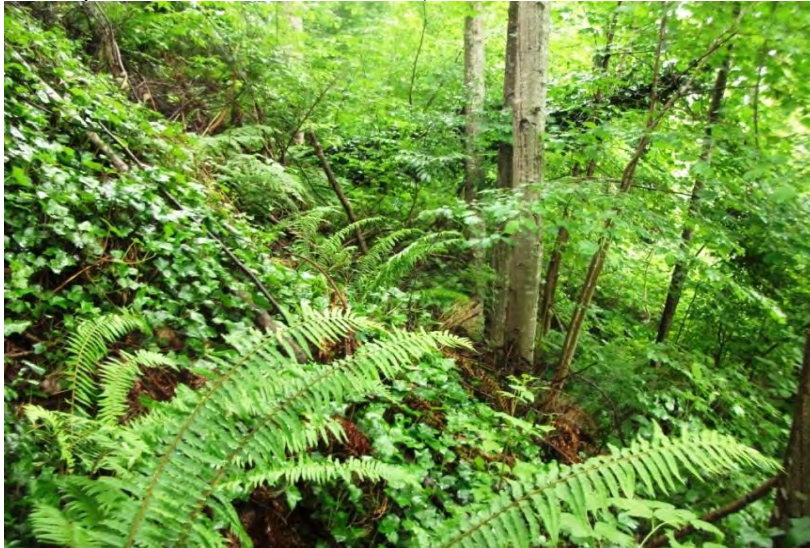
Cracks in Driveway Suggest Fill Subsidence Below

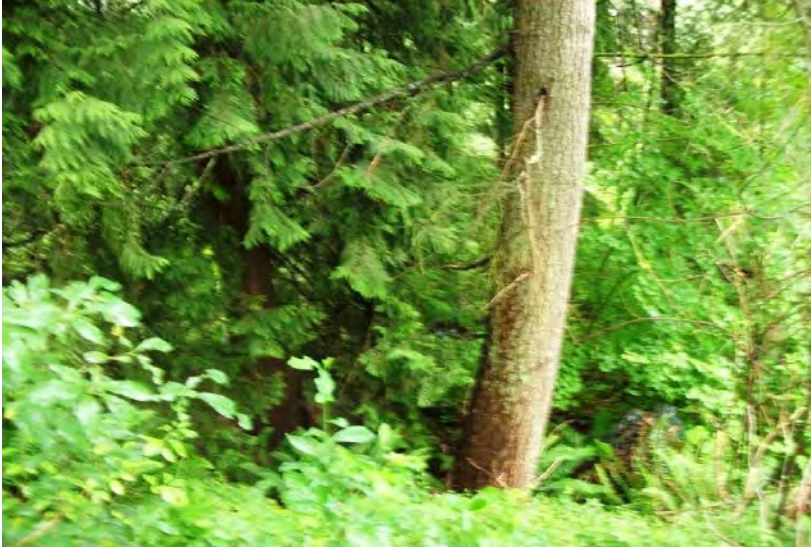
Slope Below With Curved Tree

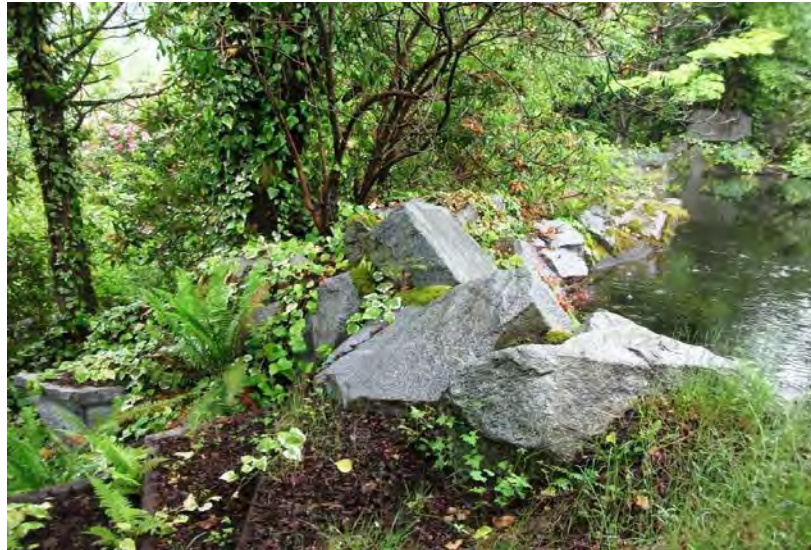
South Pond Near Property Boundary and House

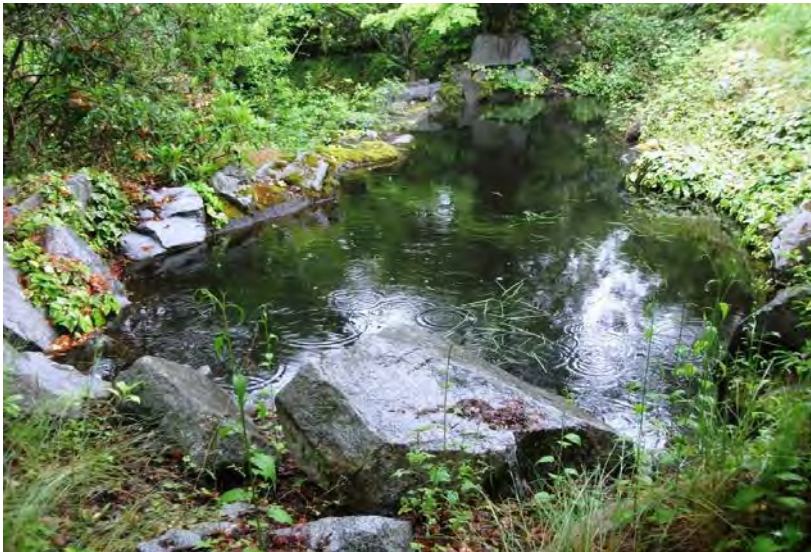
Pond Near West Boundary

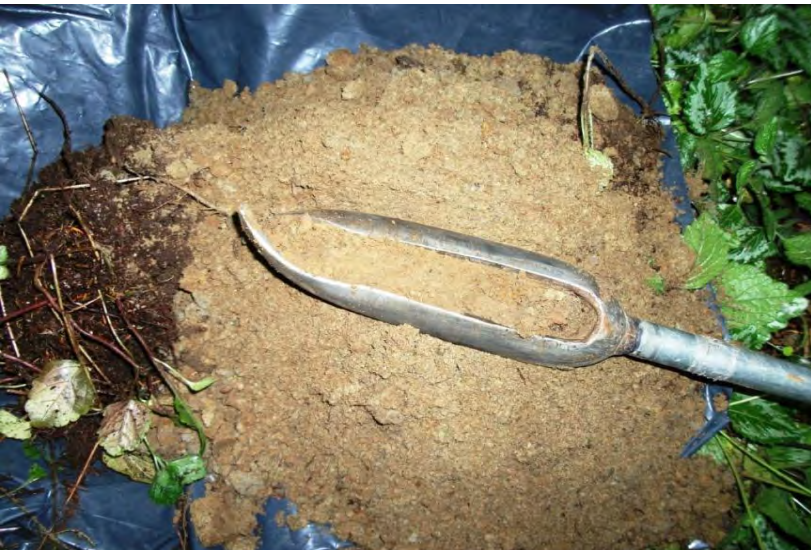
Soil At about 0.9 Depth

Interval (m)	Crest
0-0.08	Organics, roots
0.08-0.5	Brown grey, dry silty sand, occ. pebble
0.5-0.8	Fine - med. silty sand, iron mottles, coarser with depth
0.8-0.95	Med to coarse sand denser, more iron stain, more pebbles
0.95	Refusal

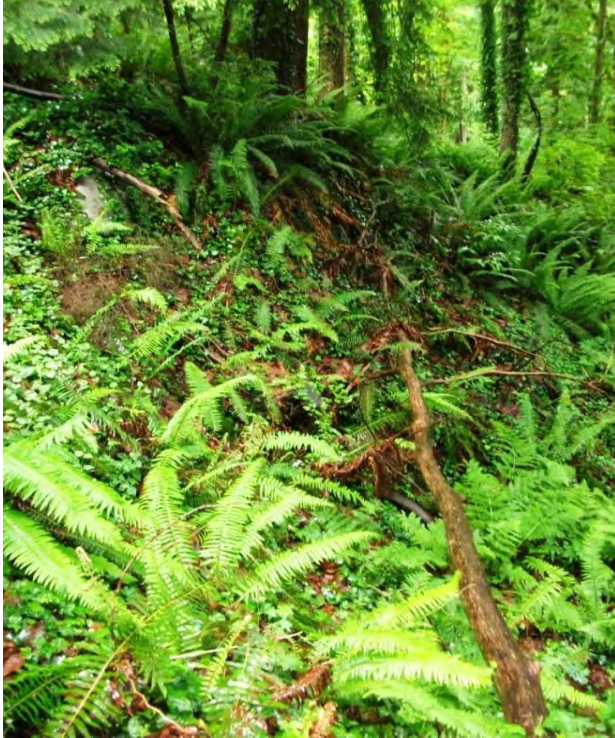
Soil Test Hole Layers

Interval	15 m d/slope
0 - 0.35	Dry, dark brown, organics plus sand and silt, colluvium
0.35 - 0.7	Red brown to grey, silty sand, colluvium
0.7 - 0.8	Sandy silt, oxidized patches, tr.pebs. native soil - refusal at cobble

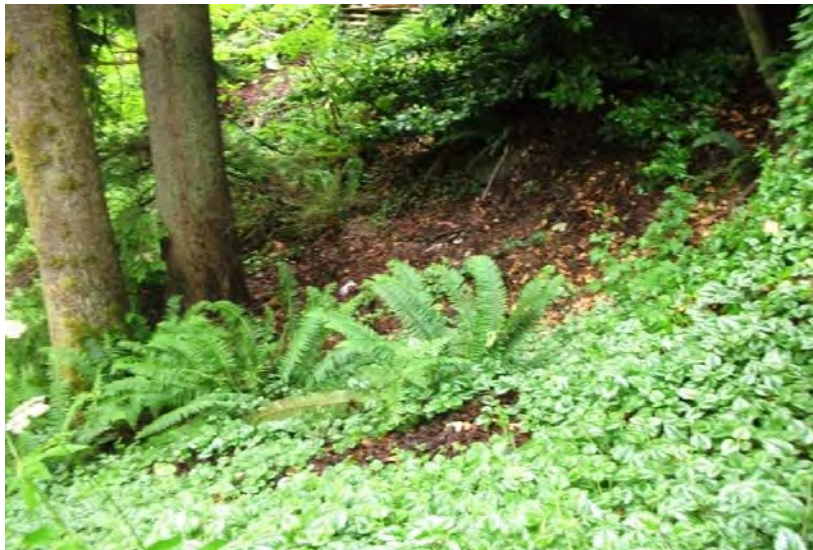
Small Erosion Scar Below Crest

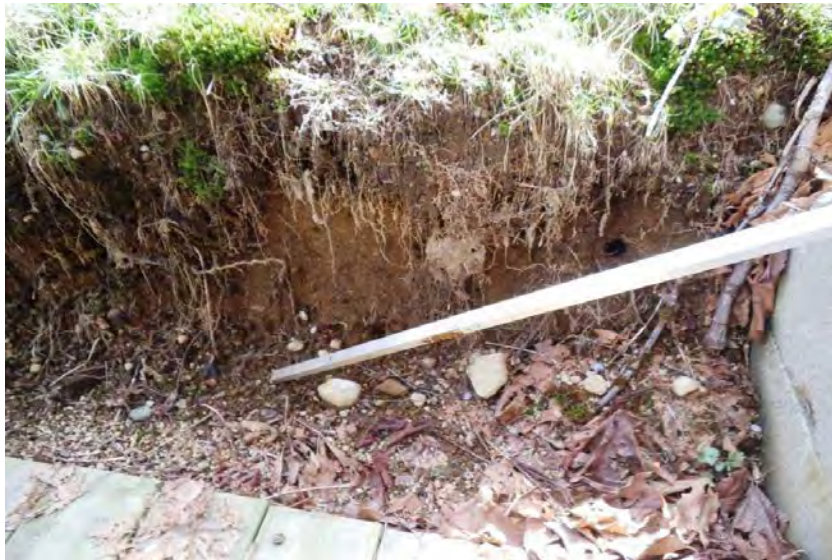
Small Excavation Into Loose Sand and Cobbles Near Crest

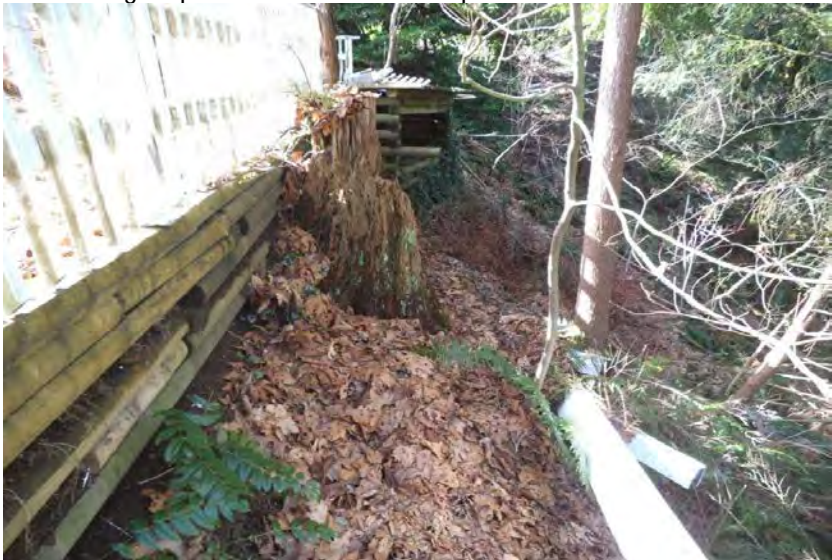
View Along Slope Crest With Old Stump

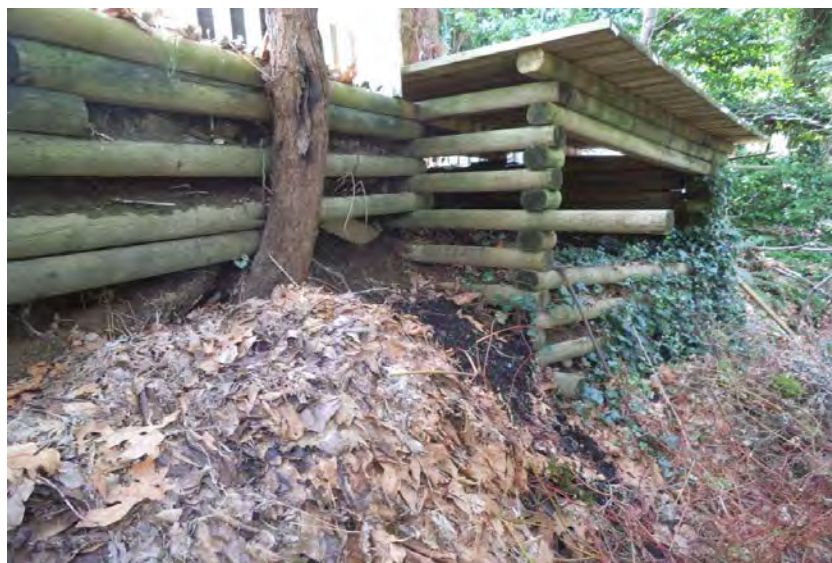
Wood Tie Retaining Wall and Structure With Floor

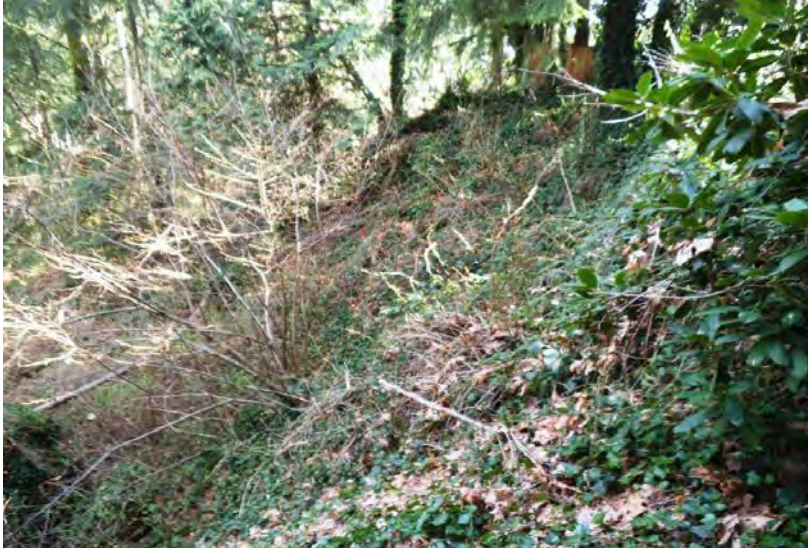
Across Slope With Old Headscarp

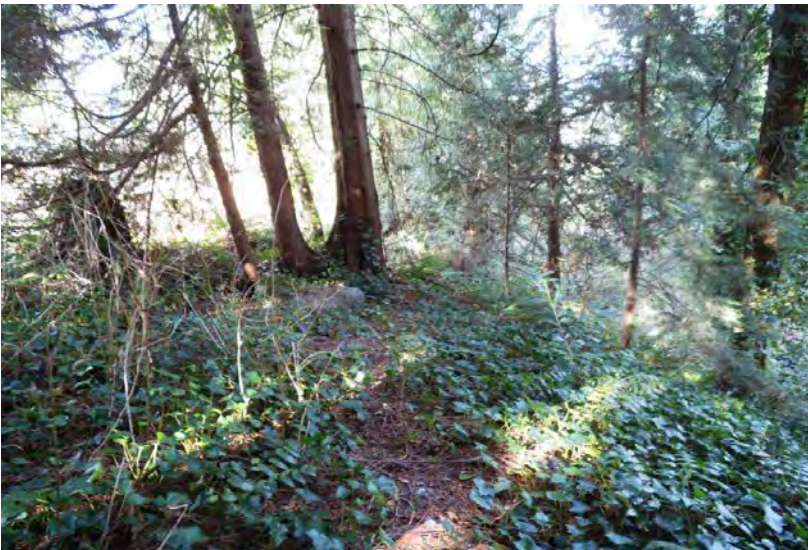
Nose of Fill at Northeast Corner

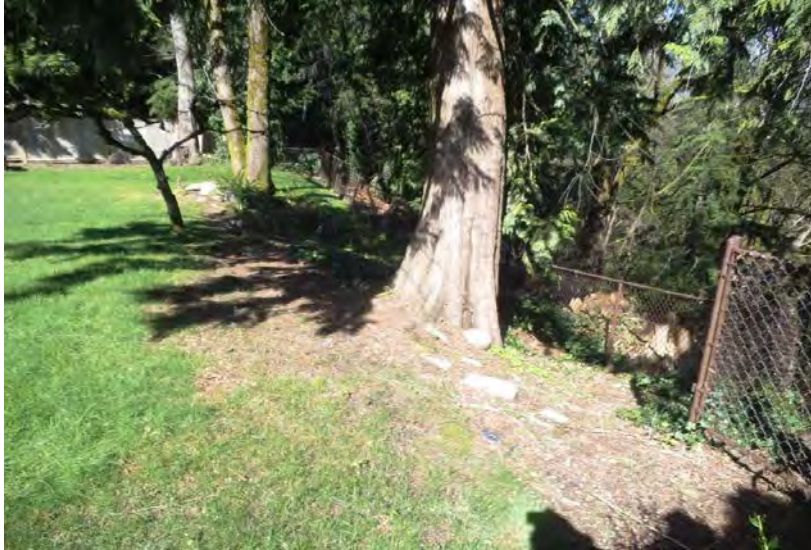
Size	Condition
Timber crib	Y 1 m H	old, bulges out
Stacked blocks	N	
Concrete	N	
Rock / mortar	N	
Engineered	N

Across Crest with Old Cedar Stump and Old Wood Retaining Wall

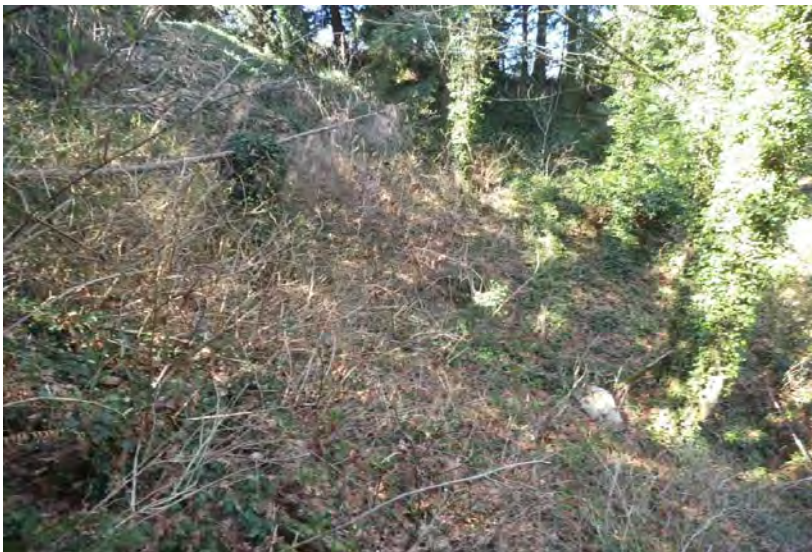
Fill Apron To North

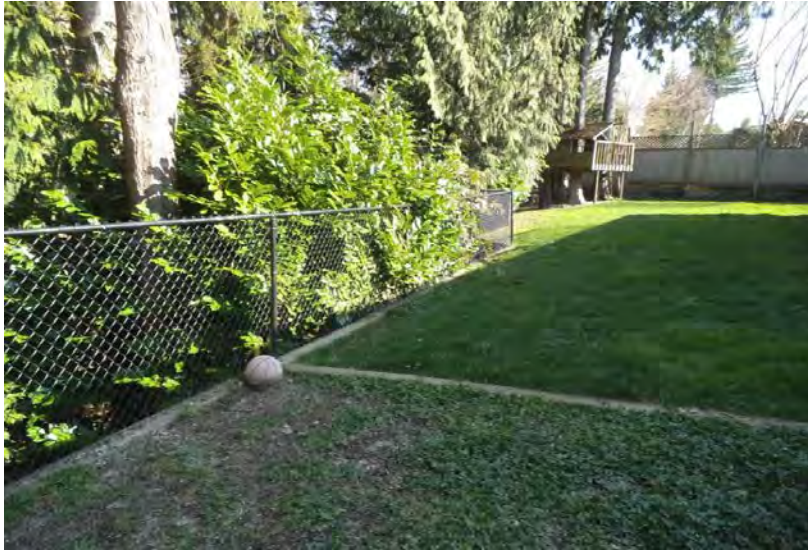
Comments Tension crack about 4 m L, 0.1 m W

Tension crack or settlement feature, centre north half of back yard

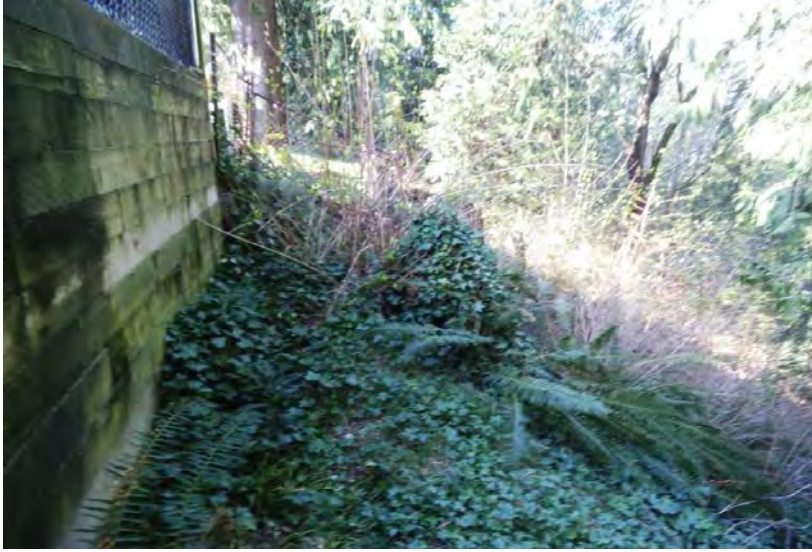
Size	Condition
Timber crib	1.5 m H North End	New but displacemt
Stacked blocks	N	
Concrete	N	
Rock / mortar	N	
Engineered	N

Drainage pipe and wall with seepage indicators

Review, and repair or replacement of the wood retaining wall is recommended.

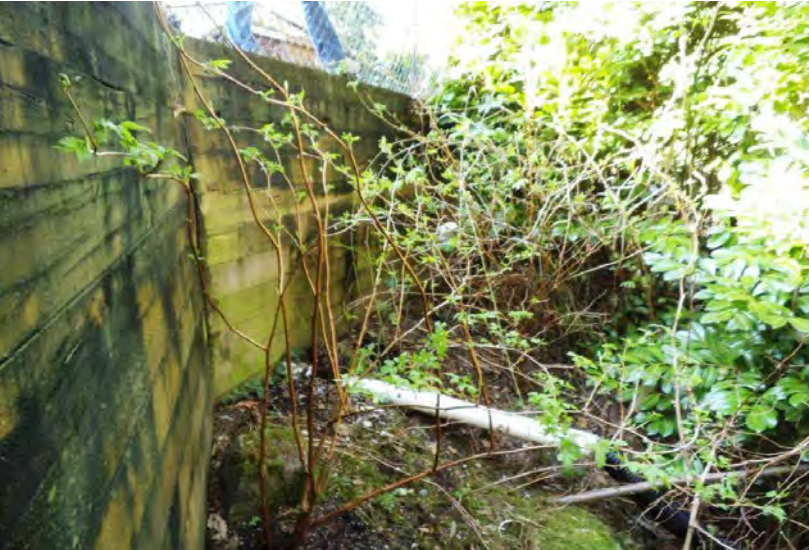
Old fill below wall with old stump

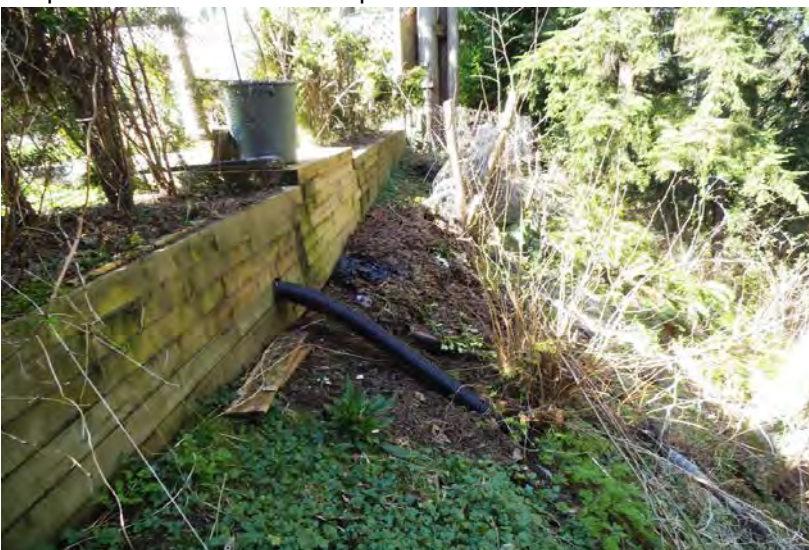
Slope Crest At Centre With Pipe

A geotechnical assessment of the retaining wall, shed and slope below is recommended.

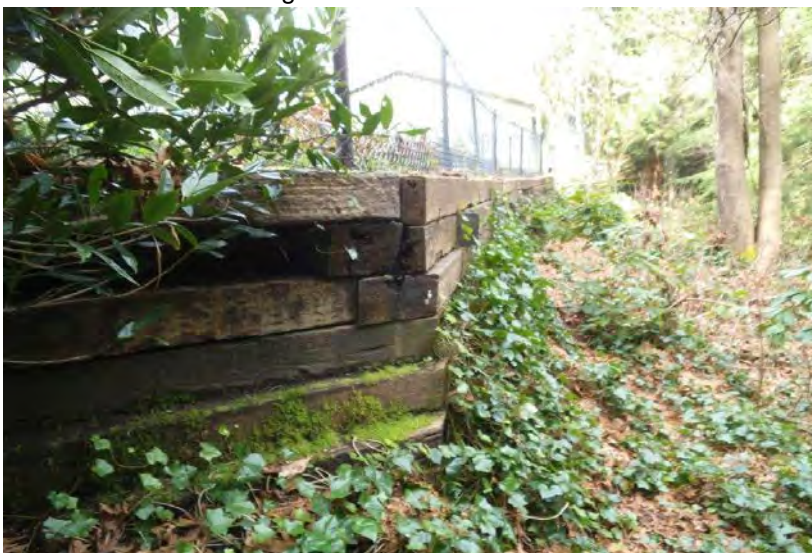
Part of Rail Tie Retaining Wall

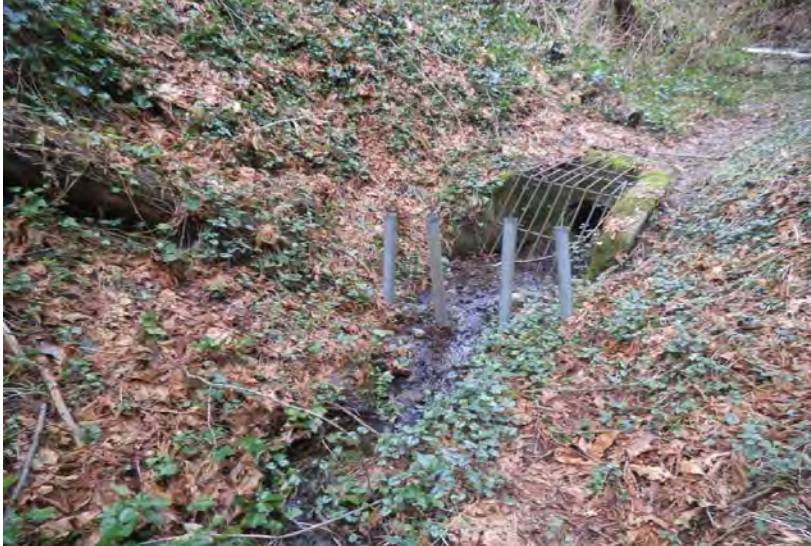
Main creek inlet to storm sewer has required maintenance and removal of accumulated gravel or plugging would occur.
Fallen tree displaced creek, caused erosion.
House is located about 6 m above bottom of ravine. Two tributary ravines join above house.

Creek Inlet to City Storm Sewer Upstream of House

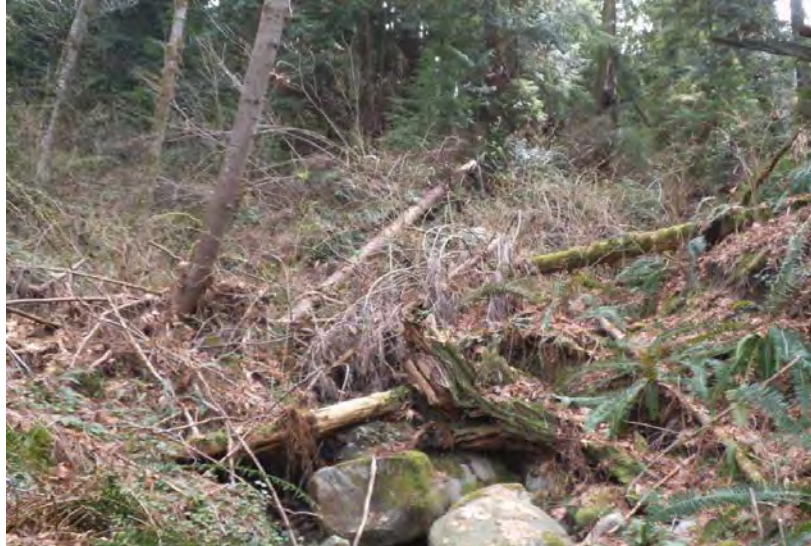
Creek Inlet Upstream of House

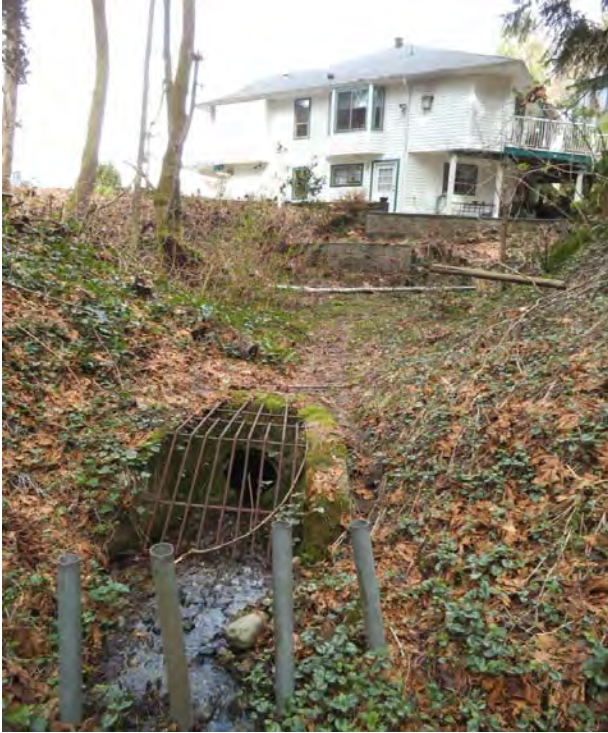
2242 Park Cres.

There is the potential that landslides or debris flows from: slope to east, ravine to southeast, and/or ravine to southwest may affect the 2242 Park Crescent house.

This Property is Exposed.

The Property Owner must be pro-active and review the streams, slopes and ravine crest areas during and after times of heavy rainfall or snowmelt to monitor slope stability and check for erosion/deposition. If there is any evidence of slope movement, water erosion or drainage problems on the property or nearby, we recommend that the Property Owner immediately contact the City and also immediately engage a geotechnical engineer to conduct an assessment.

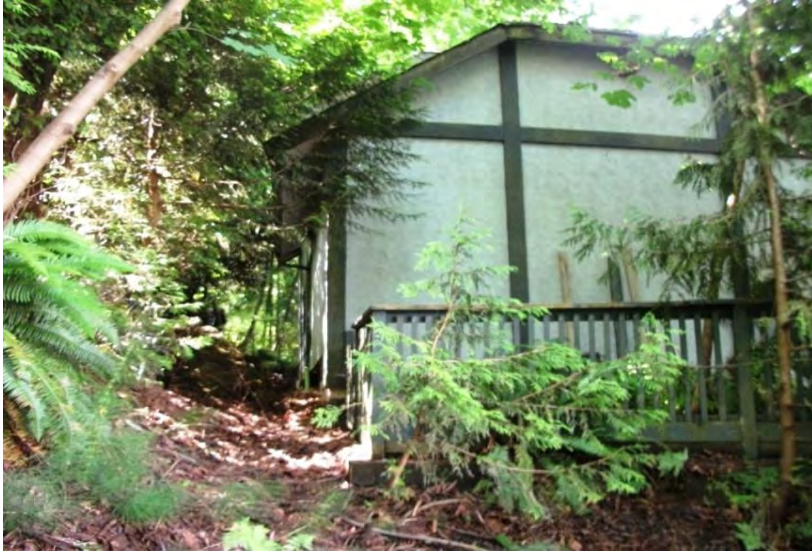
2244 Park Cres.

Backyard of House With Old Cedar Stumps

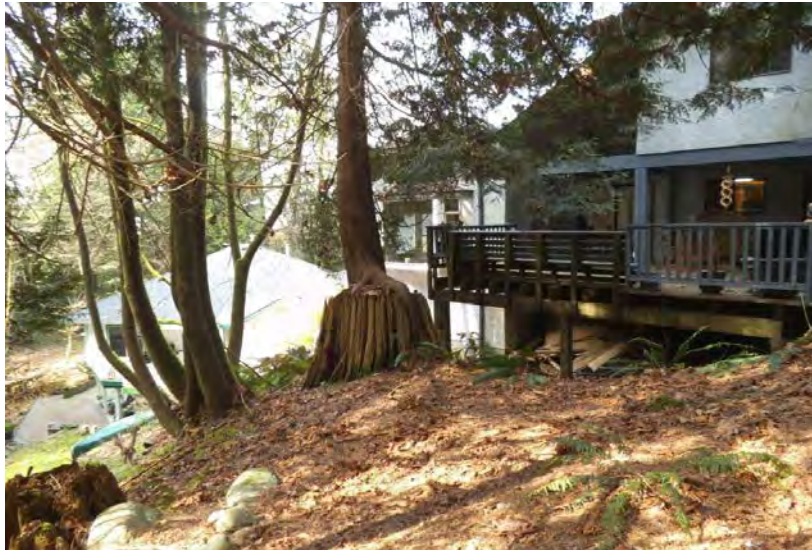
Slopes Below House Towards Ravine

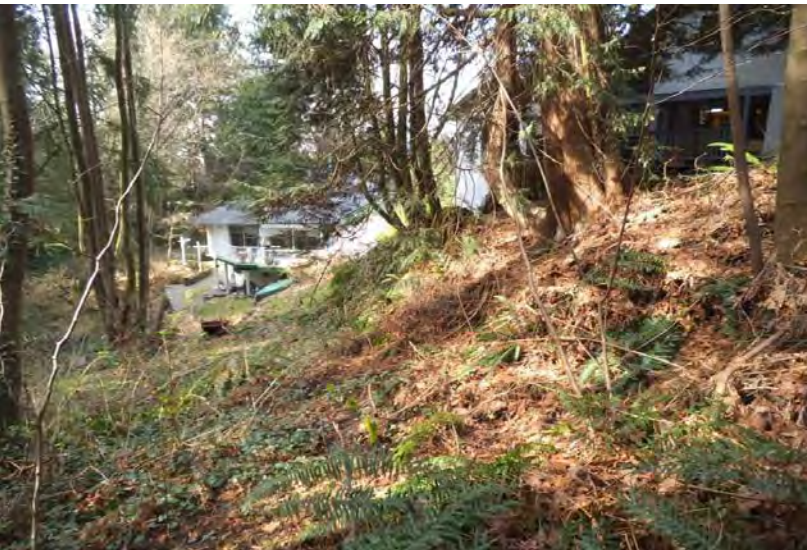
East Side of House, Surface Water Collects

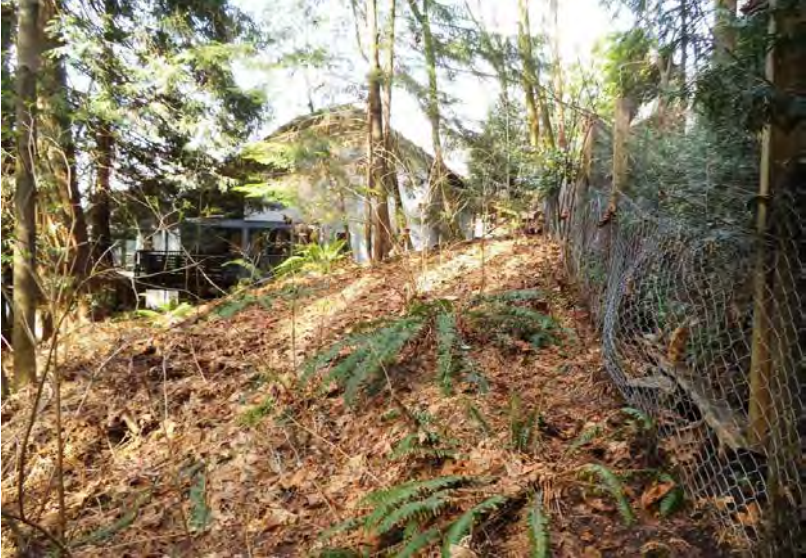
Creep and leaning trees related to moist soils

Wet Area South of House

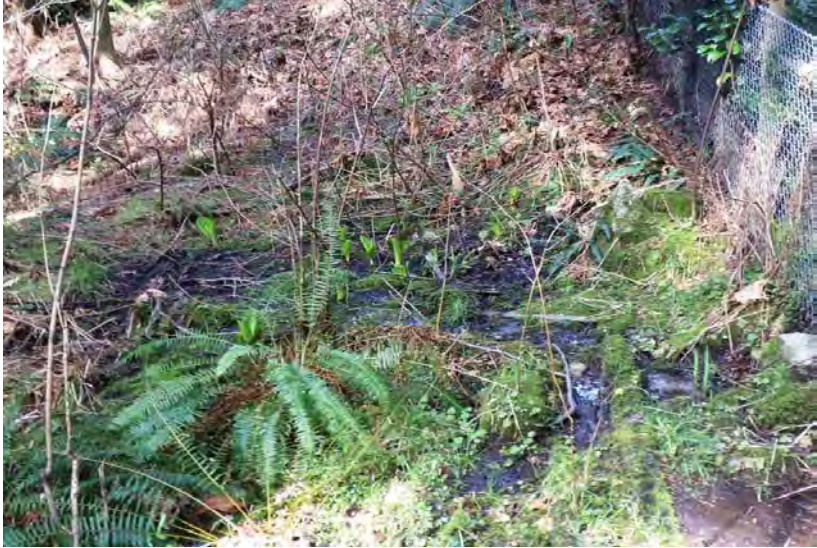
Wet Area Trending Downhill Toward Creek Ravine

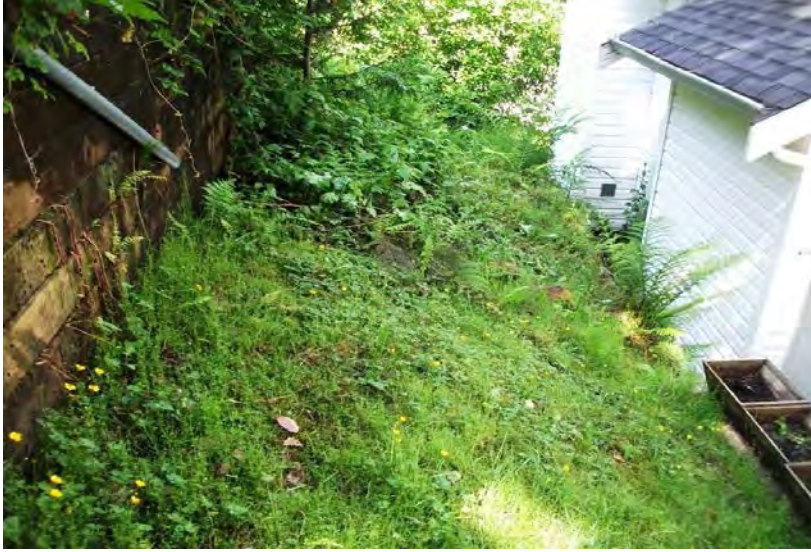
2246 Park Cres.

Top of Wet Back Yard

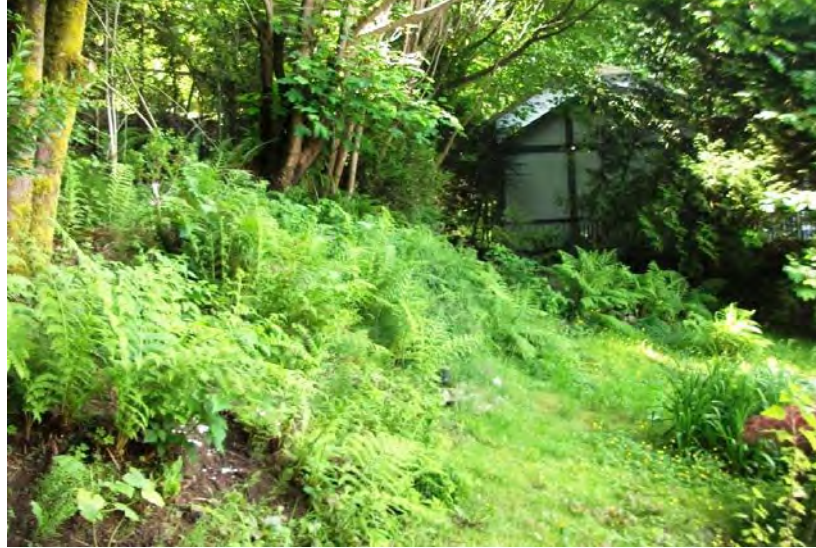
Soil Fill at Upslope Fence

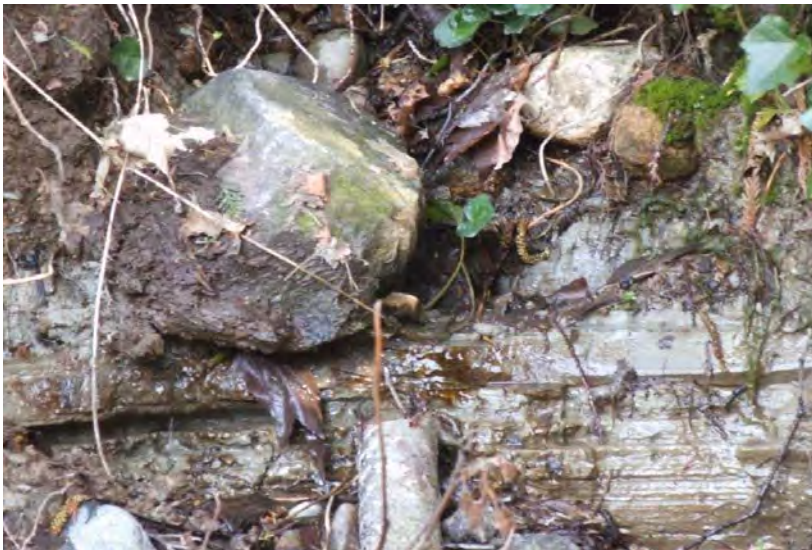
Water Notch With Added Armour Cobbles, Boulders

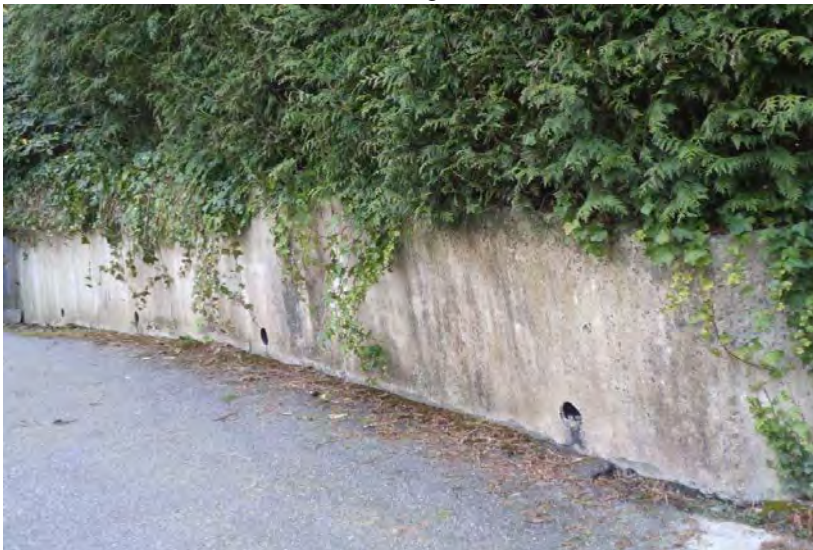
Wall At Front Of House With Drainage Features

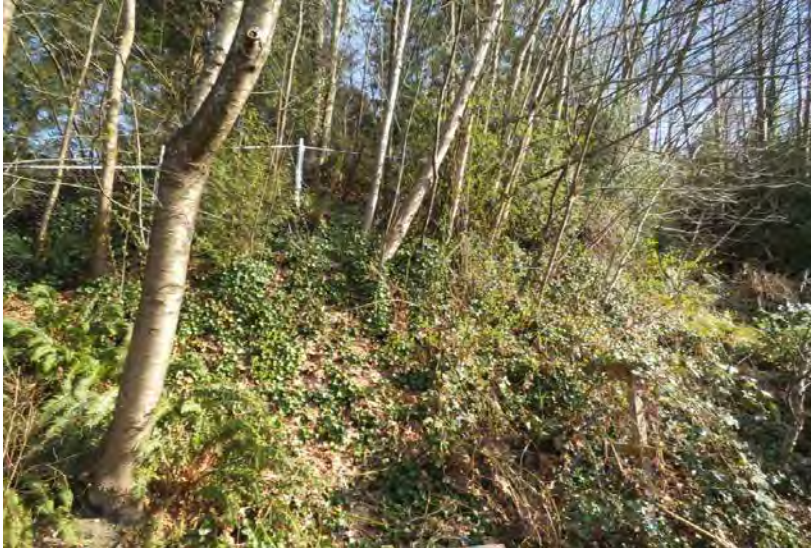
Slope Above Yard Southeast Corner

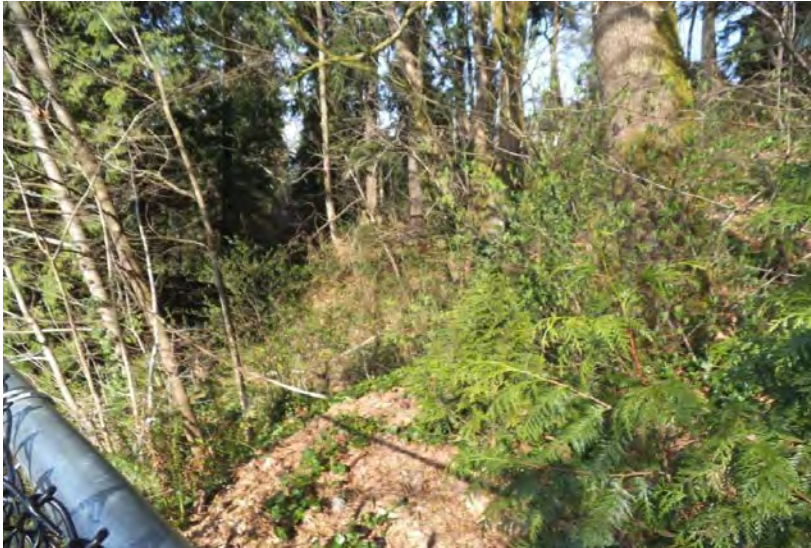
Slope Above Yard Northeast Corner

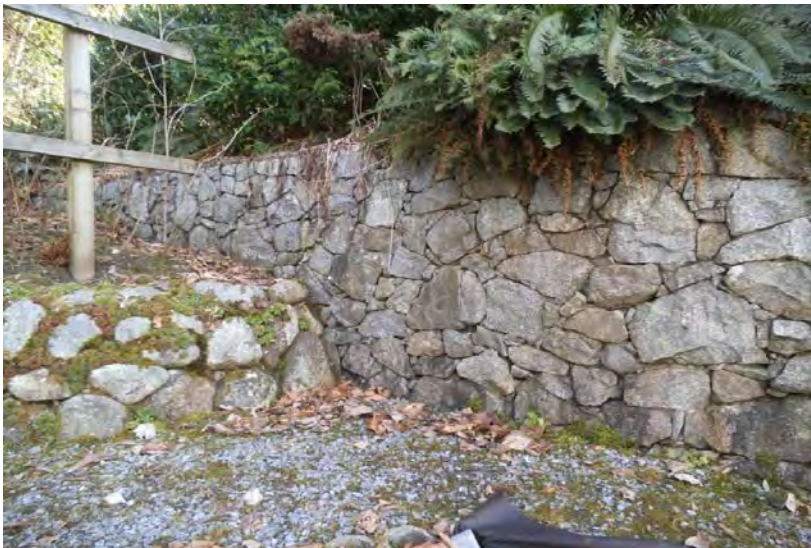
Eastern Section of Rock and Mortar Wall Near Base of Slope

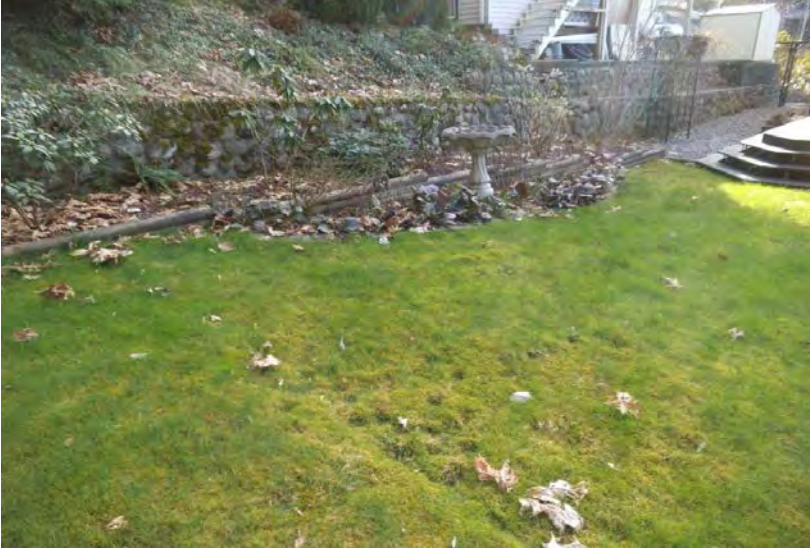
Moist Back Yard

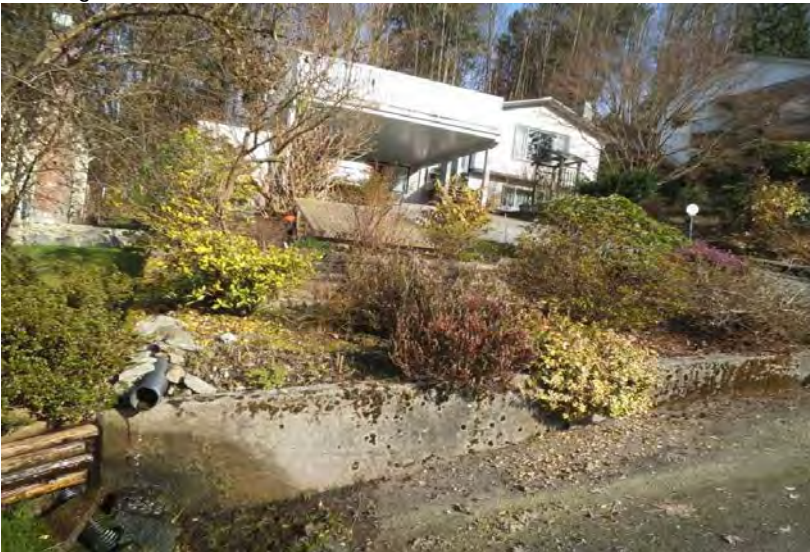
Comments Possible roof or foundation water flows into stormsewer at front of house.

Drainage At Front Of House To Storm Sewer

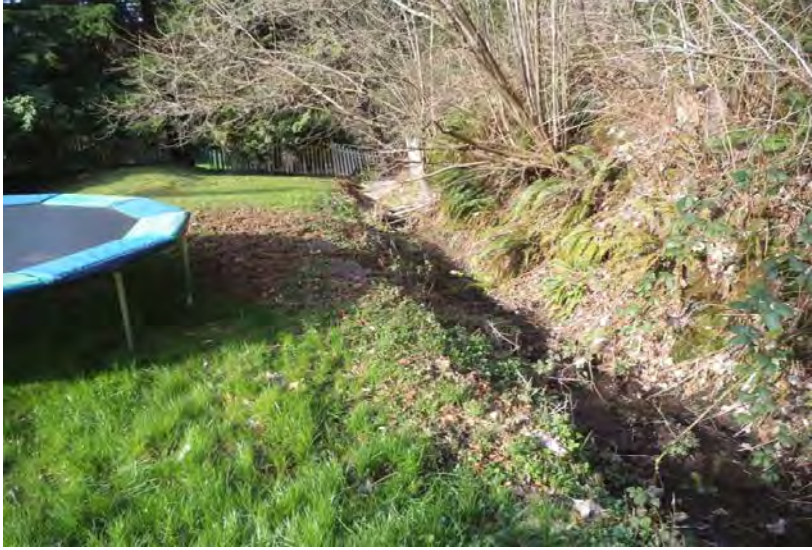
Stream From City Drainage in Ditch in Back Ya

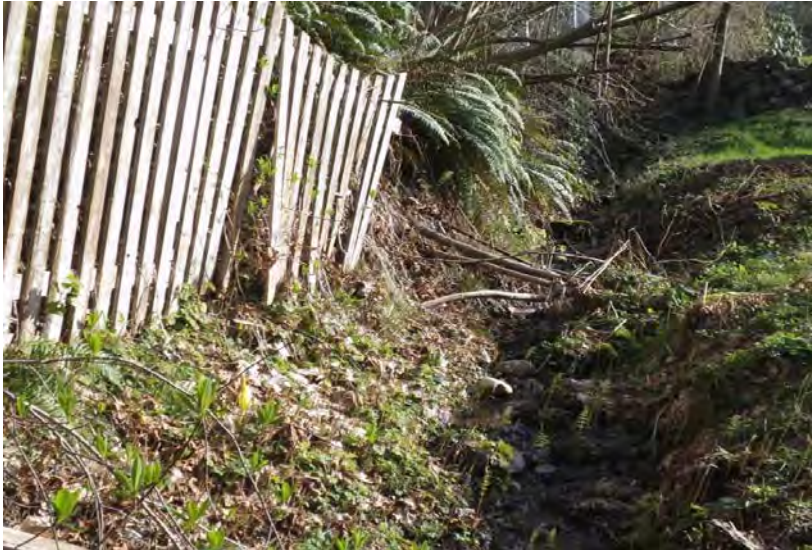
Head of Stream In Back Yard

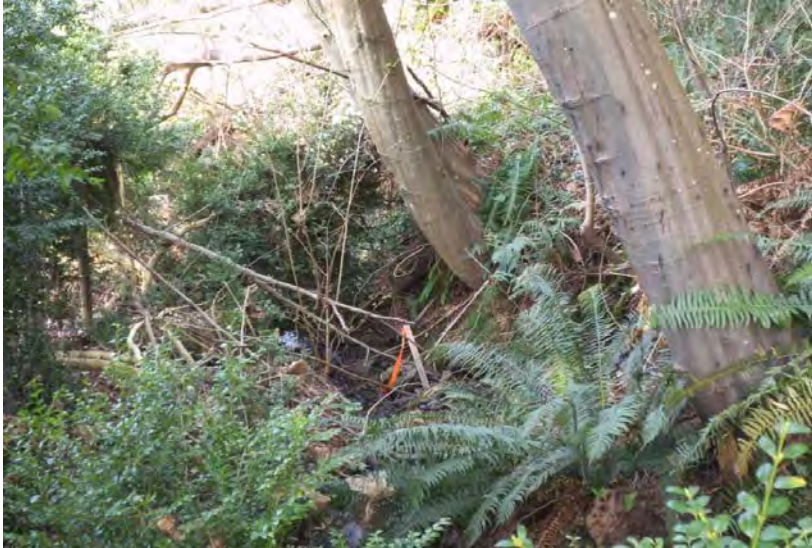
Stream At Northeast Corner of Yard And Slope Above

The slope morphology would tend to direct surface flows or landslides northwards and eventually down the stream track in this property's back yard.

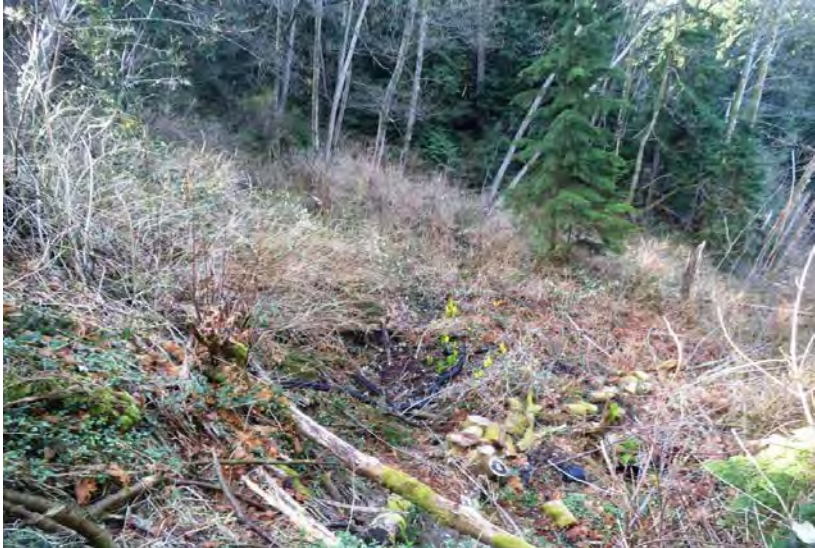
Fill Above Wet Area With Skunk Cabbage

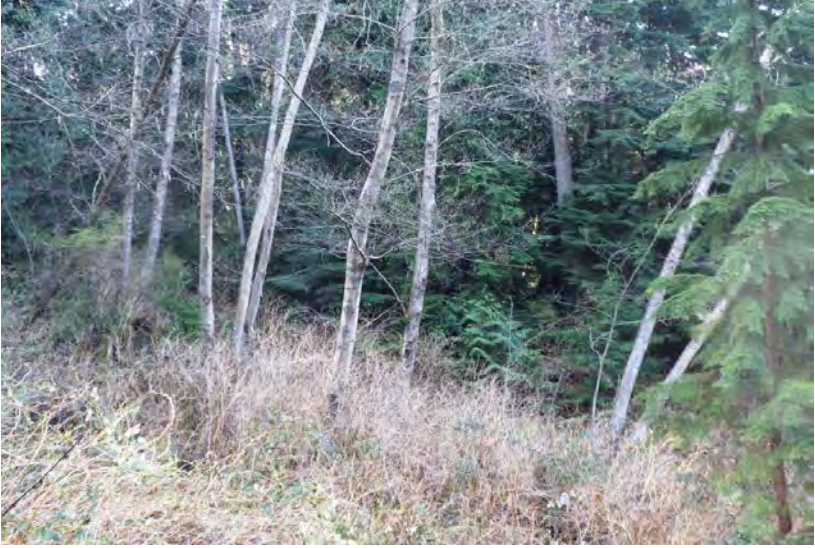
Tipped Maples on South Side of Wide Wet and Cleared Area

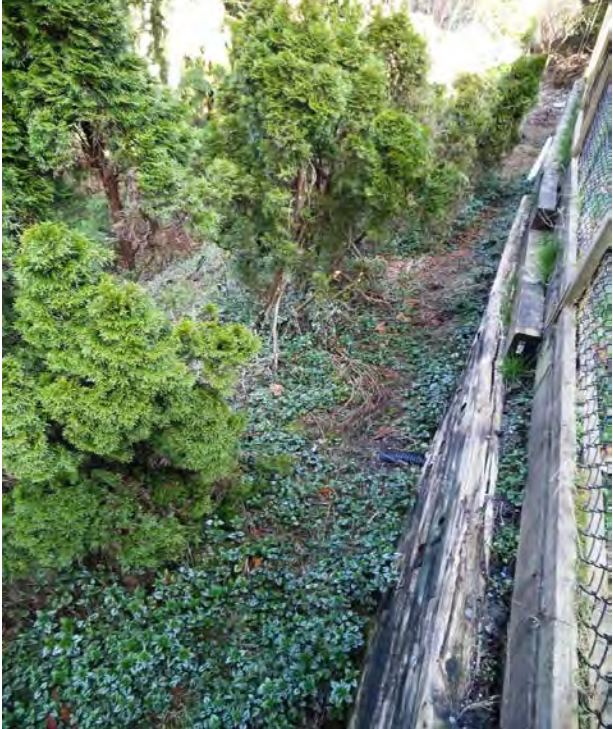
View North Along Wall with Bulge in Centre

The property owner and the City must work together regarding disposal of roof and foundation water as piping it to the steep slope behind the house is unsuitable and may lead to erosion or landslide conditions. The property owner and the City must work together regarding the removal of fill material and construction of any replacement retaining wall.

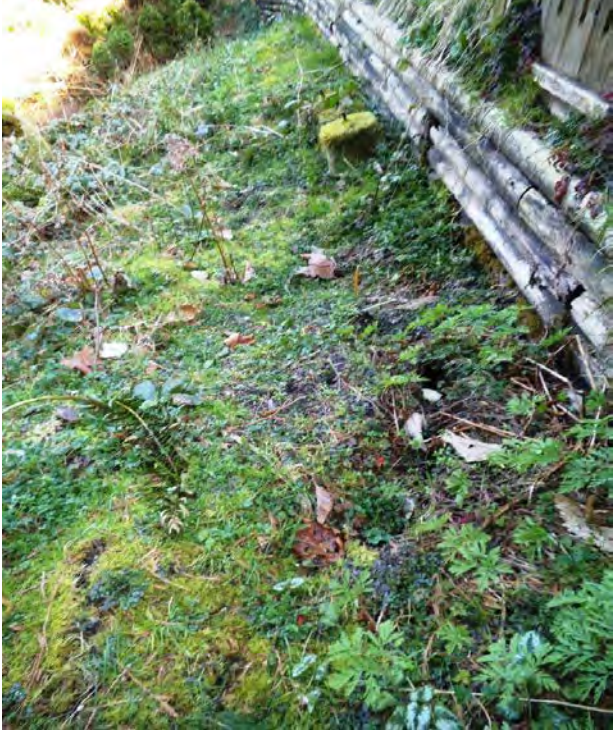
South End of Wall With Tension Crack (Pencil)

The City had Horizon Engineering prepare a geotechnical survey and report regarding the March 2013 subsidence and tension cracking. Summit's slope risk analysis does not preclude or replace any of Horizon's observations or recommendations.

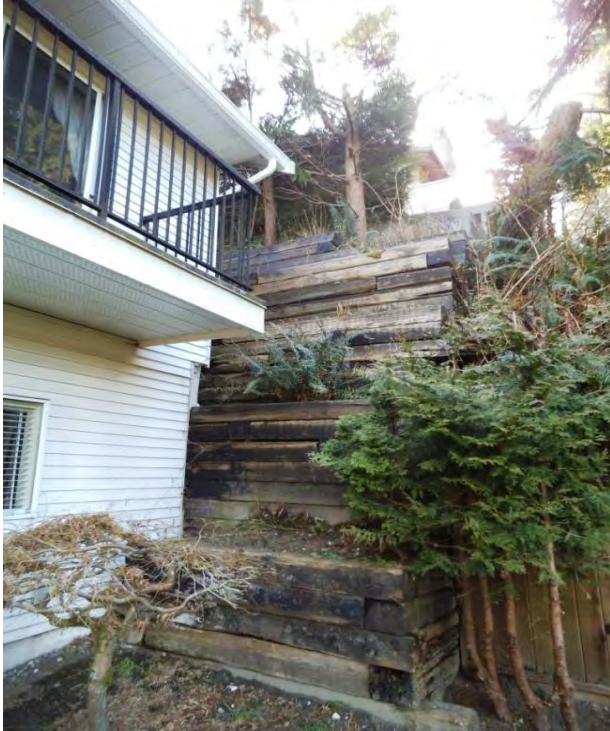
South Property Boundary With Timber Wall/Terraces

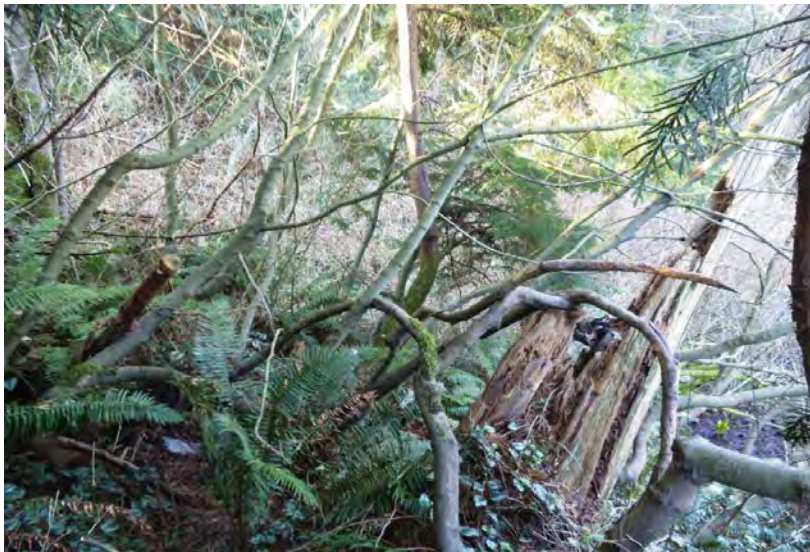
Old Cedar Stump, Now Tipped, At South Edge Wet/Cleared Area

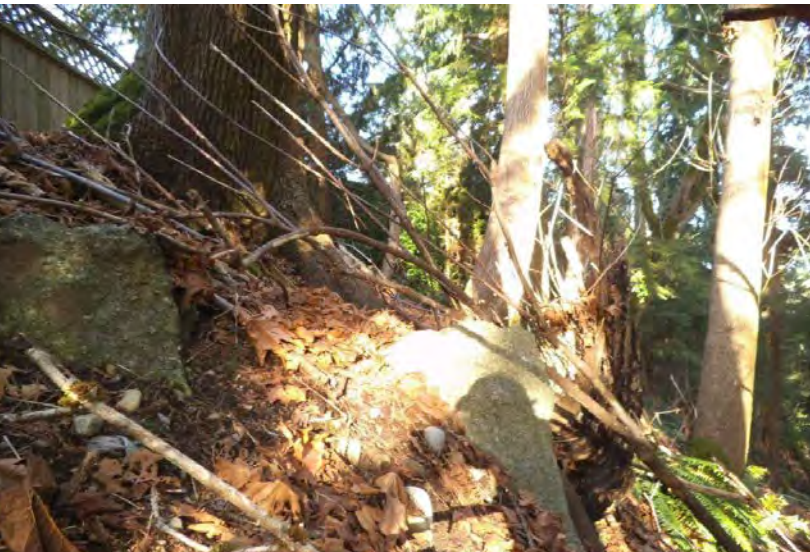
Concrete in Fill Below Crest

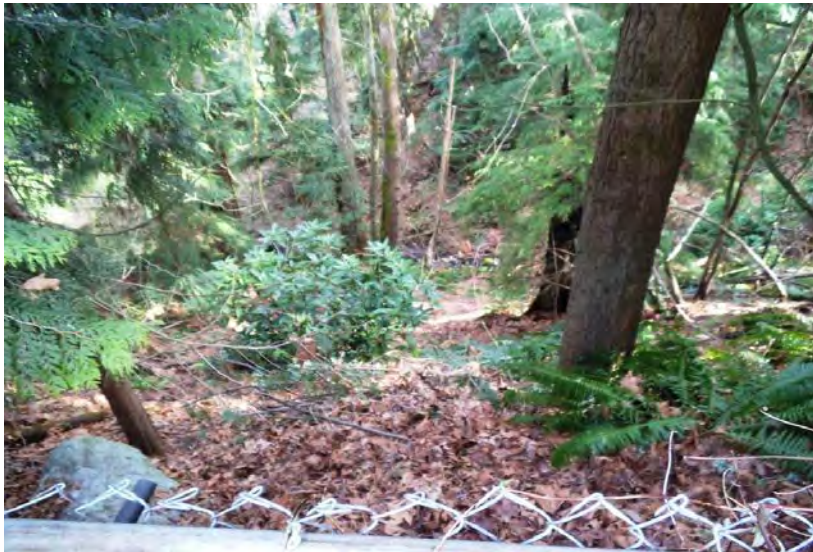
Slope At North End With Drainage Pipe

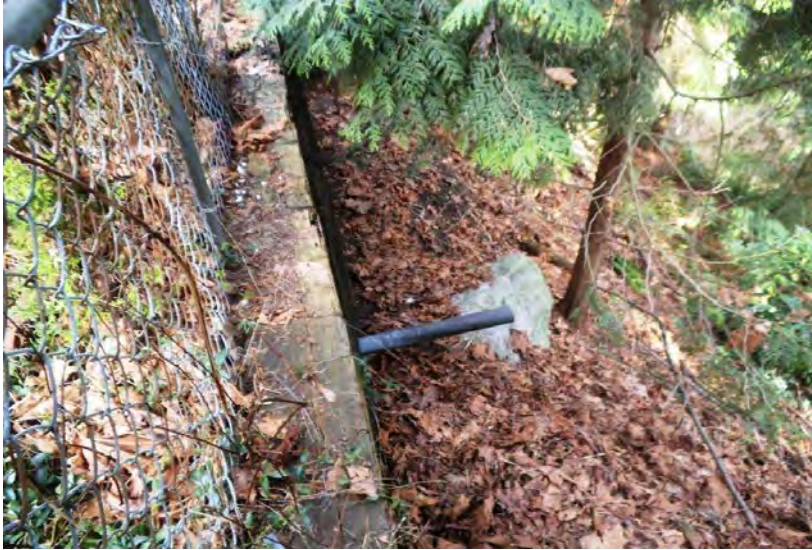
Wood Tie Wall, Northeast Corner, With Drainage Pipe
