Site Observation Form

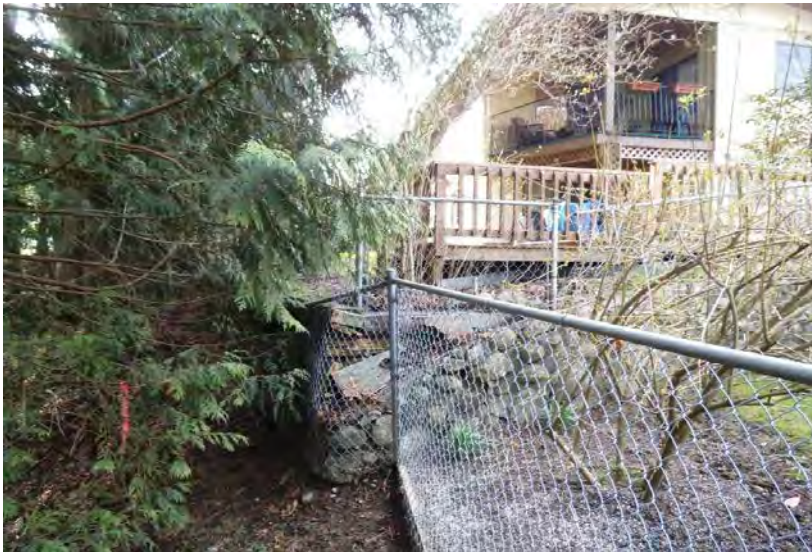
Northeast Corner of Yard With Wood Tie Wall

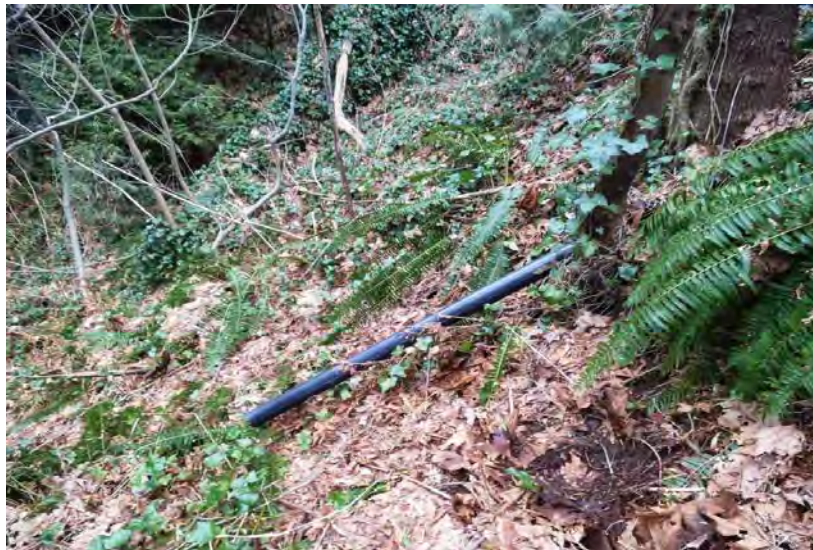
Centre Area Drainage Pipe

The Property Owner and the City must work together regarding disposal of roof and foundation water as piping it to the steep slope behind the house is unsuitable and may lead to erosion or landslide conditions.

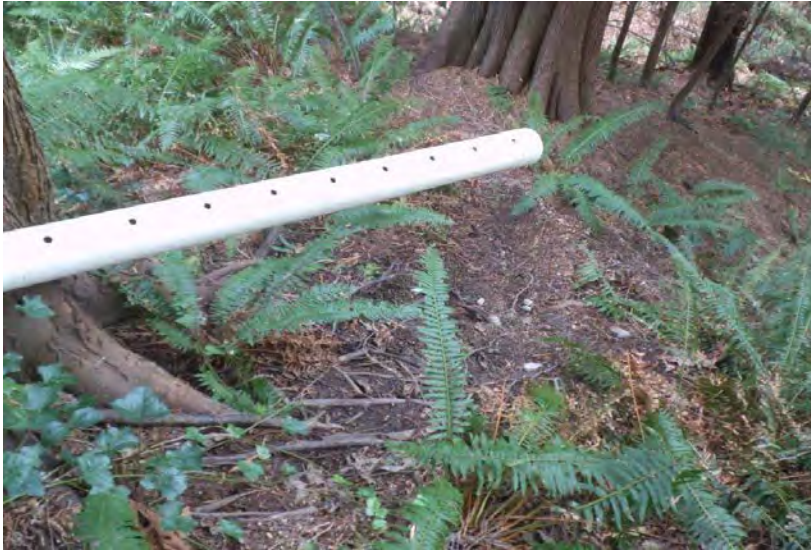
Drainage South Edge, Onto Ridge Between Swales. Some Erosion.

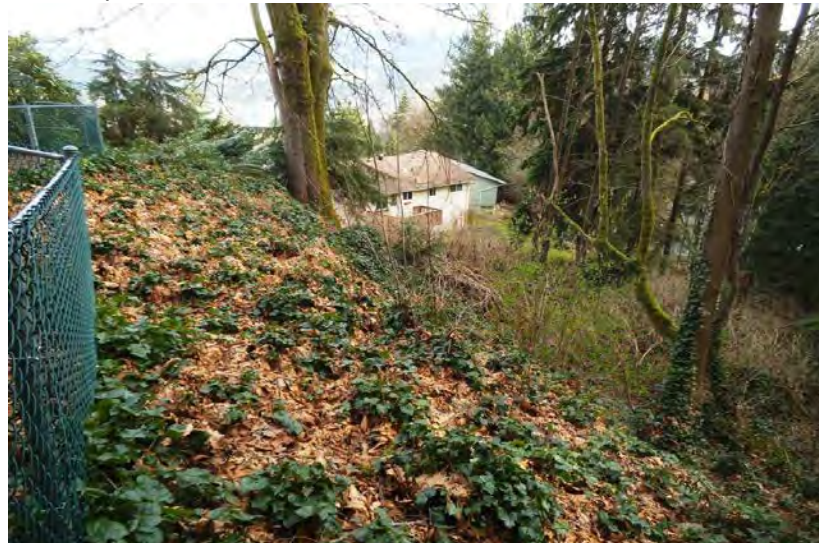
Wet Area East of Property And Slope Above

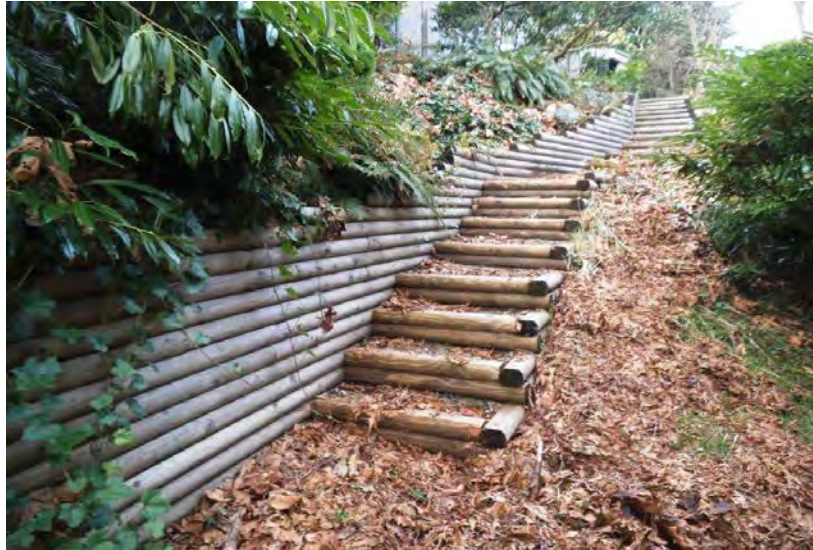
Stairs and Wood Retaining Wall On Slope Below House
